## Phase I - Environmental Site Assessment

Northern Part of 5123 Hawthorne Road  
Ottawa, Ontario

November 20, 2020

Report: PE5100-1

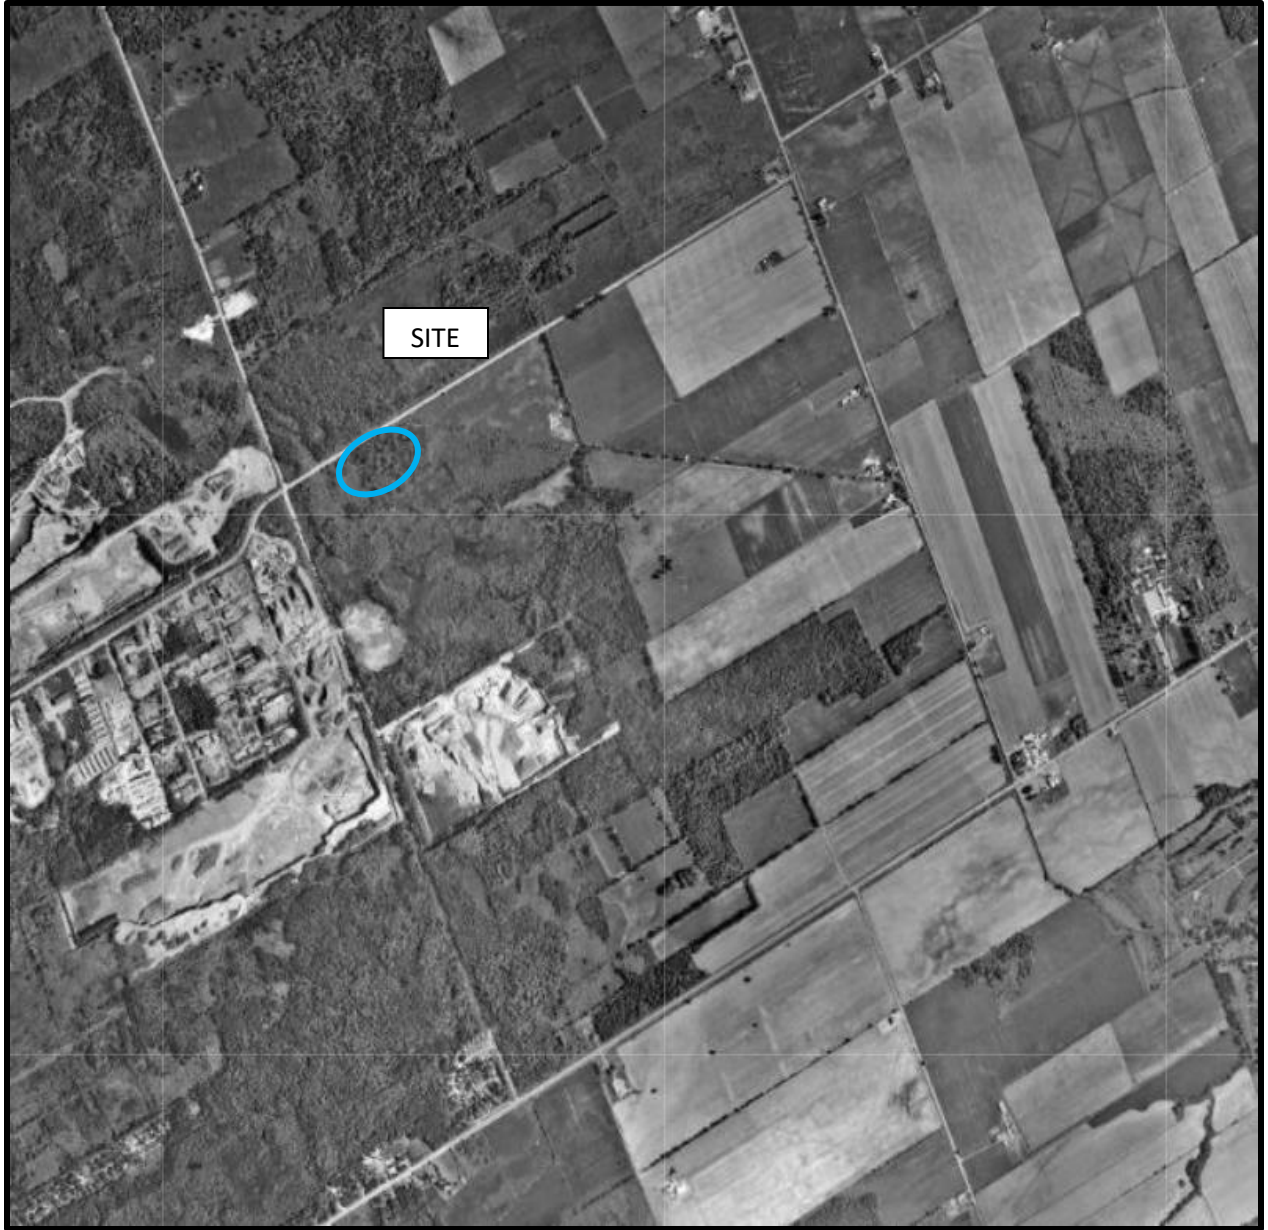
AERIAL PHOTOGRAPH  
1991

- 1991      The subject site and neighbouring lands remain unchanged from the previous photograph.
- 2002      Fill material is being placed on the southeastern portion of the site and the neighbouring lands to the south. appear to be under construction associated with new roadways. A quarry operation is present further west and south. Surrounding lands to the east and southeast are either vacant lands or farmland.

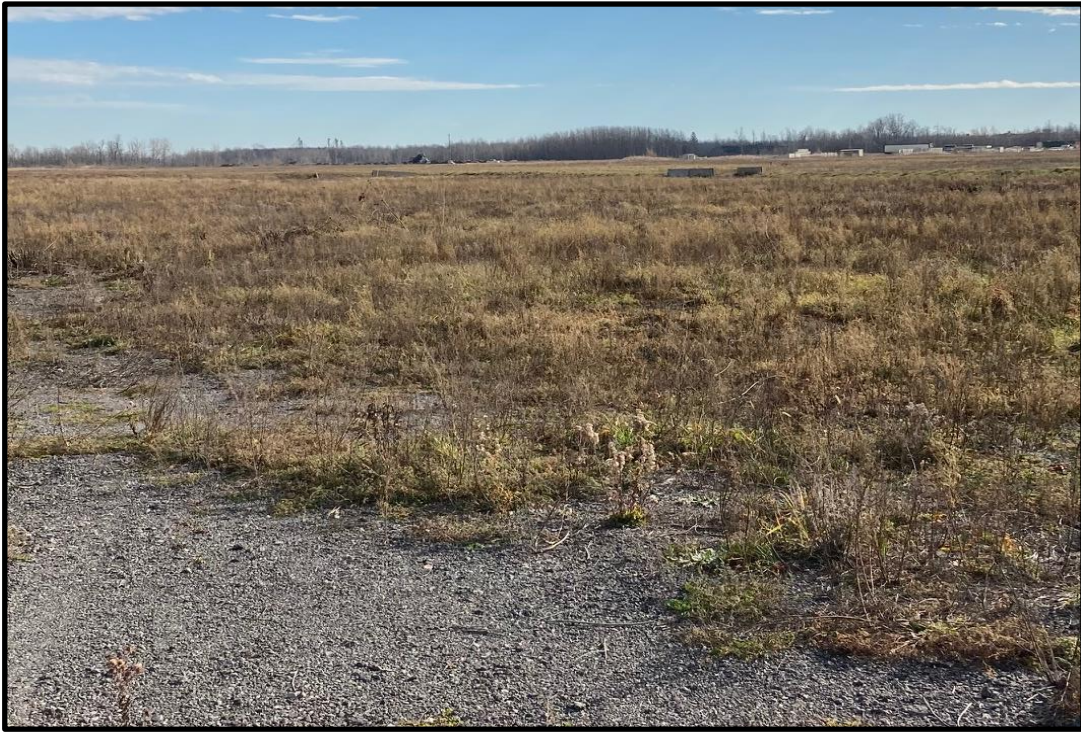
Photograph 1: Eastern view of the Phase I Property, taken from Somme Street.

Imported fill material was observed across the Phase I Property. The unknown quality of the fill material imported on-site between 2002 to 2014 represents an APEC on the Phase I Property.

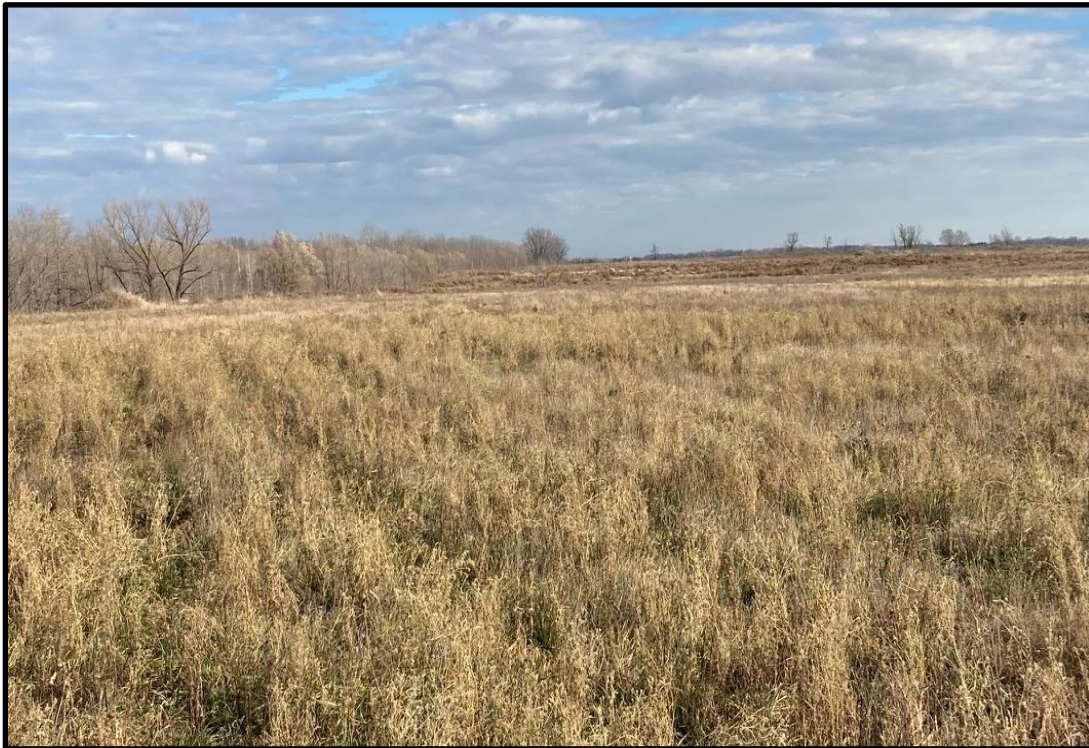
Photograph 2: Central view of the Phase I Property, looking north.
