Hydrogeological and Impact Assessment Report

**Proposed Commercial Development, 301
Somme Street, Ottawa, Ontario**

Consolidated Fastfrate (Ottawa) Holdings Inc.

September 22, 2022

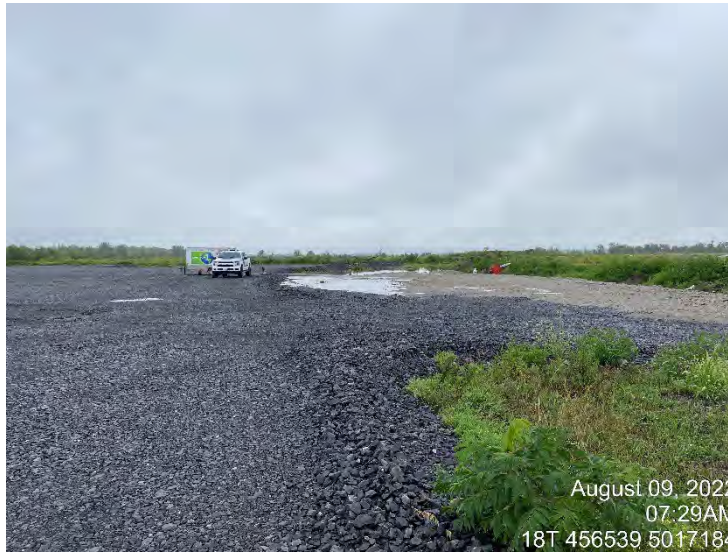
Photo 1 - View of drilled water well on the Site used during pumping test and proposed building area showing ground improvement.

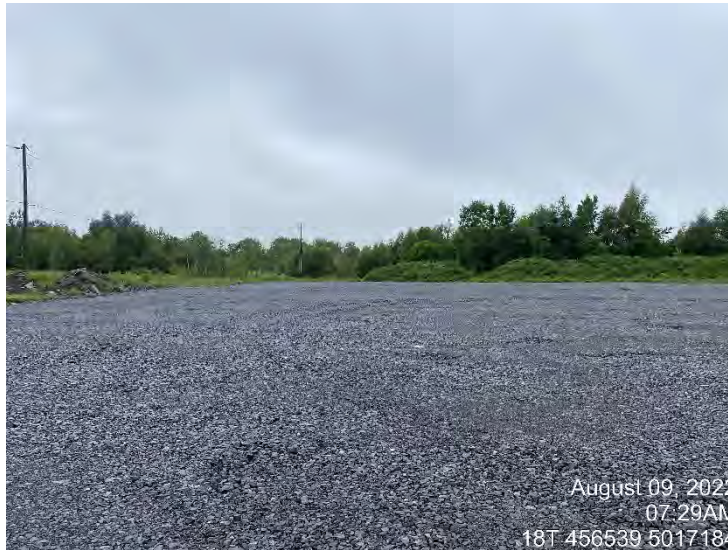
Photo 2 - View of ground improvement area.

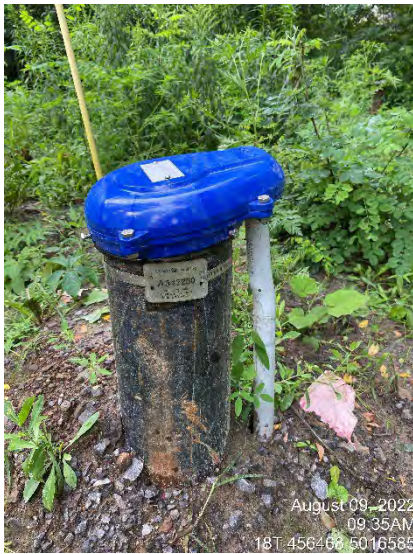
Photo 6 - Observation well (ID A342260) used during pumping test for monitoring of potential interference effects.

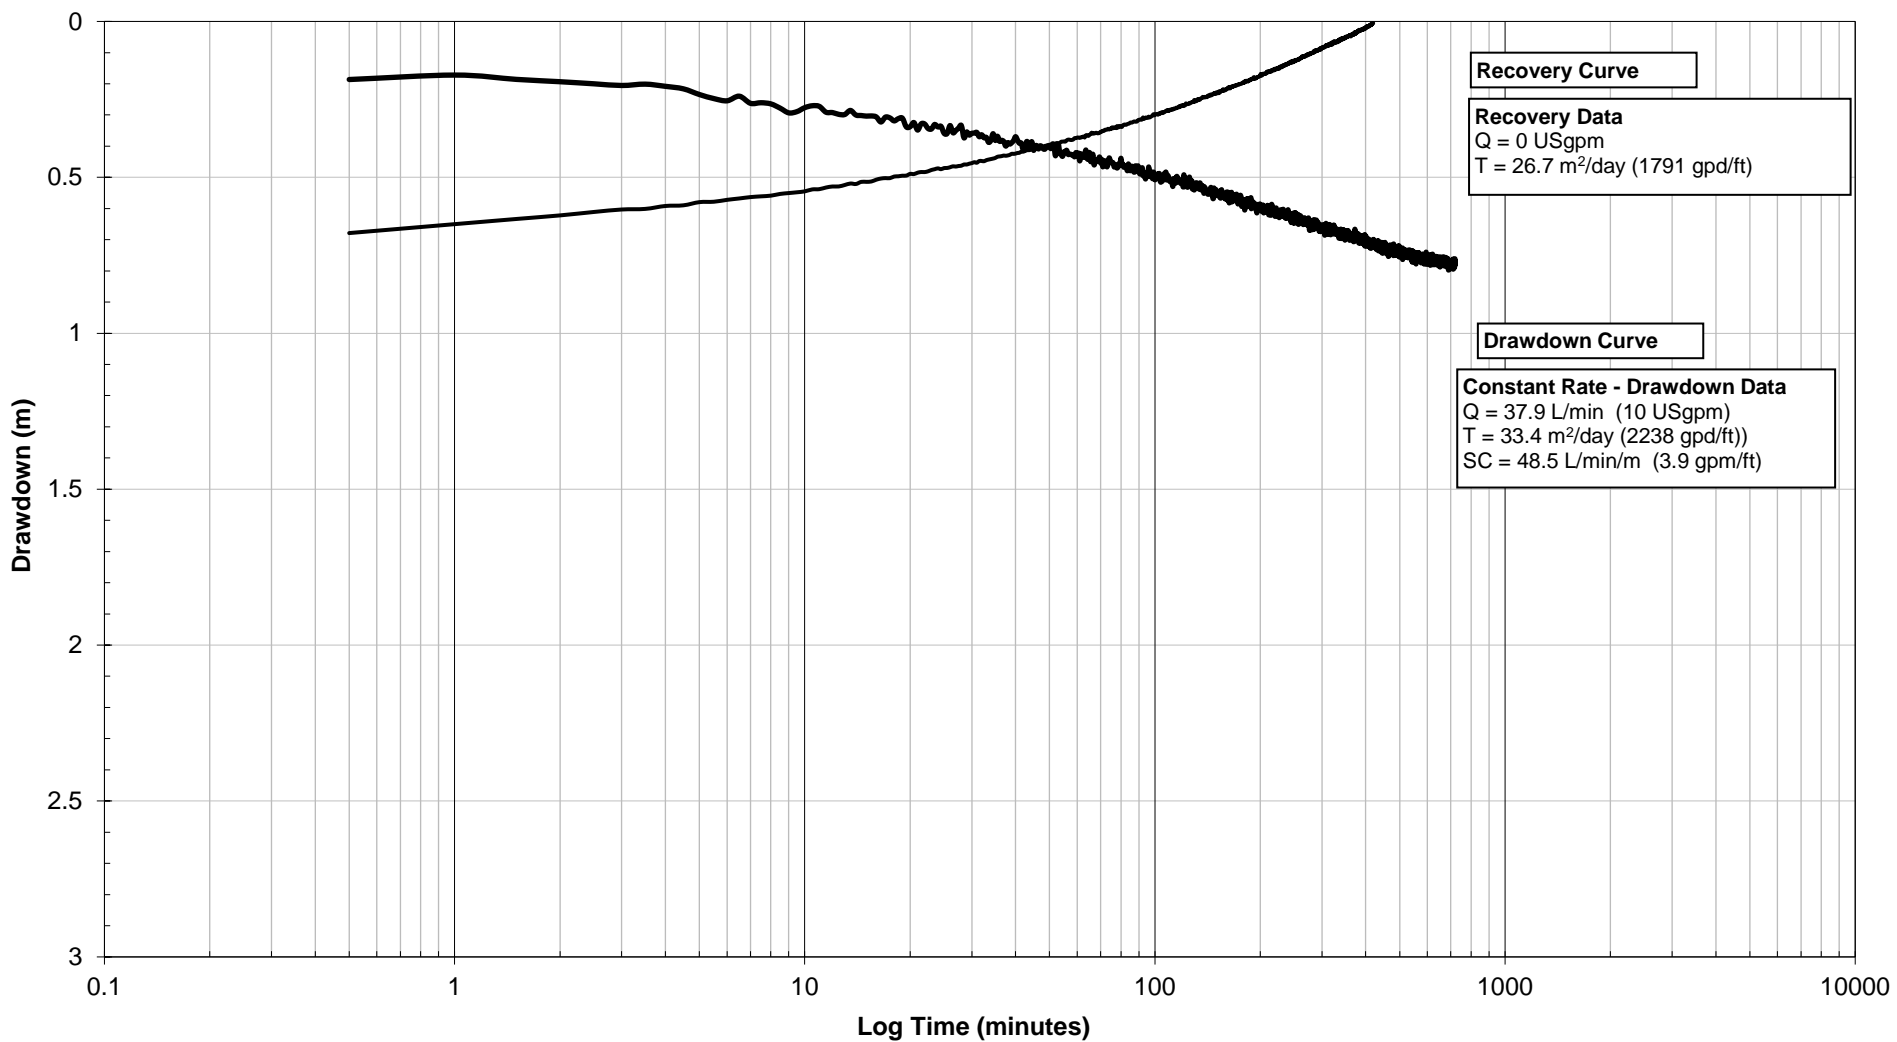
CONSTANT RATE: DRAWDOWN and RECOVERY VS LOG TIME
Well A342117: August 9-10, 2022

TRANSMISSIVITY

Drilled Water Well
 MECP Well ID: A342117

GHD completed a constant rate pumping test of well A342117 on August 9, 2022 to assess aquifer conditions and evaluate the availability of a suitable groundwater resource for the proposed commercial development. The pumping test was conducted for twelve (12) hours at a constant rate of 37.8 L/min (10 gpm). Recovery measurements were collected after the pumping was completed.
