July 26, 2022
File: PE5100-LET.03

Subject: **Phase I-Environmental Site Assessment Update**
301 Somme Street
Ottawa, Ontario

FASTFRATE (OTTAWA) HOLDINGS INC.
PHASE I - ENVIRONMENTAL SITE ASSESSMENT UPDATE
 301 SOMME STREET
 OTTAWA, ONTARIO
Title: SITE PLAN

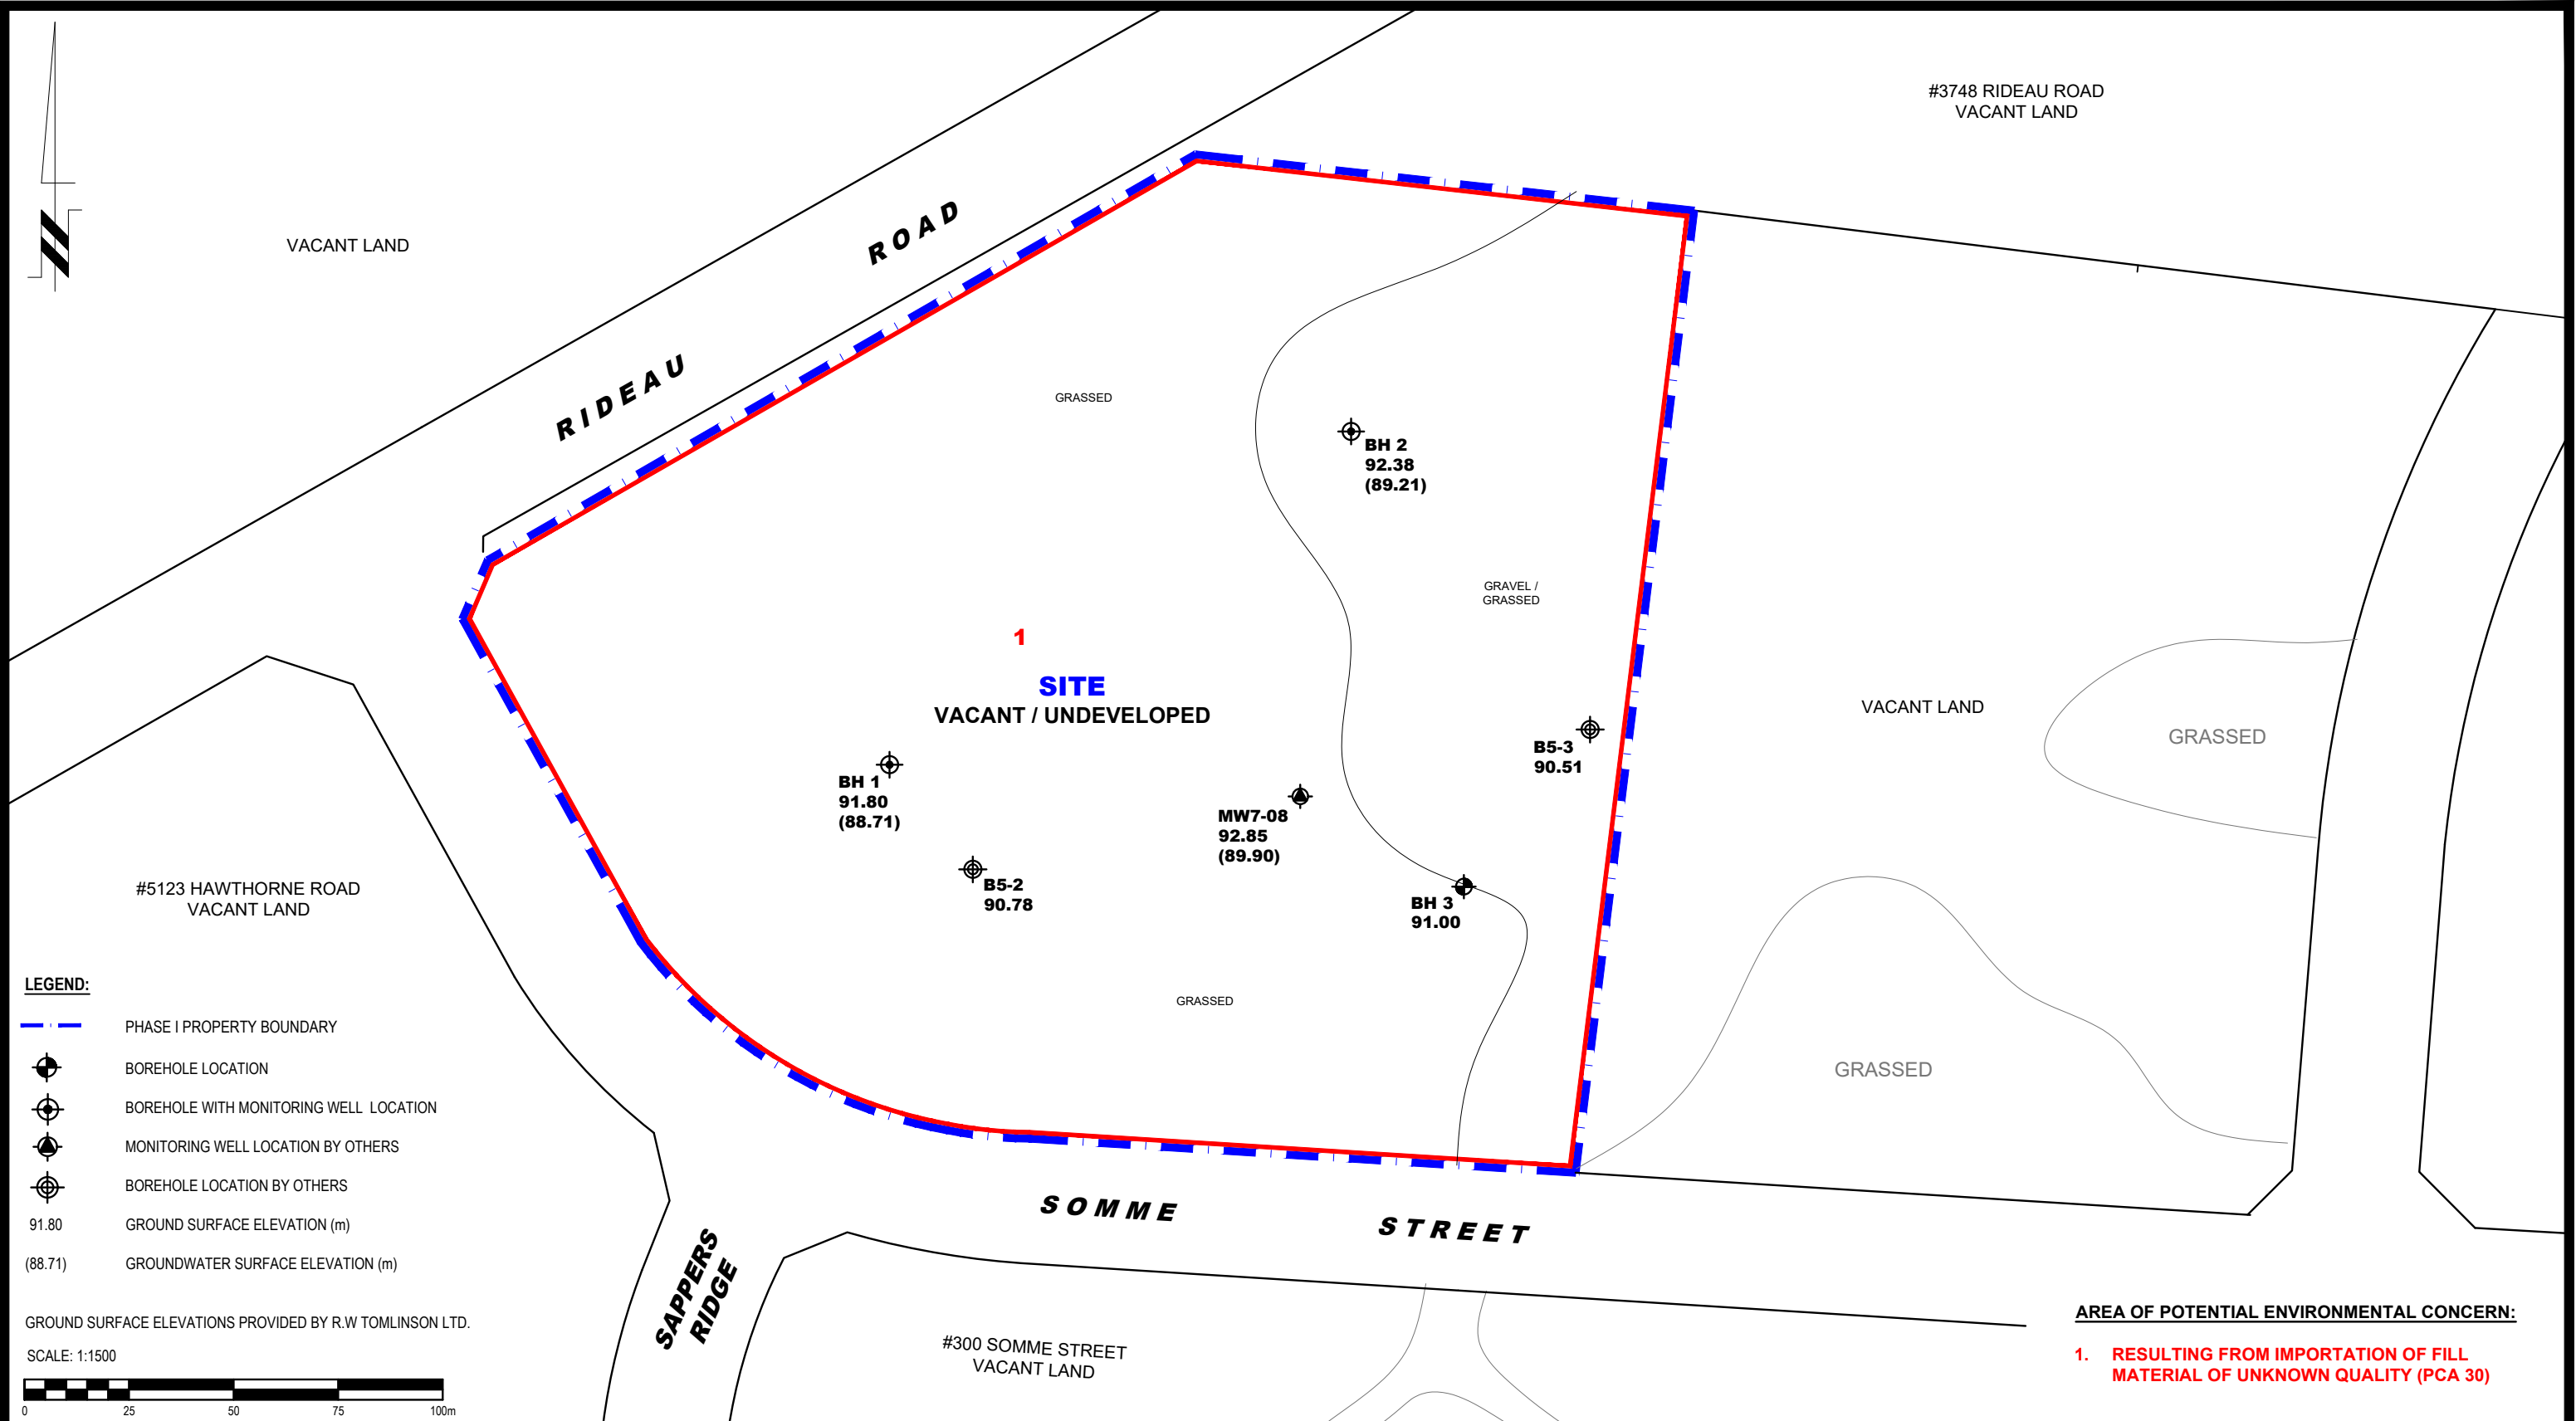
Site drainage on the Phase I Property consists primarily of surface infiltration throughout the property. No evidence of any above ground storage tanks, underground storage tanks or unidentified substances were observed on-site at this time.

No ponded water or signs of staining or indications of potential sub-surface contamination were observed at the time of the site visit.

No evidence of current or former railway or spur lines was observed on the Phase I Property at the time of the site visit. No new Potentially Contaminating Activities (PCAs) were identified on the Phase I Property.
