Phase I Environmental Site Assessment

Vacant Land
807 – 825 Montreal Road
Ottawa, Ontario

June 23, 2015

Report: PE3563-1

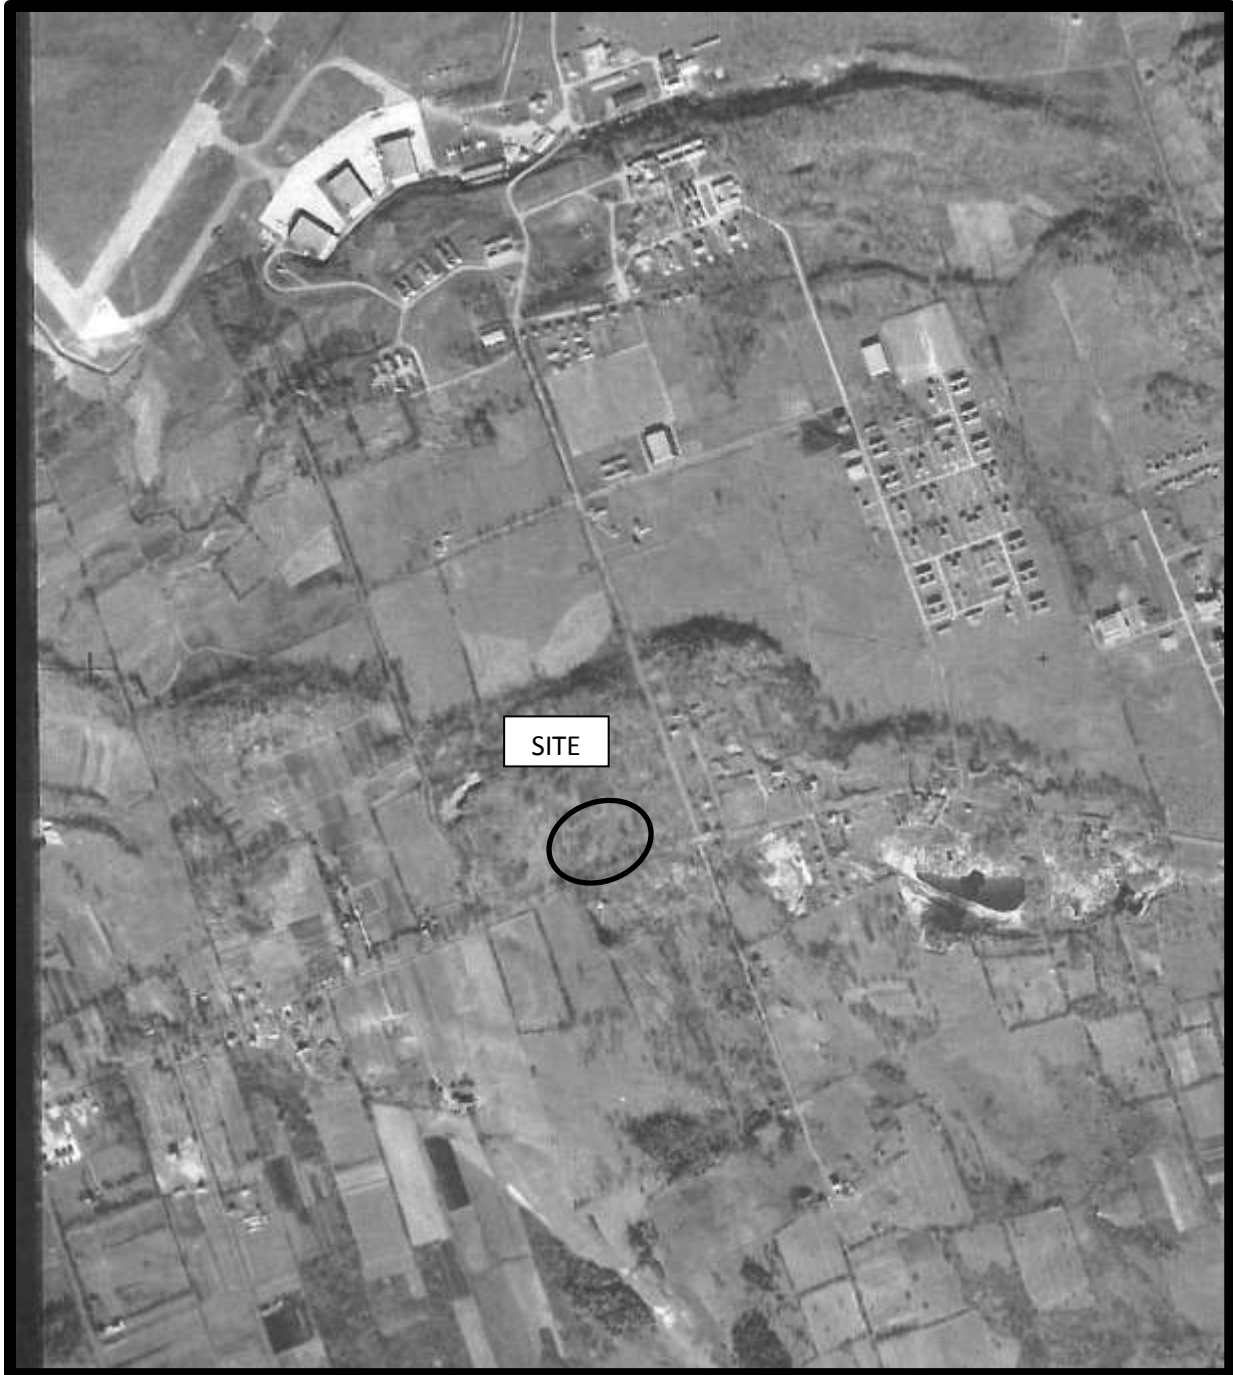
AERIAL PHOTOGRAPH
1945

| 1945 | The subject site and neighbouring properties are vacant and treed. A quarry is visible to the east of the subject site along Montreal Road. |

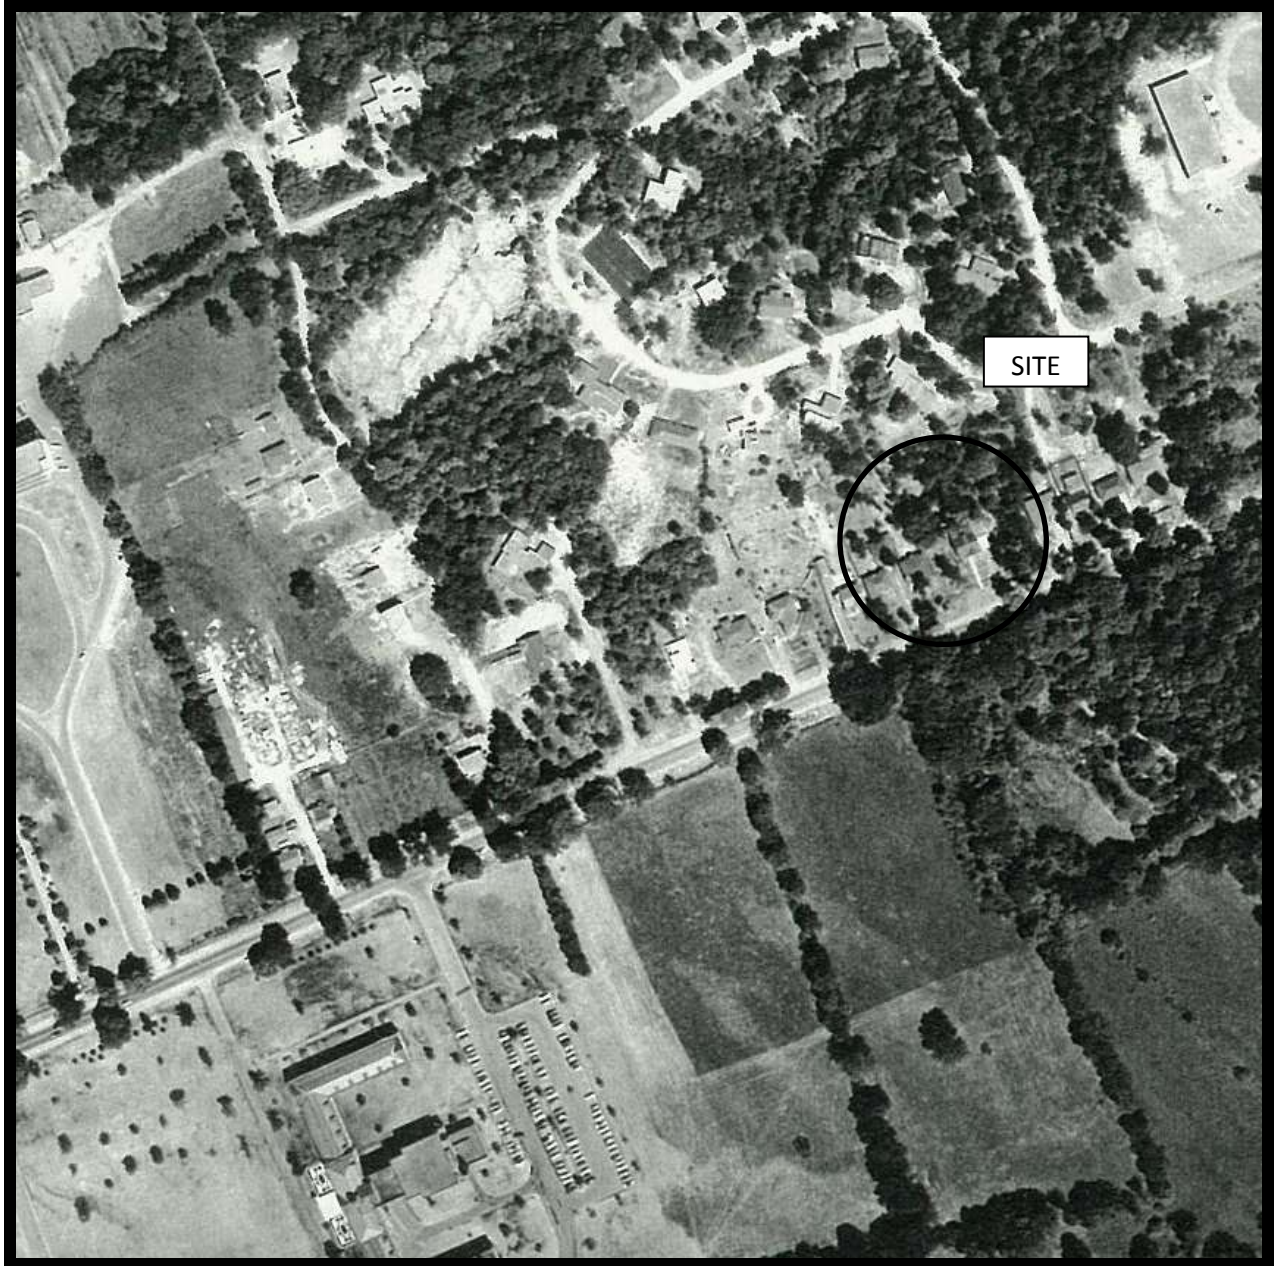
AERIAL PHOTOGRAPH
1955

| 1955 | The subject site and neighbouring properties to the north of Montreal Road are used for residential purposes. The subject site is occupied by three (3) residential dwellings. |

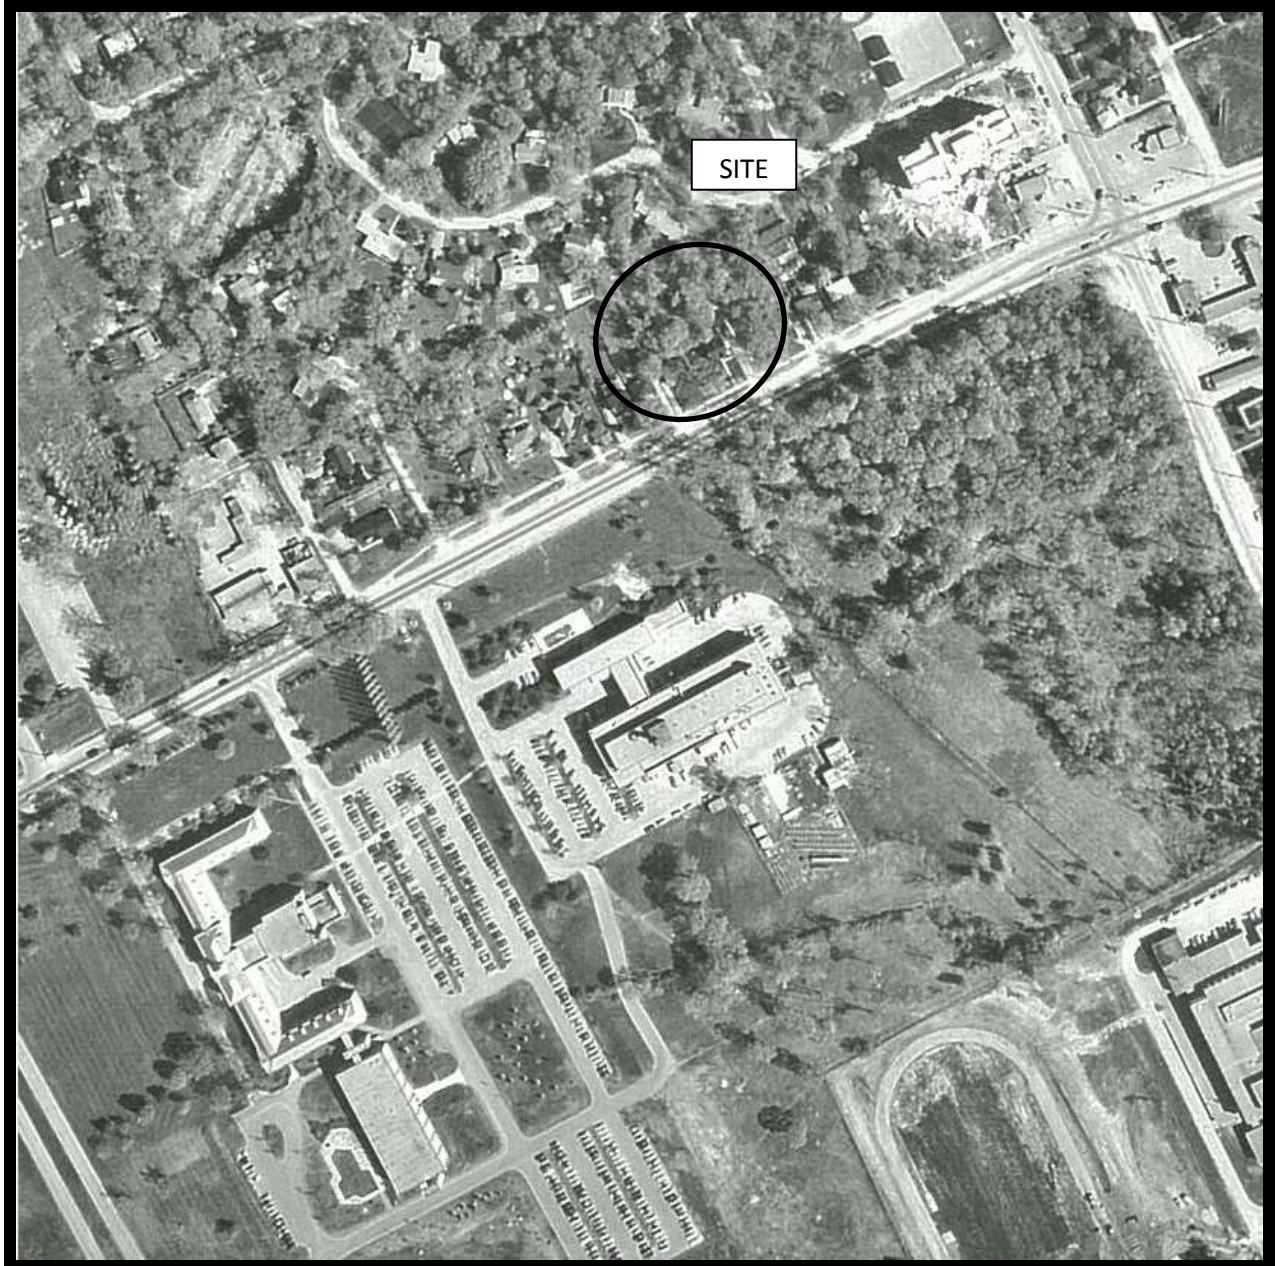
AERIAL PHOTOGRAPH
1973

| 1973 | No significant changes have been made to the subject site. A residential apartment building is being developed at 860 Blackthorne Avenue, 60 meters to the east of the subject site. Commercial and office buildings have been developed to the east and west along Montreal Road. A small quarry pit is visible approximately 120 meters to the northwest. |

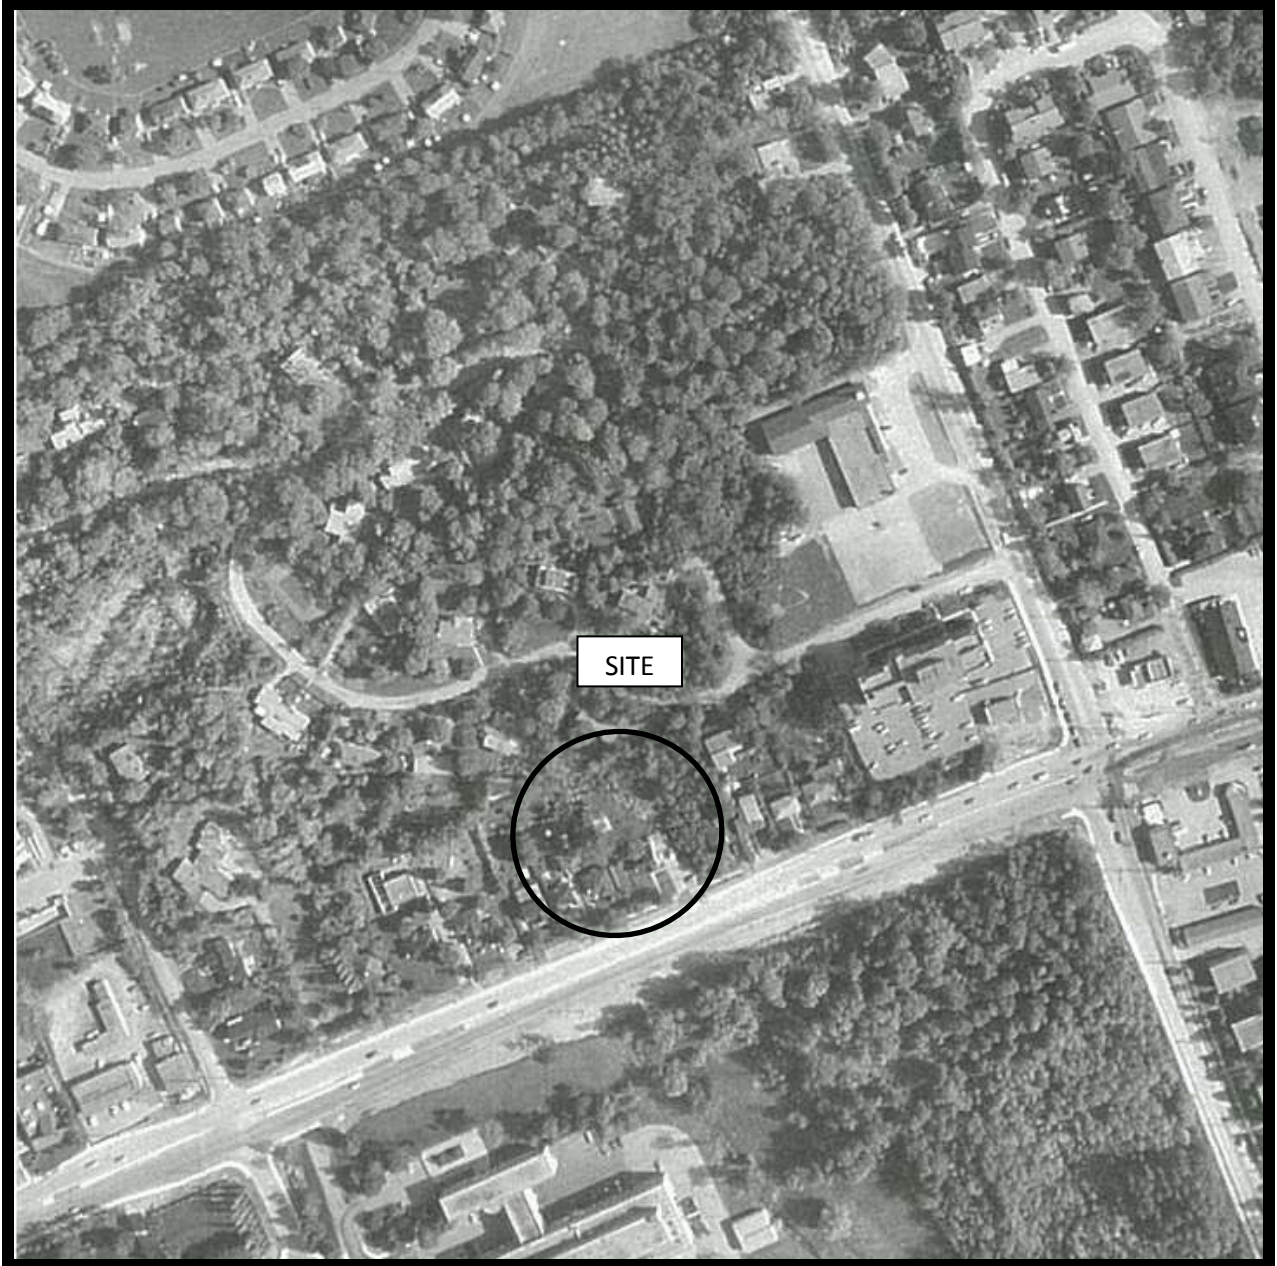
AERIAL PHOTOGRAPH
1984

| 1984 | No significant changes have been made to the subject site or neighbouring properties. |

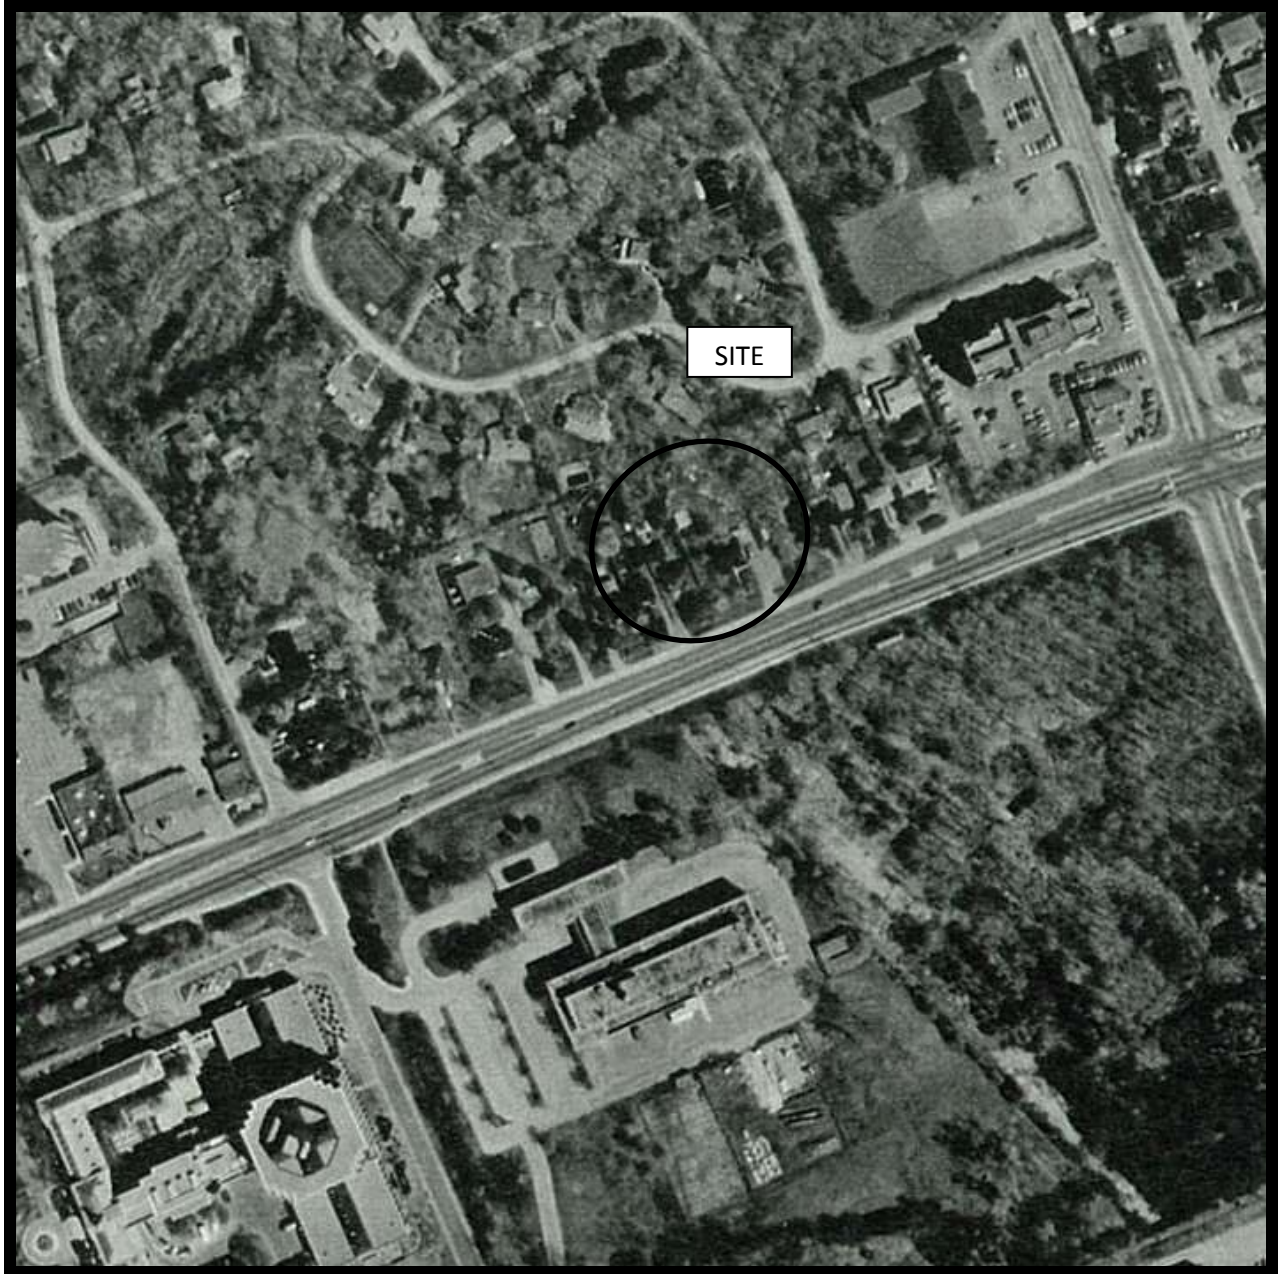
AERIAL PHOTOGRAPH
1993

| 1993 | No significant changes have been made to the subject site or neighbouring properties. |

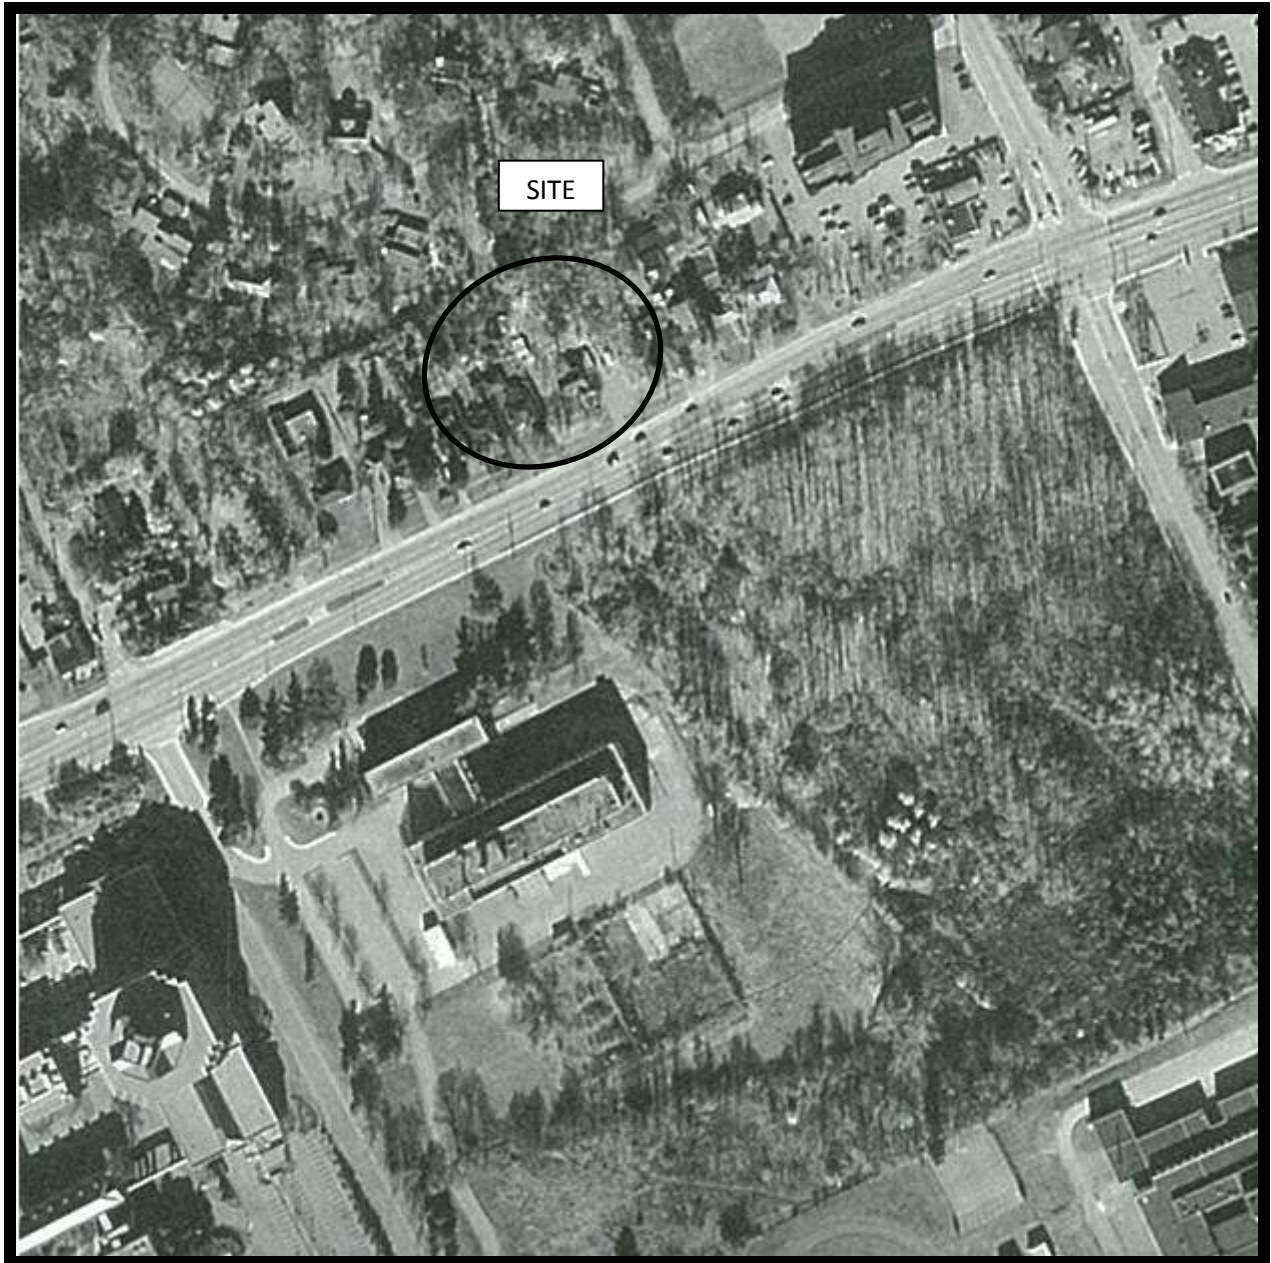
AERIAL PHOTOGRAPH
1997

| 1997 | No significant changes have been made to the subject site or neighbouring properties. |

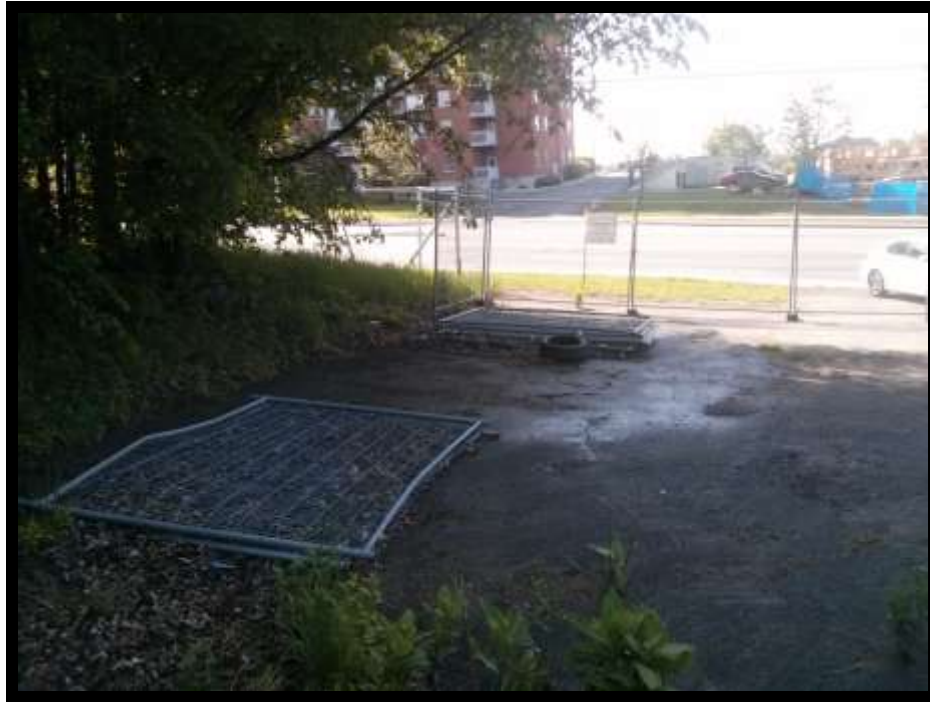
Photograph 1: View of the driveway of the former residential dwelling addressed 817 Montreal Road, facing southeast.

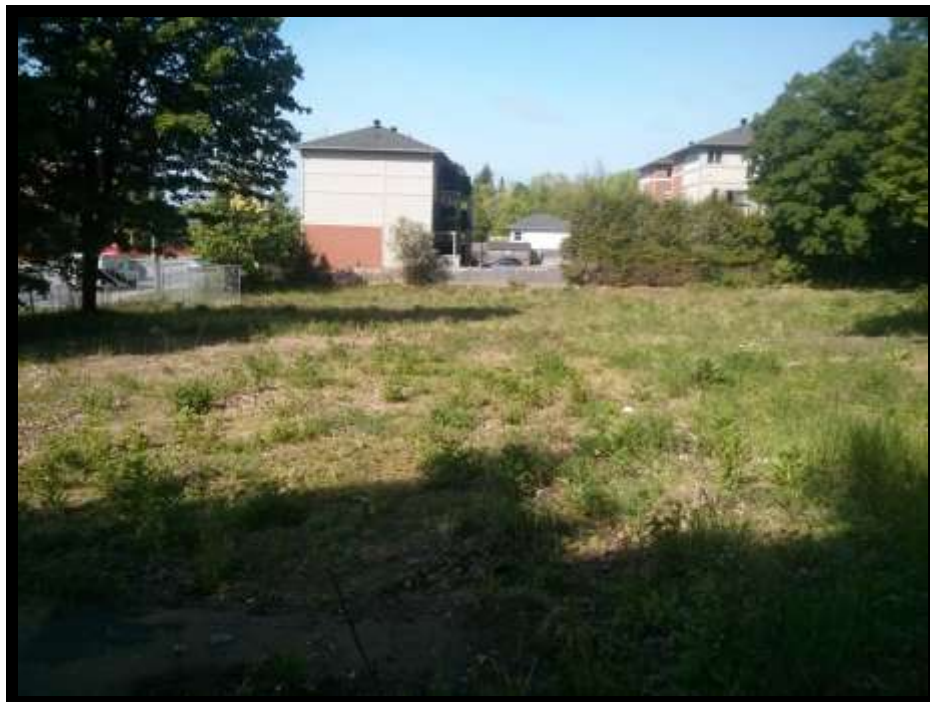
Photograph 2: View across the subject site, facing west.

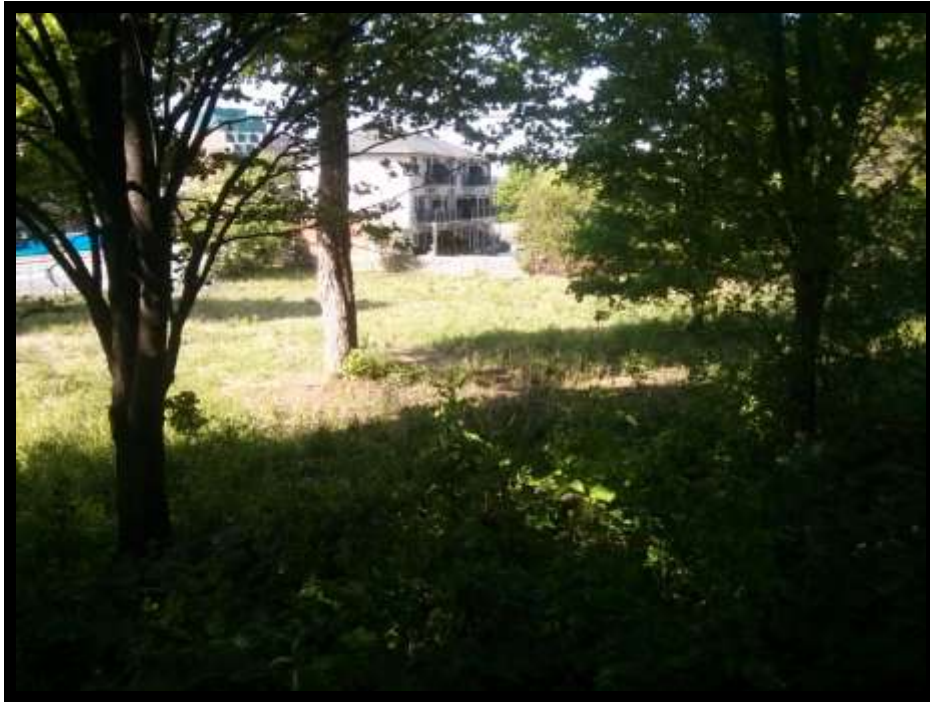
Photograph 3: View across the subject site from the wooded area, facing southwest.

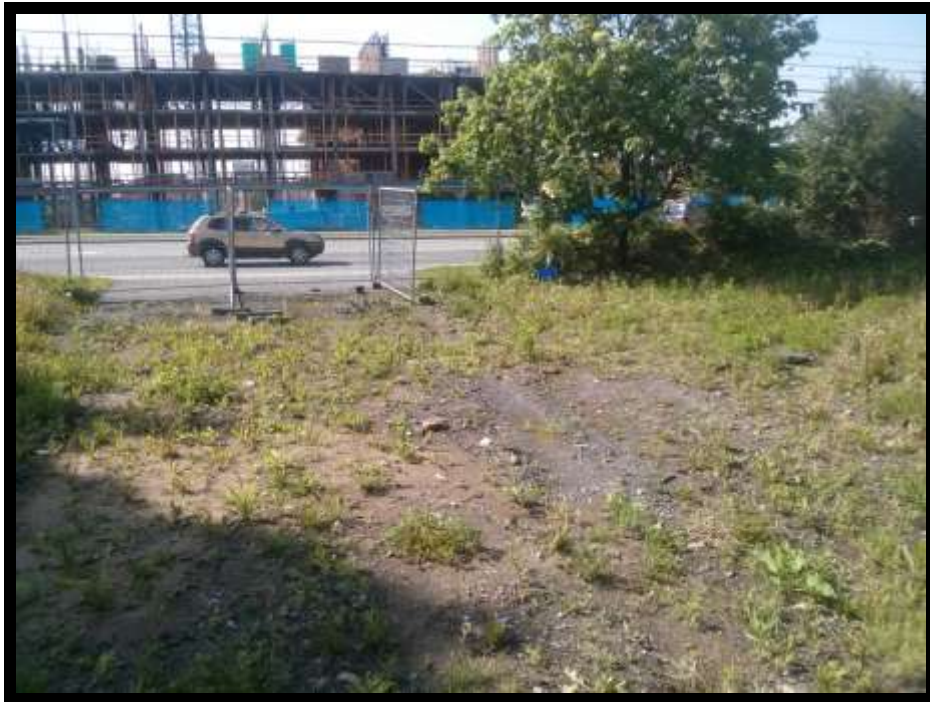
Photograph 4: View of the former driveway for 807 and 811 Montreal Road, facing south.

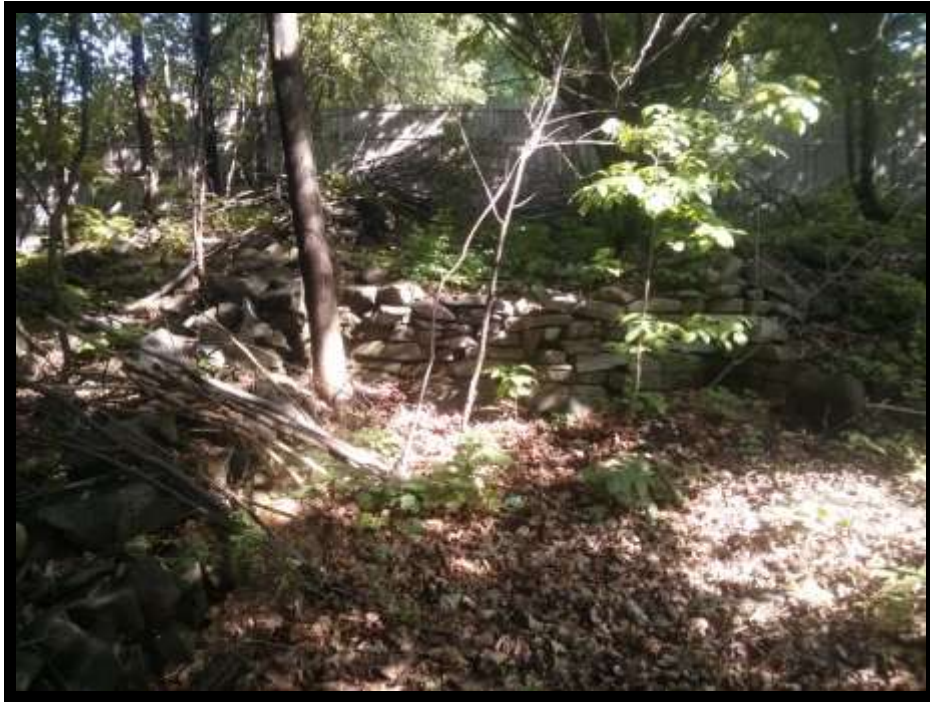
Photograph 5: Stone retaining wall located at the back of the property, facing north.

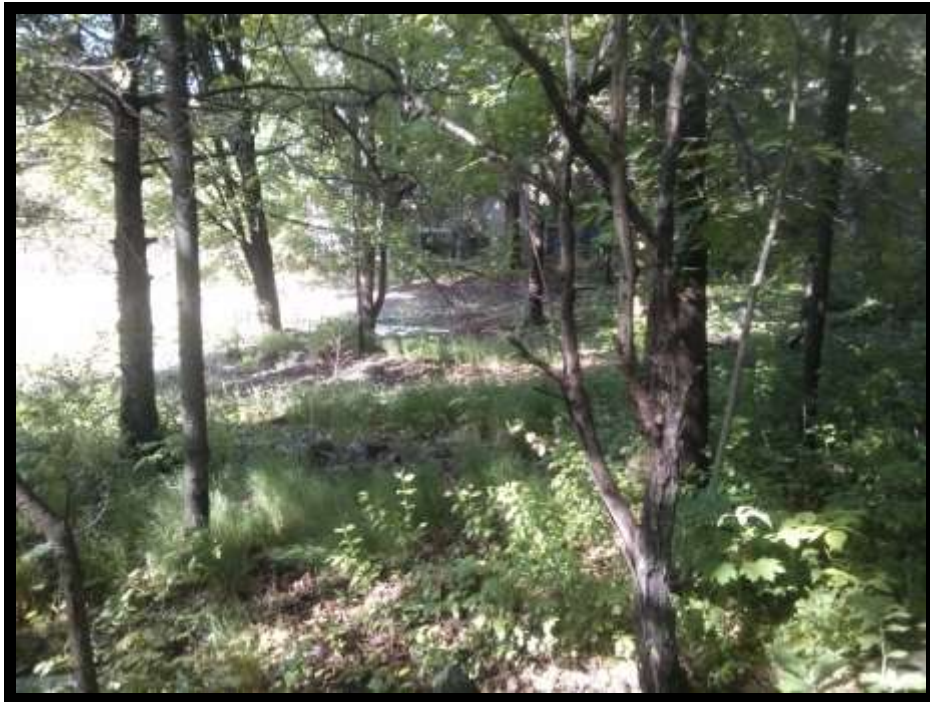
Photograph 6: View across the wooded area of the property, facing west.
