Phase I Environmental Site Assessment

Vacant and Agricultural Property
Terry Fox Drive at Cope Drive
Ottawa, Ontario

May 8, 2018

Report: PE4263-1

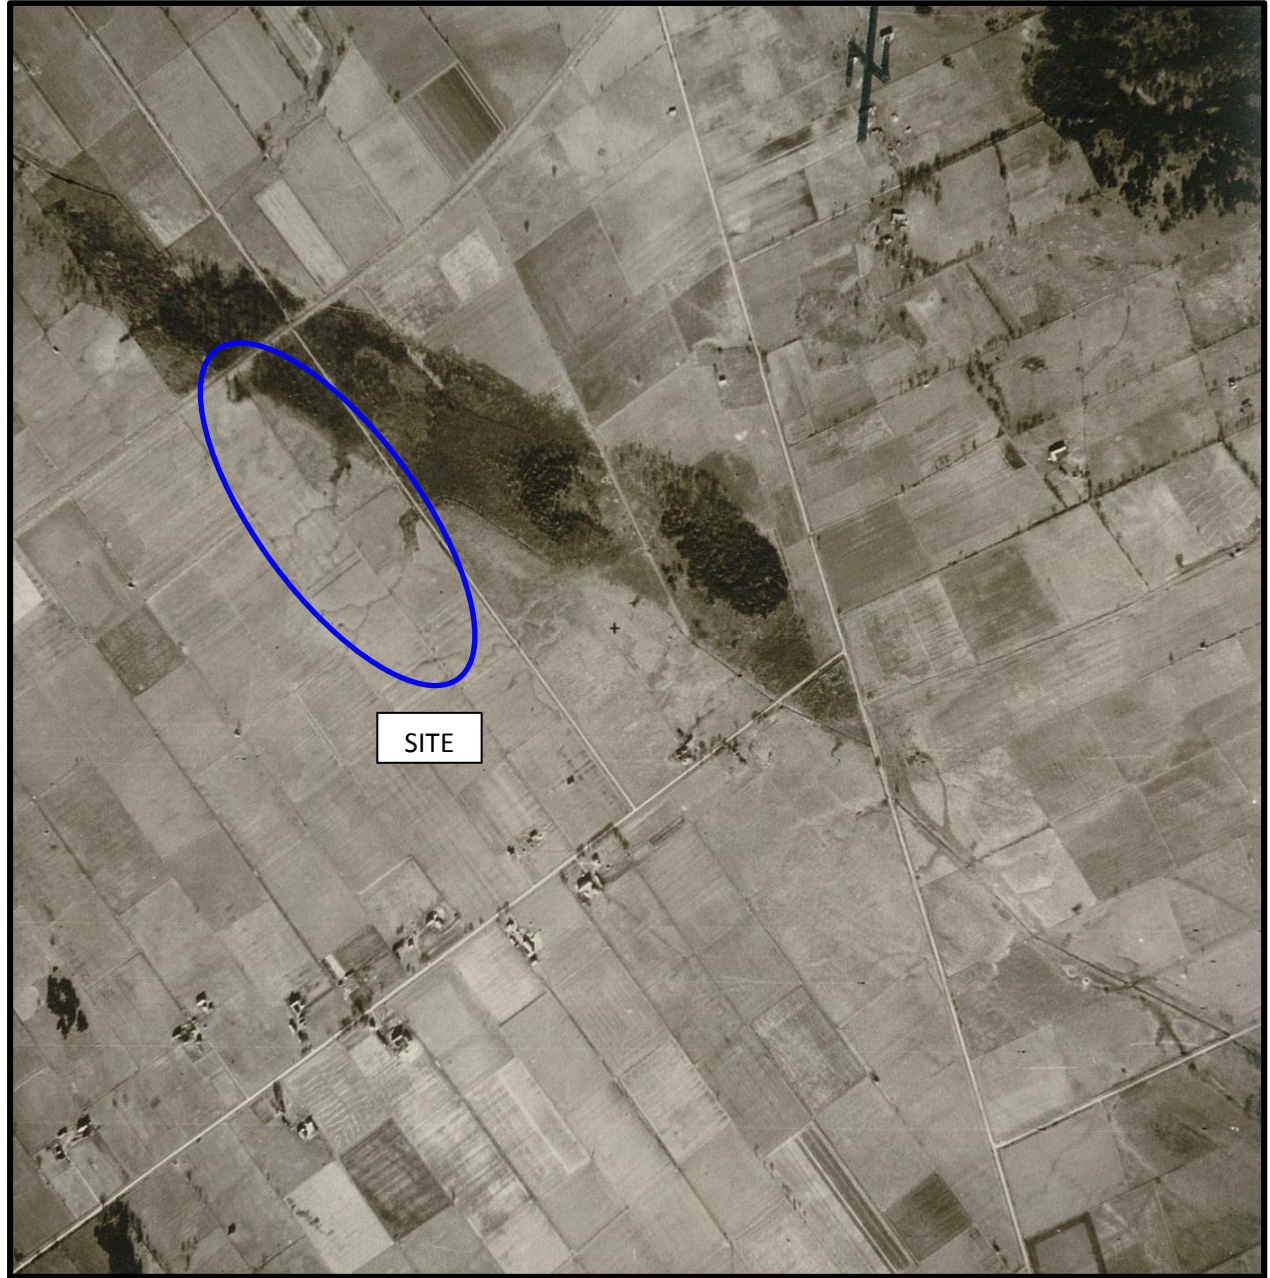
AERIAL PHOTOGRAPH
1945

| 1945 | The subject site is a vacant agricultural field, with some tree cover in the northeast corner. Two creeks or drainage ditches traverse the central part of the site. Surrounding properties are also agricultural fields, with the exception of a woodland to the northeast. Hazeldean Side Road is visible on the east side of the subject site, and a railroad is present along the northern border of the site. |

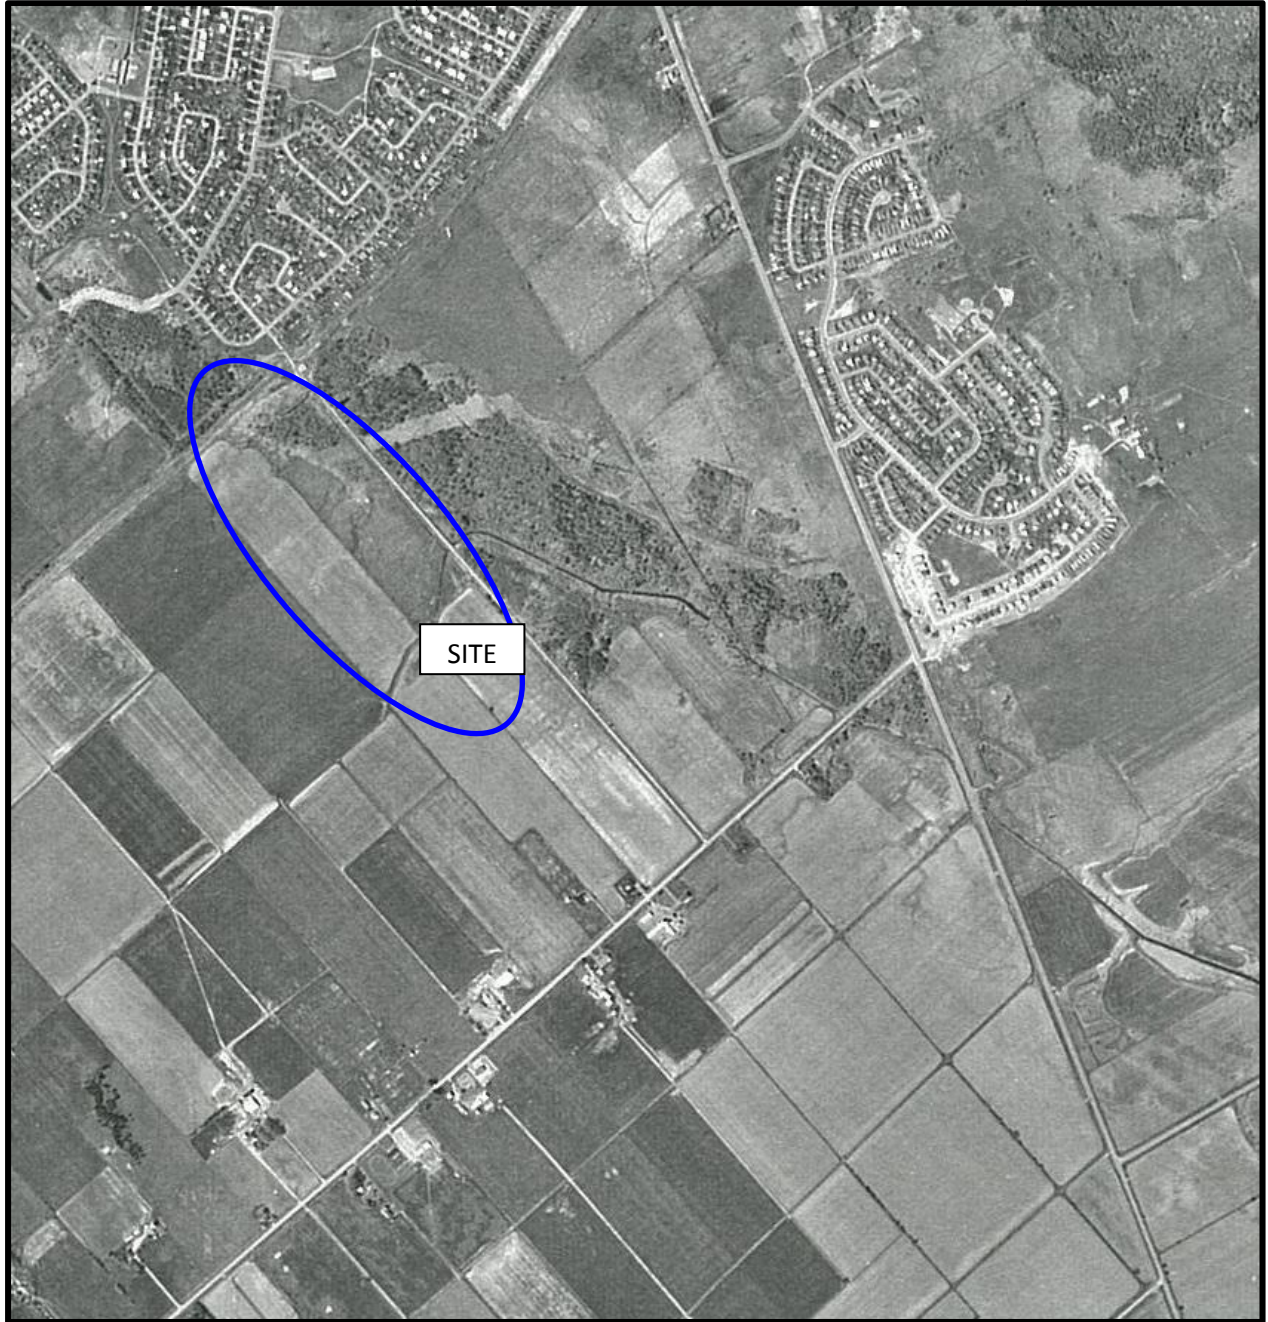
AERIAL PHOTOGRAPH
1984

| 1984 | No changes have been made to the subject site or properties in the Phase I study area. The railroad to the north appears to have been removed. Residential developments are present further to the east, on the east side of Eagleson Road. |

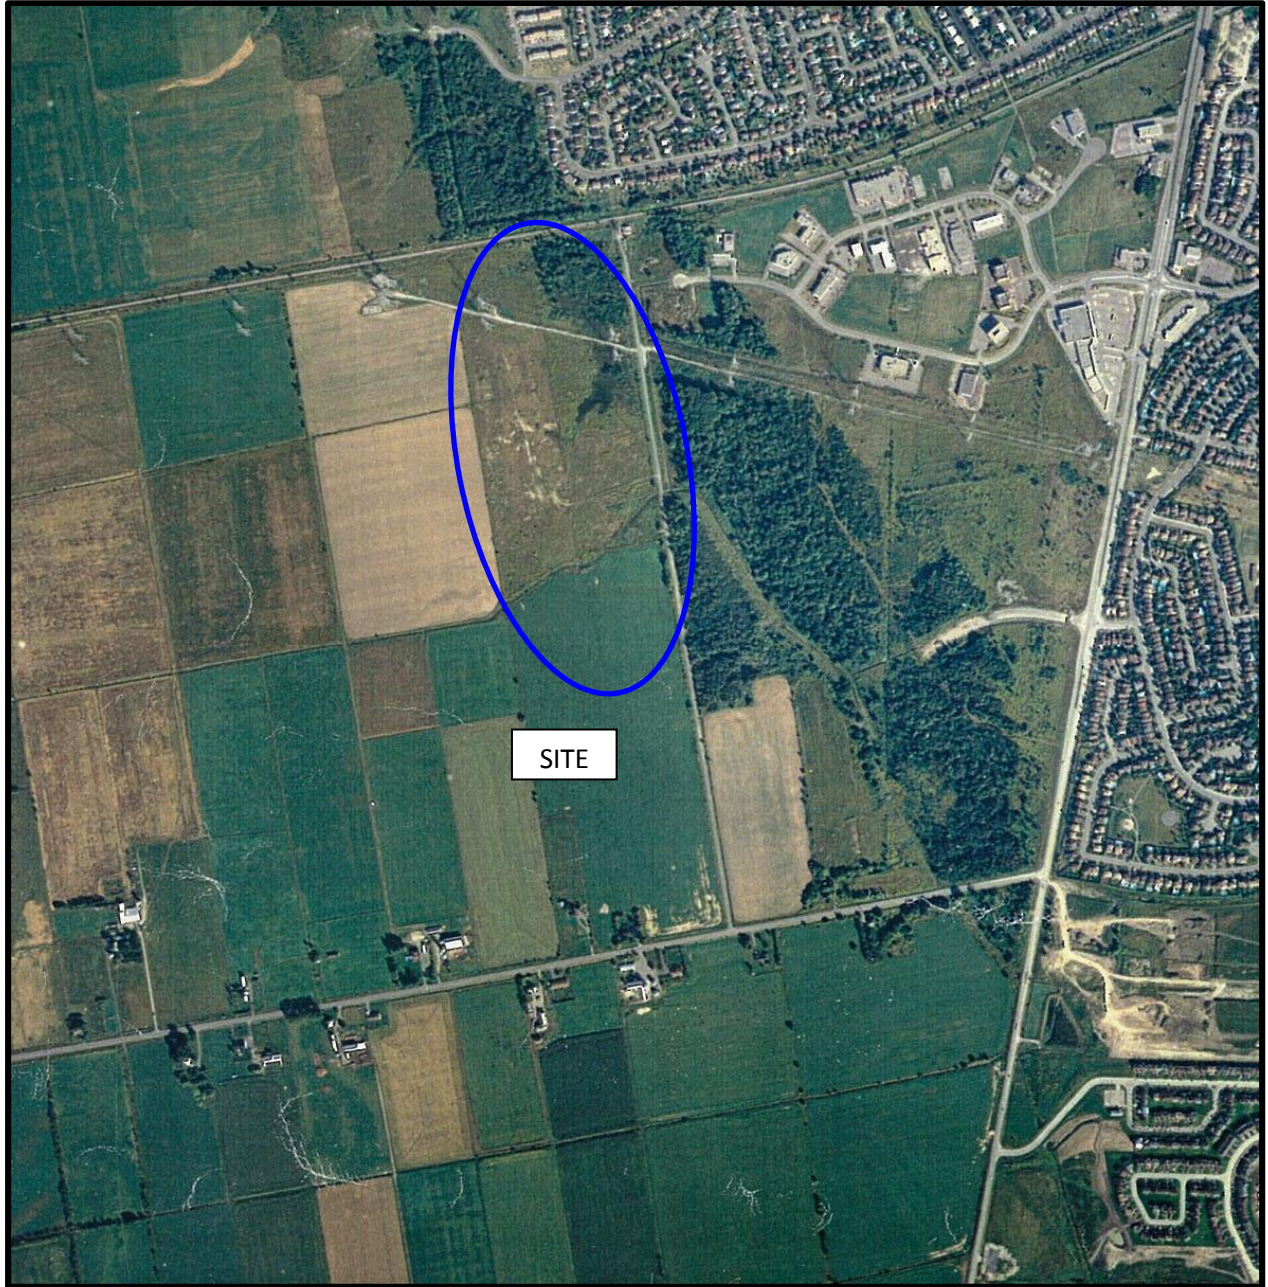
AERIAL PHOTOGRAPH
1993

| 1993 | A hydro corridor has been constructed, dividing the property into a northern and southern portion. Part of the northern half of the property appears to be unused, while the southern portion is an agricultural field. Michael Cowpland Drive has been built 95 m to the east. The railroad to the north of the subject property appears to have been converted to a recreational trail (Trans Canada Trail). |

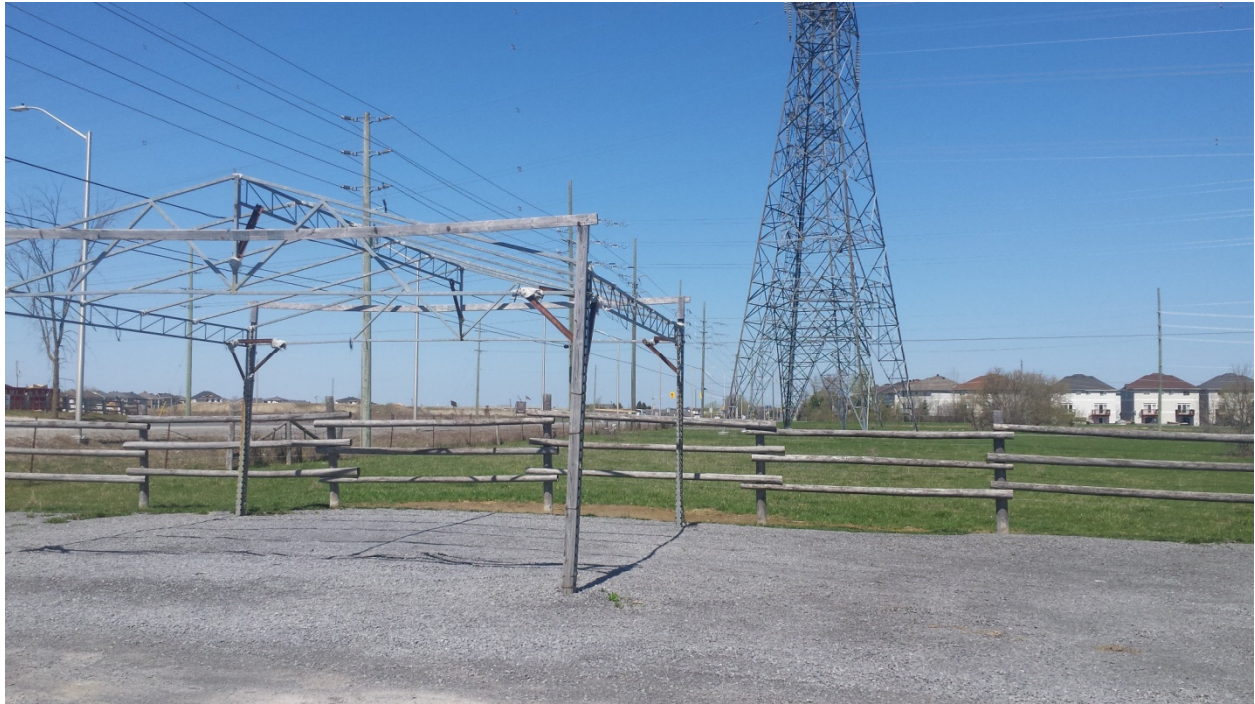
Photograph 1: View of the subject site and hydro corridor, looking east from Terry Fox Drive.

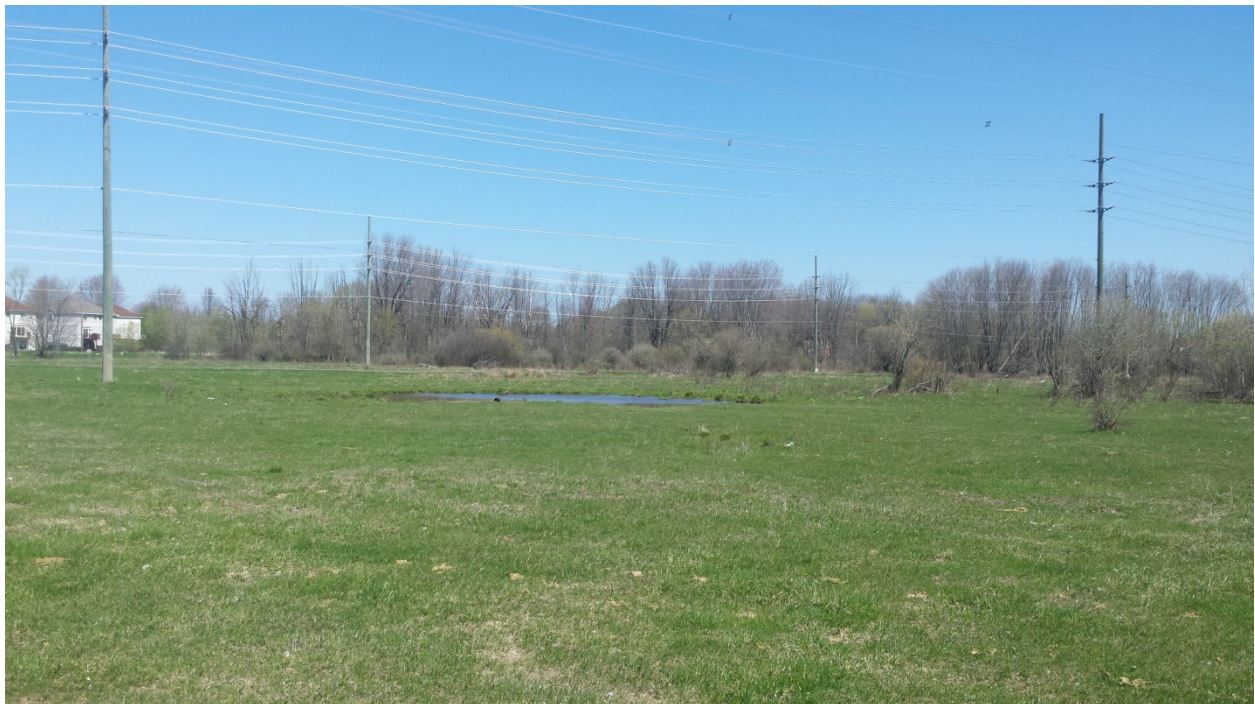
Photograph 2: View of the northern portion of the subject site from Terry Fox Drive, looking east. The Trans Canada Trail runs behind the houses visible at far left.

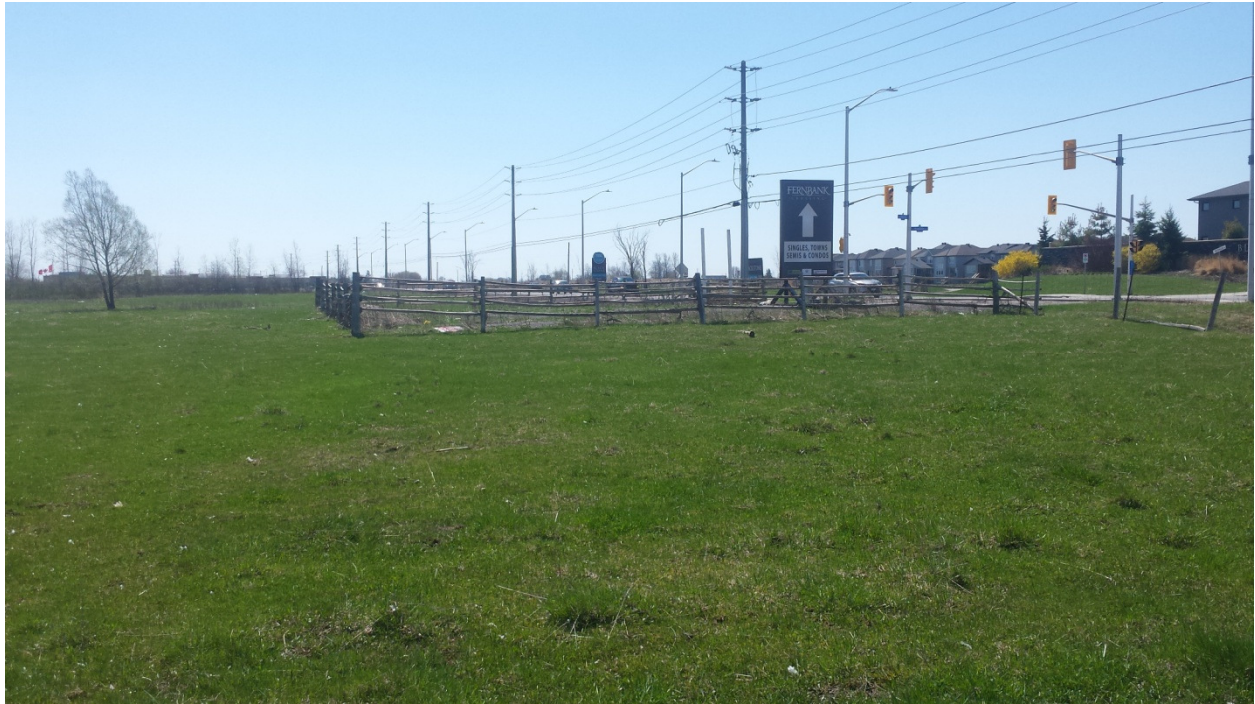
Photograph 3: View of the west-central part of the subject site, at the intersection of Terry fox Drive and Westphalian Avenue, looking south.

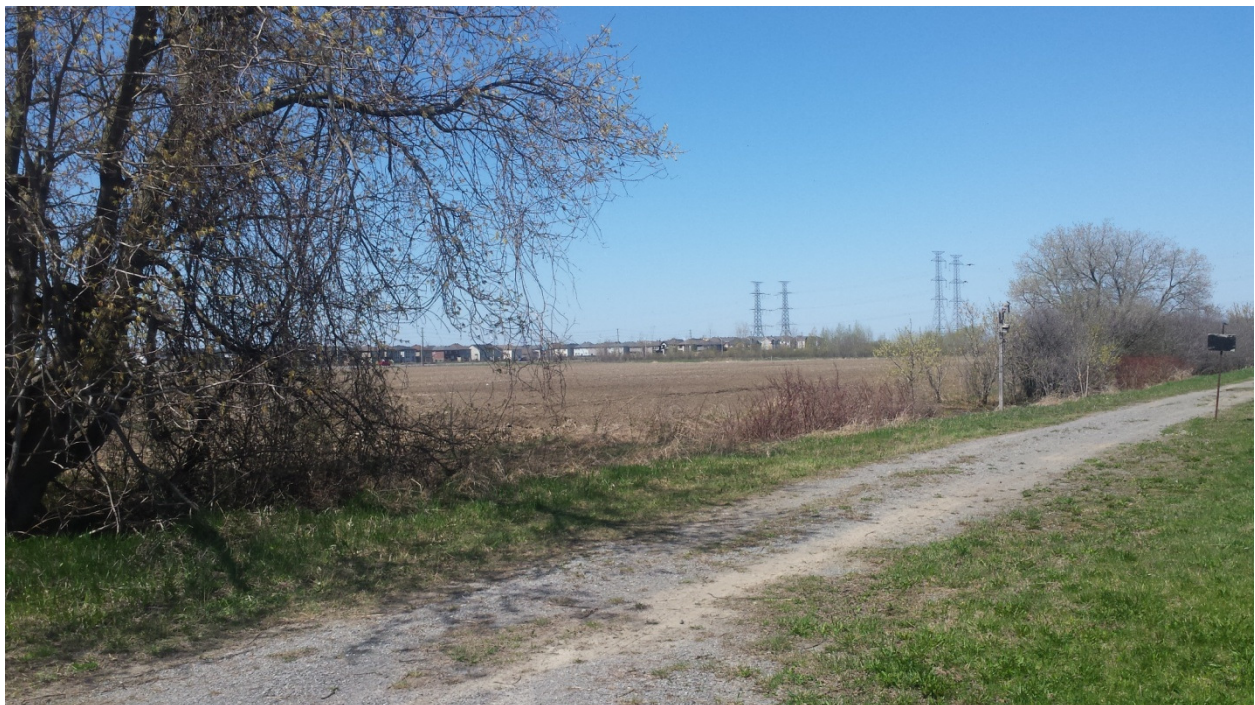
Photograph 4: View of Hazeldean Sideroad, running along the eastern boundary of the subject site, looking north from Cope Drive.

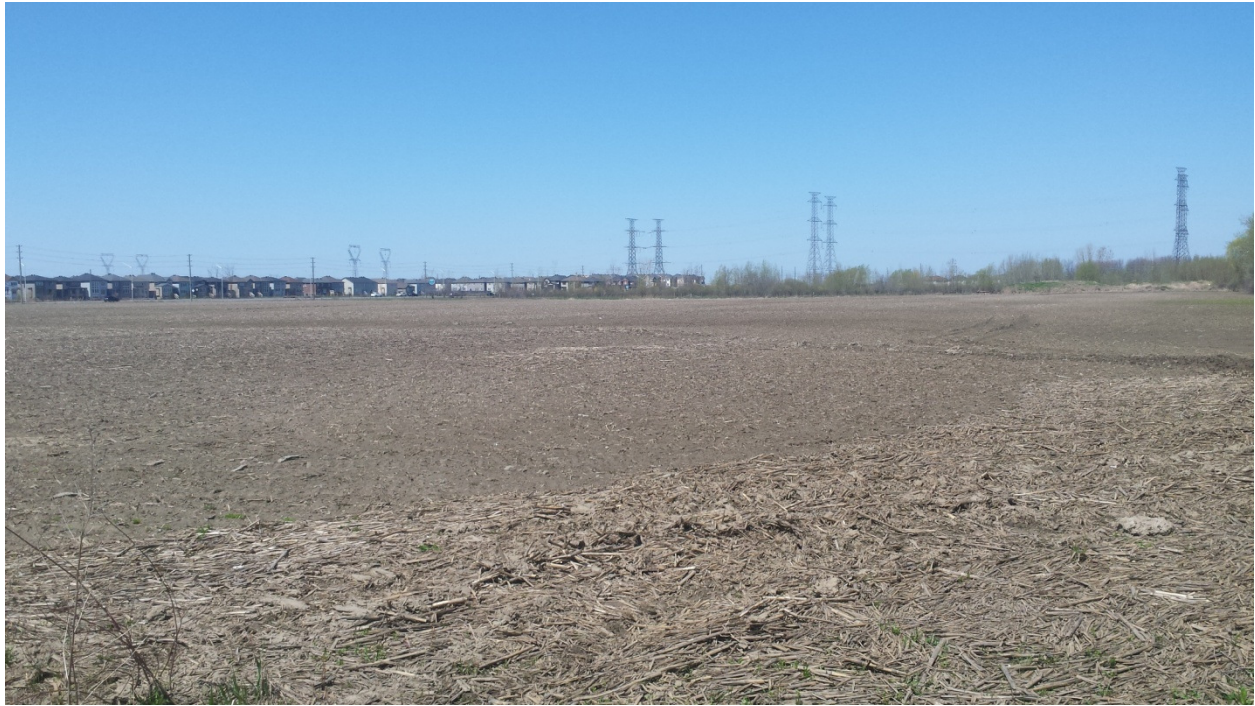
Photograph 5: View of the southern portion of the subject property, looking north from Cope Drive.
