McKINLEY
ENVIRONMENTAL
SOLUTIONS

Combined Environmental Impact Statement &
Tree Conservation Report (Revised)
Minto Communities and 2559688 Ontario Inc.
Kanata North Development (936 March Road)

July 2019

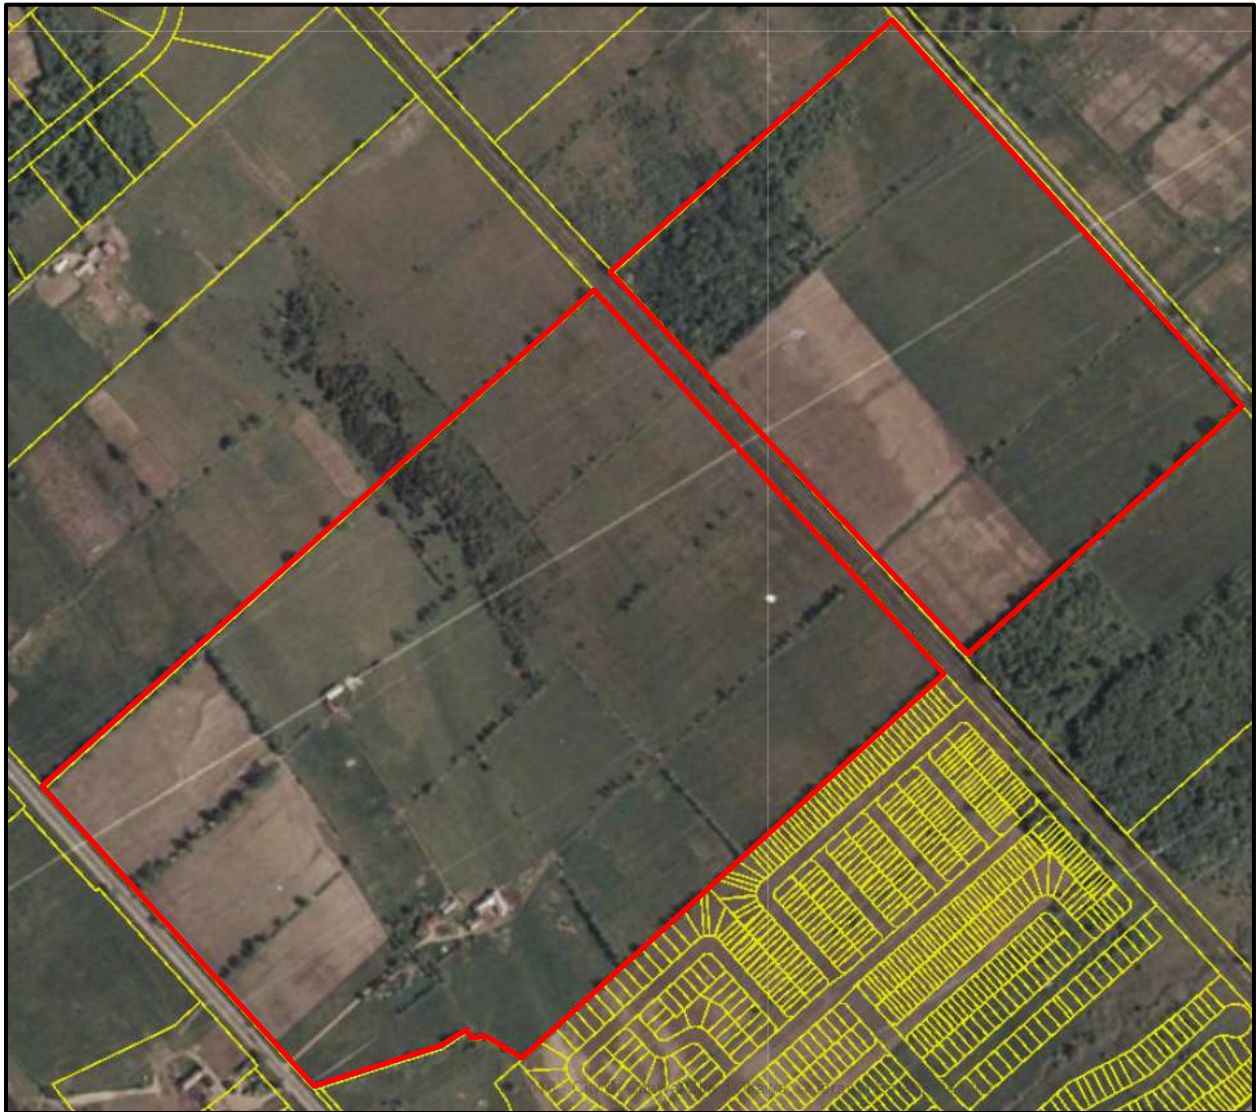
Historic Air Photograph 1: Historic Air Photo from 1976 (Study Area limits shown in red). Note the overall composition of the Study Area was similar in 1976, with most of the Study Area intensively farmed. The western portions of both Woodlot S-20 and Woodlot S-23 are present in 1976, however, the eastern portion of both features and the southern portion of Woodlot S-20 appear to be largely clear of tree cover. The Cultural Woodlot surrounding the farmhouse at 936 March Road is largely absent (Photos from City of Ottawa 2018).

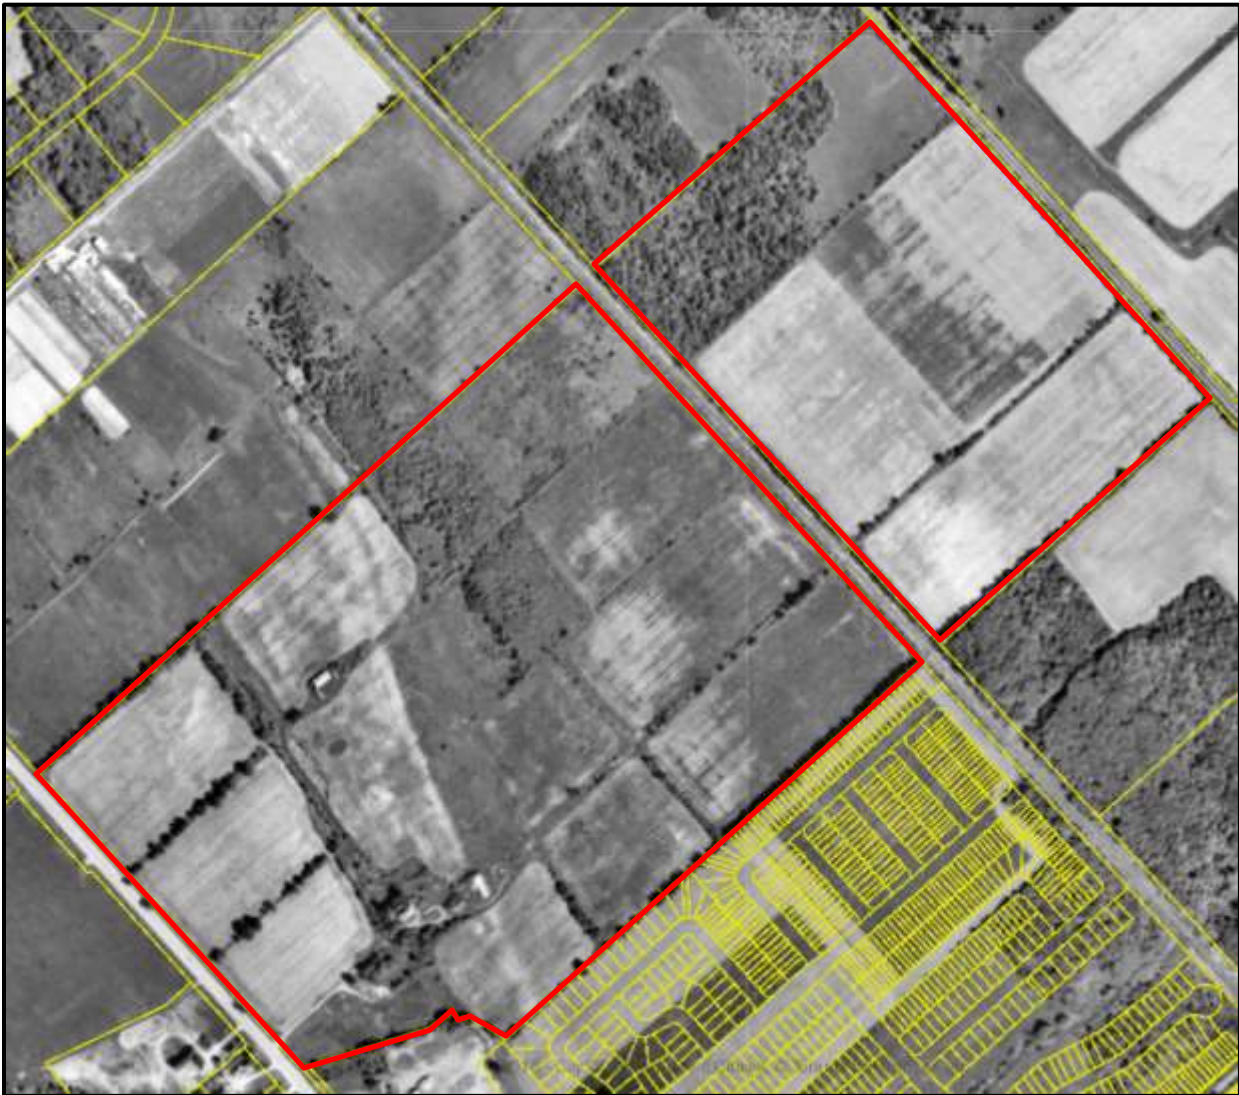
Historic Air Photograph 2: Historic Air Photo from 1991 (Study Area limits shown in red). Note the overall composition of the Study Area was similar in 1991, with most of the Study Area intensively farmed. The western portions of both Woodlot S-20 and Woodlot S-23 are present in 1991, however, the eastern portion of both features continues to be largely absent in 1991. The southern portion of Woodlot S-20 is also largely absent. The Cultural Woodlot surrounding the farmhouse at 936 March Road has expanded by 1991 (Photos from City of Ottawa 2018).

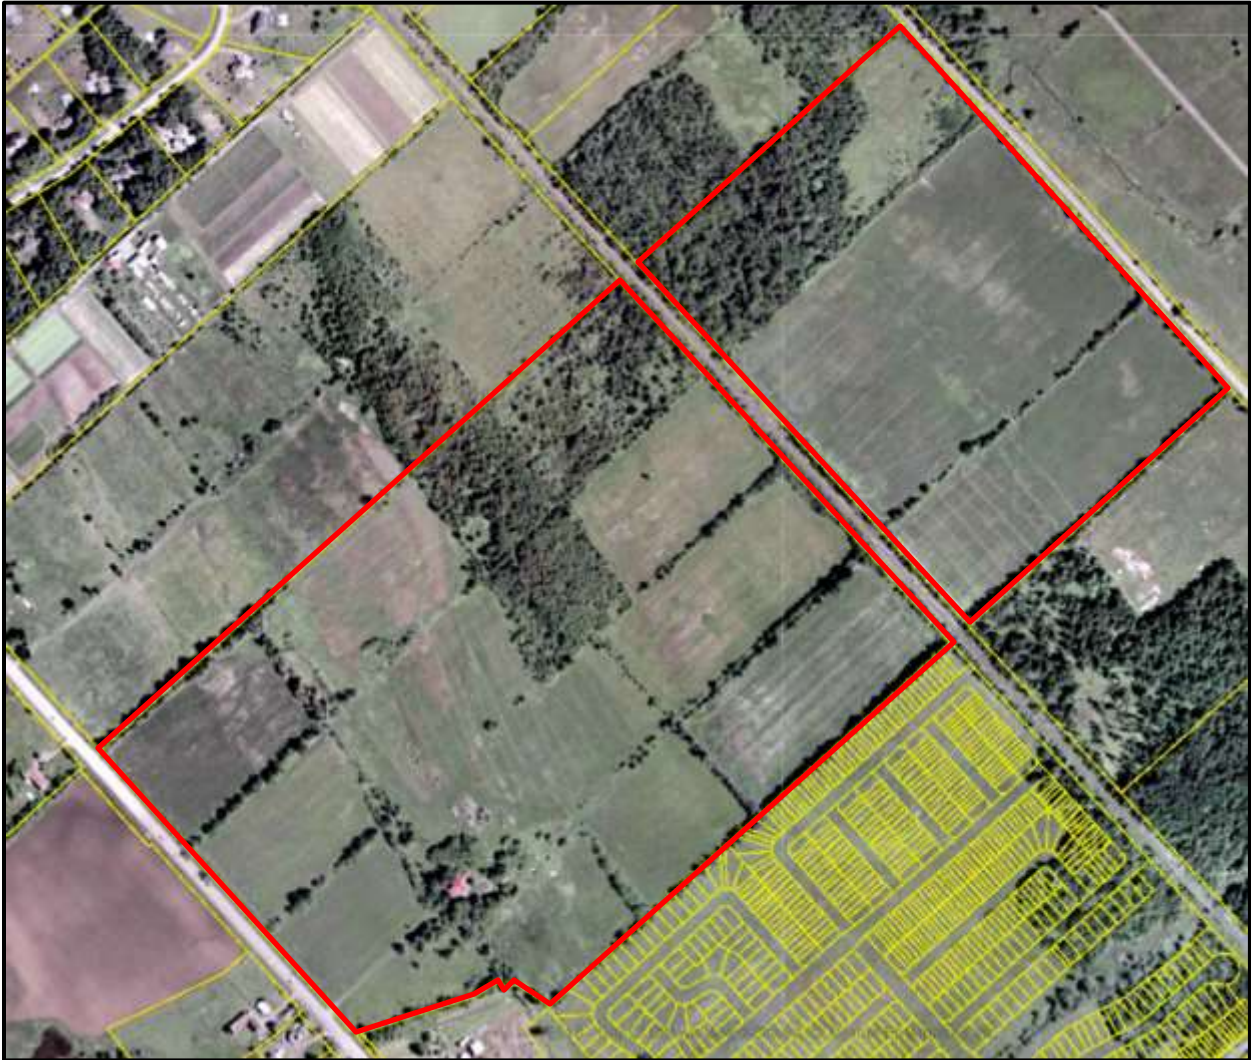
Historic Air Photograph 3: Historic Air Photo from 2005 (Study Area limits shown in red). Note the overall composition of the Study Area was similar in 2005, with most of the Study Area intensively farmed. The western portions of both Woodlot S-20 and Woodlot S-23 are present in 2005. By 2005, the eastern and southern portions of Woodlot S-20 are visibly regenerating. However, the area east of Woodlot S-23 remains largely clear of tree cover. The Cultural Woodlot surrounding the farmhouse at 936 March Road is similar to its current size in 2005 (Photos from City of Ottawa 2018).

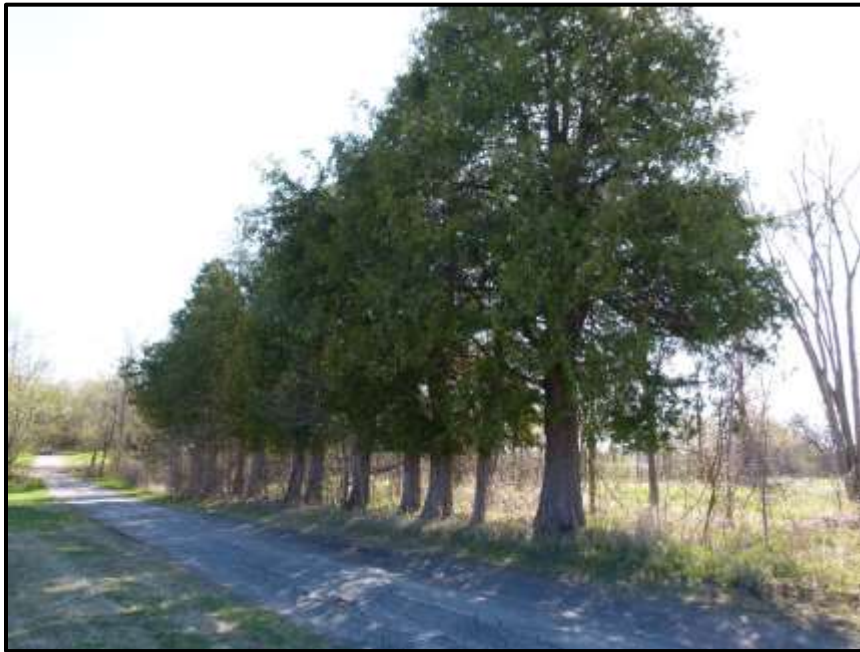
Photograph 1: Looking east at the Coniferous Hedgerow (Feature A) (May 8th, 2018).

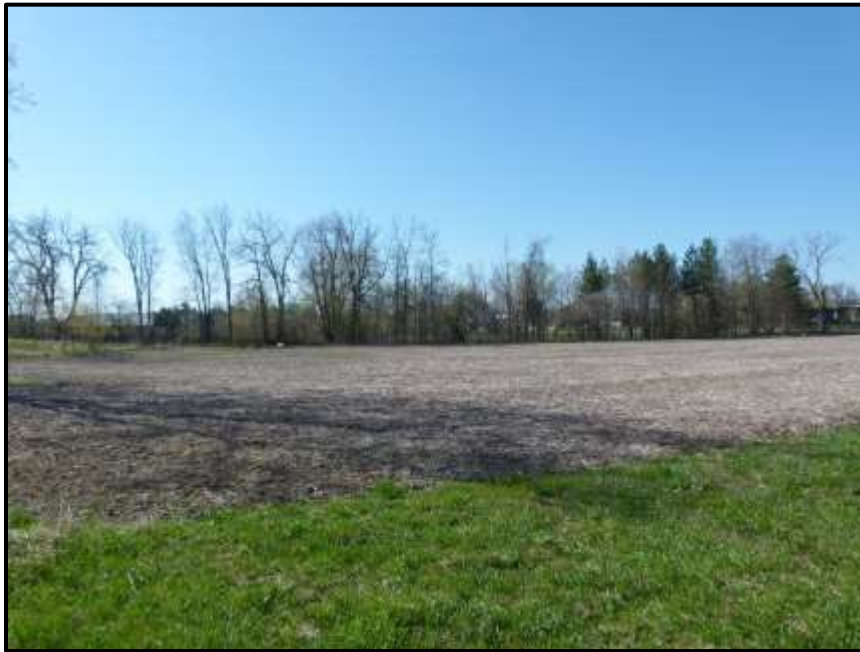
Photograph 3: Looking south at the Deciduous Hedgerow (Feature C), shown in center and left. The Coniferous Hedgerow (Feature B) is visible (at right) (May 8th, 2018).

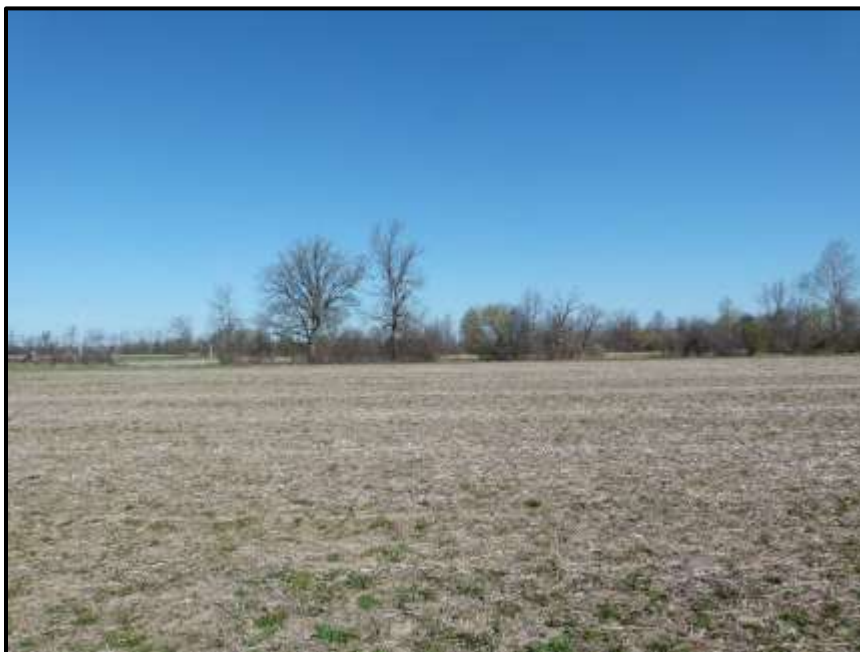
- **Deciduous Hedgerows C to F:** As noted above, White/Green Ash are the dominant trees within Deciduous Hedgerows C to F. Sugar Maple, Bur Oak, and Trembling Aspen are also well represented. Exceptionally large trees include a 107 cm dbh Bur Oak and a 96 cm dbh White Ash (declining) found within Deciduous Hedgerow F. Deciduous Hedgerow E also includes an 86 cm dbh Sugar Maple, a 91 cm dbh Sugar Maple, and a 96 cm dbh White Ash (declining).

Photograph 4: Looking north at the Deciduous Hedgerow (Feature D). A 107 cm dbh Bur Oak and a 96 cm dbh White Ash are visible in the middle of the photograph (May 8th, 2018).

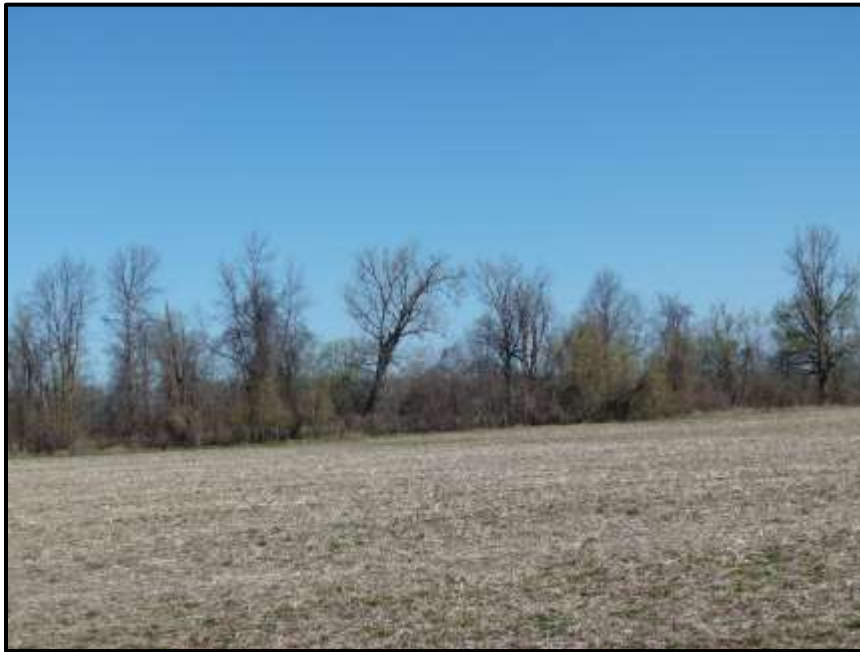
Photograph 5: Looking north at the Deciduous Hedgerow (Feature E). An 86 cm dbh Sugar Maple, a 91 cm dbh Sugar Maple, and a 96 cm dbh White Ash are visible in the center and right of the photograph (May 8th, 2018).

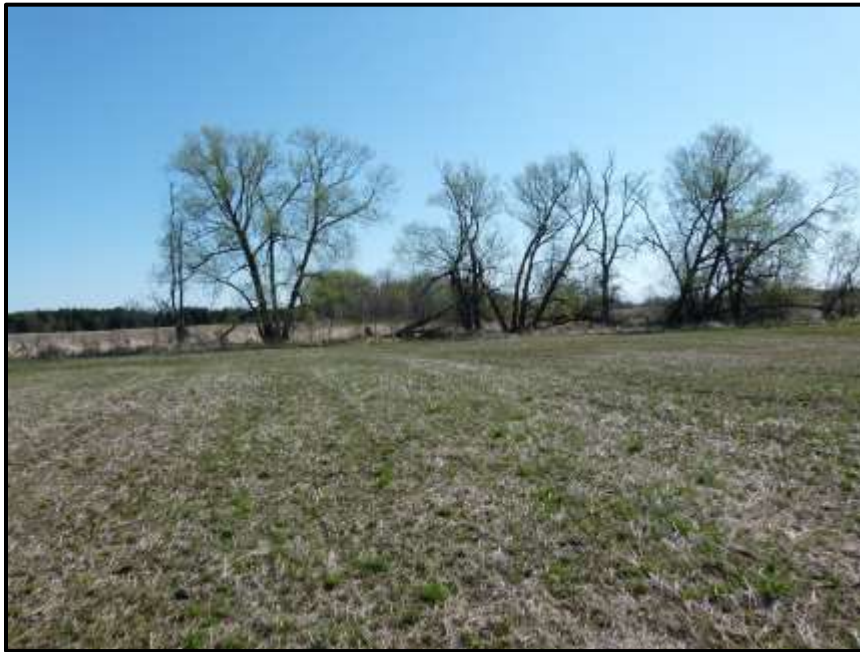
A corridor of Riparian Vegetation (Feature R) exists surrounding the North Tributary. Tree cover is dominated by White/Green Ash and Manitoba Maples. However, several large Crack Willows are present, most of which are 60 cm to 80 cm dbh in size, although some specimens up to 150 cm dbh are also present. The Crack Willows are not native species, and were likely planted as landscaping features along the creek. Shrub cover includes Wild Red Raspberry, Common Buckthorn and Tartarian Honeysuckle. Groundcover is dominated by Reed Canary Grass with Purple Loosestrife, Spotted Touch Me Not, and Common Cattail present.

Photograph 18: Looking east at the large Crack Willows (60 cm to 80 cm dbh) present in the Riparian Vegetation (Feature R) surrounding the North Tributary (May 8th, 2018).

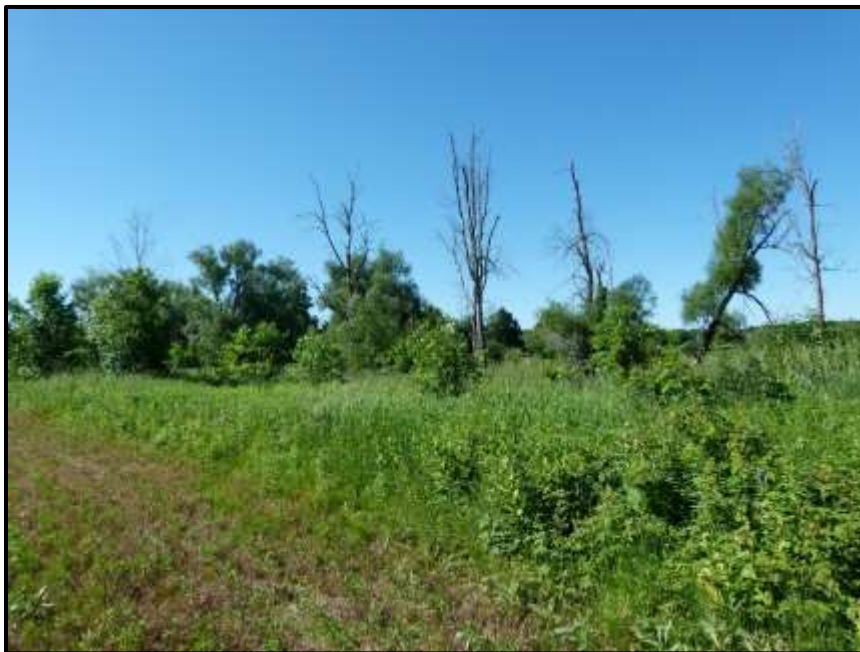
Photograph 19: Looking west at the Riparian Vegetation (Feature R) (June 21st, 2018).

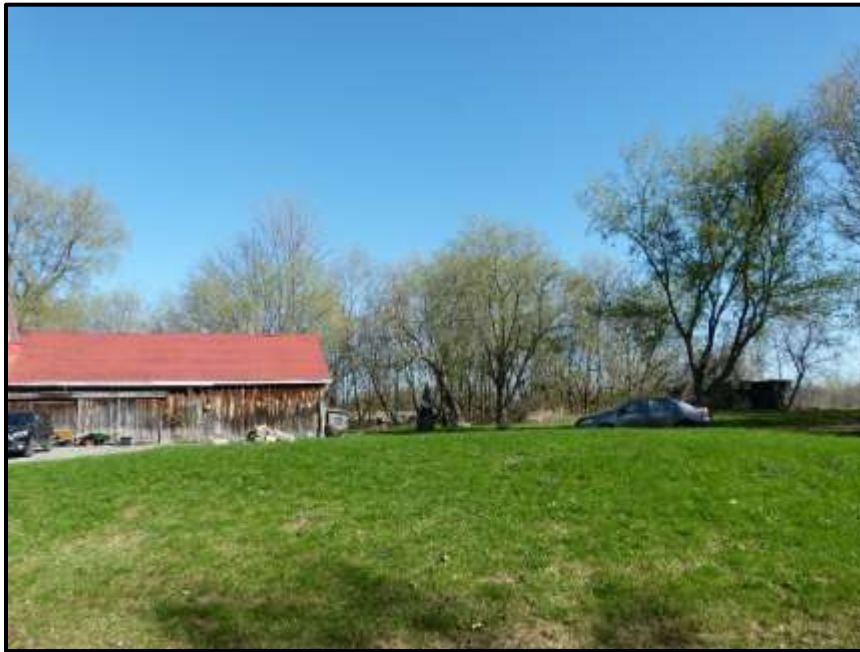
Photograph 20: Looking north at the northeast part of the Cultural Woodlot (Feature S). The existing farmhouse at 936 March Road is visible at the left (May 8th, 2018).

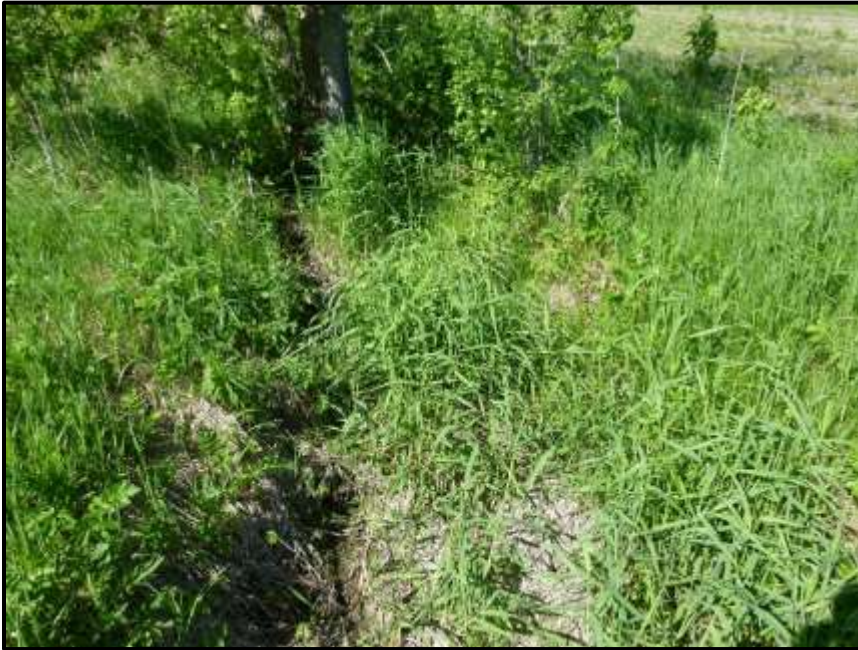
These observations are consistent with those documented by Paterson Group (2015) as part of their *Shallow Bedrock Hydrogeological Assessment*. Paterson Group (2015) noted that at several locations, groundwater elevations were within the elevation of the overburden layers, or above ground surface. This suggests that the upper fractured bedrock layer is fully saturated, and that overburden soils are acting as a confining layer (Paterson Group 2015). The presence of overburden soils of lower hydraulic conductivity overlying the bedrock aquifer units limits the potential for significant groundwater discharge in these areas (Paterson Group 2015). Paterson Group (2015) concluded that the groundwater recharge and discharge is occurring on a localized scale within the shallow silty sand soils, while underlying clay soils and the limited extent of silty sand soils preclude any significant discharge or recharge from the underlying bedrock aquifer. Lastly, Paterson Group (2015) also noted that the adjacent Ephemeral Farm Drainage Channel (Side Branch 2) is negatively graded in areas, which allows water to pond and prevents water from flowing to adjacent areas. As such, the groundwater upwelling represents a negligible source of water contribution.

Photograph 39: Ephemeral Farm Drainage Channel in the southeastern part of the Study Area, east of the Former CN Railway Corridor. Note the channel is entirely dry by late May (May 29th, 2018).

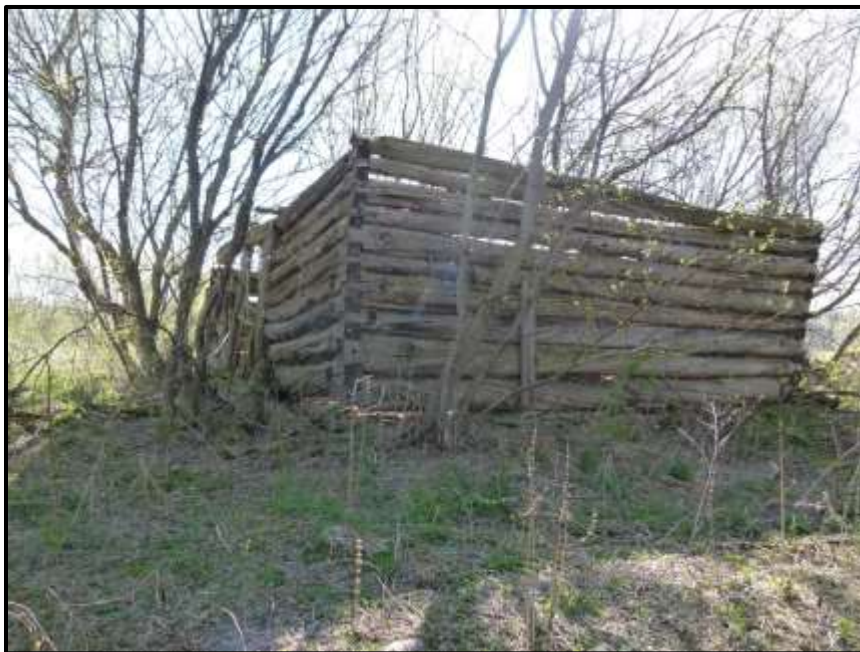
Photograph 47: Building #5 – Looking south at the old barn foundation (May 8th, 2018).

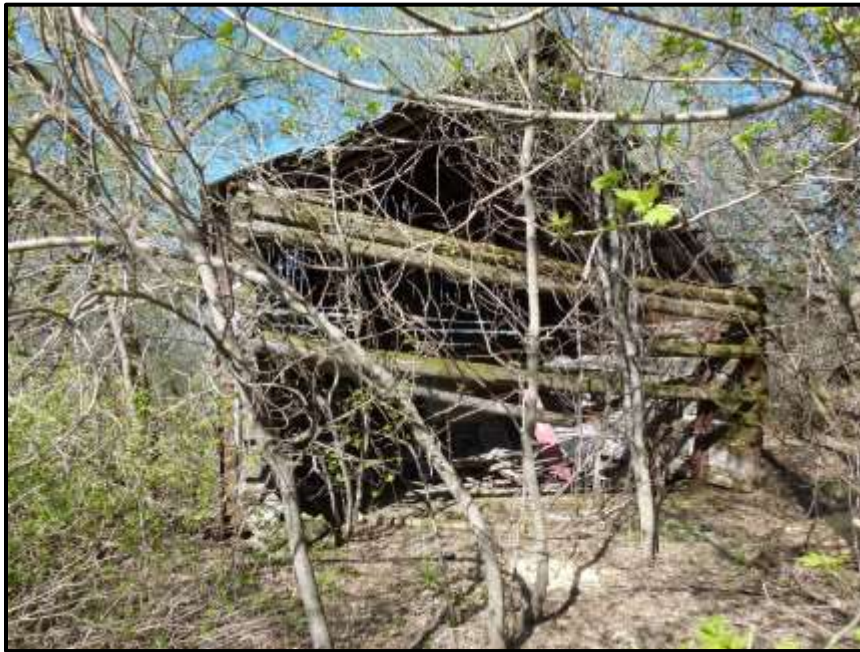
Photograph 48: Building #6 – Looking west at the collapsing barn (May 8th, 2018).

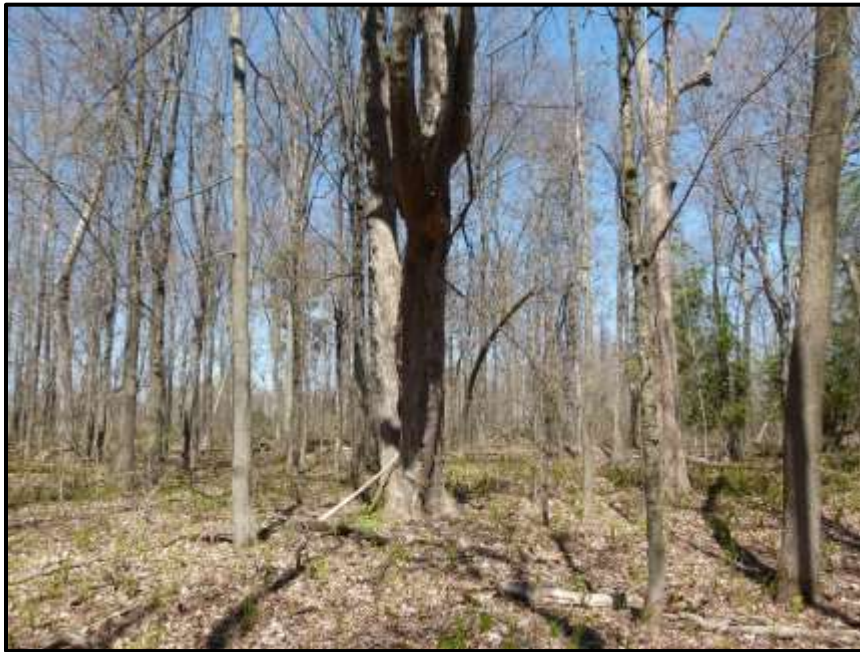
- **Dry – Fresh Sugar Maple – Ash Deciduous Forest (Feature Y):** As noted in Section 3.3, Feature Y also includes comparatively more mature trees than elsewhere within the Study Area. However, the mature trees are generally surrounded by younger stems that make up the majority of the forest cover, and hence the density of mature trees over 25 cm dbh remains inherently low. A snag/cavity tree count was completed for Feature Y, and only two (2) cavity trees were noted. The density of snag/cavity trees is hence too low to support potential maternity roosting habitat.

Photograph 50: Example of a cavity tree (111 cm dbh Sugar Maple) – found within the Dry-Fresh Sugar Maple – White Ash Deciduous Forest (Feature Y). Note that the large tree is surrounded mostly by smaller stems, and hence the density of trees over 25 cm dbh is inherently low (May 8th, 2018).

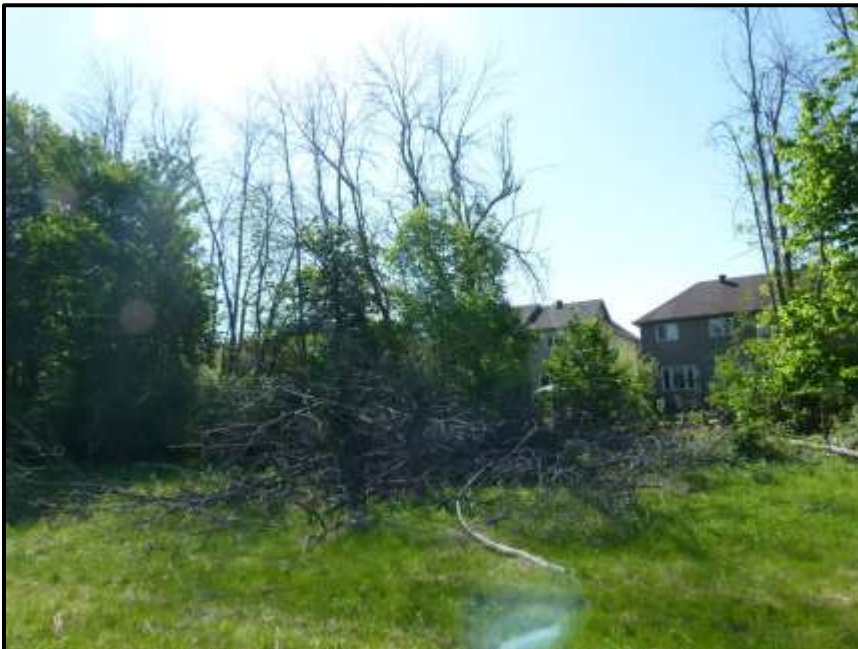
Photograph 4: Looking south at the Deciduous Hedgerow. The bare trees are dead White/Green Ash. Note the fallen trees in the foreground (May 29th, 2018).

the City of Ottawa's letter by retaining a contractor to remove any dead/dying White/Green Ash trees. Tree removal was completed in June 2018. MES was asked by Minto Communities to prepare a letter documenting the rationale for tree removal and the condition of trees at the time. This letter is included in Appendix F. It should be noted that the tree inventory outlined below in Table A was completed before tree removal. Since completion of the tree inventory, the majority of White/Green Ash trees have been removed from Deciduous Hedgerows H and J.
