Phase I Environmental Site Assessment

2009 & 2013 Prince of Wales Drive Nepean (Ottawa), Ontario

Jane Thompson Architect 404 MacKay Street Ottawa, Ontario

LRL File No.: 220528 November 22, 2022

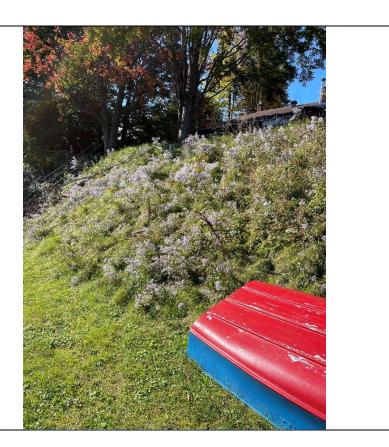
Photograph No. 12

Slope present along the eastern portion of the subject Site.

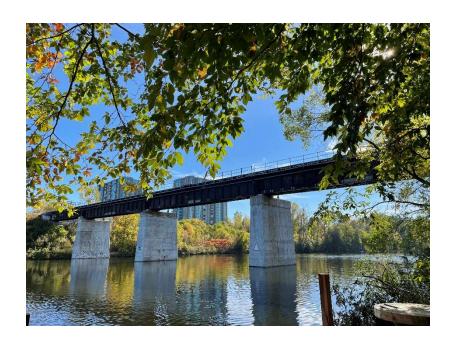
Rail Corridor bridge southeast of the Site over the Rideau River.
