February 21, 2024 (Revision 1)

Project Name: **Geotechnical Investigation – Slope Stability Analysis in Support of Zoning By-Law Amendment, 4380 Trail Road, Ottawa, Ontario**

EXP Project Number: **OTT-21023795-A0**

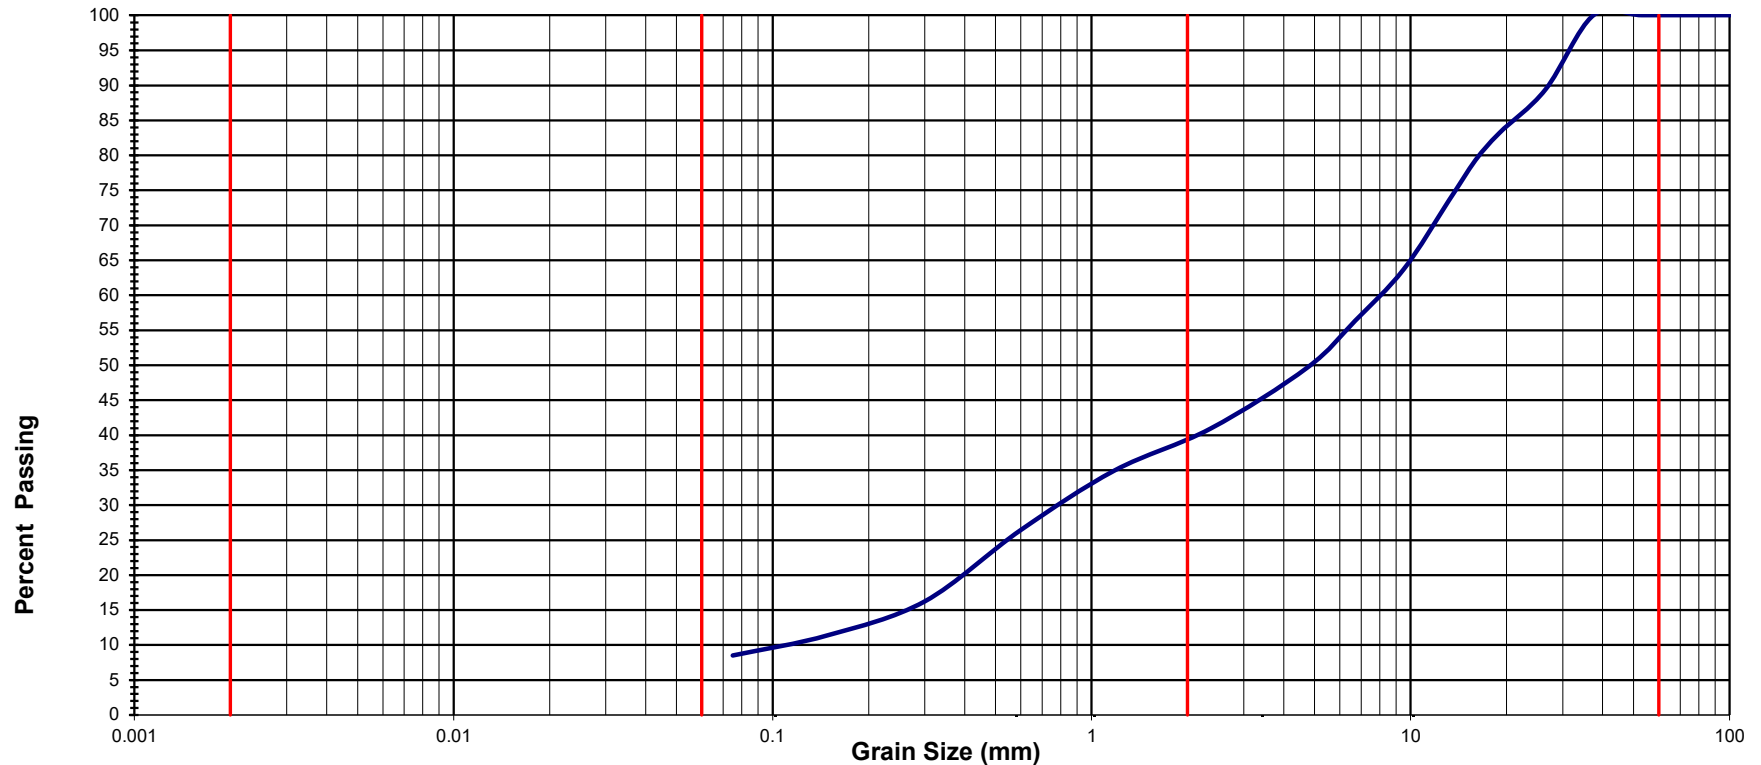
EXP Project No.:	OTT-21023795-A0	Project Name :	Geotechnical Investigation - Slope Stability Trail Road					
Client :	Drain-All Ltd.	Project Location :	4380 Trail Road, Ottawa, Ontario					
Date Sampled :	May 12, 2022	Borehole No:	MW7	Sample:	SS2	Depth (m) :	0.8 - 1.4	
Sample Composition :	Gravel (%)	61	Sand (%)	31	Silt & Clay (%)	8	Figure :	6
Sample Description :	<b>Poorly Graded Sandy Gravel (SP)</b>

Underlying the fill in borehole MW-07 is a layer of sandy gravel which extends to 1.4 m depth (Elevation 99.4 m). The sandy gravel is brown in colour. Based on the standard penetration N-values of 42 for 300 mm of sampler penetration, followed by 50 blows for 100 mm of penetration of the sampler, the sandy gravel is considered to be in a dense state. It contains boulders and cobbles. The natural moisture content of the sandy gravel is 3 percent. The results of a grain size analysis performed on this stratum are given on Table 1 (Figure 6).

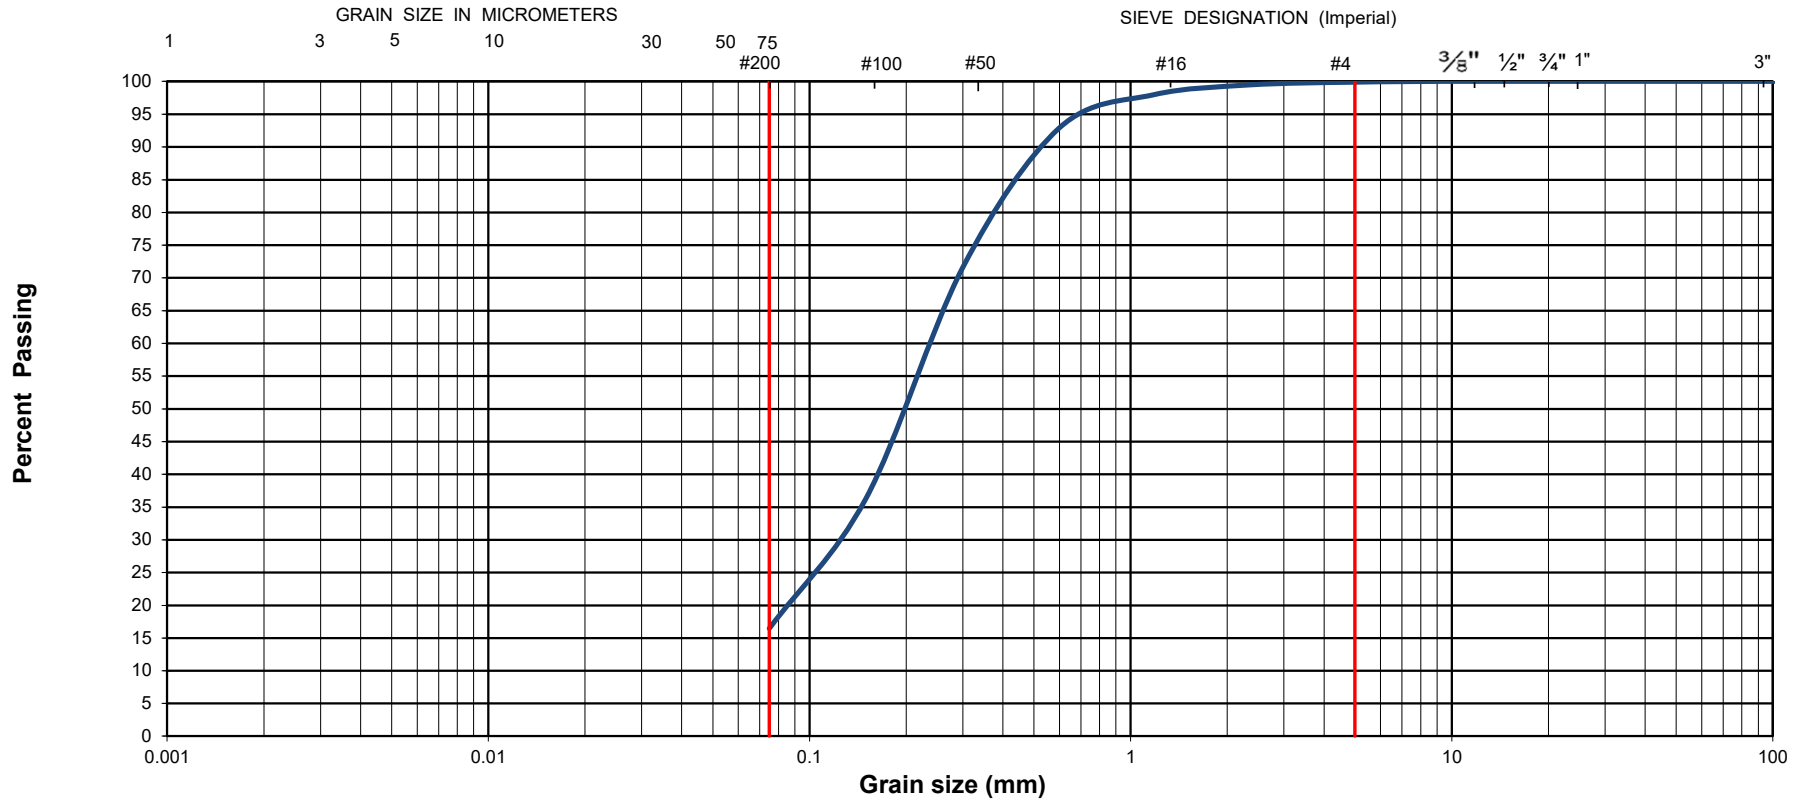
EXP Project No.:	OTT-21023795-A0	Project Name :	Geotechnical Investigation - Slope Stability Trail Road			
Client :	Drain-All Ltd.	Project Location :	4380 Trail Road, Ottawa, Ontario			
Date Sampled :	May 13, 2022	Borehole No:	MW5	Sample:	SS6	
Sample Composition :		Gravel (%)	0	Sand (%)	84	
Sample Description :	<b>Silty Sand (SM)</b>				Silt & Clay (%)	16
					Depth (m) :	3.8 - 4.4
					Figure :	7

The fill in boreholes MW-05 and MW-06 and the sandy gravel in borehole MW-07 are underlain by a layer of sand which extends to the entire depth investigated in all three boreholes, i.e., from 6.7 m to 9.8 m depth (Elevation 94.1 m to Elevation 93.3 m). It is brown in colour and becomes grey at 5.3 m to 7.6 m depth (Elevation 96.2 m to Elevation 95.2 m). Based on standard penetration N-values of 4 to 48 for 300 mm of sampler penetration, the sand is considered to be in a loose to dense state. The natural moisture content of the sand is 2 to 26 percent. It comprises of 5 to 16 percent clay and silt, 84 to 92 percent sand and 0 to 3 percent gravel. (Figures 7 to 9). The results of the grain size analyses have been summarized on Table 2.

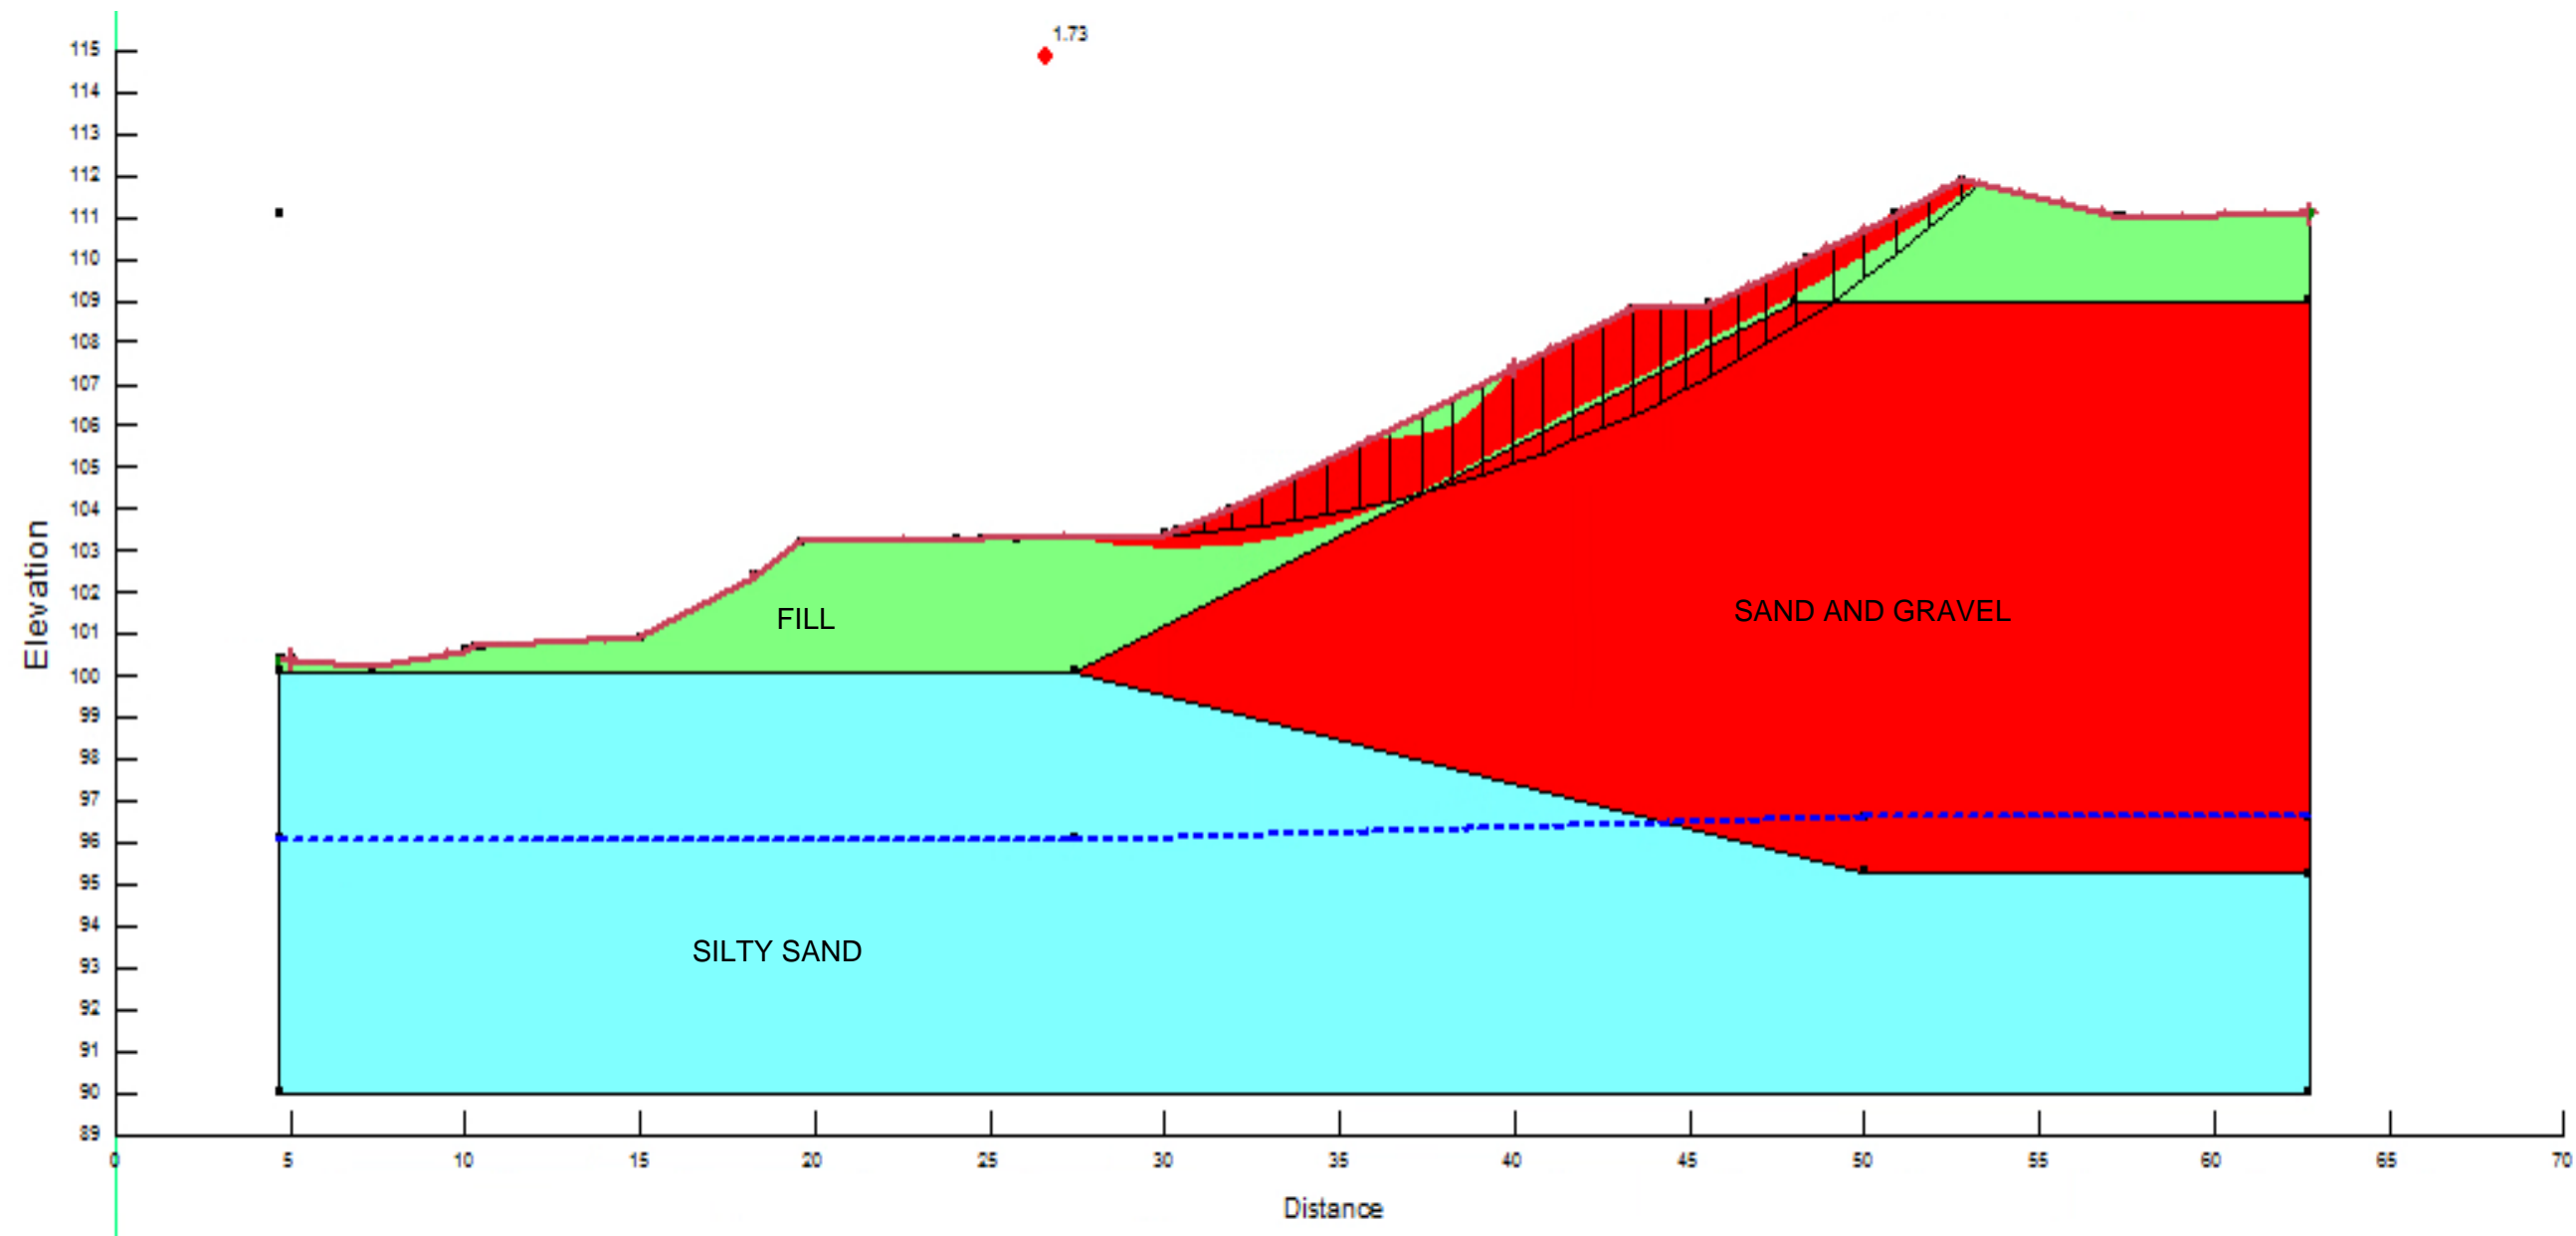
DATE Aug 26, 2022	CLIENT: DRAIN-ALL LTD.	project no. OTT-21023795-A0
DESIGN DW	CHECKED SA	scale Not to scale
DRAWN BY DW		TITLE: STATIC SLOPE STABILITY ANALYSIS 4380 Trail Road, Ottawa, Ontario
		Figure 12A

Color	Name	Model	Unit Weight (kN/m <sup>3</sup> )	Cohesion' (kPa)	Phi' (°)
Green	FILL	Mohr-Coulomb	19	0	27
Red	Sand and Gravel	Mohr-Coulomb	22	0	33
Cyan	Silty Sand	Mohr-Coulomb	19.8	0	30

Table 6: Results of Slope Stability Analyses			
Section	Loading Condition	Factor of Safety	Figure No.
Section A-A	Effective Stress Analysis	1.76	11A
	Effective Stress Analysis with seismic loading	1.1	11B
Section B-B	Effective Stress Analysis	1.73	12A
	Effective Stress Analysis with seismic loading	1.1	12B
Section C-C	Effective Stress Analysis	1.38	13A
	Effective Stress Analysis with seismic loading	0.93	13B
Section D-D	Effective Stress Analysis	1.11	14A
	Effective Stress Analysis with seismic loading	0.76	14B
Section E-E	Effective Stress Analysis	1.42	15A
	Effective Stress Analysis with seismic loading	0.92	15B

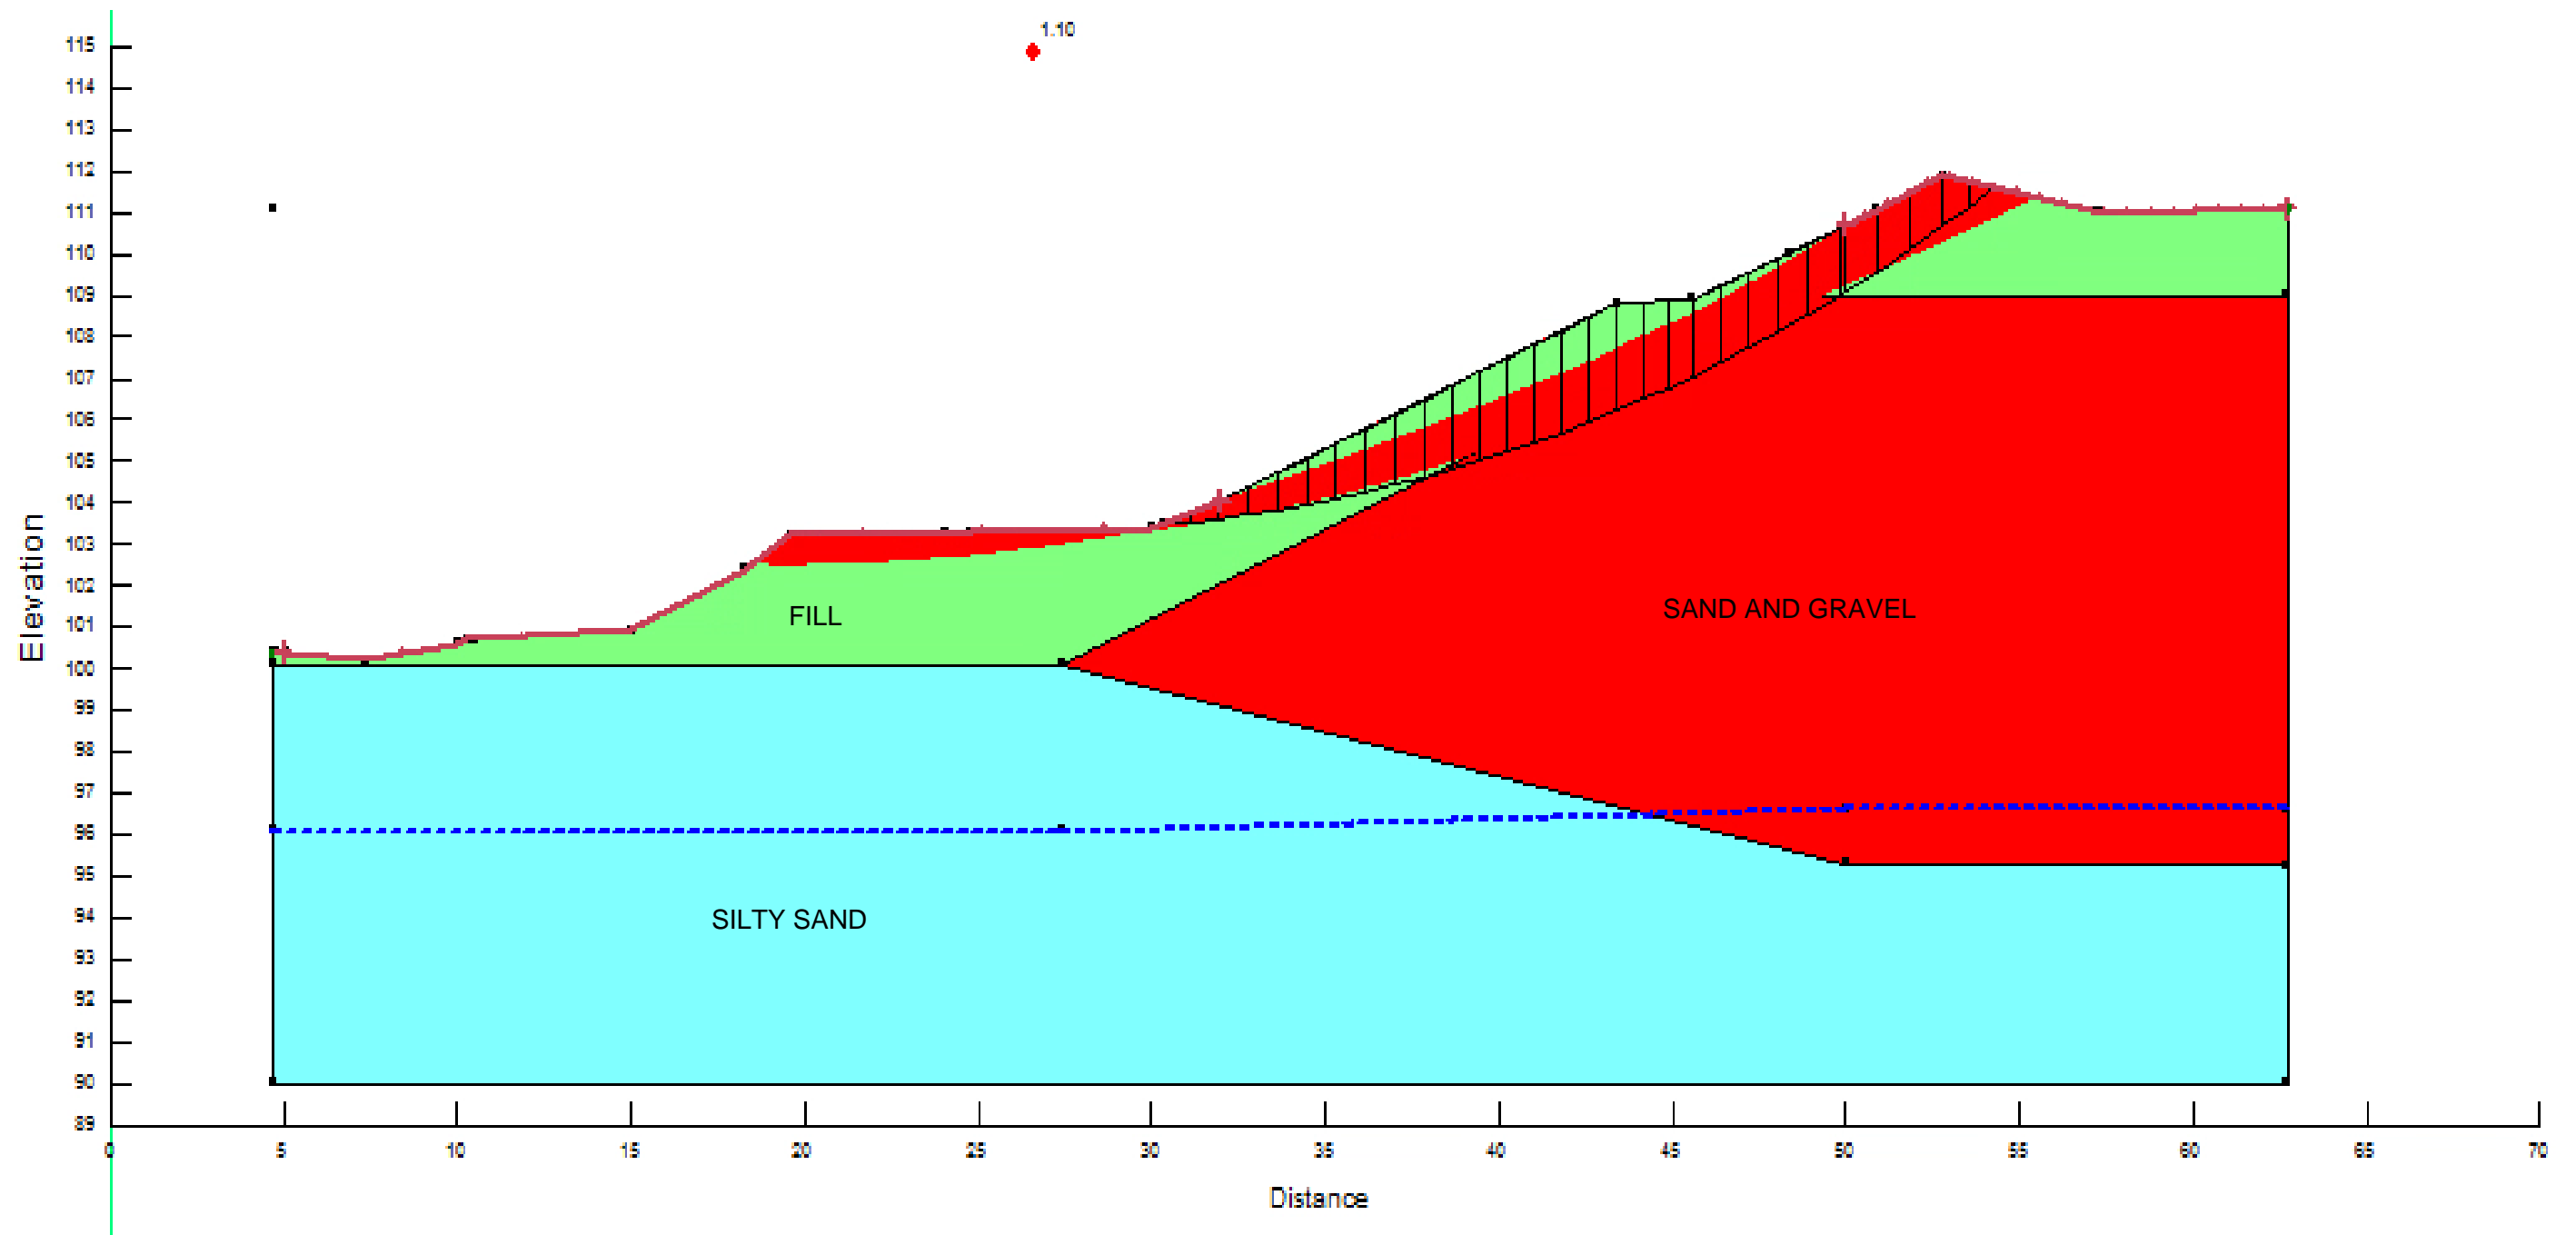
DATE Aug 26, 2022	CLIENT: DRAIN-ALL LTD.	project no. OTT-21023795-A0
DESIGN DW	CHECKED SA	scale Not to scale
DRAWN BY DW		TITLE: PSEUDO-STATIC SLOPE STABILITY ANALYSIS 4380 Trail Road, Ottawa, Ontario
		Figure 12B

Color	Name	Model	Unit Weight (kN/m <sup>3</sup> )	Cohesion' (kPa)	Phi' (°)
Green	FILL	Mohr-Coulomb	19	0	27
Red	Sand and Gravel	Mohr-Coulomb	22	0	33
Cyan	Silty Sand	Mohr-Coulomb	19.8	0	30

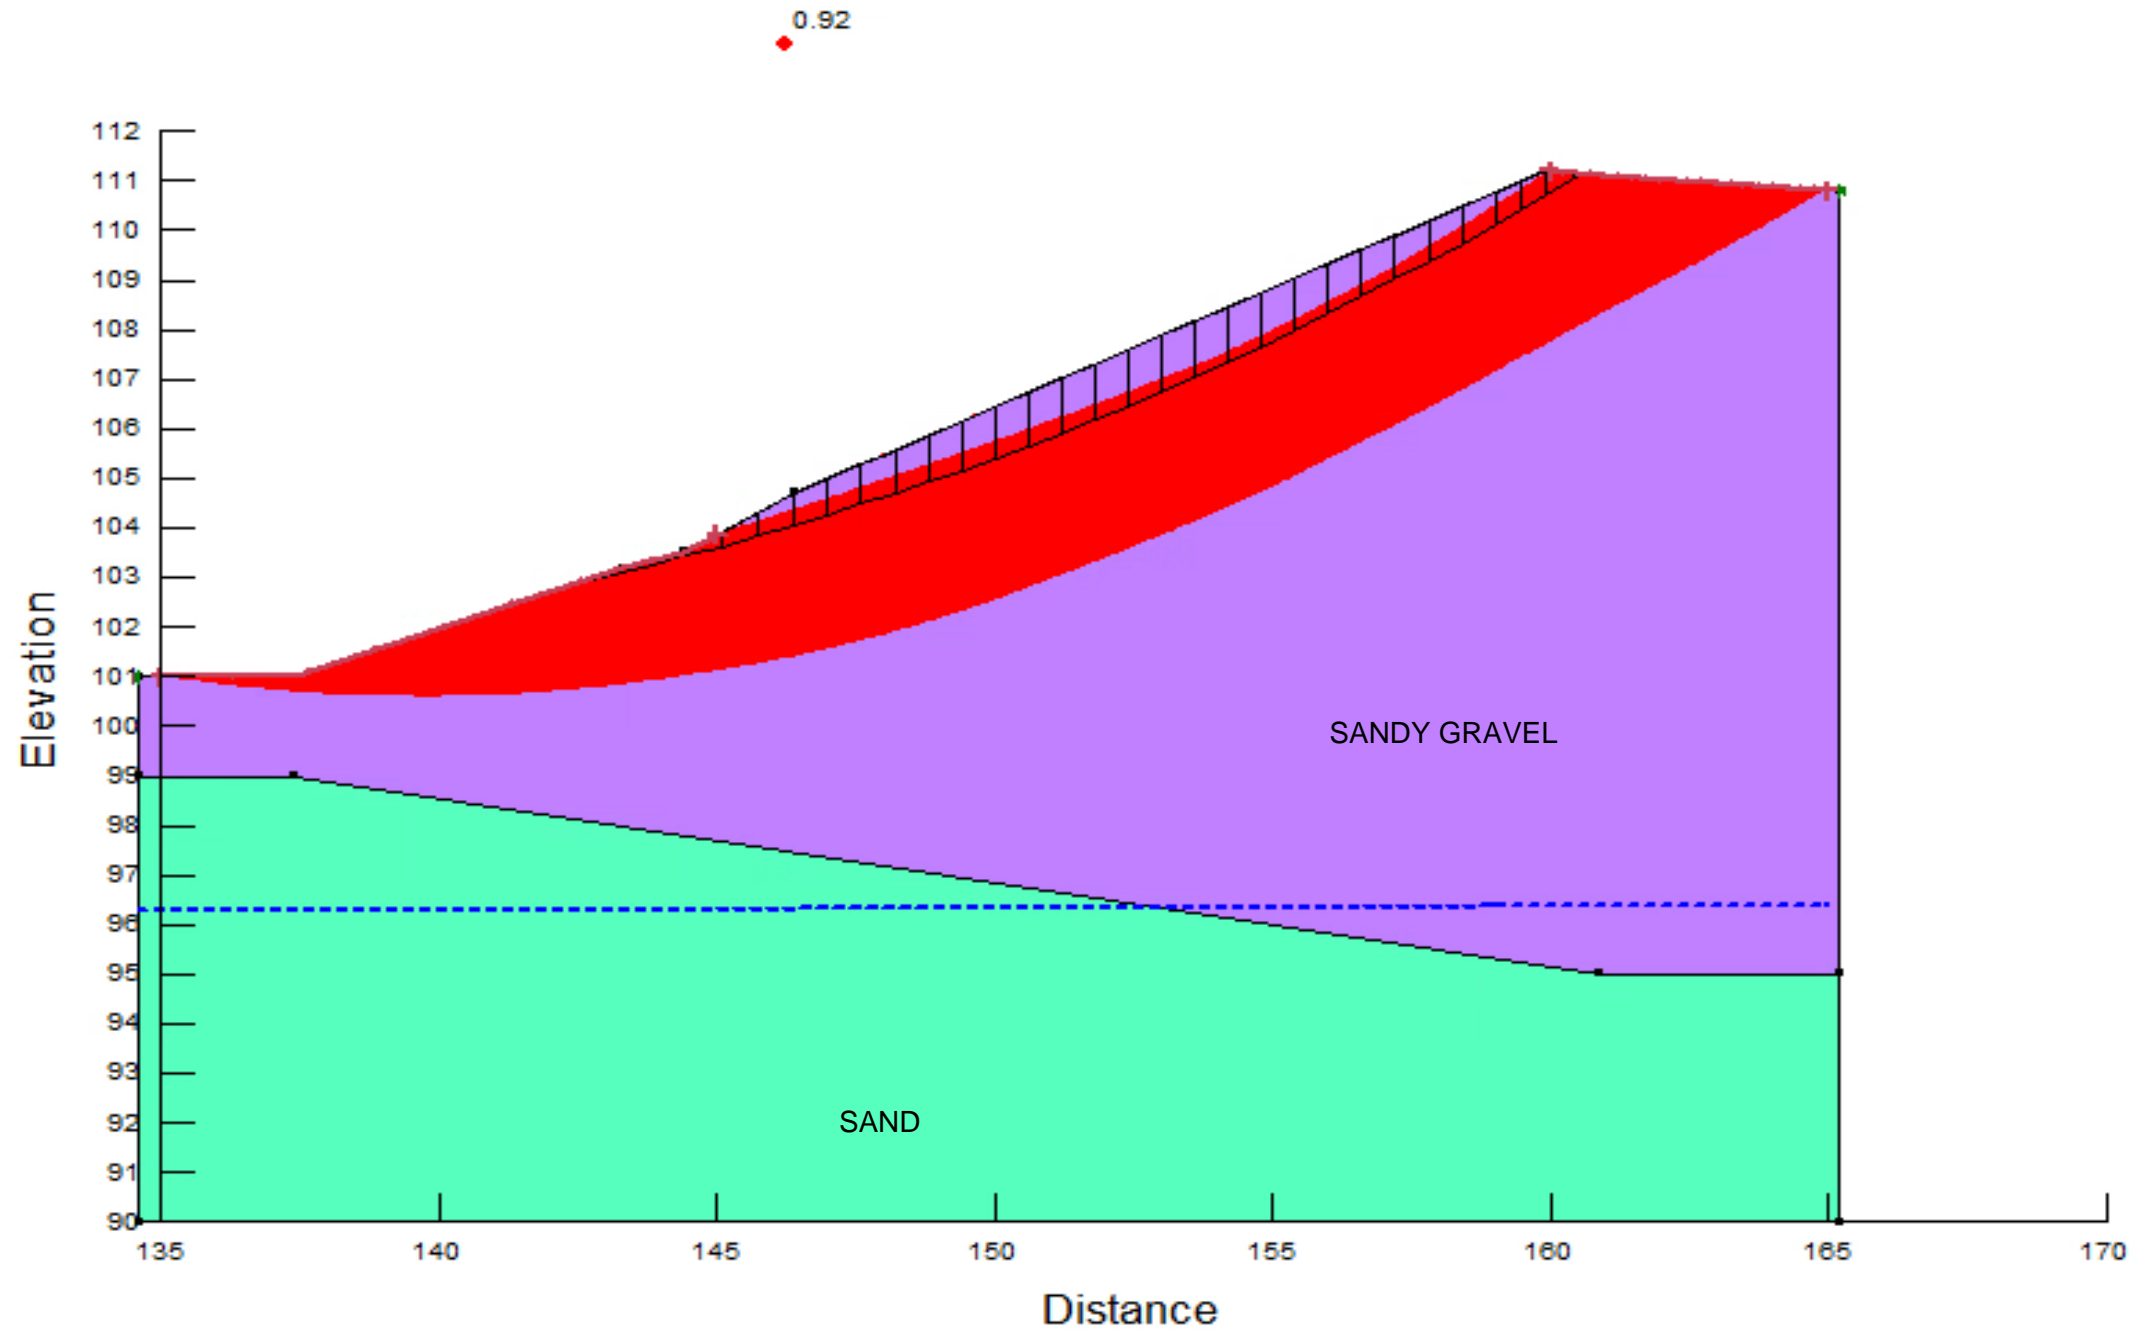
Color	Name	Model	Unit Weight (kN/m <sup>3</sup> )	Cohesion' (kPa)	Phi' (°)
	Sand	Mohr-Coulomb	19.8	0	30
	Sandy Gravel	Mohr-Coulomb	22	0	33

Current practice in the industry and the City of Ottawa requires a factor of safety of 1.5 for static loading conditions (i.e., for effective stress and total stress analyses). The minimum acceptable factor of safety for seismic loading conditions is 1.1 (Mitchell 1983). A review of Table 6 indicates that the slope sections C-C, D-D, and E-E do not meet the City of Ottawa criteria for static loading conditions. Also, Sections C-C, D-D, and E-E do not meet the acceptable factor of safety for seismic loading conditions.

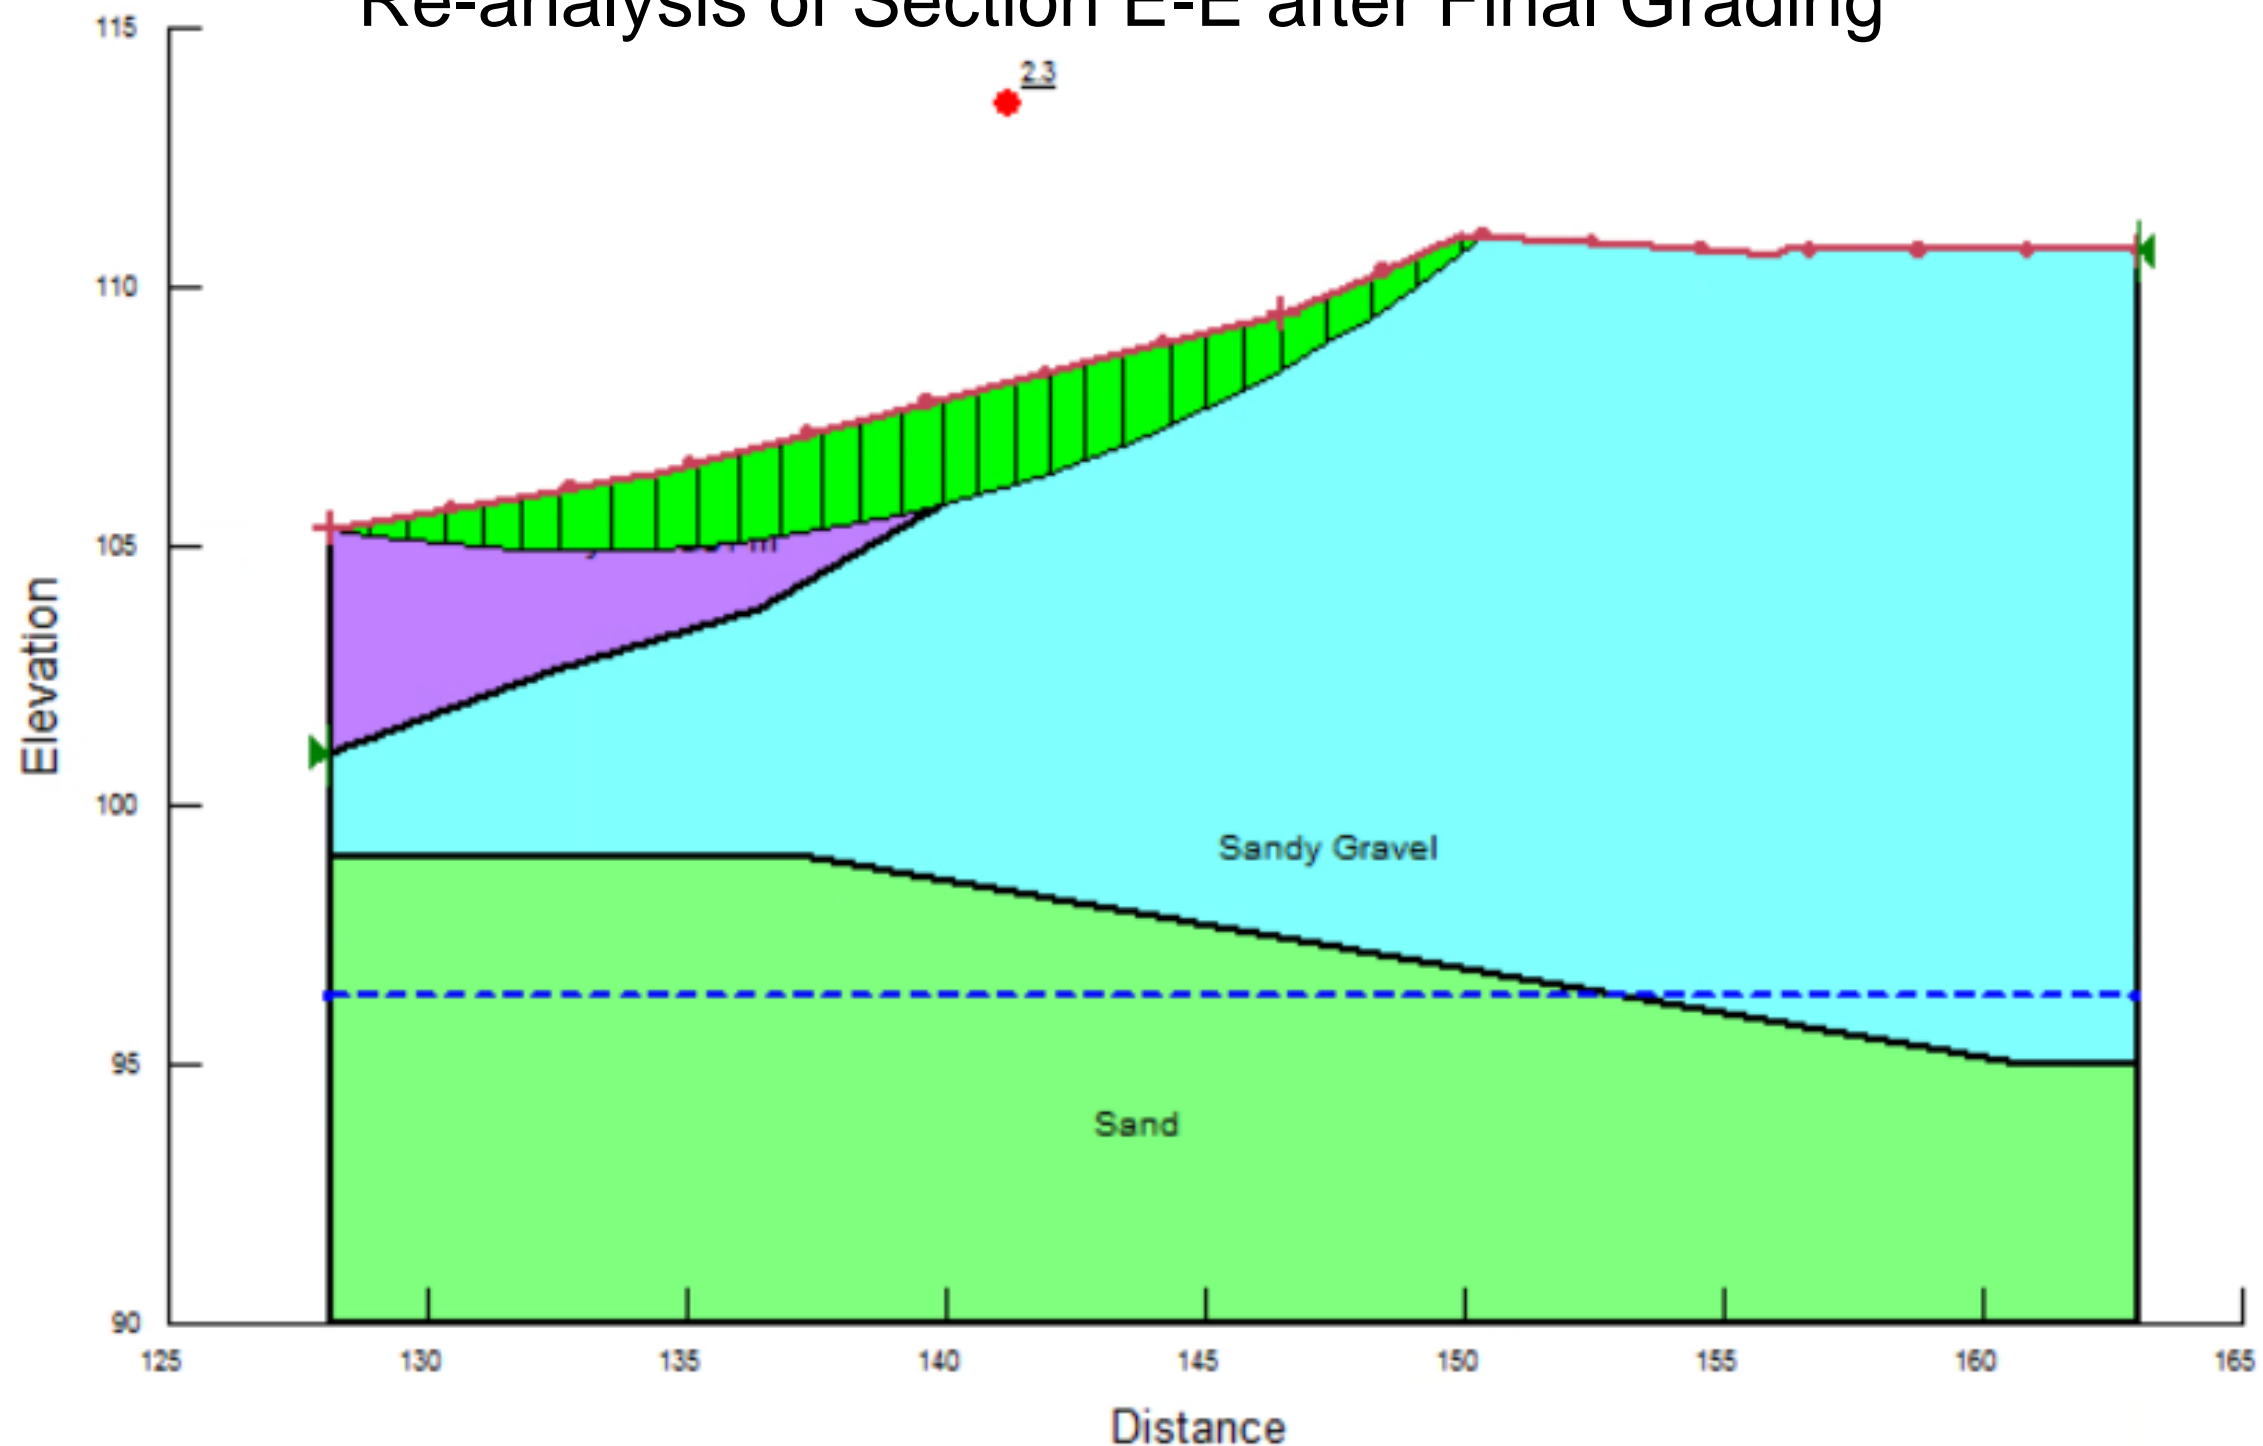
# Re-analysis of Section E-E after Final Grading

Color	Name	Model	Unit Weight (kN/m <sup>3</sup> )	Cohesion' (kPa)	Phi' (°)
Light Green	Compact to Dense Sand	Mohr-Coulomb	19.7	0	31
Purple	HydroVac Fill	Mohr-Coulomb	18	0	27
Green	Sand	Mohr-Coulomb	19.8	0	30

Table 8: Results of Slope Stability Analyses of Proposed Slopes			
Section	Loading Condition	Factor of Safety	Figure No.
Section D-D	Effective Stress Analysis	3.0	16A
	Effective Stress Analysis with Seismic Loading	1.5	16B
Section E-E	Effective Stress Analysis	2.3	17A
	Effective Stress Analysis with Seismic Loading	1.3	17B
Section X-X	Effective Stress Analysis	1.8	18A
	Effective Stress Analysis with Seismic Loading	1.1	18B
Section Y-Y	Effective Stress Analysis	1.7	19A
	Effective Stress Analysis with Seismic Loading	1.1	19B
Section Z-Z	Effective Stress Analysis	1.7	20A
	Effective Stress Analysis with Seismic Loading	1.1	20B

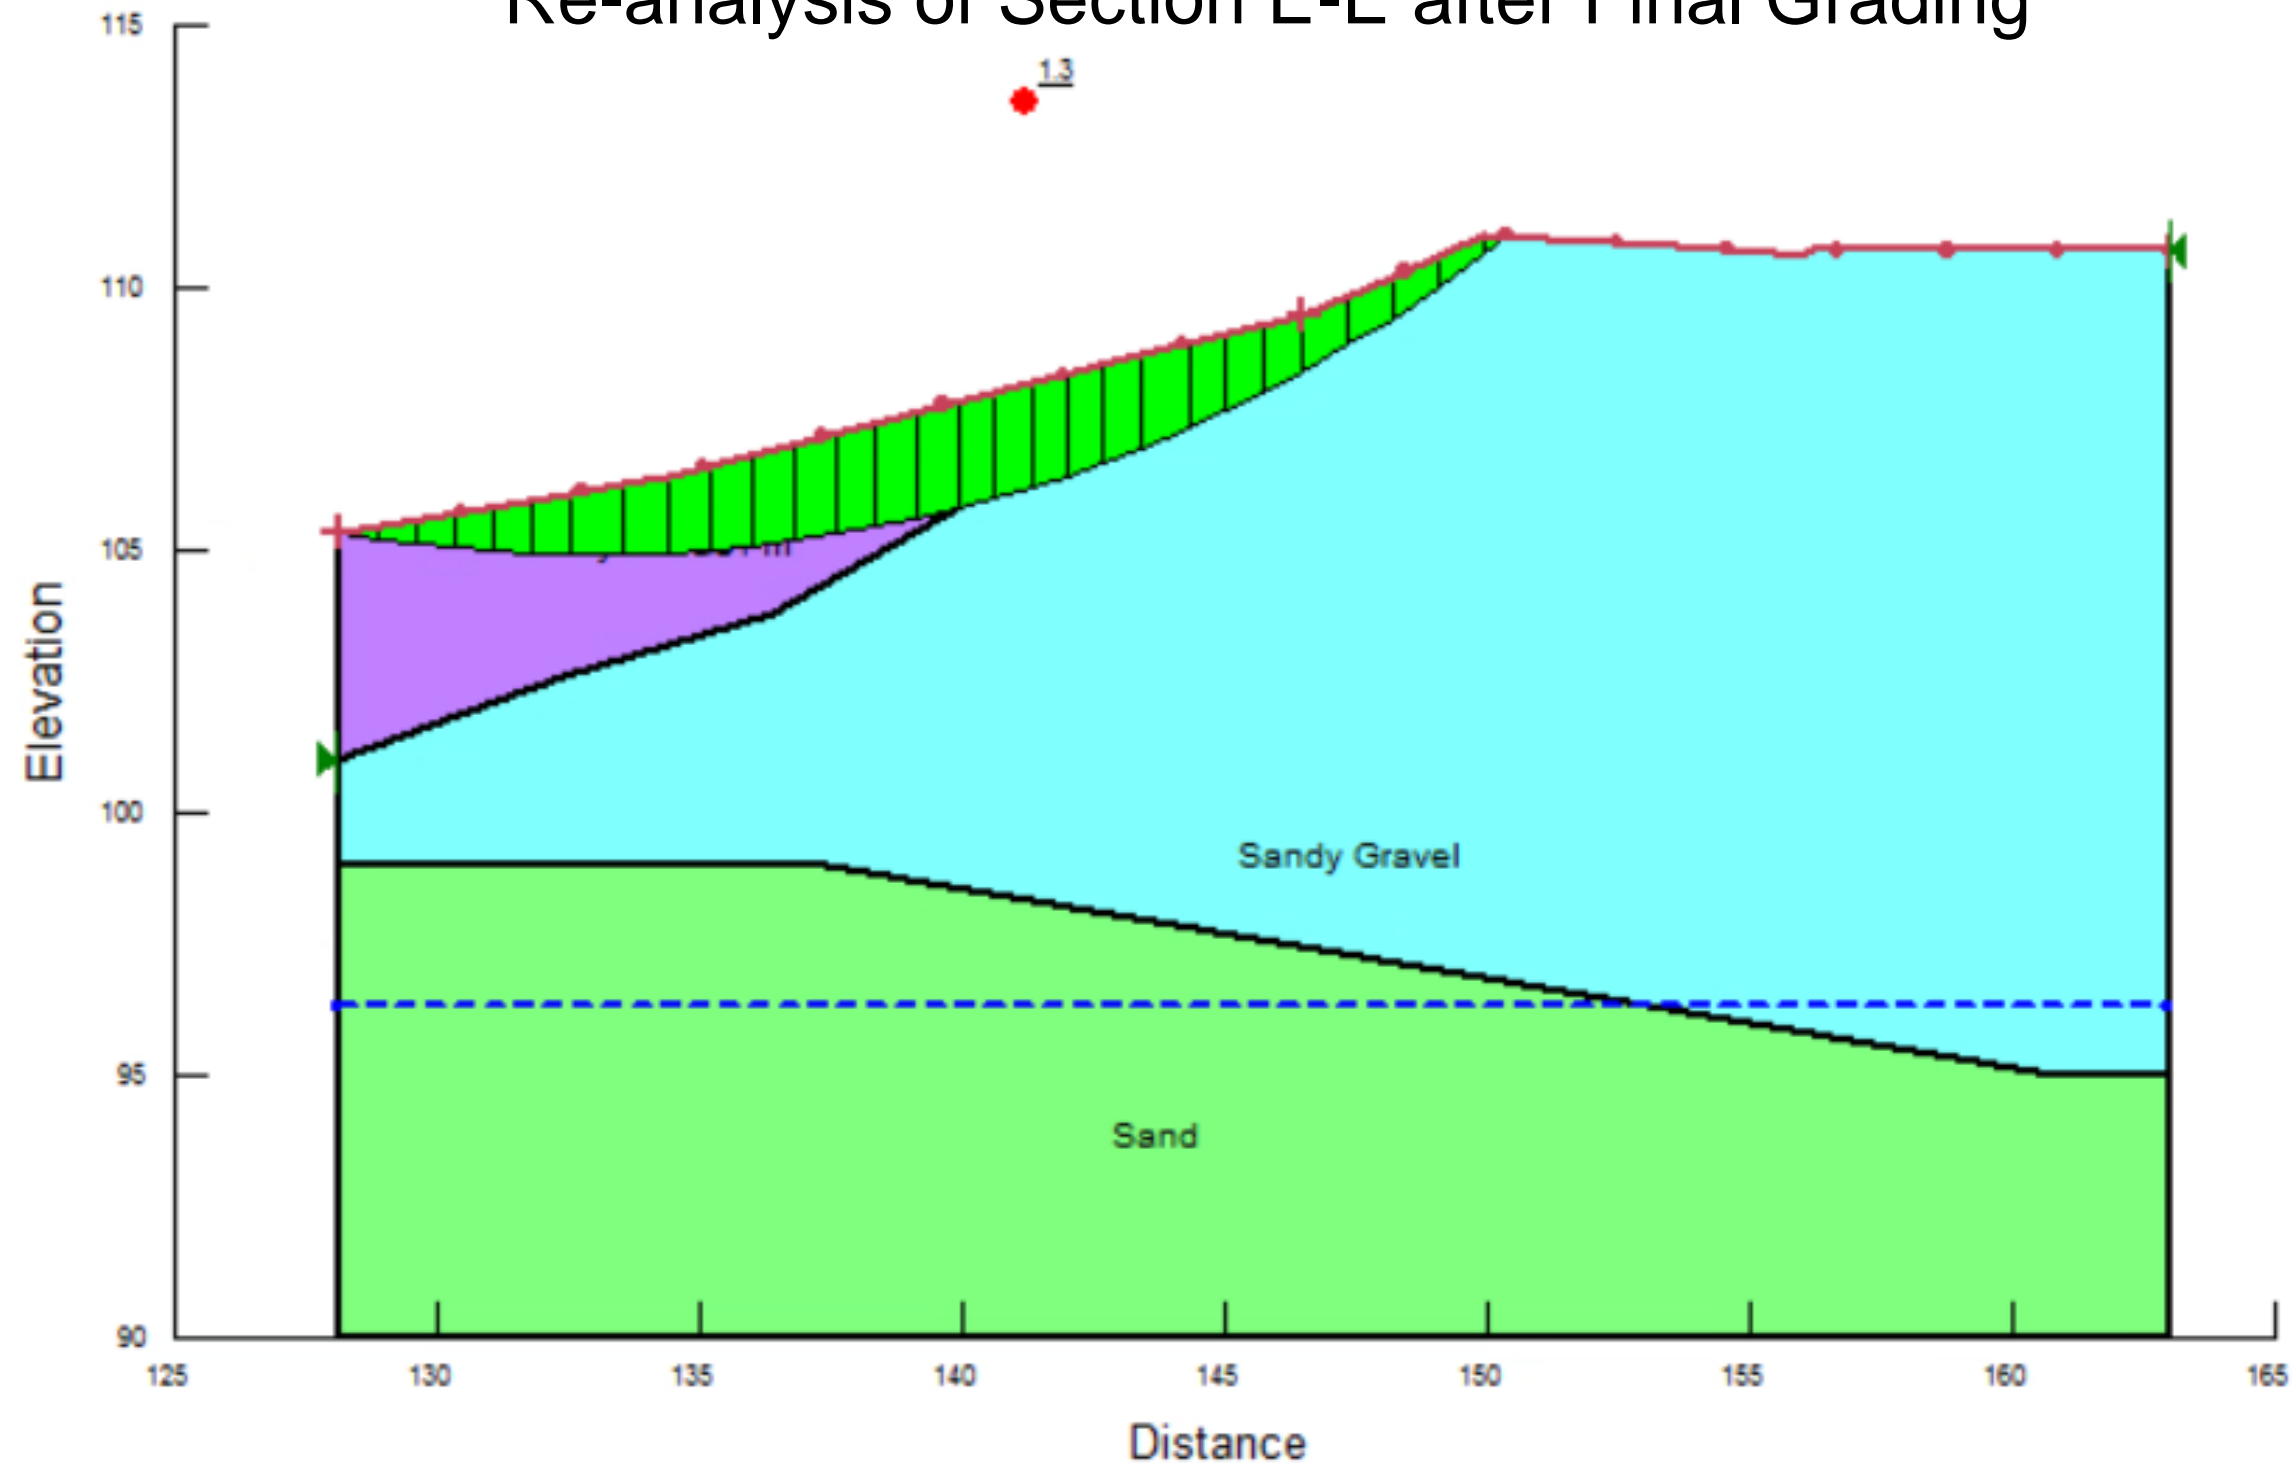
# Re-analysis of Section E-E after Final Grading

Color	Name	Model	Unit Weight (kN/m <sup>3</sup> )	Cohesion' (kPa)	Phi' (°)
Light Green	Compact to Dense Sand	Mohr-Coulomb	19.7	0	31
Purple	HydroVac Fill	Mohr-Coulomb	18	0	27
Green	Sand	Mohr-Coulomb	19.8	0	30
