February 21, 2024 (Revision 1)

Project Name: **Geotechnical Investigation – Slope Stability Analysis in Support of Zoning By-Law Amendment, 4380 Trail Road, Ottawa, Ontario**

EXP Project Number: **OTT-21023795-A0**

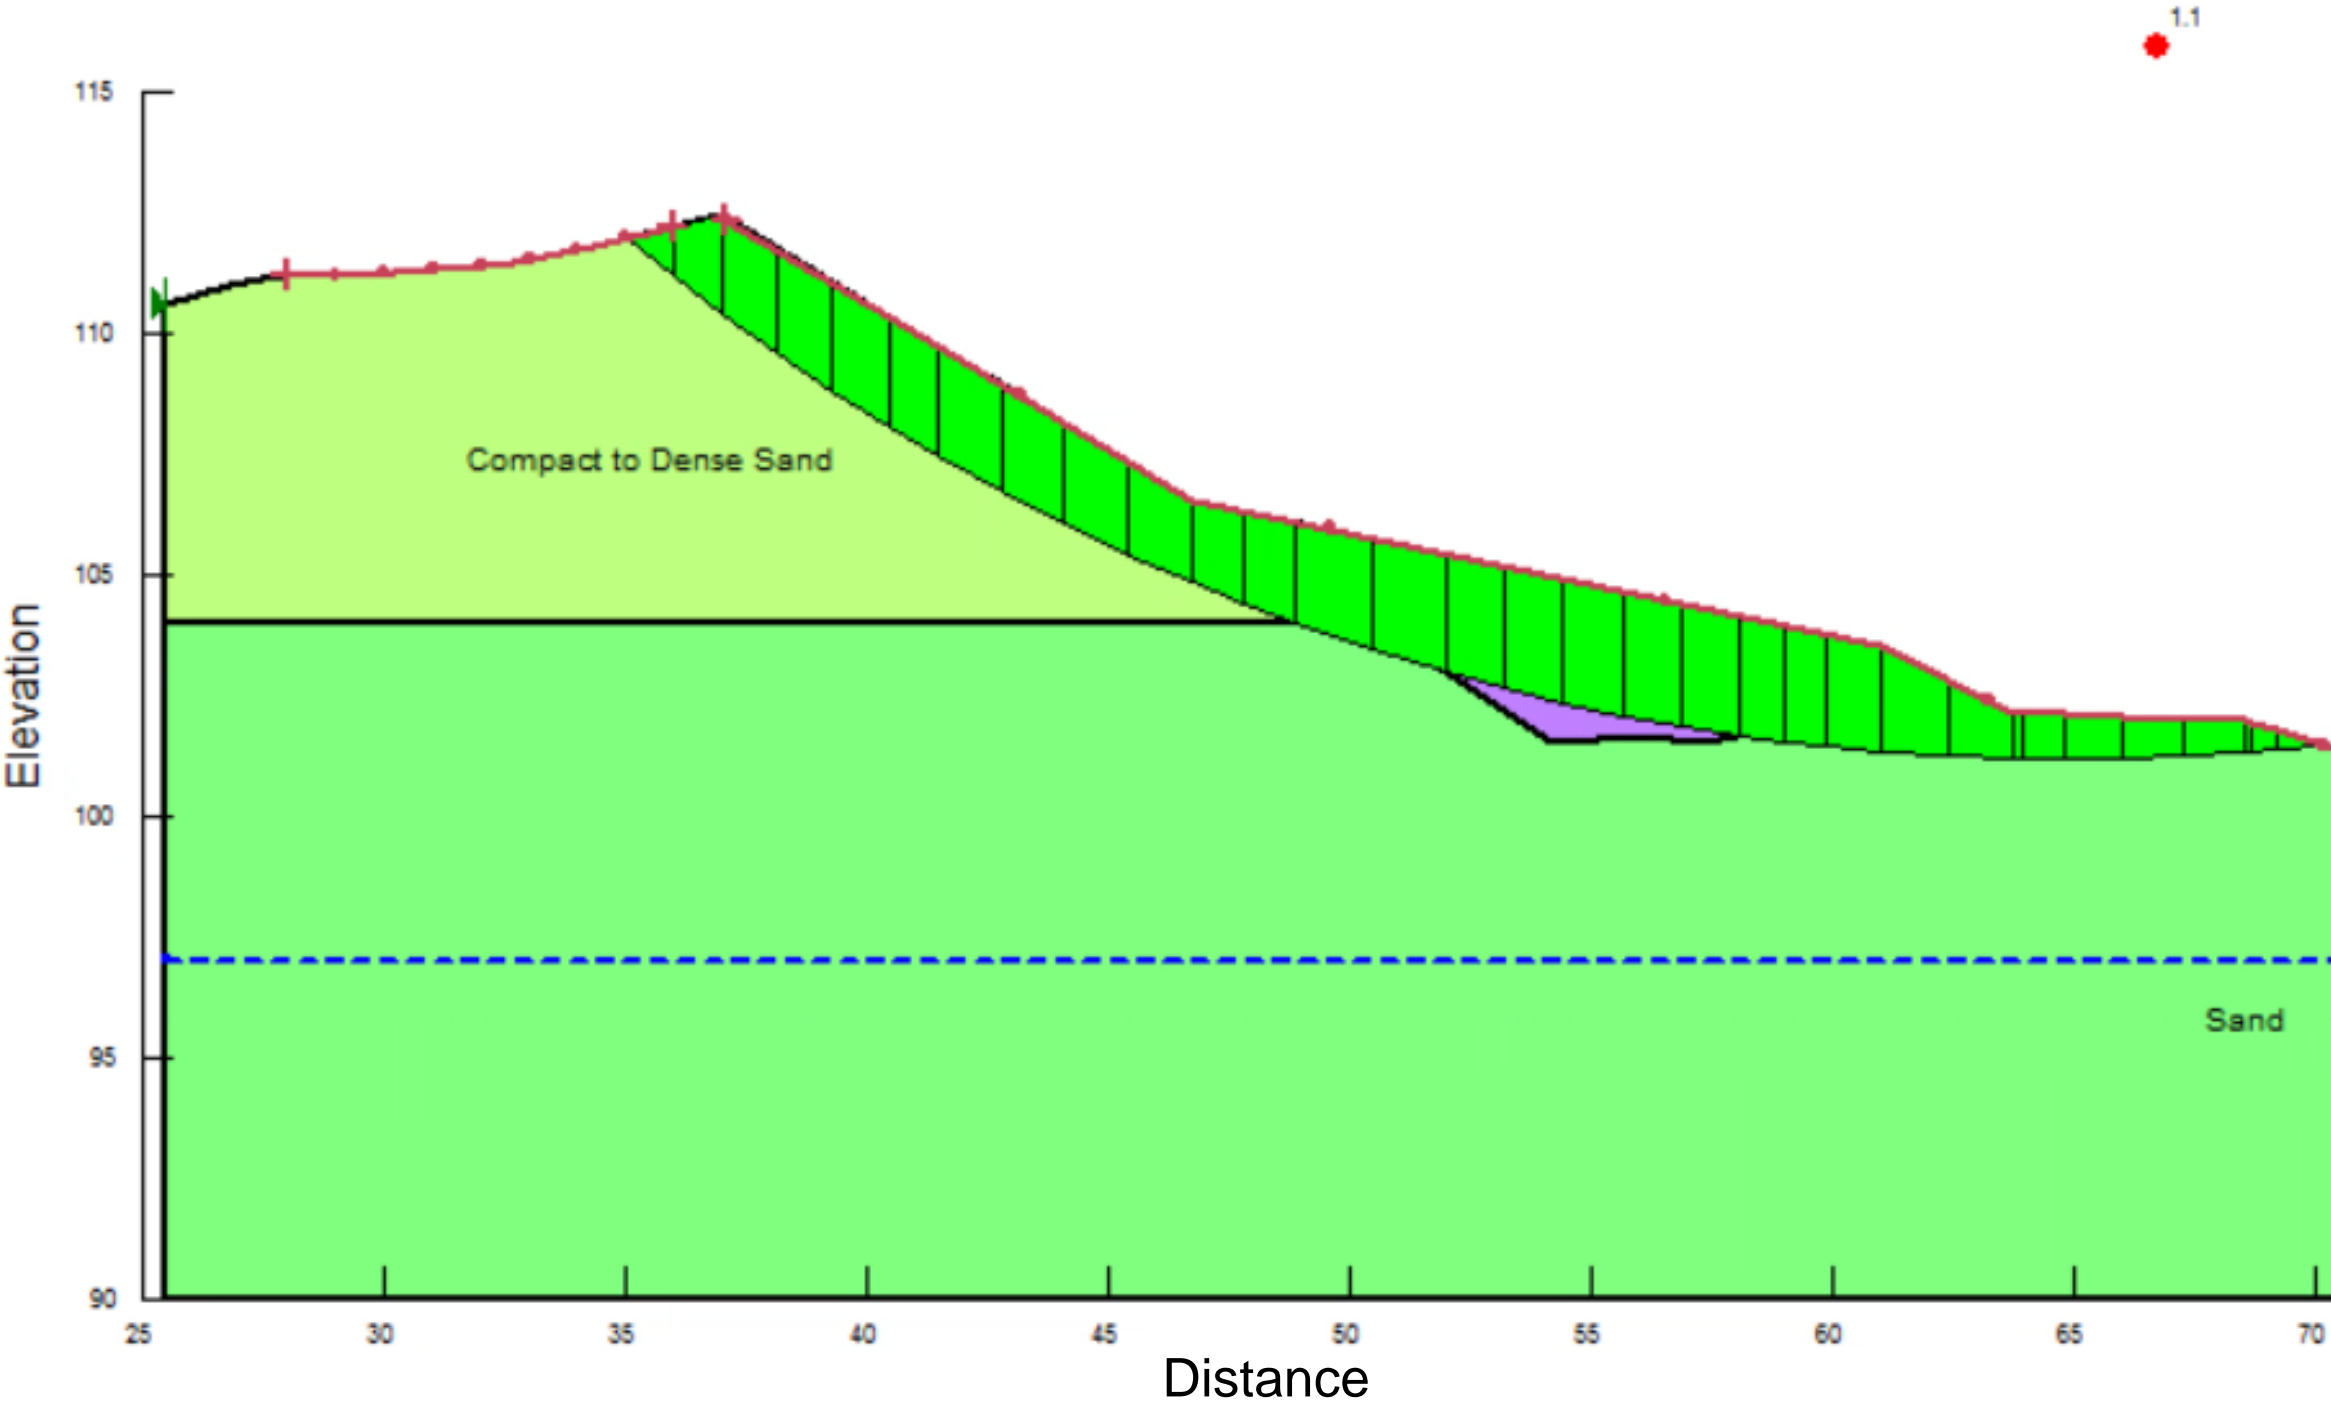
# Section X-X' after Final Grading

Color	Name	Model	Unit Weight (kN/m <sup>3</sup> )	Cohesion' (kPa)	Phi' (°)
Light Green	Compact to Dense Sand	Mohr-Coulomb	19.7	0	31
Purple	HydroVac Fill	Mohr-Coulomb	18	0	27
Light Green	Sand	Mohr-Coulomb	19.8	0	30

Table 8: Results of Slope Stability Analyses of Proposed Slopes			
Section	Loading Condition	Factor of Safety	Figure No.
Section D-D	Effective Stress Analysis	3.0	16A
	Effective Stress Analysis with Seismic Loading	1.5	16B
Section E-E	Effective Stress Analysis	2.3	17A
	Effective Stress Analysis with Seismic Loading	1.3	17B
Section X-X	Effective Stress Analysis	1.8	18A
	Effective Stress Analysis with Seismic Loading	1.1	18B
Section Y-Y	Effective Stress Analysis	1.7	19A
	Effective Stress Analysis with Seismic Loading	1.1	19B
Section Z-Z	Effective Stress Analysis	1.7	20A
	Effective Stress Analysis with Seismic Loading	1.1	20B

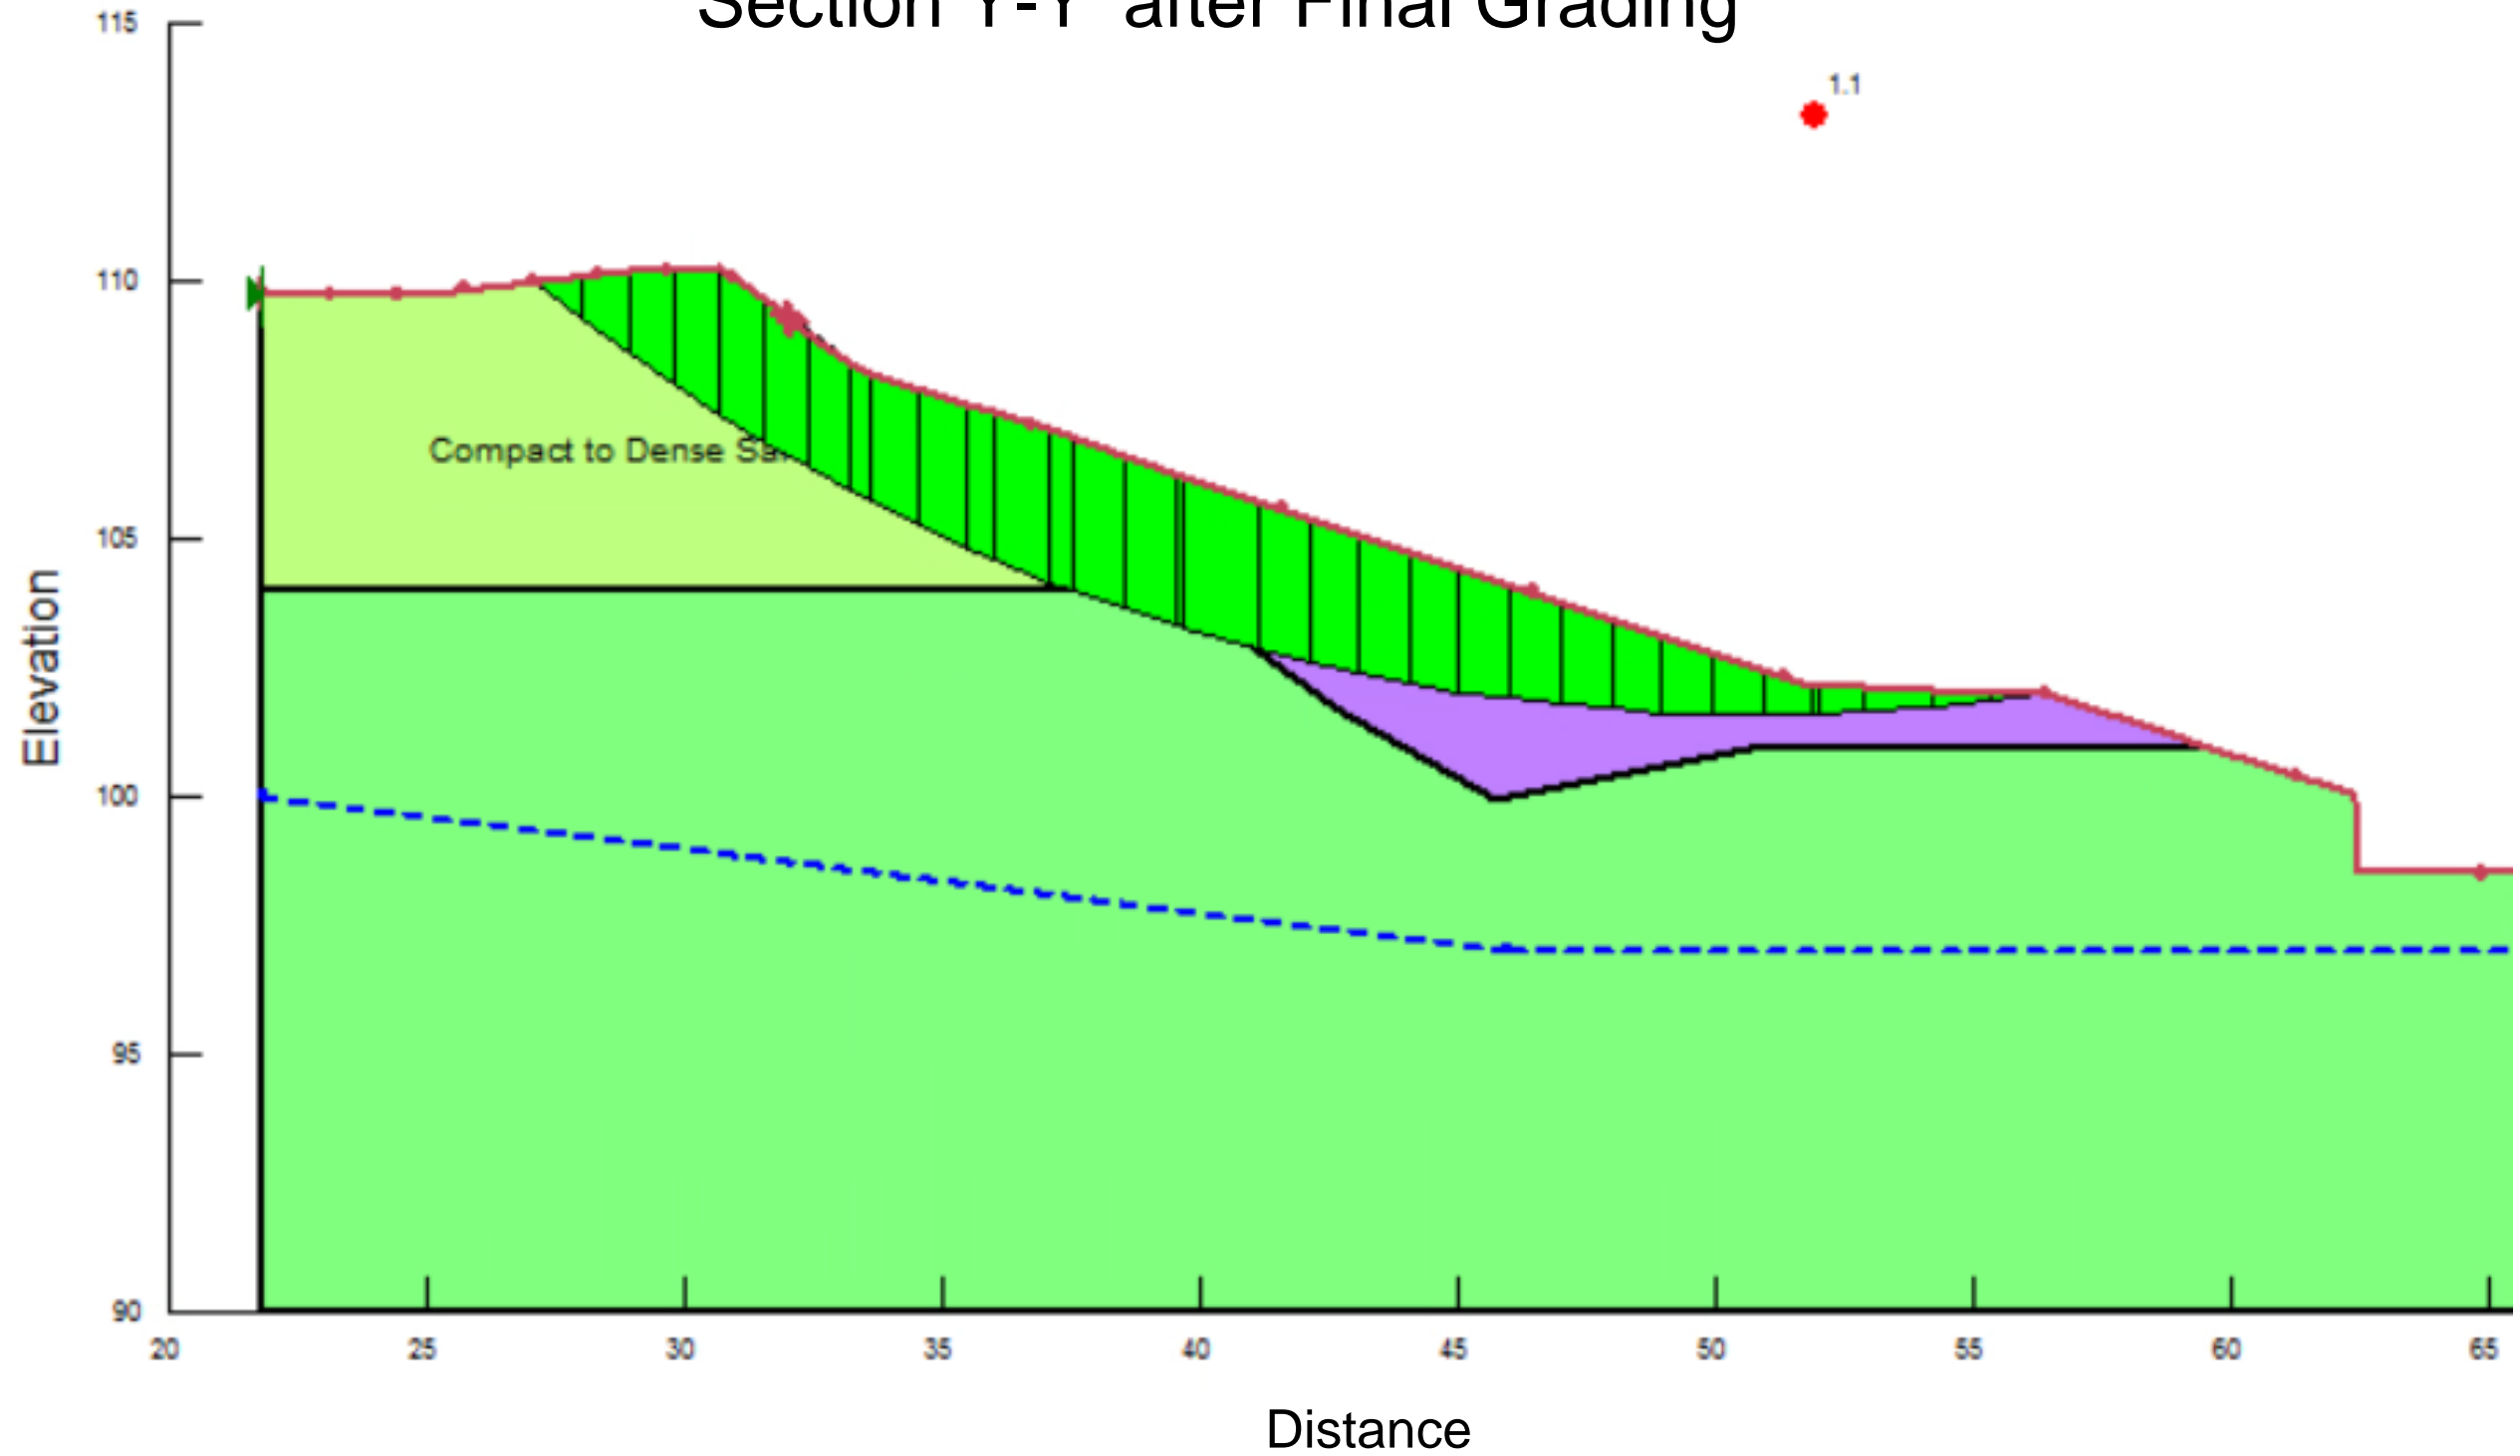
# Section Y-Y' after Final Grading

Color	Name	Model	Unit Weight (kN/m <sup>3</sup> )	Cohesion' (kPa)	Phi' (°)
Light Green	Compact to Dense Sand	Mohr-Coulomb	19.7	0	31
Purple	HydroVac Fill	Mohr-Coulomb	18	0	27
Dark Green	Sand	Mohr-Coulomb	19.8	0	30

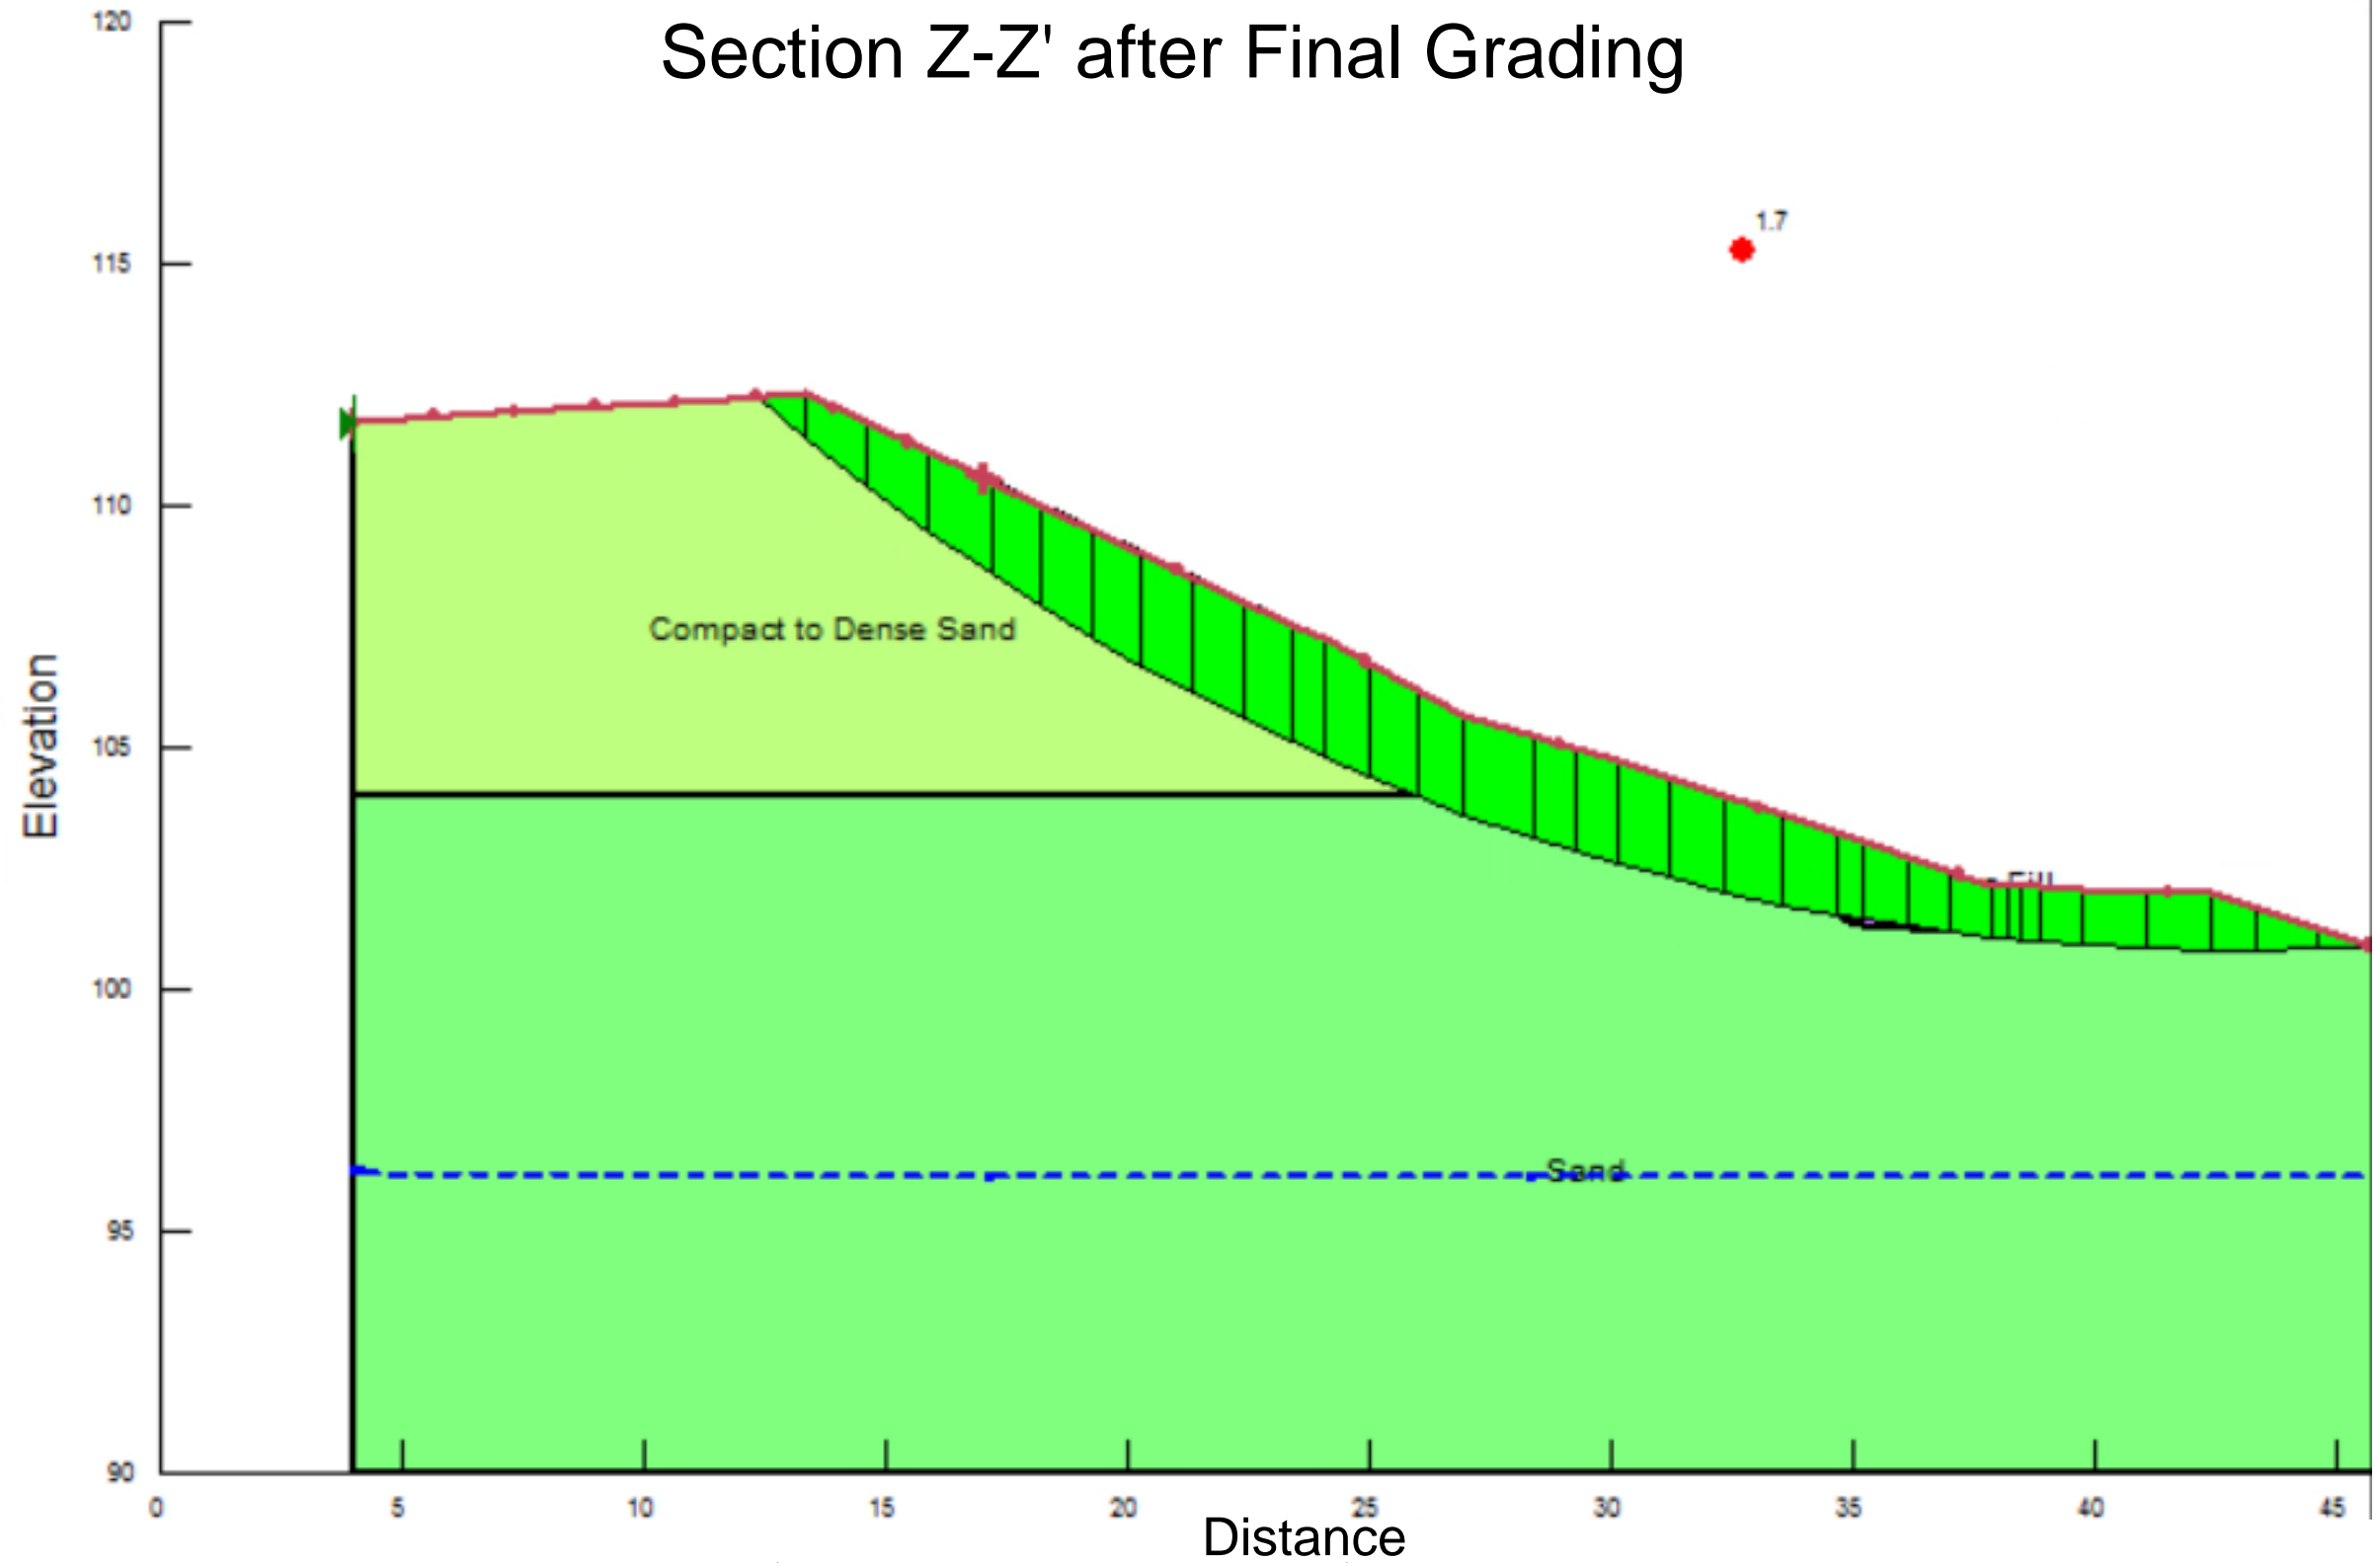
# Section Z-Z' after Final Grading

Color	Name	Model	Unit Weight (kN/m <sup>3</sup> )	Cohesion' (kPa)	Phi' (°)
Light Green	Compact to Dense Sand	Mohr-Coulomb	19.7	0	31
Purple	HydroVac Fill	Mohr-Coulomb	18	0	27
Bright Green	Sand	Mohr-Coulomb	19.8	0	30
