Preliminary Geotechnical Investigation

Proposed Mixed Use Development
1987 Robertson Road
Ottawa, Ontario

March 9, 2022

Report: PG5715-1 Revision 3

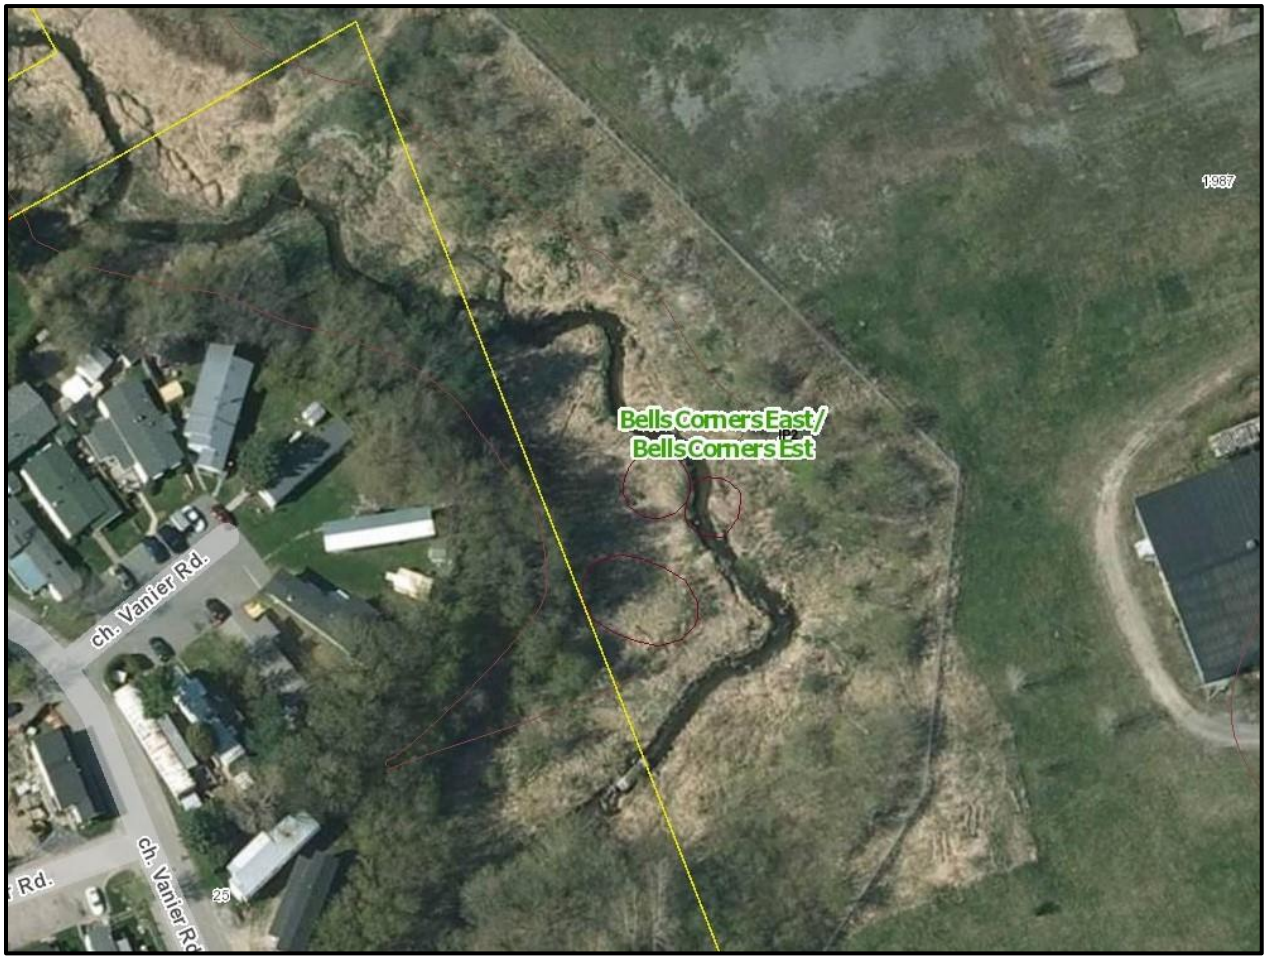
FIGURE 2

Based on historical aerial images of the slope face obtained from GeoOttawa, the natural course of the creek has been altered due to fill placement within the subject site. When aerial images of the creek from 1958 and 2011, shown in Figures 2 to 4 in Appendix 2, are compared the natural course of the creek was observed to have shifted to the west and the meander shapes were altered. In-filling at the site has forced the water course to re-establish further west. The original top of slope is set back further from the apparent existing top of slope as under existing conditions what appears to be the top of slope has been infilled and does not represent the natural top of slope.

1958 AERIAL IMAGE

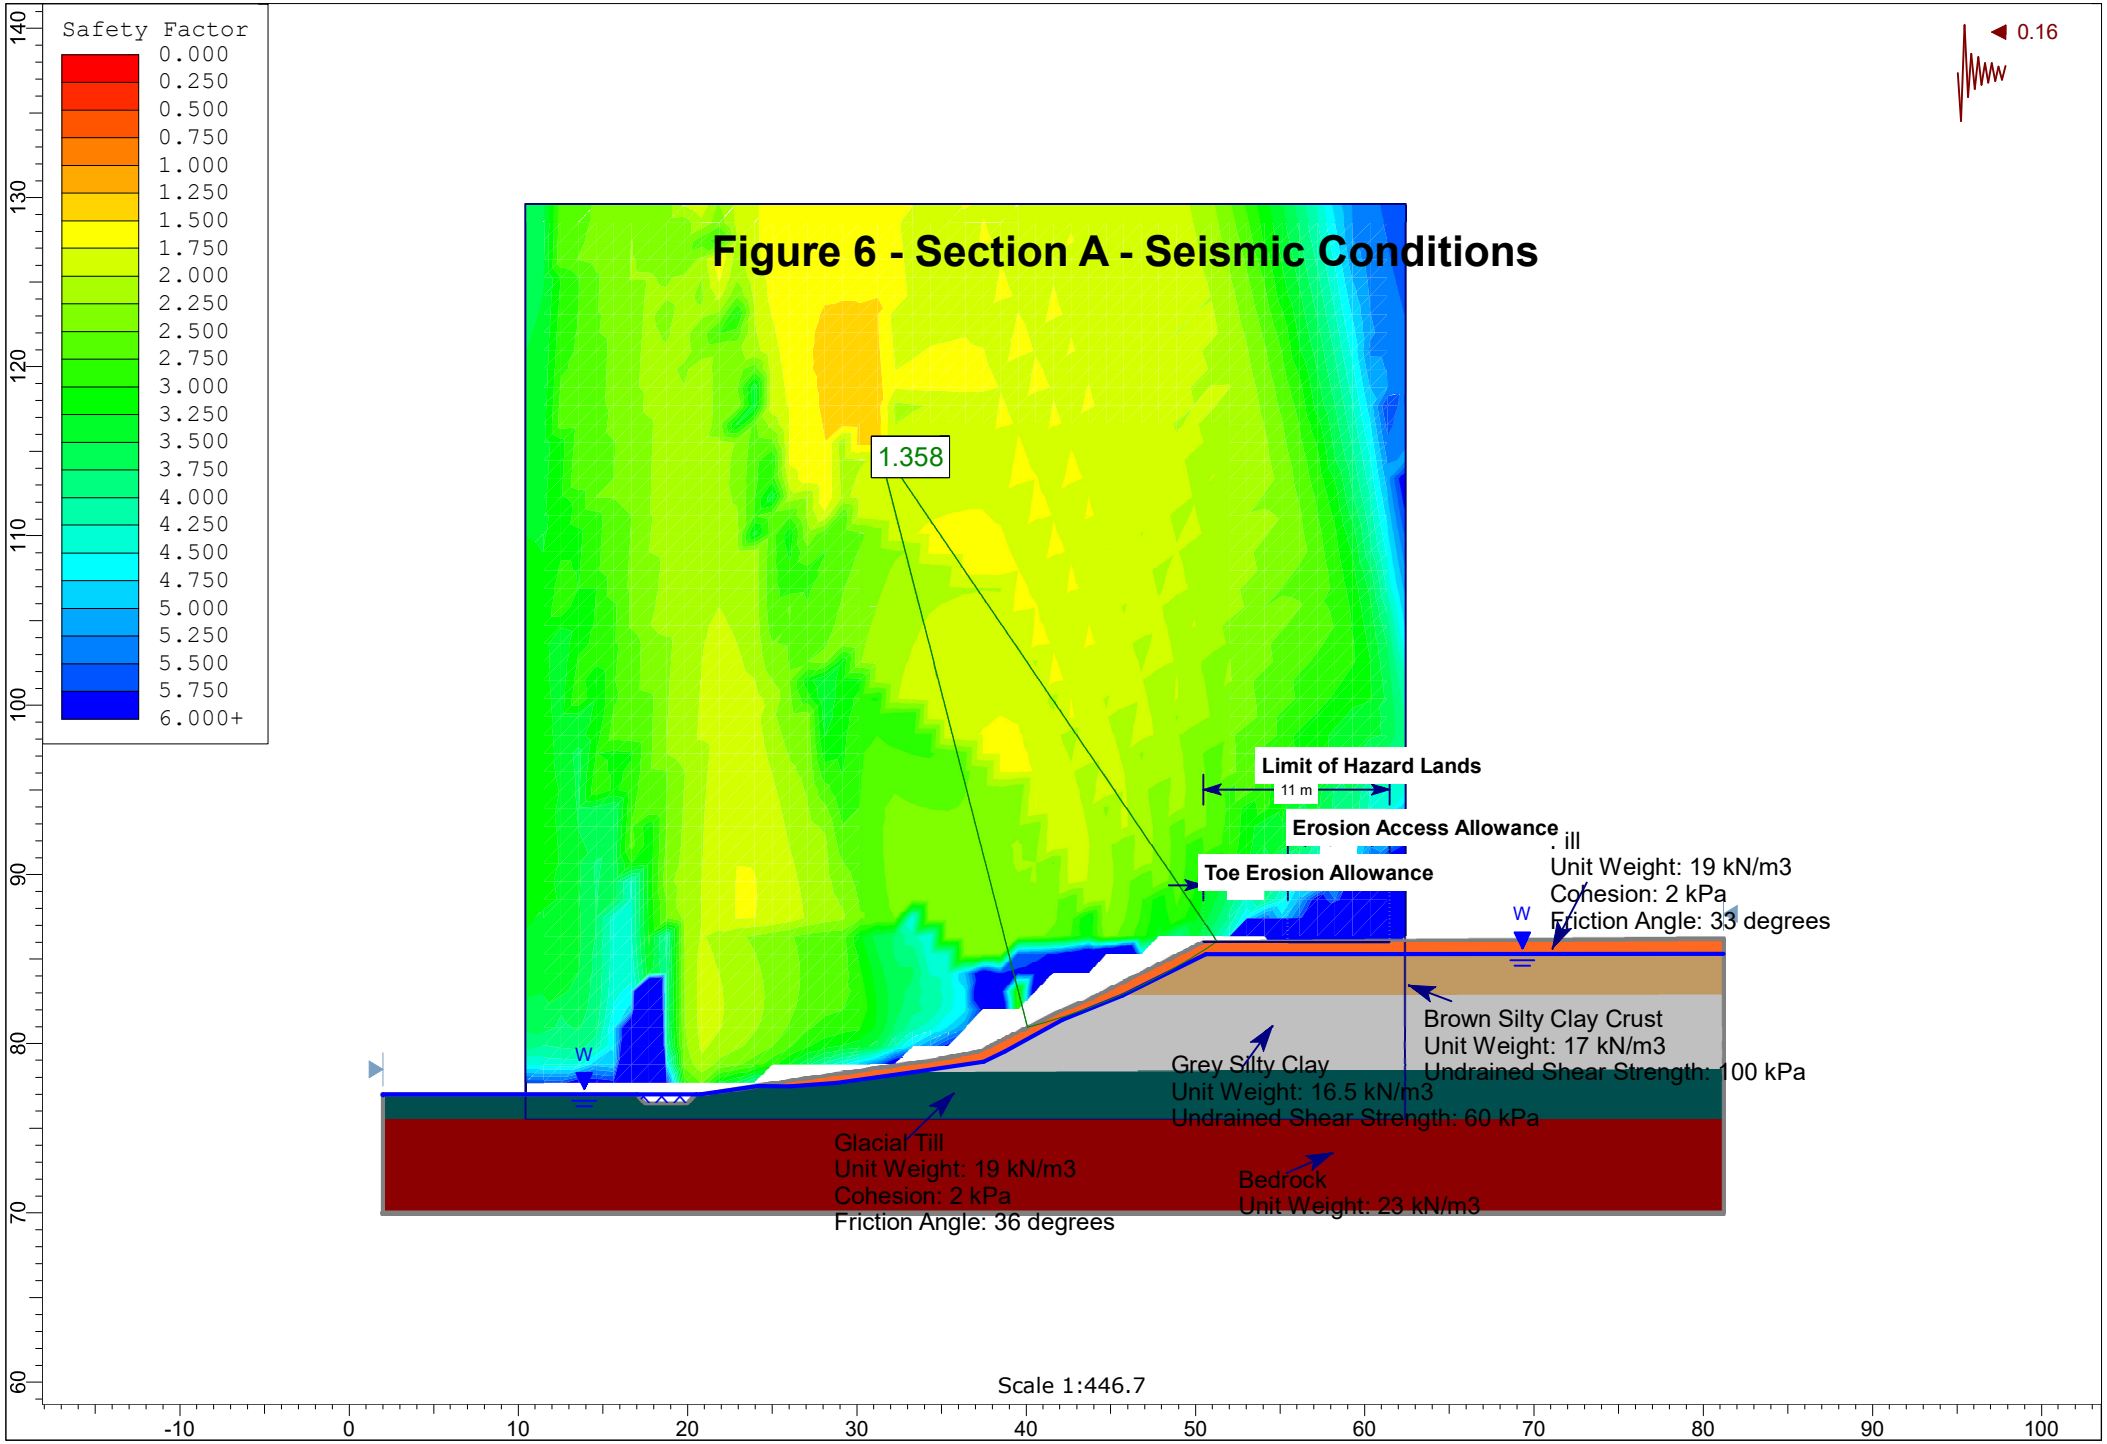
Subsoil conditions at the cross-sections were inferred based on nearby boreholes. For a conservative review of the groundwater conditions, the silty clay deposit was noted to be fully saturated for our analysis and exiting at the toe of the slope. The results are shown in Figures 5, 7, 9, 11, 13, and 15 in Appendix 2. The results indicate a slope with a factor of safety of 1.53 at Section A, a slope with a factor of safety of 13.98 at Section F, and slopes with factors of safety less than 1.5 beyond the top of slope at Section B, C, D, and E. Based on these results, a stable slope setback varying between 9 and 15 m from the top of the slope are required to achieve a factor of safety of 1.5 for the limit of the hazard lands in the area of Sections B, C and D. It should be noted that the failure planes with a factor of safely of less than 1.5 on Section E did not pass the top of slope, therefore a stable slope setback from the top of slope was not needed.

The results of the analyses including seismic loading are shown in Figures 6, 8, 10, 12, 14, and 16 in Appendix 2. The results indicate a slope with a factor of safety of 1.36 at Section A, 1.30 at Section D, 2.74 at Section F, and slopes with factors of safety less than 1.1 beyond the top of slope at Sections B, C, and E. Based on these results, a stable slope setback varying between 1 and 5 m from the top of the slope is required to achieve a factor of safety of 1.1 for the limit of the hazard lands.

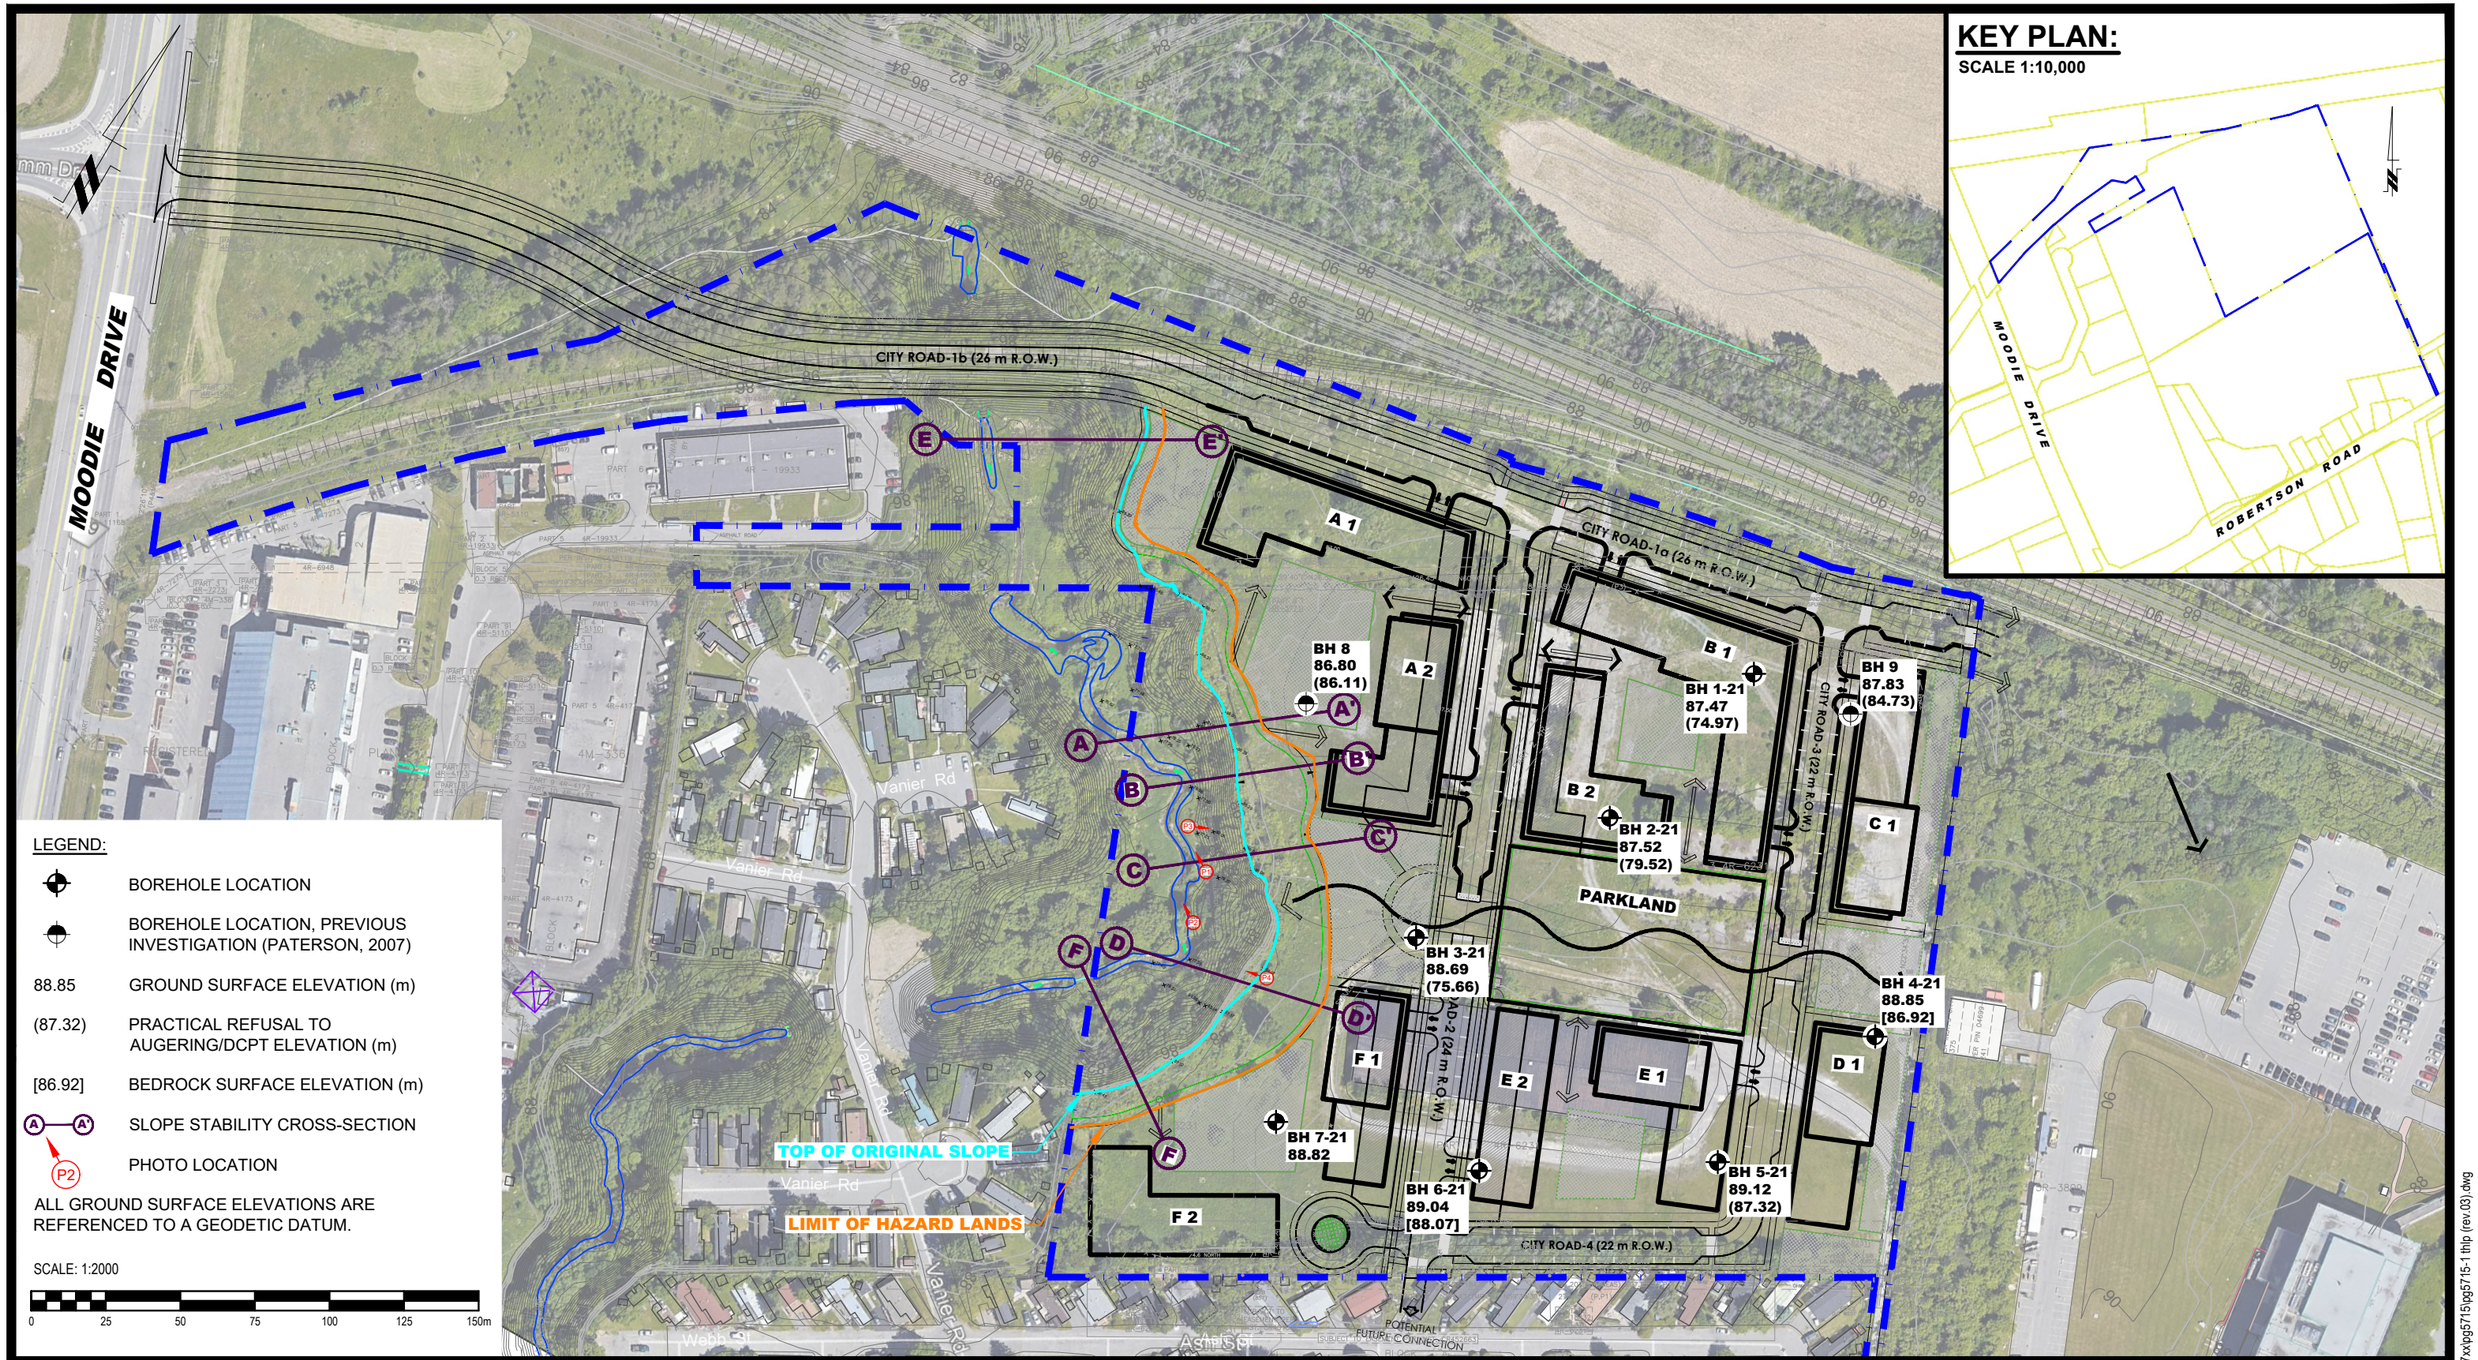
Figure 16 - Section F - Seismic Conditions
Safety Factor
0.000
0.250
0.500
0.750
1.000
1.250
1.500
1.750
2.000
2.250
2.500
2.750
3.000
3.250
3.500
3.750
4.000
4.250
4.500
4.750
5.000
5.250
5.500
5.750
6.000+
2.741
0.16
Limit of Hazard Lands
11 m
Erosion Access Allowance
6 m
Toe Erosion Allowance
5 m
Top of Slope
Fill
Unit Weight: 19 kN/m3
Cohesion: 2 kPa
Friction Angle: 33 degrees
W
W
Brown Silty Clay Crust
Unit Weight: 17 kPa
Undrained Shear Strength: 100 kPa
Grey Silty Clay
Unit Weight: 16.5 kN/m3
Undrained Shear Strength: 60 kPa
Bedrock
Unit Weight: 23 kN/m3
140
130
120
110
100
90
80
70
-30
-20
-10
0
10
20
30
40
50
60
70
