Phase I – Environmental Site Assessment

75 Breezehill Avenue

Ottawa, Ontario

Report: PE6049-1
August 8, 2023

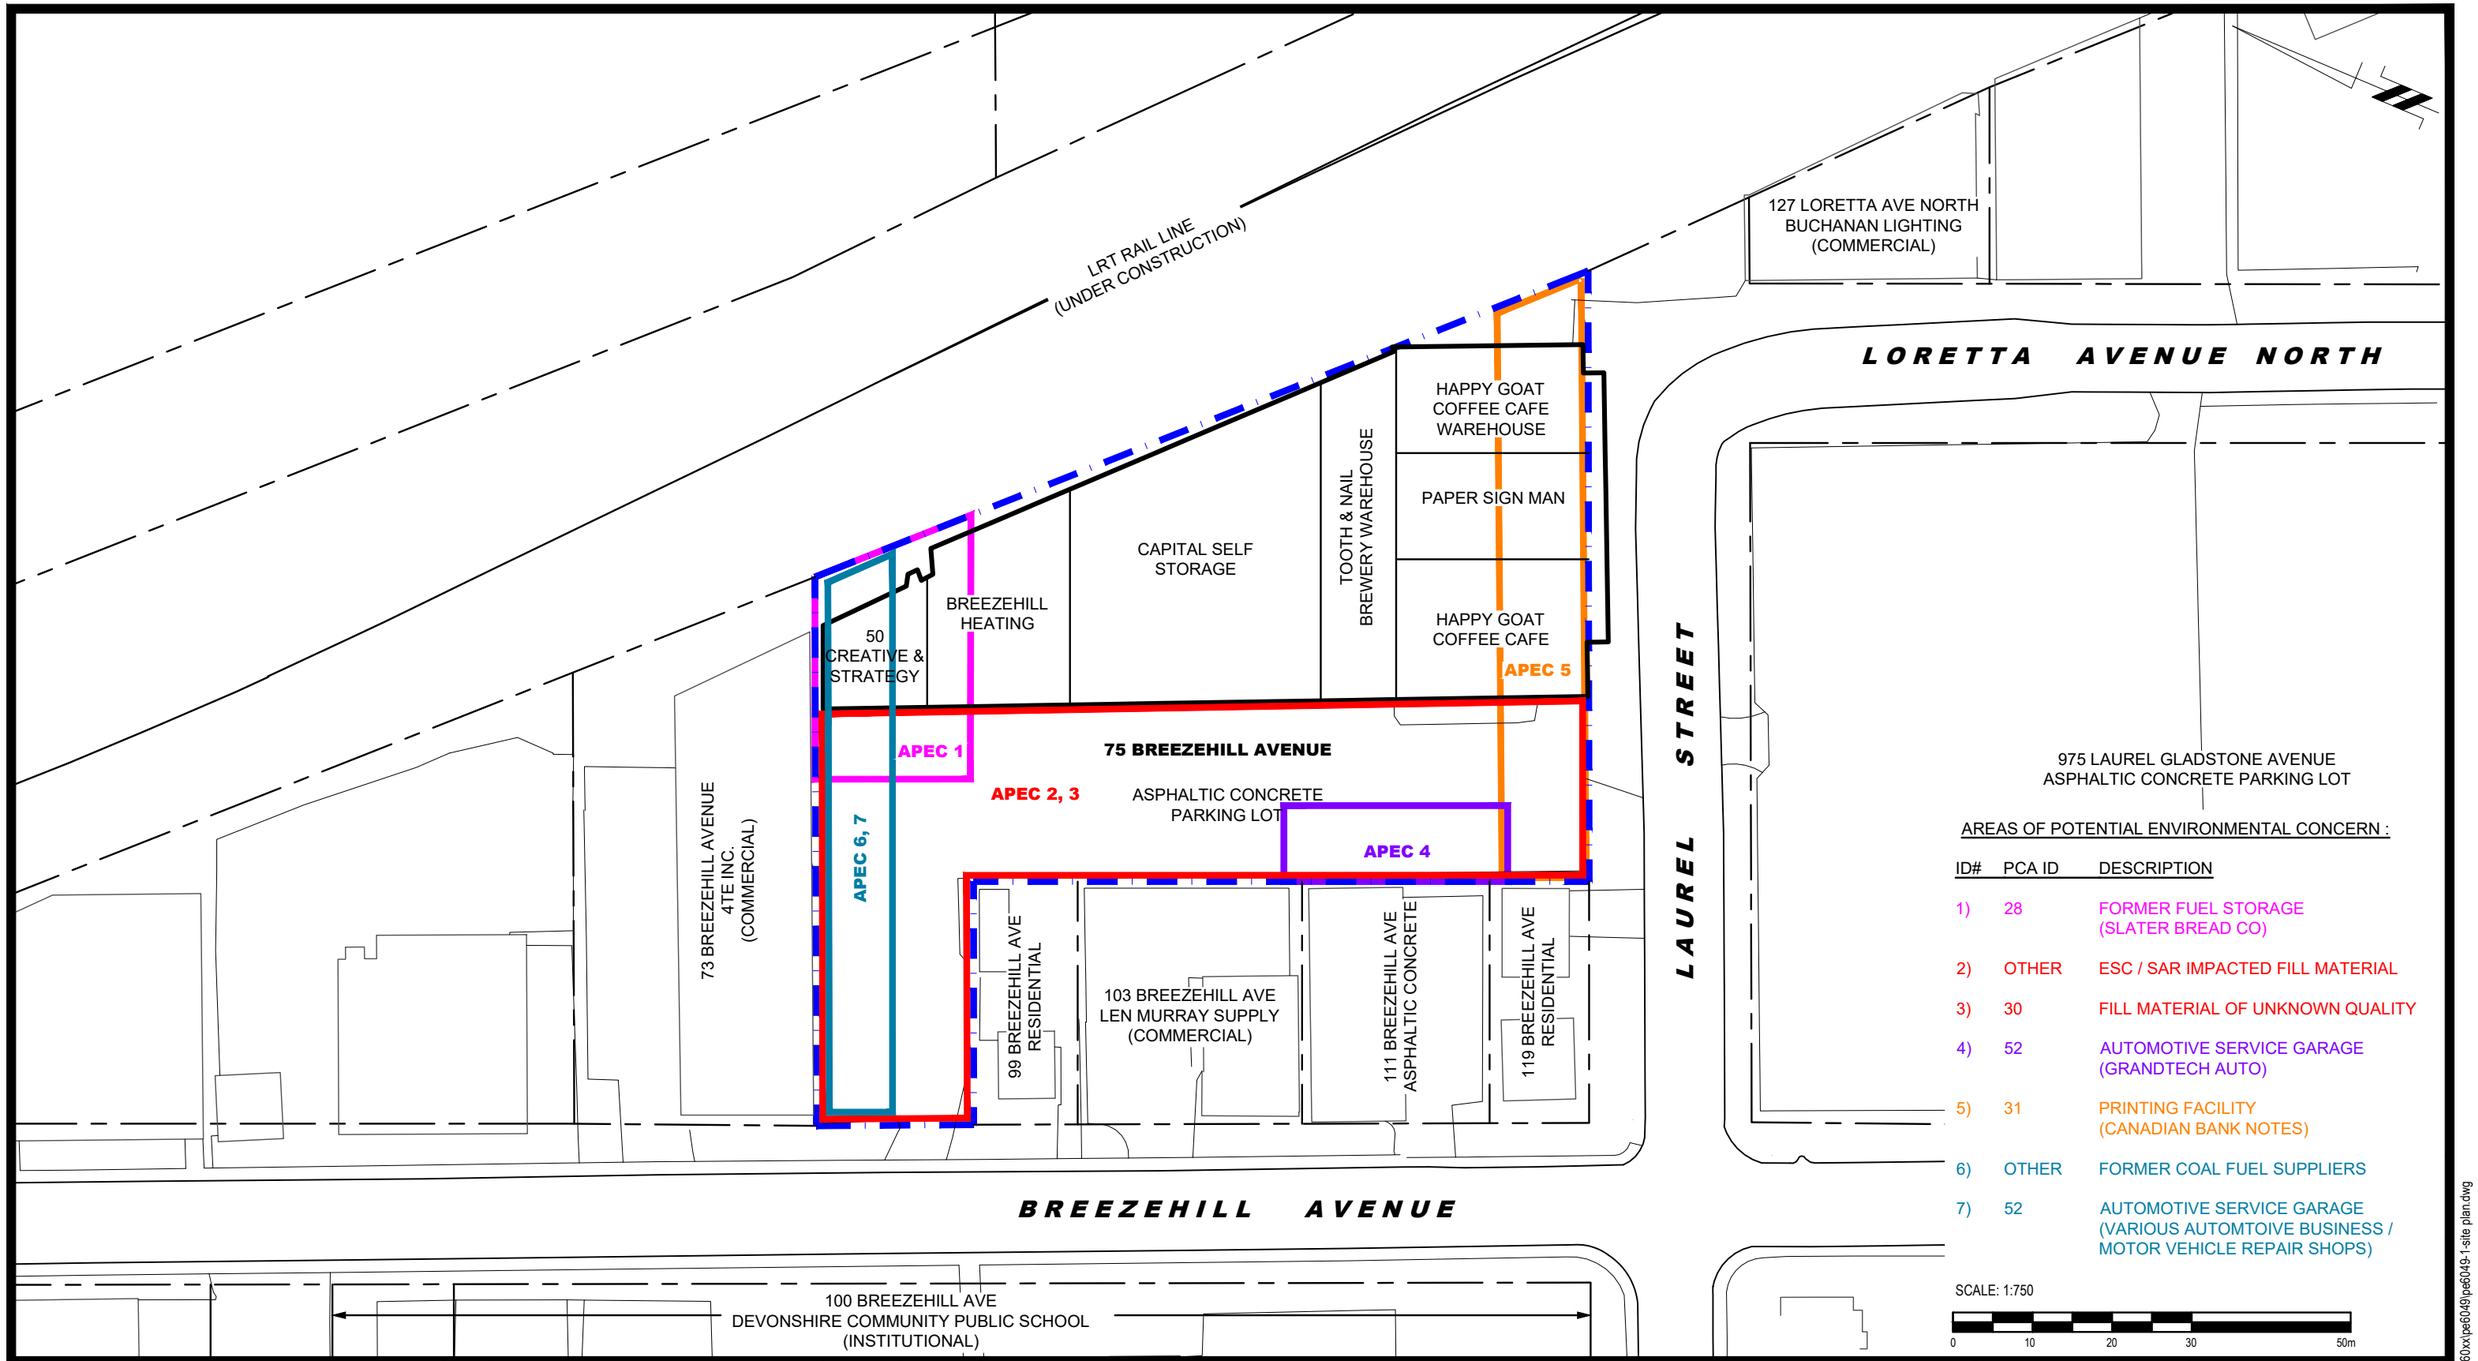
DRAWING PE6049-1 – SITE PLAN

ID#	PCA ID	DESCRIPTION
1)	28	FORMER FUEL STORAGE (SLATER BREAD CO)
2)	OTHER	ESC / SAR IMPACTED FILL MATERIAL
3)	30	FILL MATERIAL OF UNKNOWN QUALITY
4)	52	AUTOMOTIVE SERVICE GARAGE (GRANDTECH AUTO)
5)	31	PRINTING FACILITY (CANADIAN BANK NOTES)
6)	OTHER	FORMER COAL FUEL SUPPLIERS
7)	52	AUTOMOTIVE SERVICE GARAGE (VARIOUS AUTOMTOIVE BUSINESS / MOTOR VEHICLE REPAIR SHOPS)

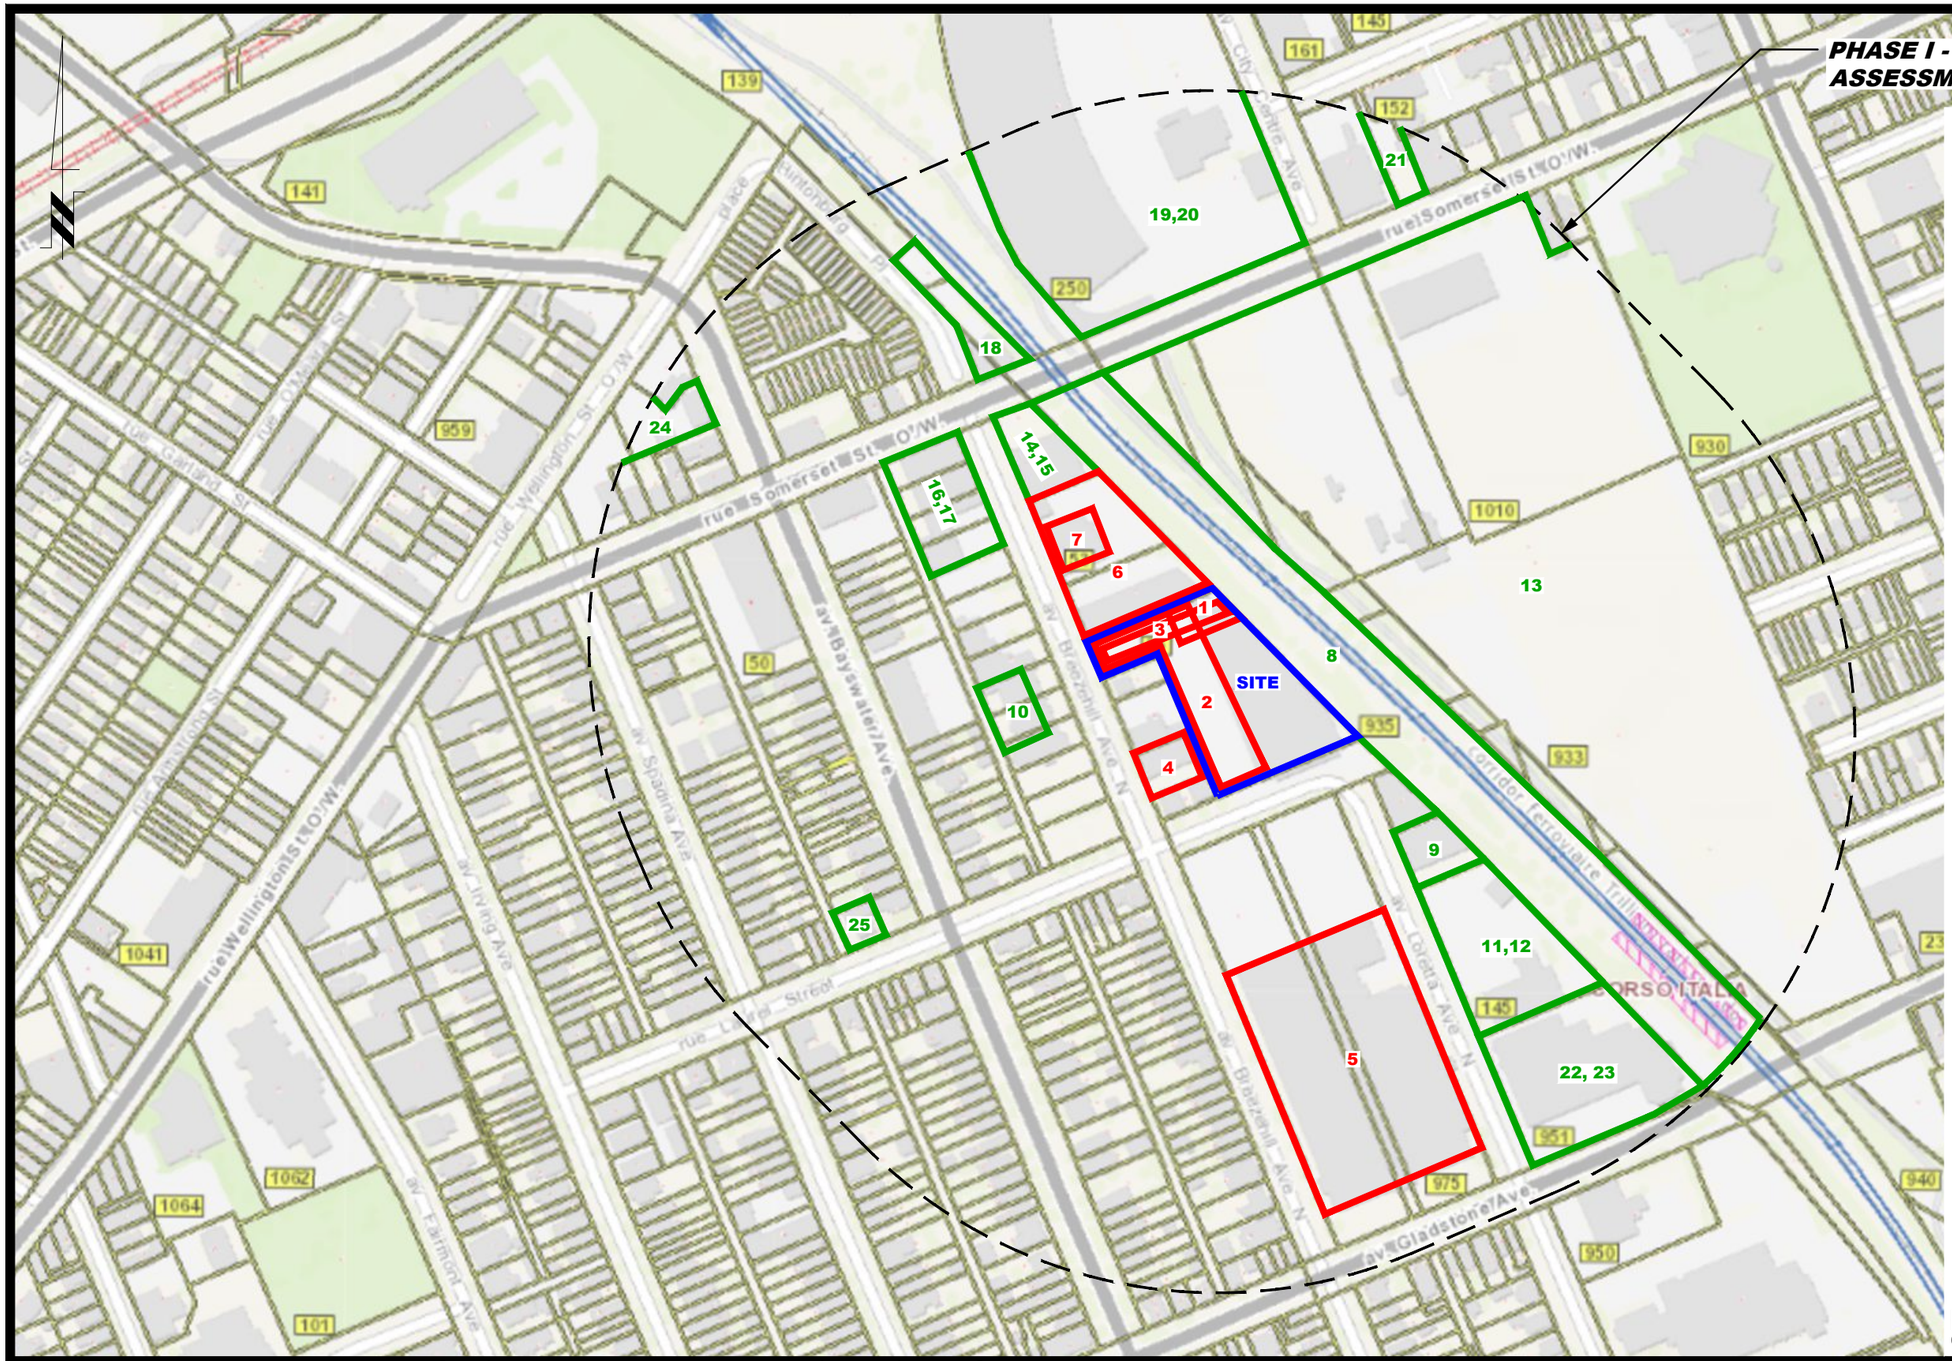
DRAWING PE6049-2 – SURROUNDING LAND USE PLAN

5)	31	PRINTING FACILITY (CANADIAN BANK NOTES)
6)	OTHER	FORMER COAL FUEL SUPPLIERS
7)	52	VARIOUS AUTOMTOIVE BUSINESS / MOTOR VEHICLE REPAIR SHOPS
8)	46	FORMER RAIL WAY LINE
