Phase One Environmental Site Assessment
1052, 1060, and 1064 St. Laurent Boulevard
Ottawa, Ontario

GEMTEC Project: 103499.002

August 8, 2025
GEMTEC Project: 103499.002

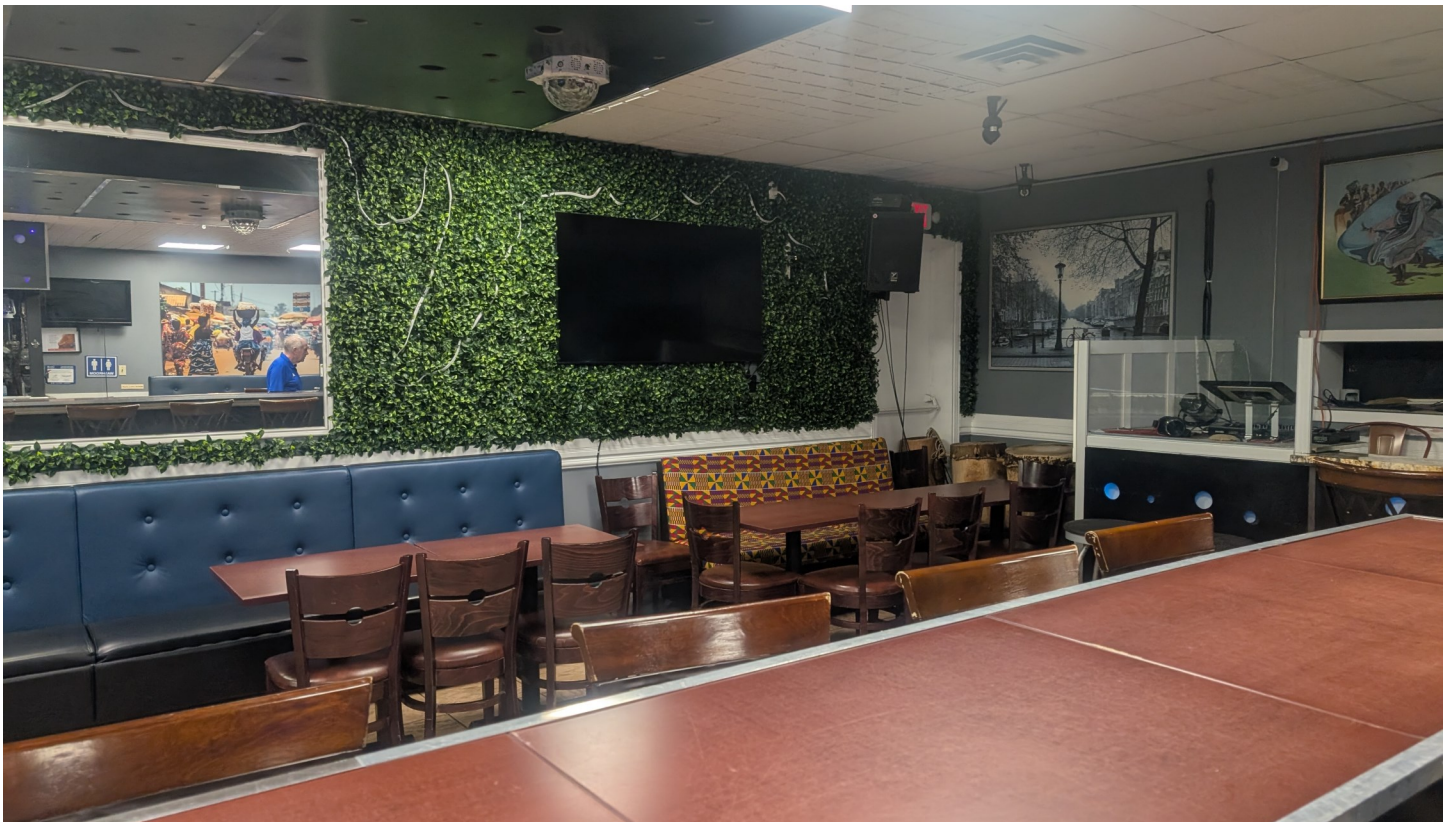
Photo 9 - Looking north and towards a monitoring well installed at the Site as part of GEMTEC's 2024 intrusive investigation.

Photo 10 - Looking west and an inside view of the restaurant at 1060 St. Laurent Boulevard.

Photo 11 - Looking west/southwest at the sump pit located in the basement of 1060 St. Laurent Boulevard.
