Phase I - Environmental Site Assessment

797 Richmond Road
Ottawa, Ontario

April 12, 2021

Report: PE5190-1

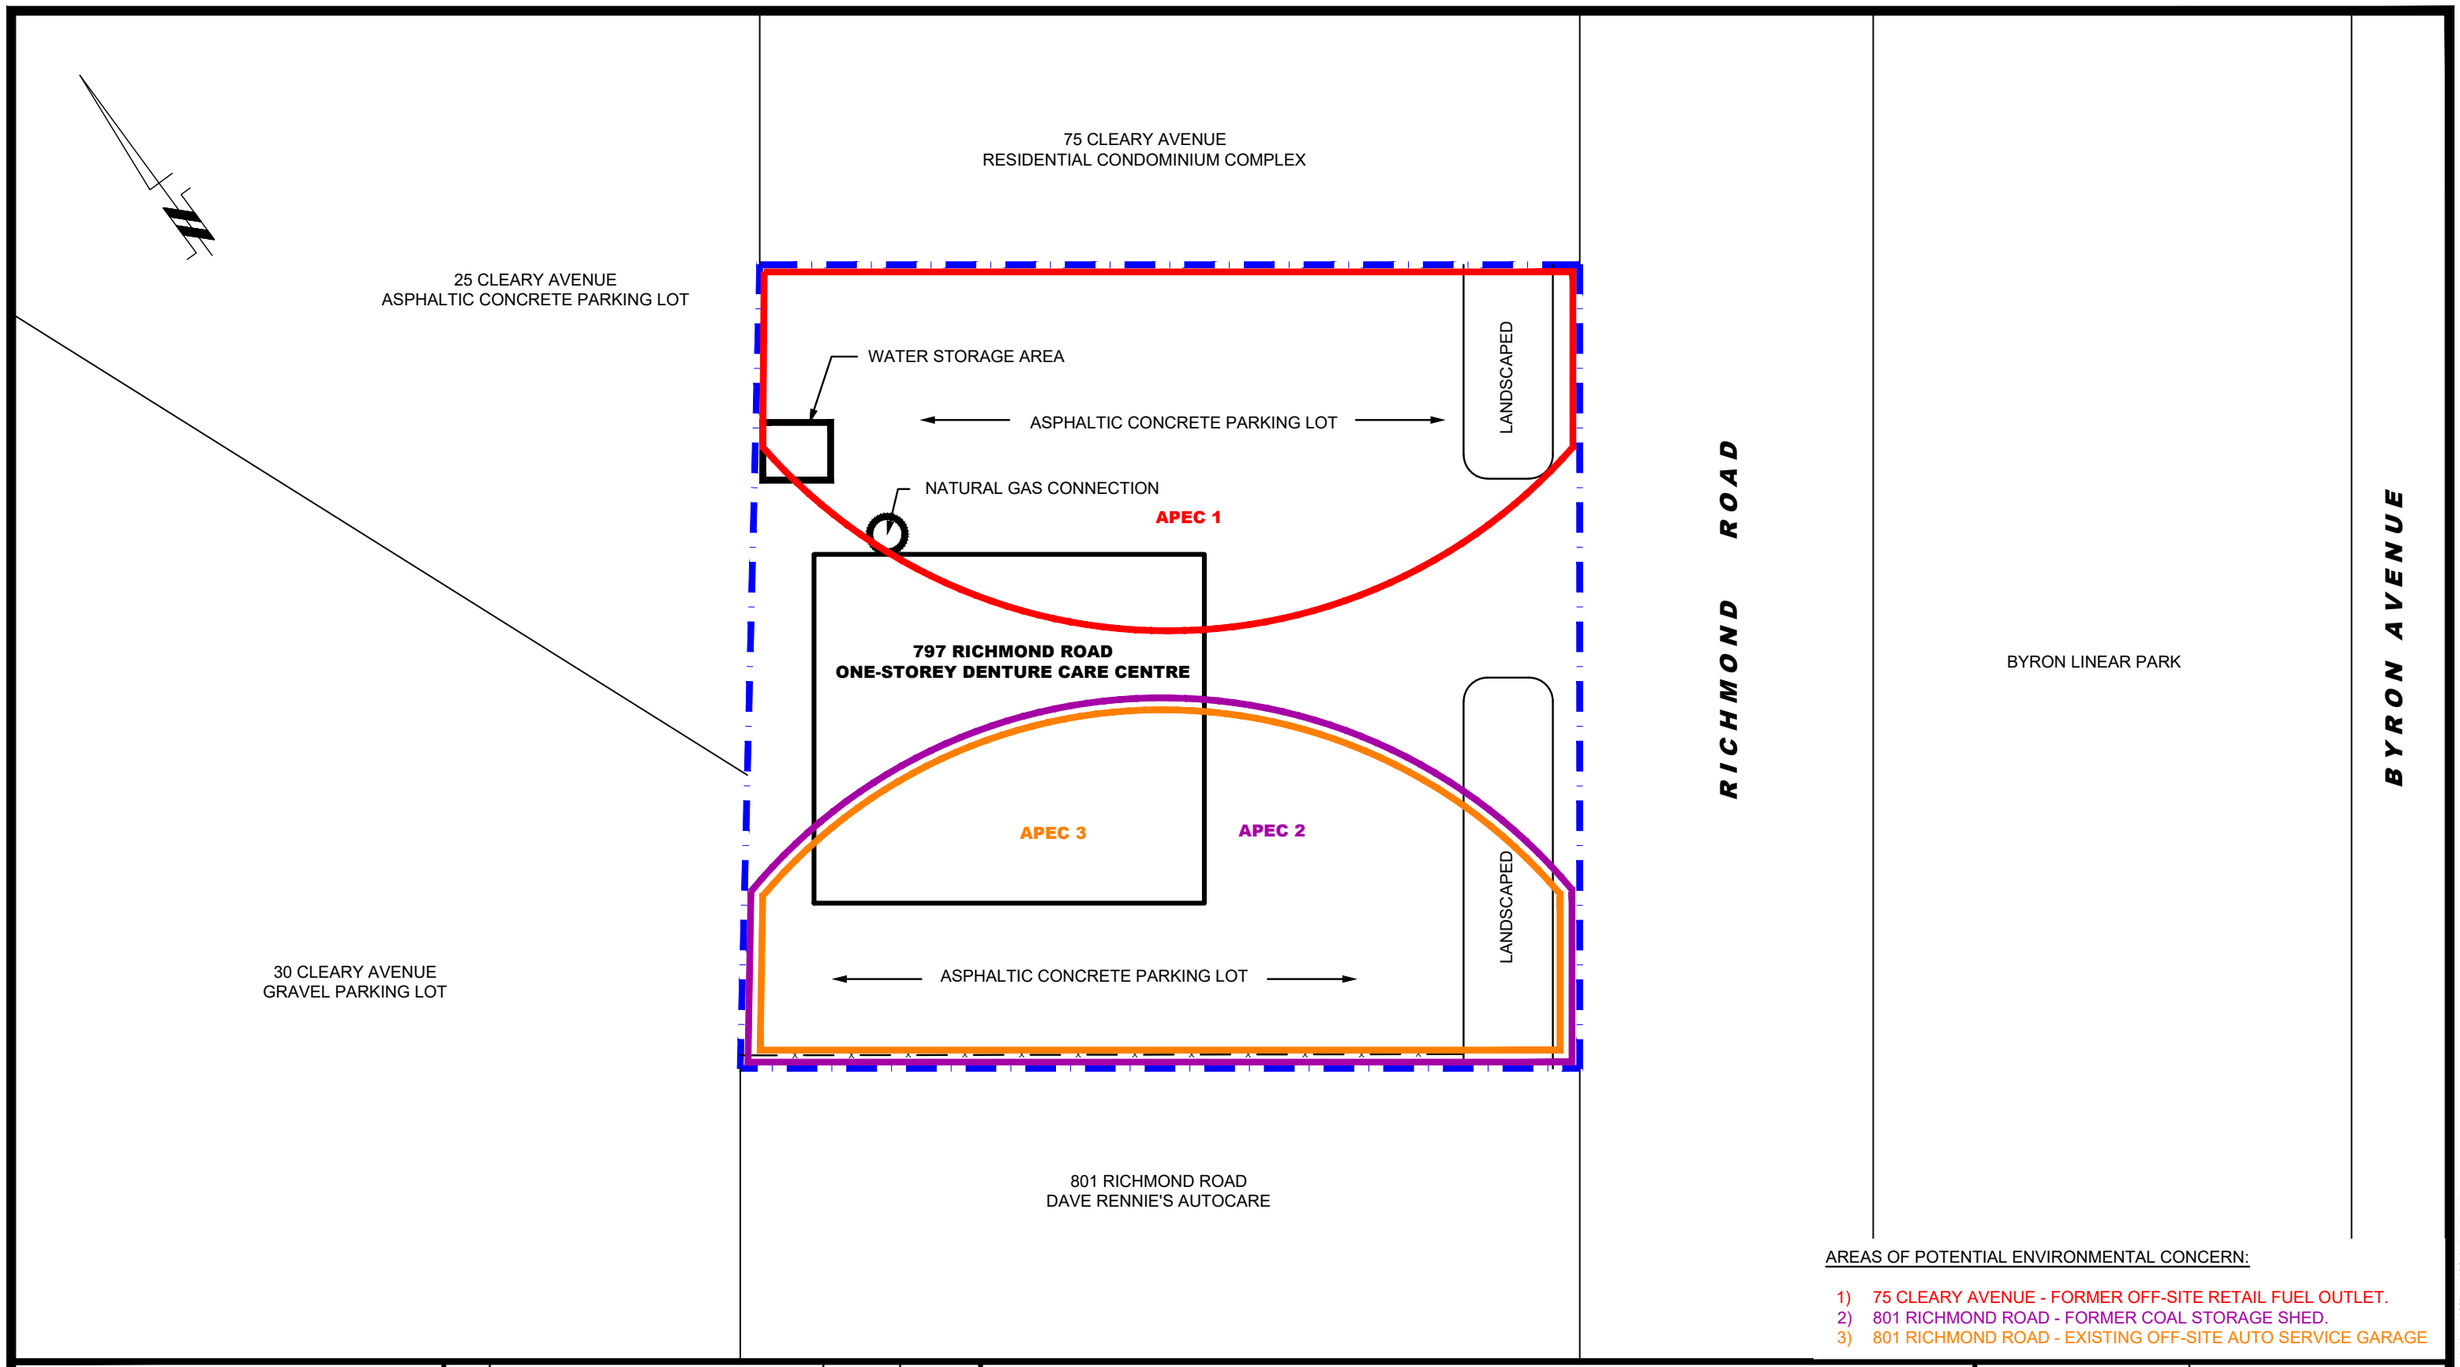
SITE PLAN

AREAS OF POTENTIAL ENVIRONMENTAL CONCERN:

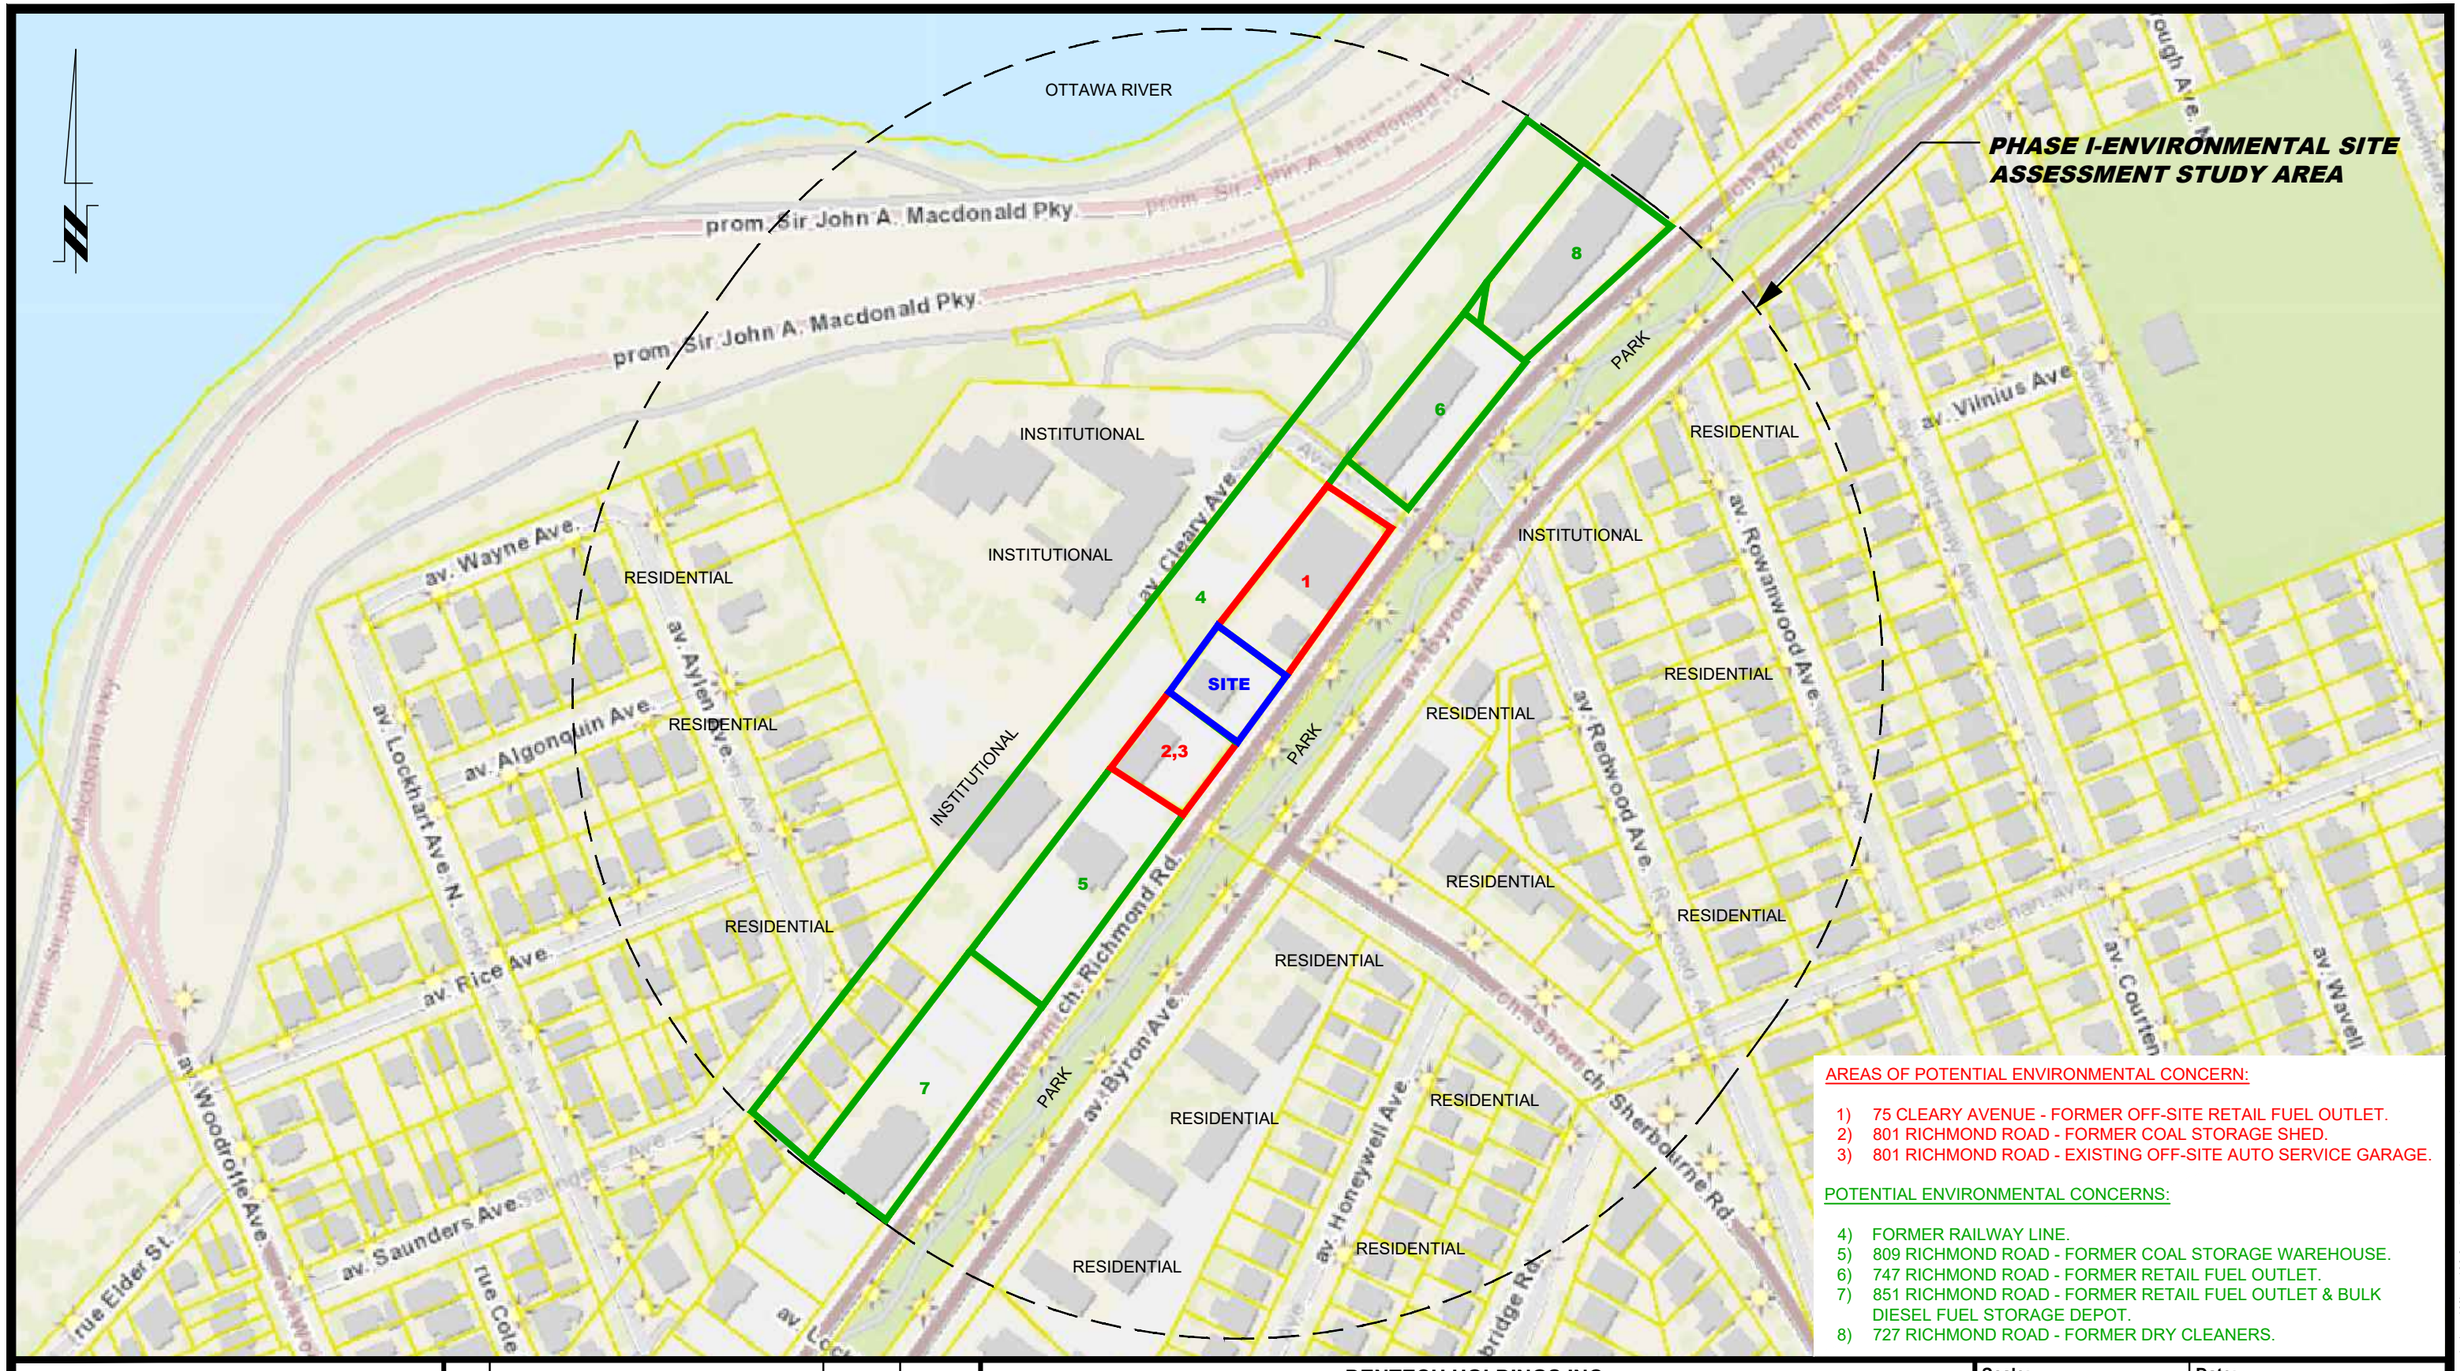
AREAS OF POTENTIAL ENVIRONMENTAL CONCERN:
