Phase II – Environmental Site Assessment

797 Richmond Road
Ottawa, Ontario

April 12, 2021

Report: PE5190-2

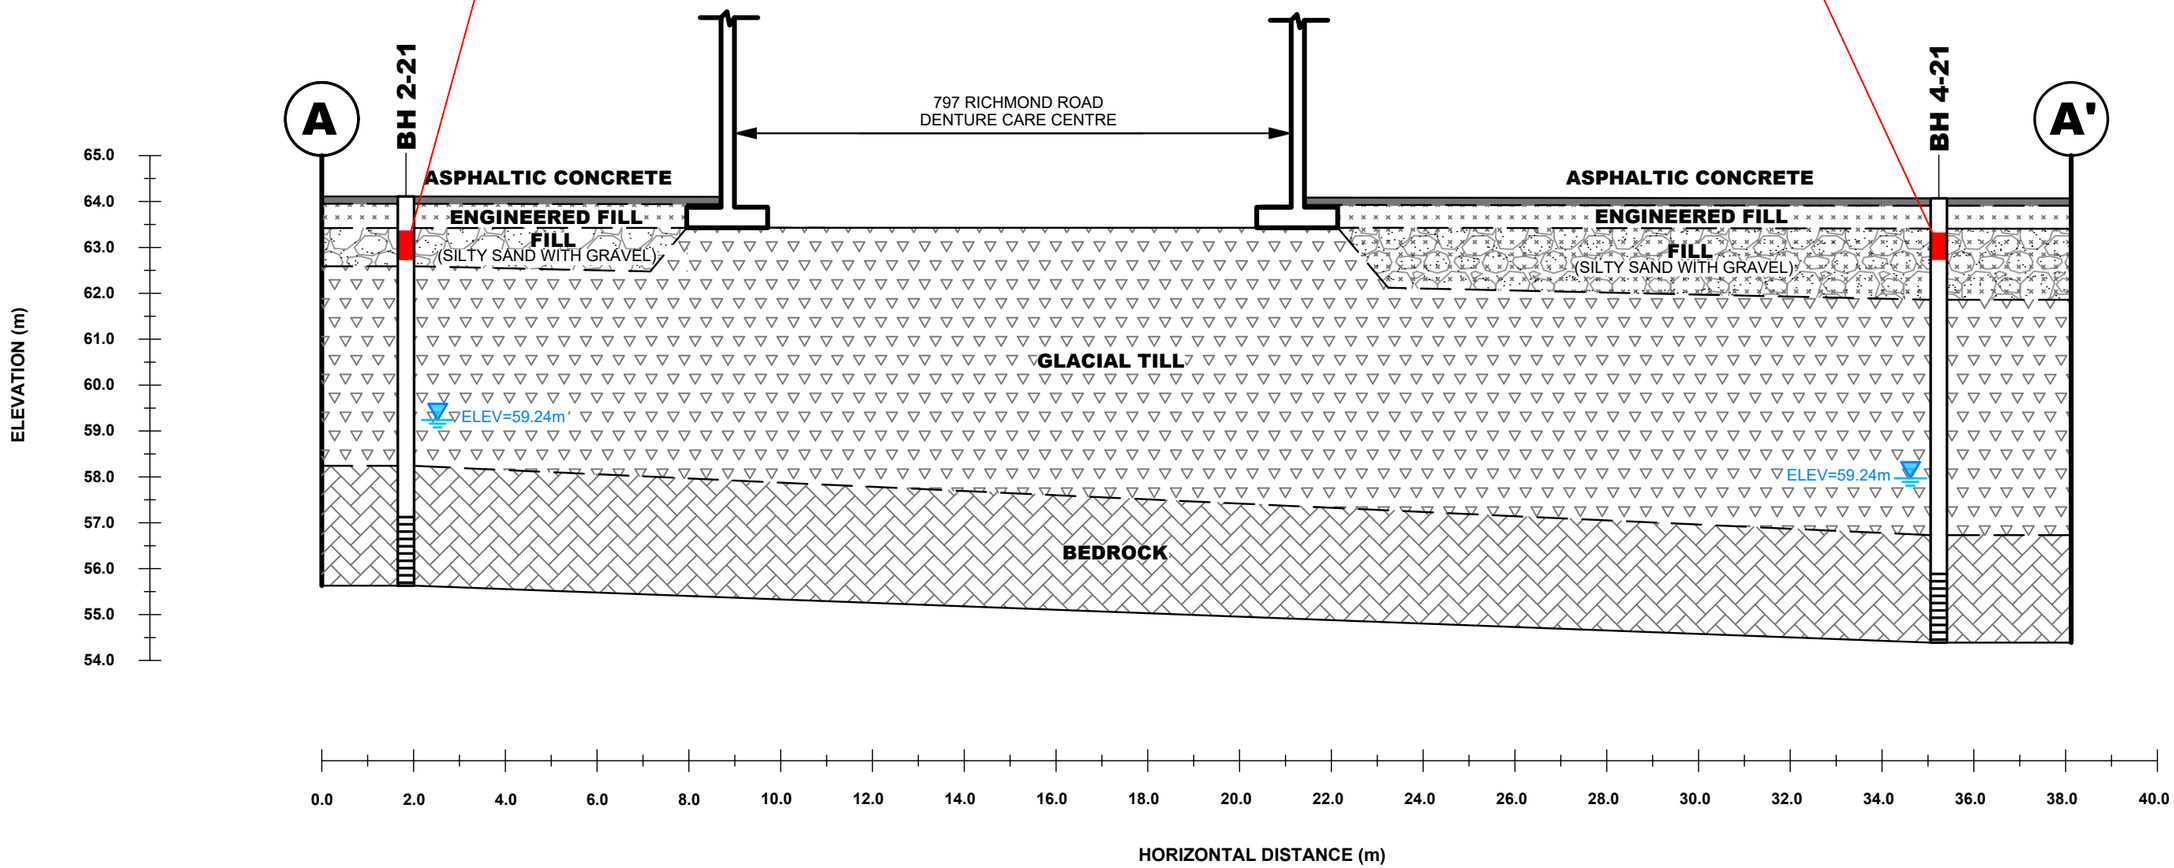
BH2-SS2	0.76-1.37m	03-Mar-21
PARAMETER	RESULT(µg/g)	STANDARD(µg/g)
Acenapthylene	0.28	0.15
Benzo[a]pyrene	0.56	0.3
Fluoranthene	0.88	0.69
Remaining PAHs comply with MECP Table 3 Standards

BH4-SS2	0.76-1.37m	04-Mar-21
PARAMETER	RESULT(µg/g)	STANDARD(µg/g)
Acenapthylene	0.51	0.15
Benzo[a]anthracene	1.09	0.5
Benzo[a]pyrene	1.38	0.3
Benzo[b]fluoranthene	0.80	0.78
Dibenzo[a,h]anthracene	0.23	0.1
Fluoranthene	1.65	0.69
Indeno[1,2,3-cd]pyrene	0.88	0.38
Remaining PAHs comply with MECP Table 3 Standards

SOIL RESULTS COMPLY WITH MECP TABLE 3 STANDARDS

SOIL RESULTS EXCEED MECP TABLE 3 STANDARDS

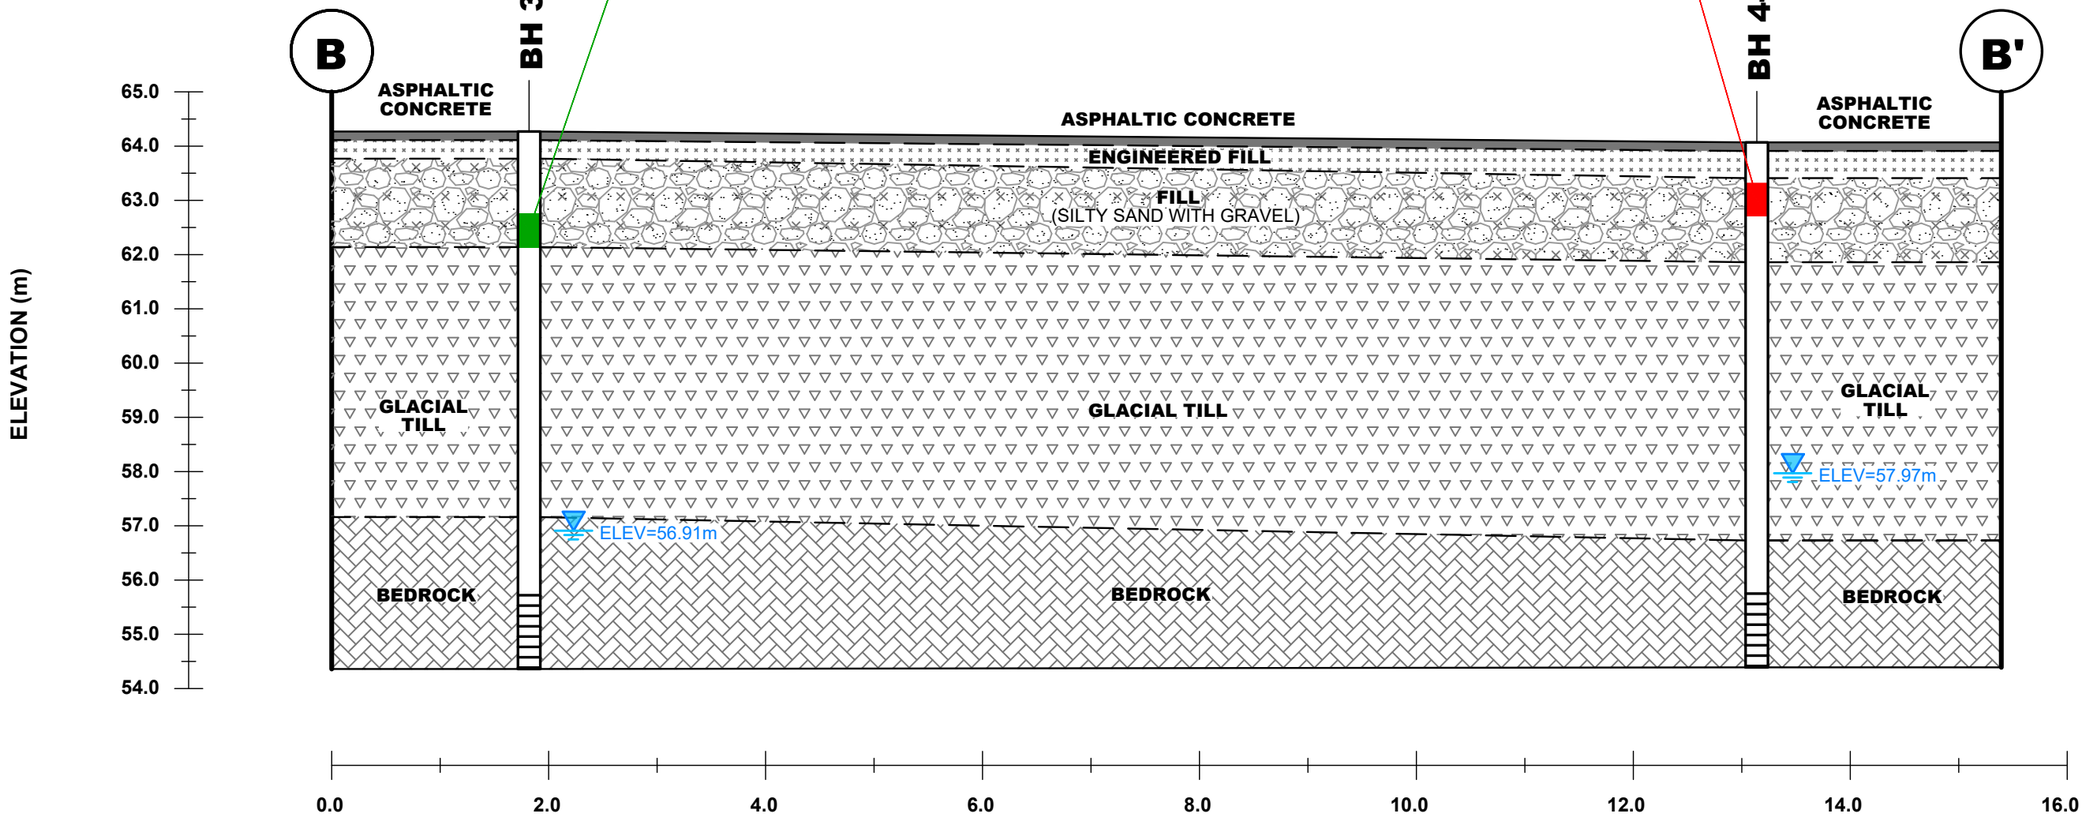
BH3-SS3	1.52-2.13m	03-Mar-21
PAHs comply with MECP Table 3 Standards

BH4-SS2	0.76-1.37m	04-Mar-21
PARAMETER	RESULT(µg/g)	STANDARD(µg/g)
Acenapthylene	0.51	0.15
Benzo[a]anthracene	1.09	0.5
Benzo[a]pyrene	1.38	0.3
Benzo[b]fluoranthene	0.80	0.78
Dibenzo[a,h]anthracene	0.23	0.1
Fluoranthene	1.65	0.69
Indeno[1,2,3-cd]pyrene	0.88	0.38
Remaining PAHs comply with MECP Table 3 Standards

SOIL RESULTS COMPLY WITH MECP TABLE 3 STANDARDS

SOIL RESULTS EXCEED MECP TABLE 3 STANDARDS

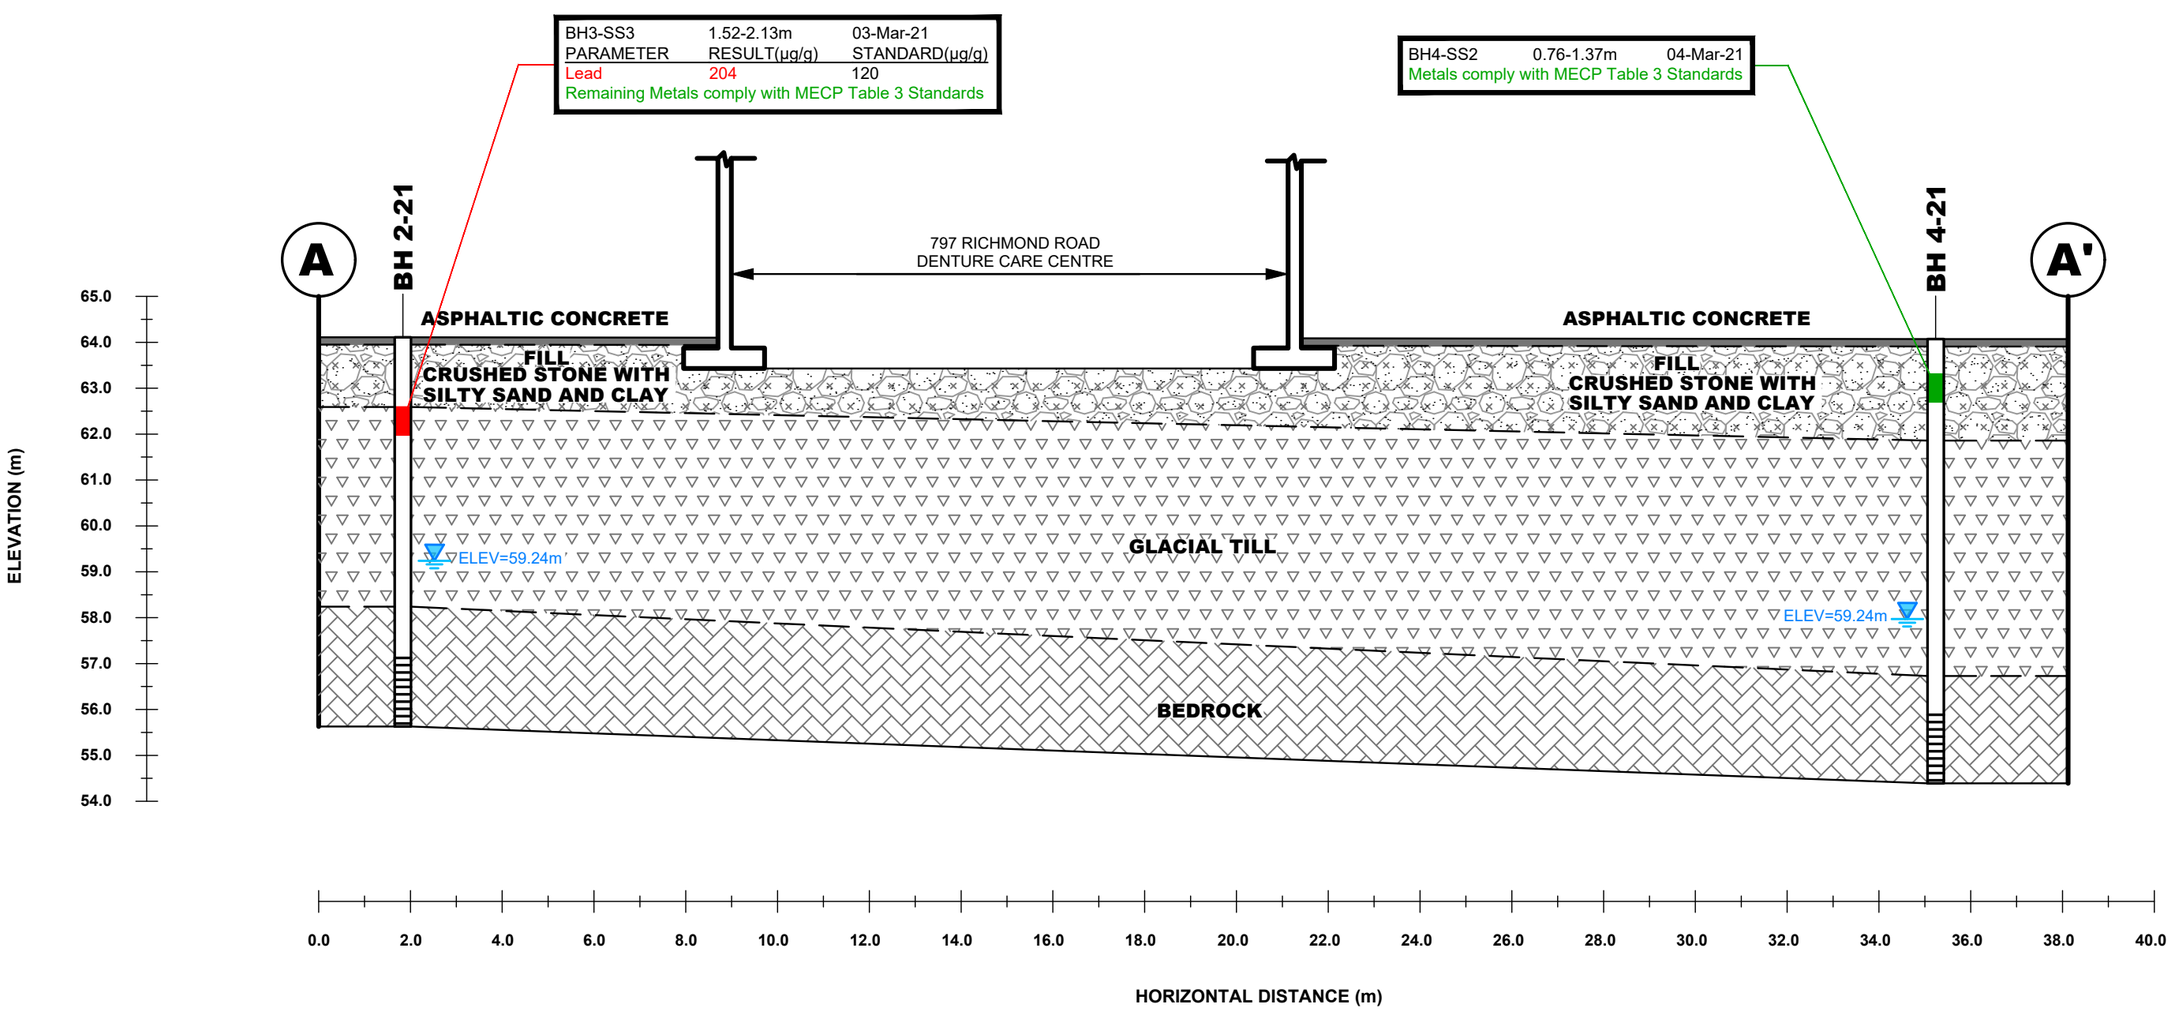
BH3-SS3	1.52-2.13m	03-Mar-21
PARAMETER	RESULT(µg/g)	STANDARD(µg/g)
Lead	204	120

Remaining Metals comply with MECP Table 3 Standards

BH4-SS2 0.76-1.37m 04-Mar-21
Metals comply with MECP Table 3 Standards

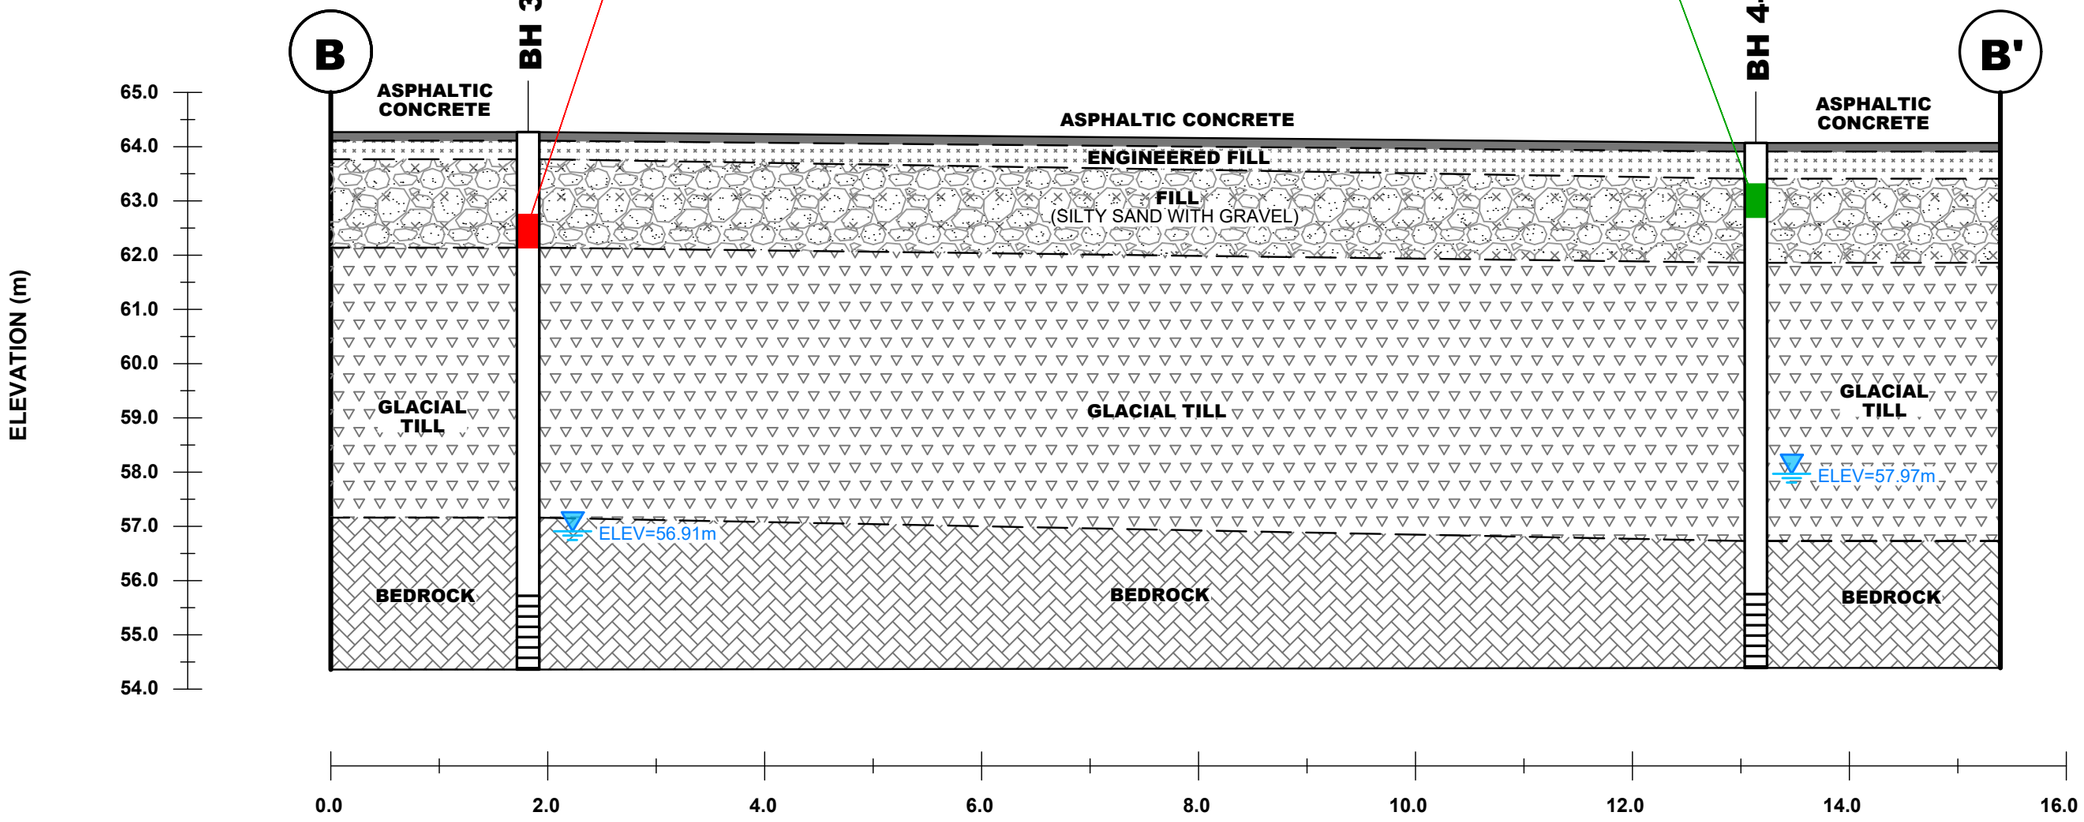
BH3-SS3	1.52-2.13m	03-Mar-21
PARAMETER	RESULT(µg/g)	STANDARD(µg/g)
Lead	204	120

Remaining Metals comply with MECP Table 3 Standards

BH4-SS2 0.76-1.37m 04-Mar-21
Metals comply with MECP Table 3 Standards
