Phase I - Environmental Site Assessment

1649 Montreal Road & 741 Blair Road
Ottawa, Ontario

October 9, 2020

Report: PE5061-1

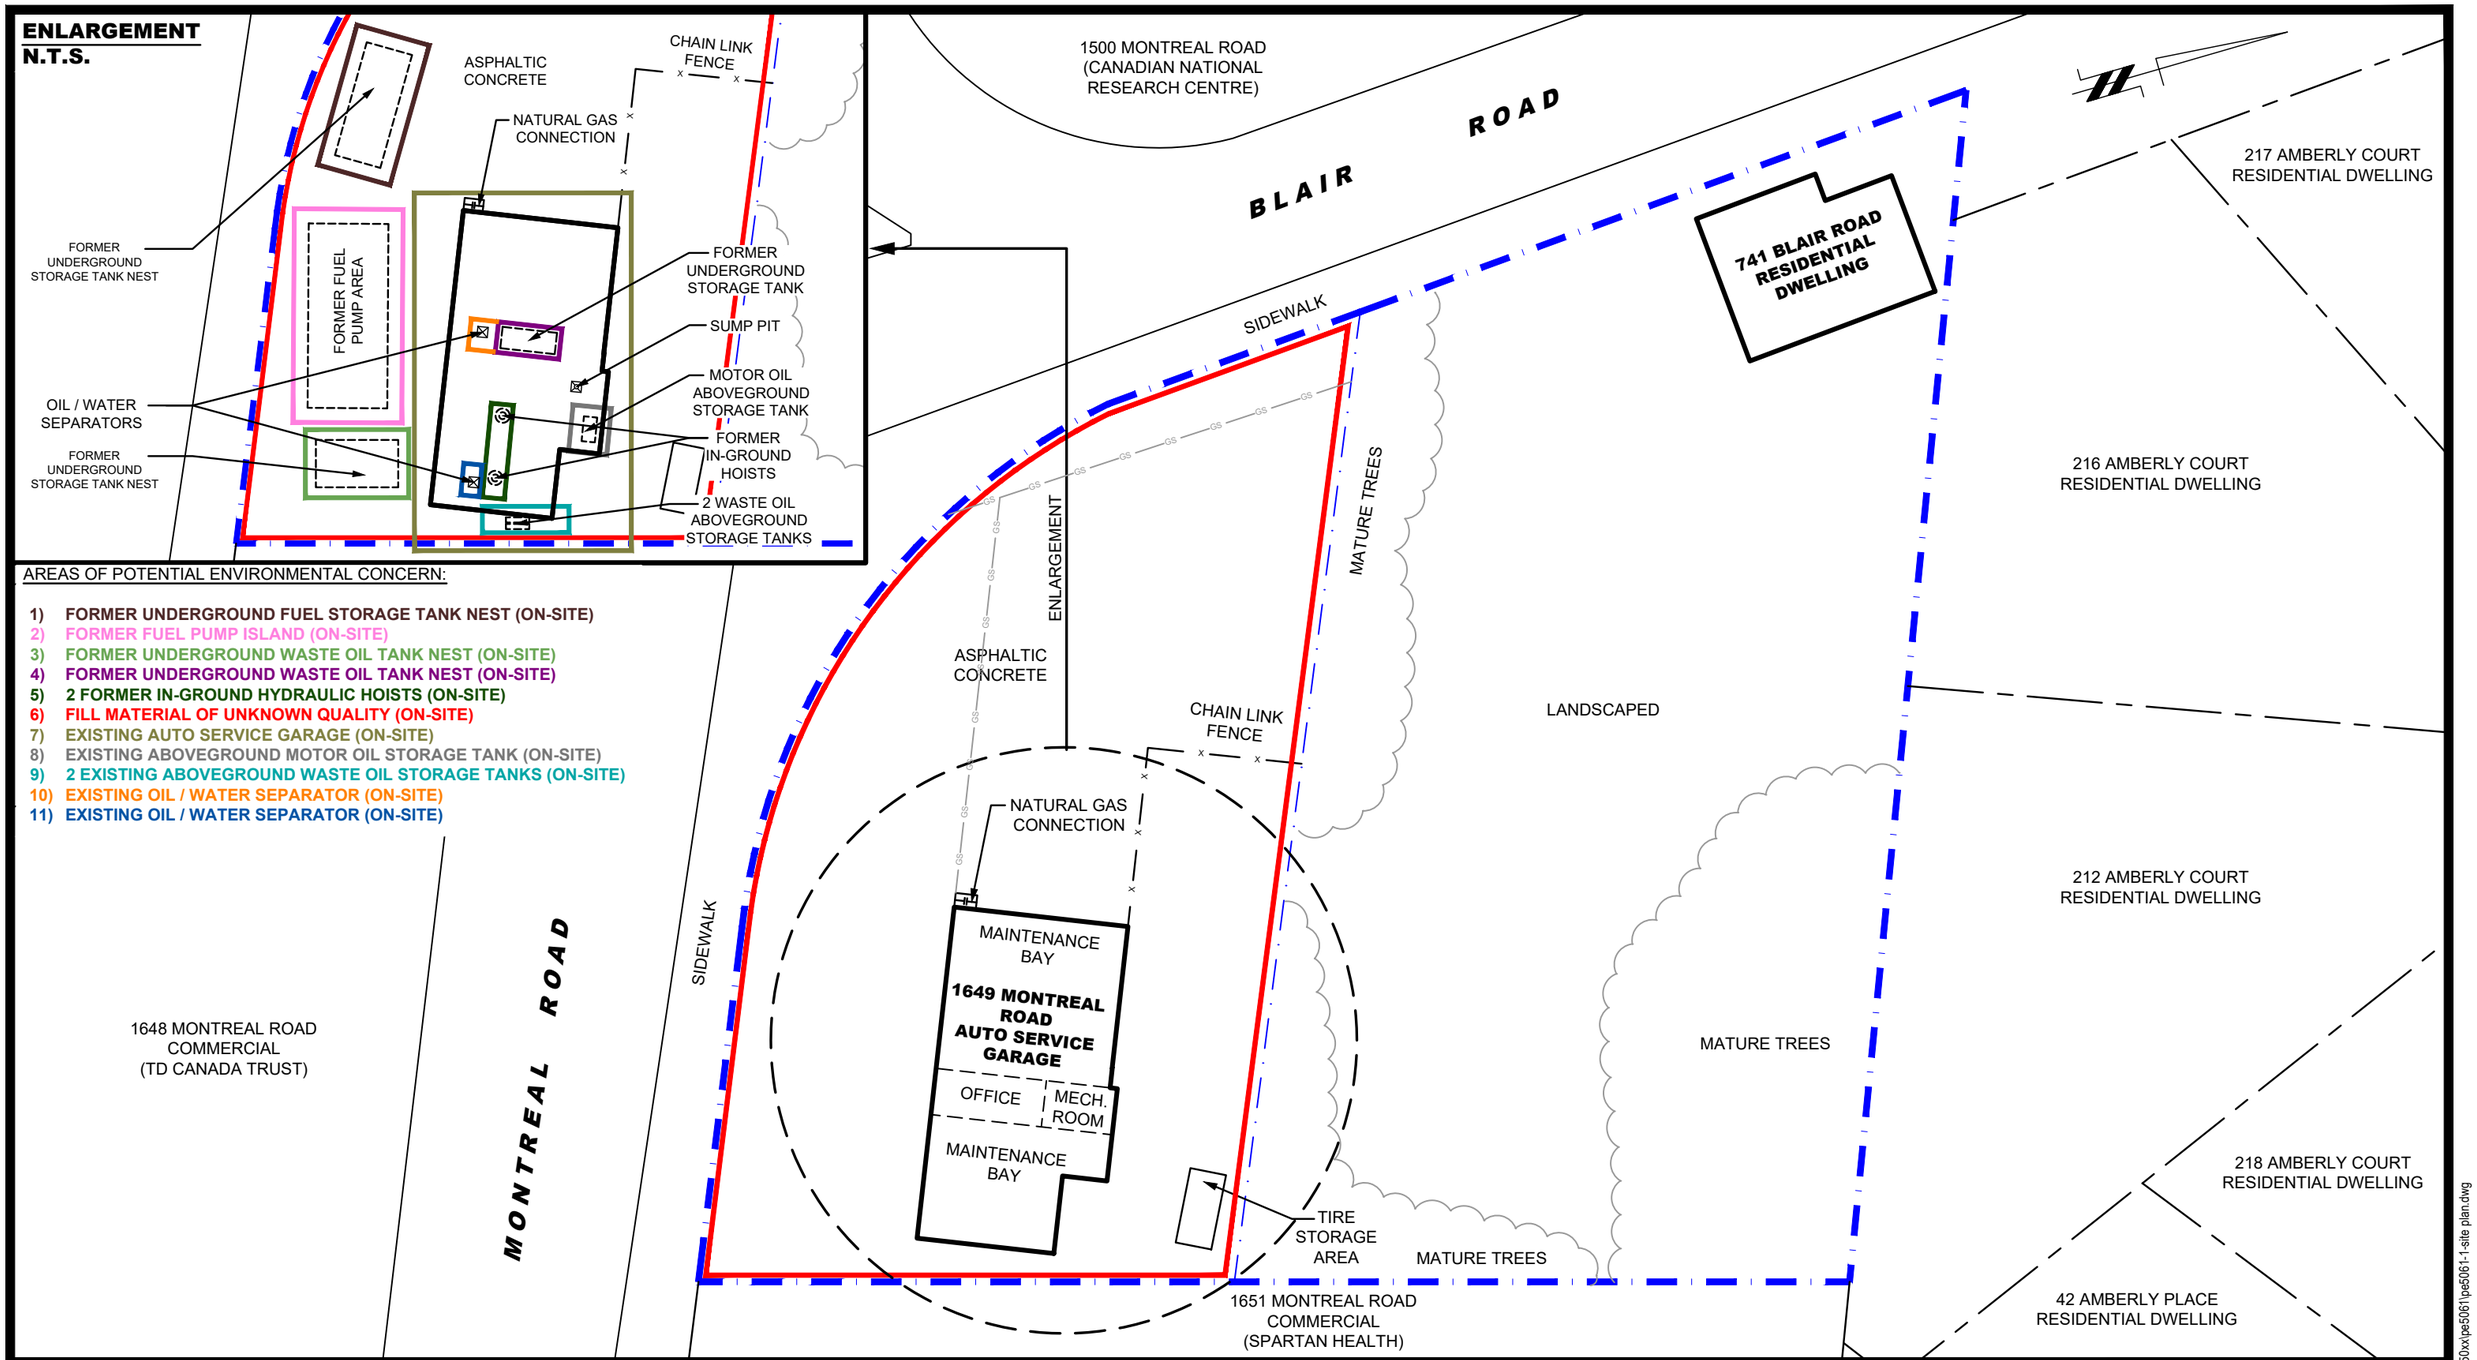
DRAWING PE5061-1 – SITE PLAN

AREAS OF POTENTIAL ENVIRONMENTAL CONCERN:

1) **FORMER UNDERGROUND FUEL STORAGE TANK NEST (ON-SITE)**
2) **FORMER FUEL PUMP ISLAND (ON-SITE)**
3) **FORMER UNDERGROUND WASTE OIL TANK NEST (ON-SITE)**
4) **FORMER UNDERGROUND WASTE OIL TANK NEST (ON-SITE)**
5) **2 FORMER IN-GROUND HYDRAULIC HOISTS (ON-SITE)**
6) **FILL MATERIAL OF UNKNOWN QUALITY (ON-SITE)**
7) **EXISTING AUTO SERVICE GARAGE (ON-SITE)**
8) **EXISTING ABOVEGROUND MOTOR OIL STORAGE TANK (ON-SITE)**
9) **2 EXISTING ABOVEGROUND WASTE OIL STORAGE TANKS (ON-SITE)**
10) **EXISTING OIL / WATER SEPARATOR (ON-SITE)**
11) **EXISTING OIL / WATER SEPARATOR (ON-SITE)**

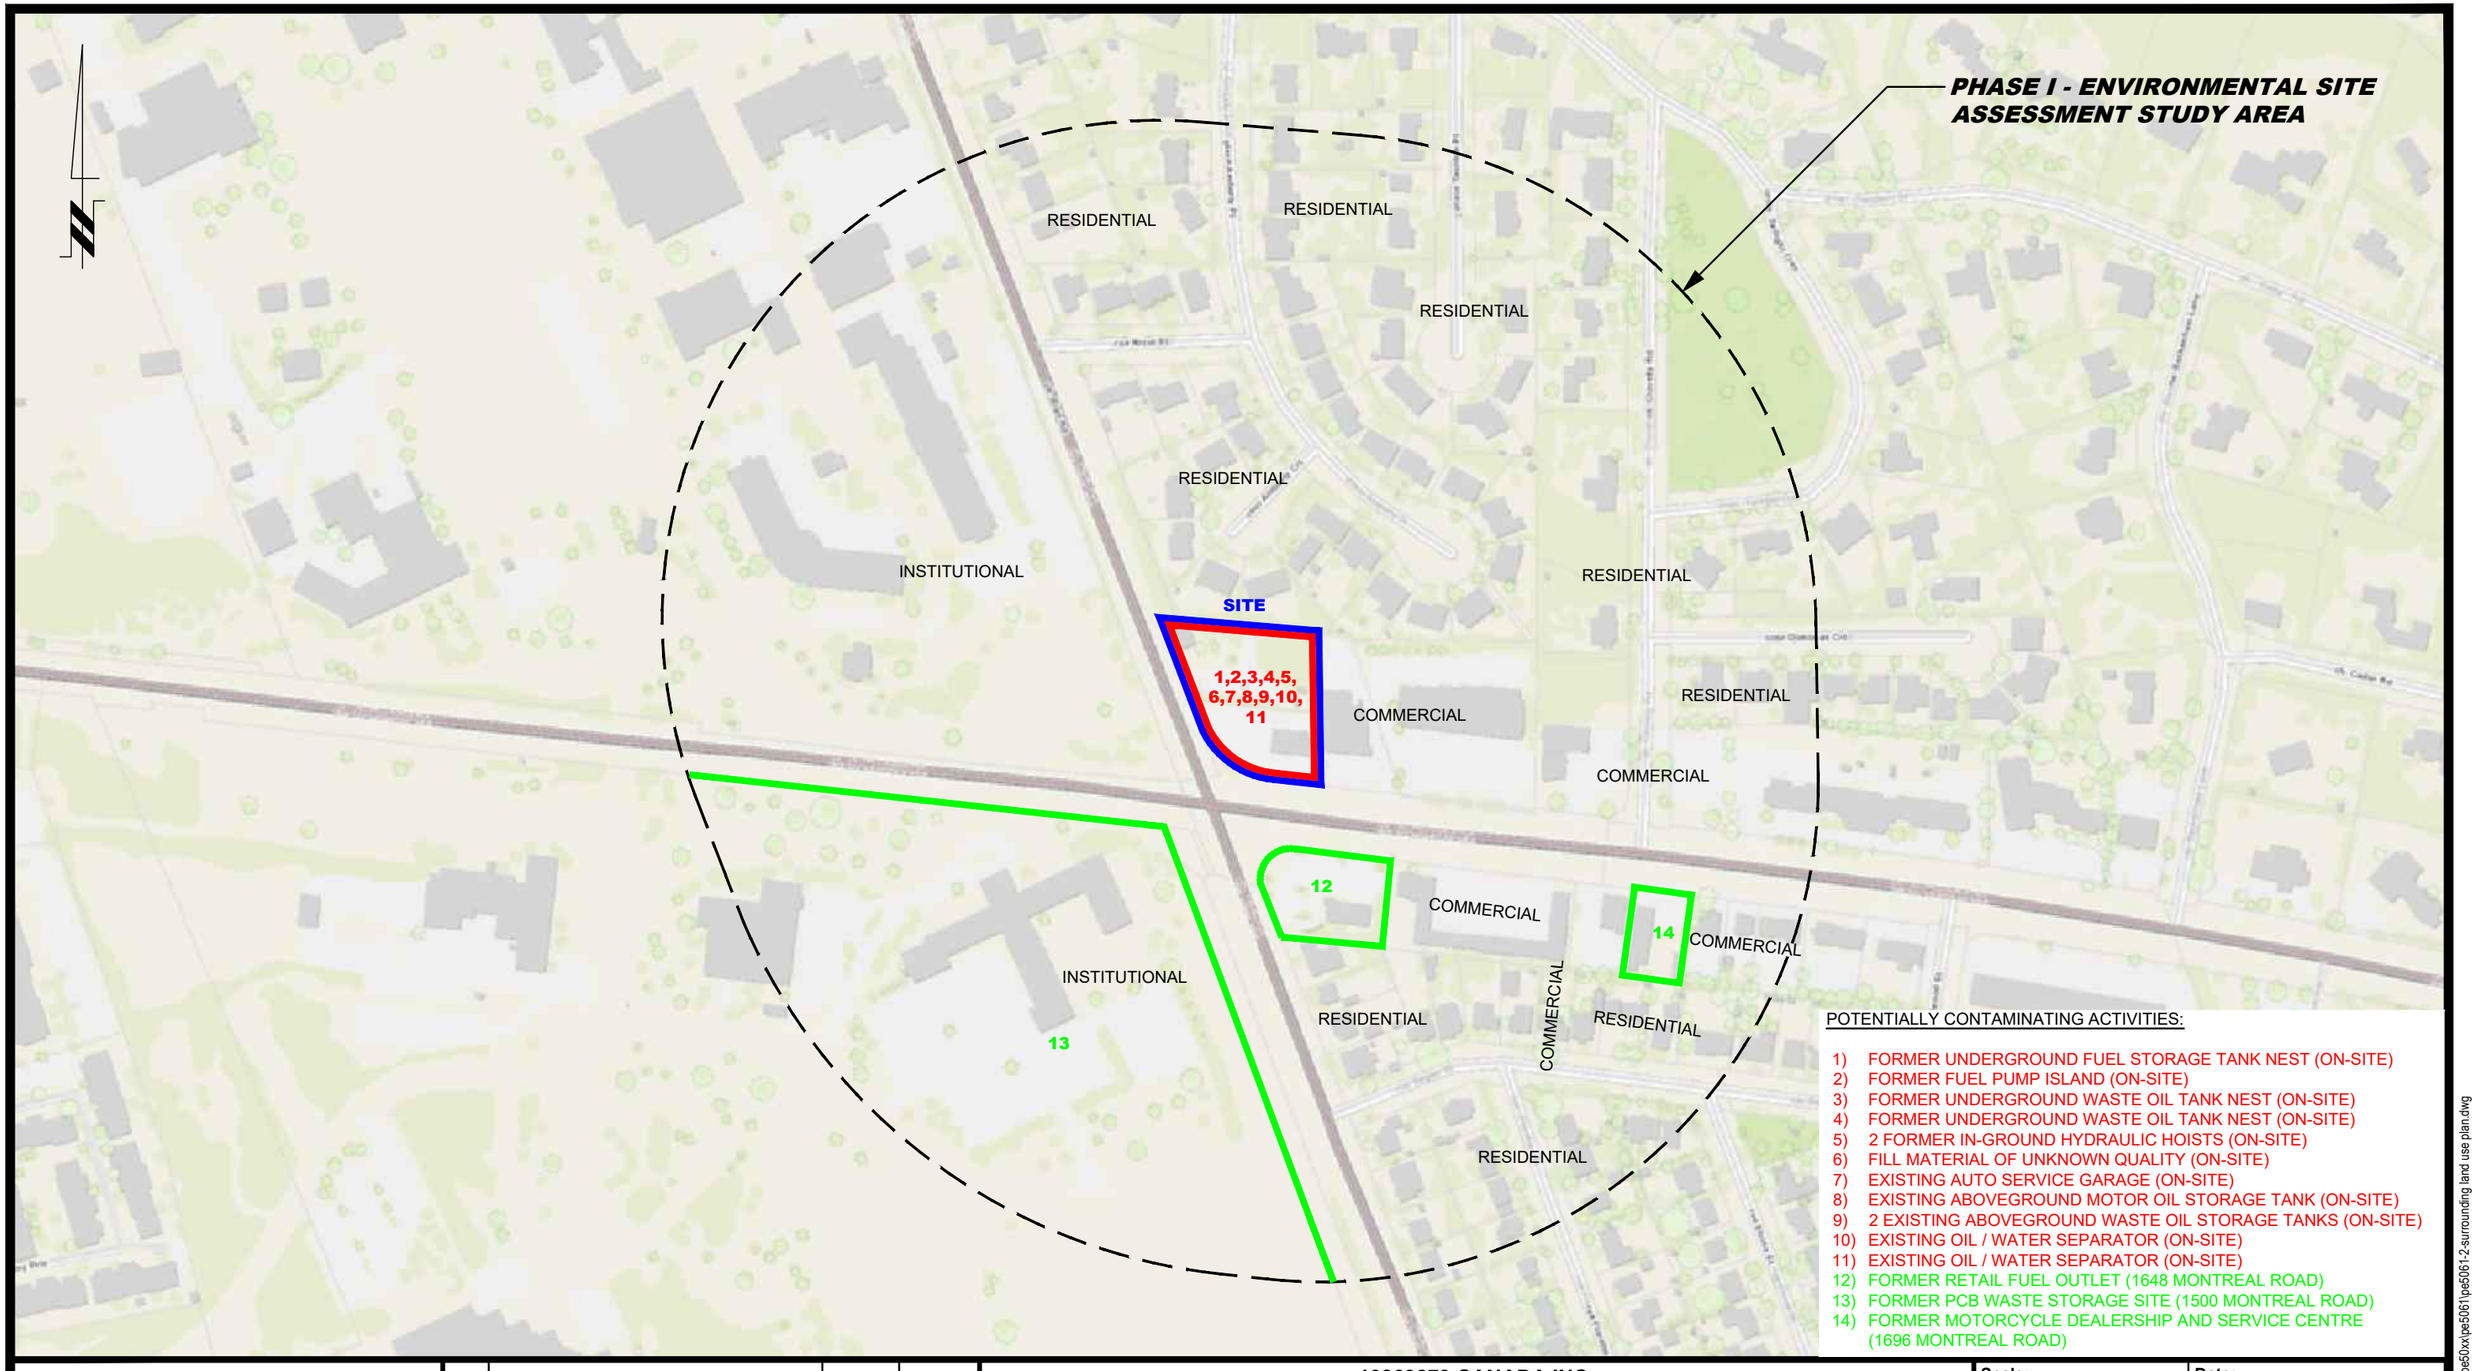
DRAWING PE5061-2 – SURROUNDING LAND USE PLAN

POTENTIALLY CONTAMINATING ACTIVITIES:

1) FORMER UNDERGROUND FUEL STORAGE TANK NEST (ON-SITE)
2) FORMER FUEL PUMP ISLAND (ON-SITE)
3) FORMER UNDERGROUND WASTE OIL TANK NEST (ON-SITE)
4) FORMER UNDERGROUND WASTE OIL TANK NEST (ON-SITE)
5) 2 FORMER IN-GROUND HYDRAULIC HOISTS (ON-SITE)
6) FILL MATERIAL OF UNKNOWN QUALITY (ON-SITE)
7) EXISTING AUTO SERVICE GARAGE (ON-SITE)
8) EXISTING ABOVEGROUND MOTOR OIL STORAGE TANK (ON-SITE)
9) 2 EXISTING ABOVEGROUND WASTE OIL STORAGE TANKS (ON-SITE)
10) EXISTING OIL / WATER SEPARATOR (ON-SITE)
11) EXISTING OIL / WATER SEPARATOR (ON-SITE)
12) FORMER RETAIL FUEL OUTLET (1648 MONTREAL ROAD)
13) FORMER PCB WASTE STORAGE SITE (1500 MONTREAL ROAD)
14) FORMER MOTORCYCLE DEALERSHIP AND SERVICE CENTRE (1696 MONTREAL ROAD)

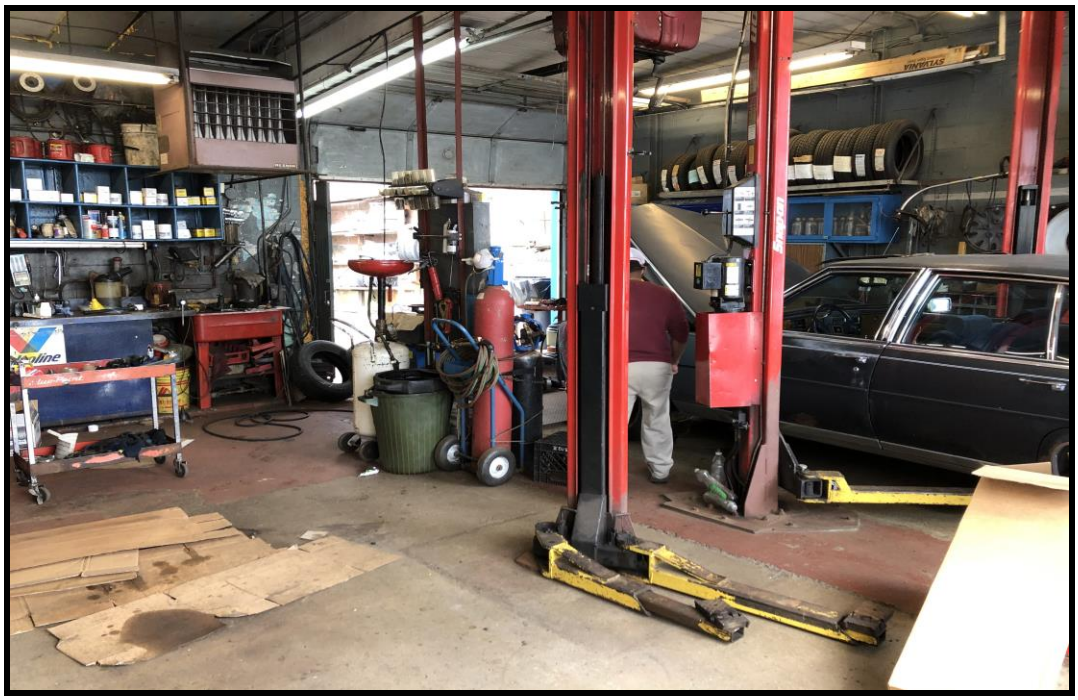
One (1) aboveground oil storage tank was identified within maintenance bay of the auto service garage (1649 Montreal Road). The tank was noted to be constructed with a single 2 mm thick steel wall and contained a capacity for 1,000 L of motor oil. The tank was noted to be in good condition, with no signs of leaks or stains observed at the time of the site inspection. The underlying floor was observed to consist of poured concrete, which was also noted to be in good condition at the time of the site inspection, with no signs of cracks visible. The presence of this oil tank is considered to represent an APEC with respect to the subject site.

As previously noted, a 1,000 L motor oil storage tank was observed within the eastern maintenance bay of the auto service garage at 1649 Montreal Road, in addition to multiple containers (less than 10 L in volume) of various motor oils, washer fluid, brake fluid, transmission fluid, greases, and lubricants. Minor areas of surficial staining were noted on the concrete floor throughout the garage maintenance bays at the time of the site inspection. The concrete floor was noted to be in good condition, with no cracks visible at the time of the site inspection.

Photograph 5: View of the interior of the eastern portion of the auto service garage and an aboveground motor oil storage tank, facing north.
