REPORT

Phase Two Environmental Site Assessment

Wateridge Village Phase 4, Part of 1076 Hemlock Private, Ottawa, Ontario

19124906

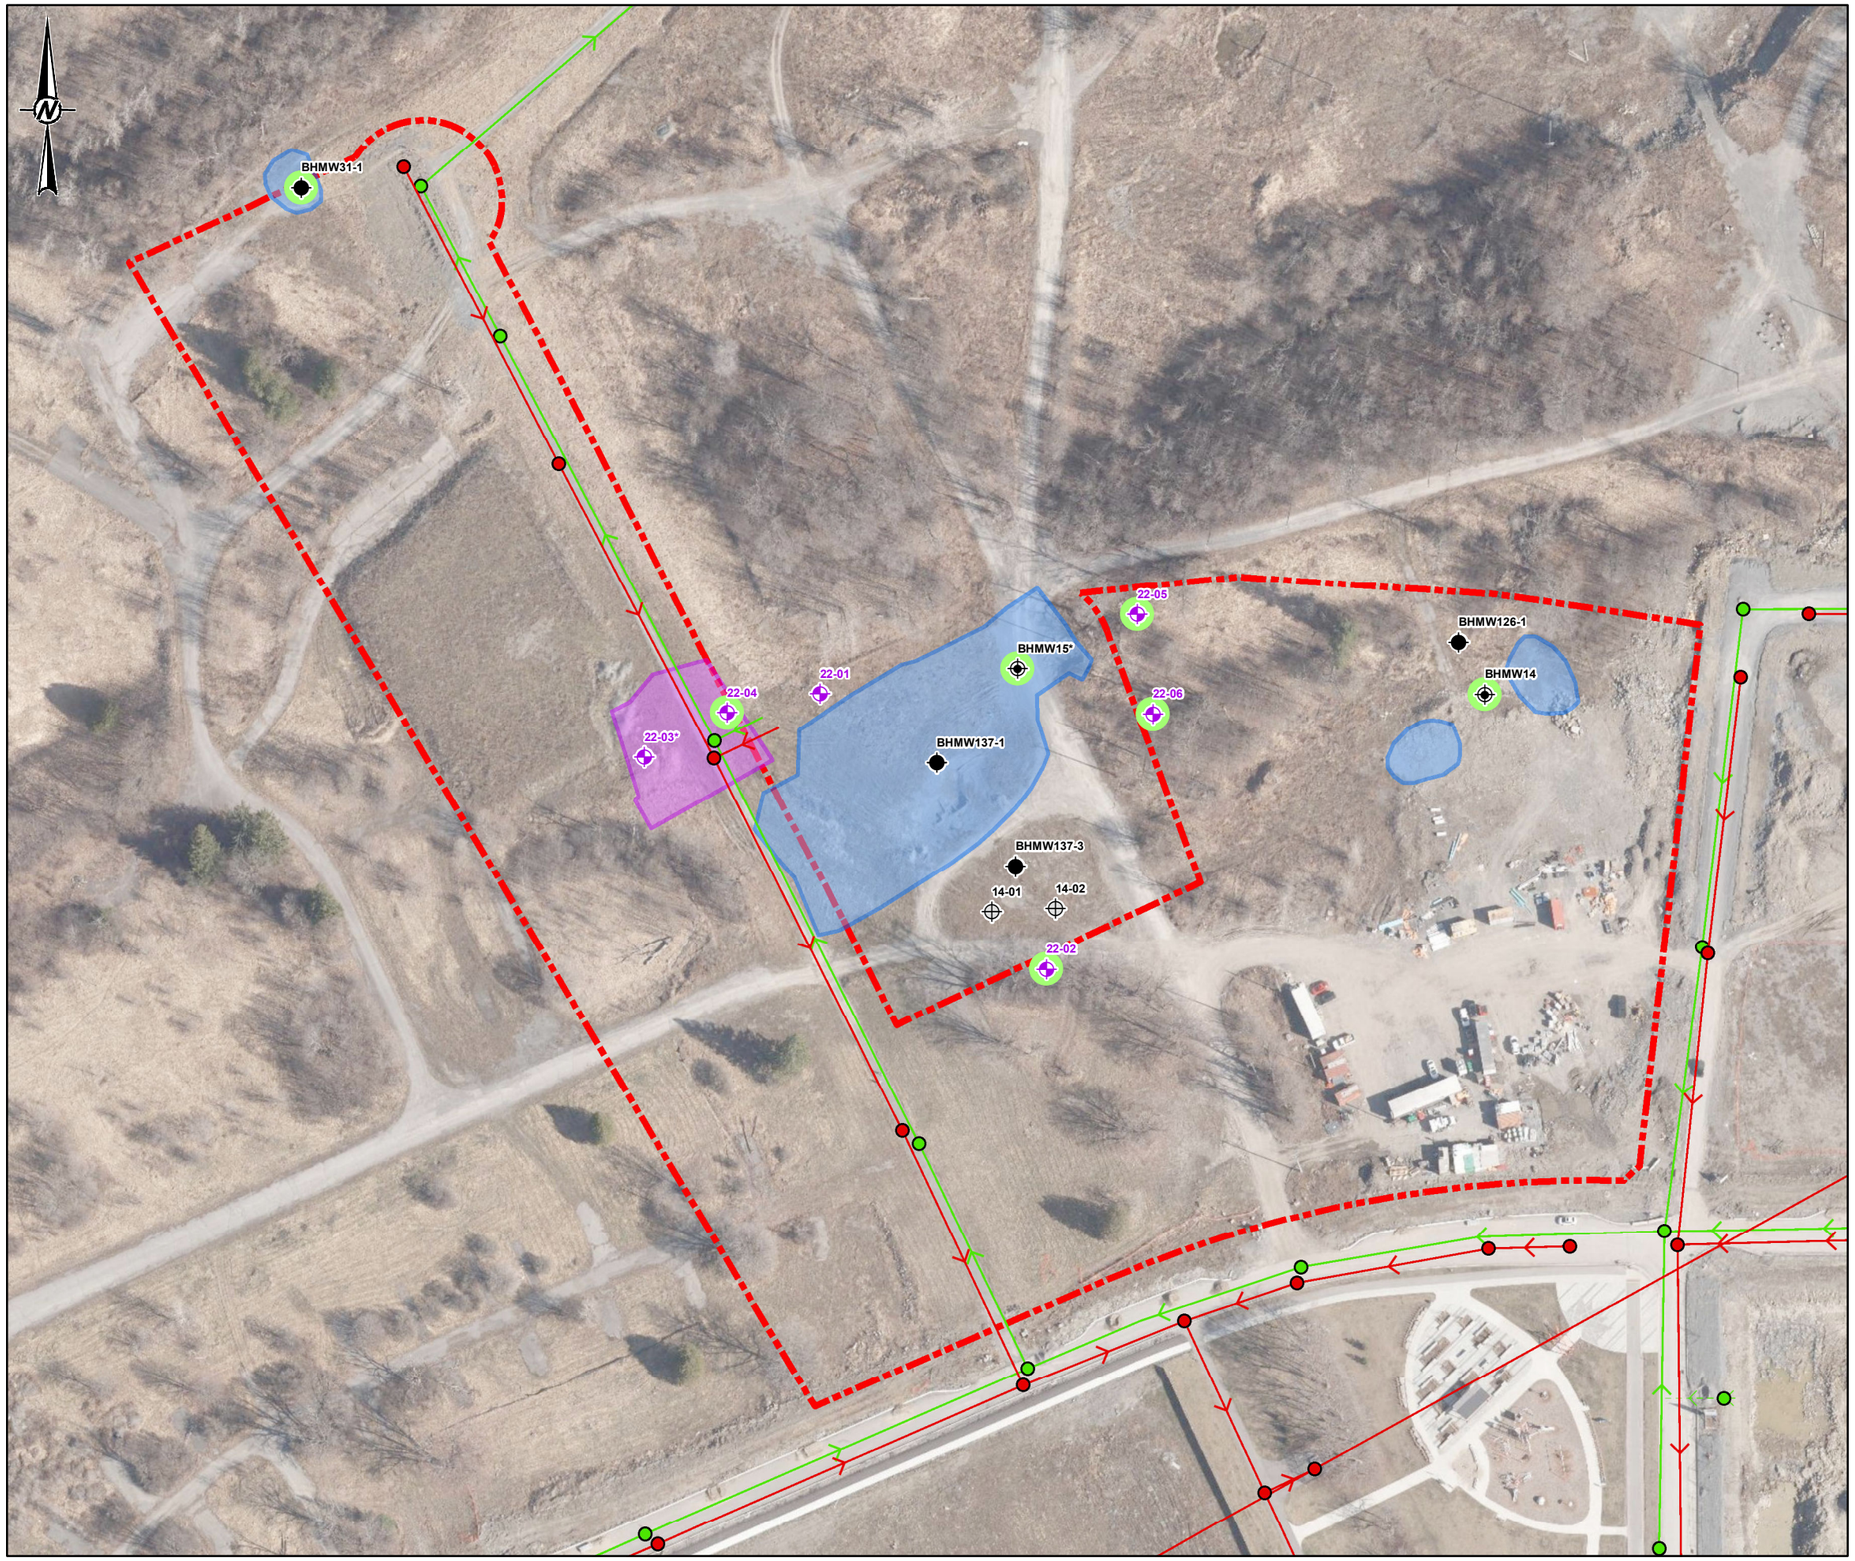
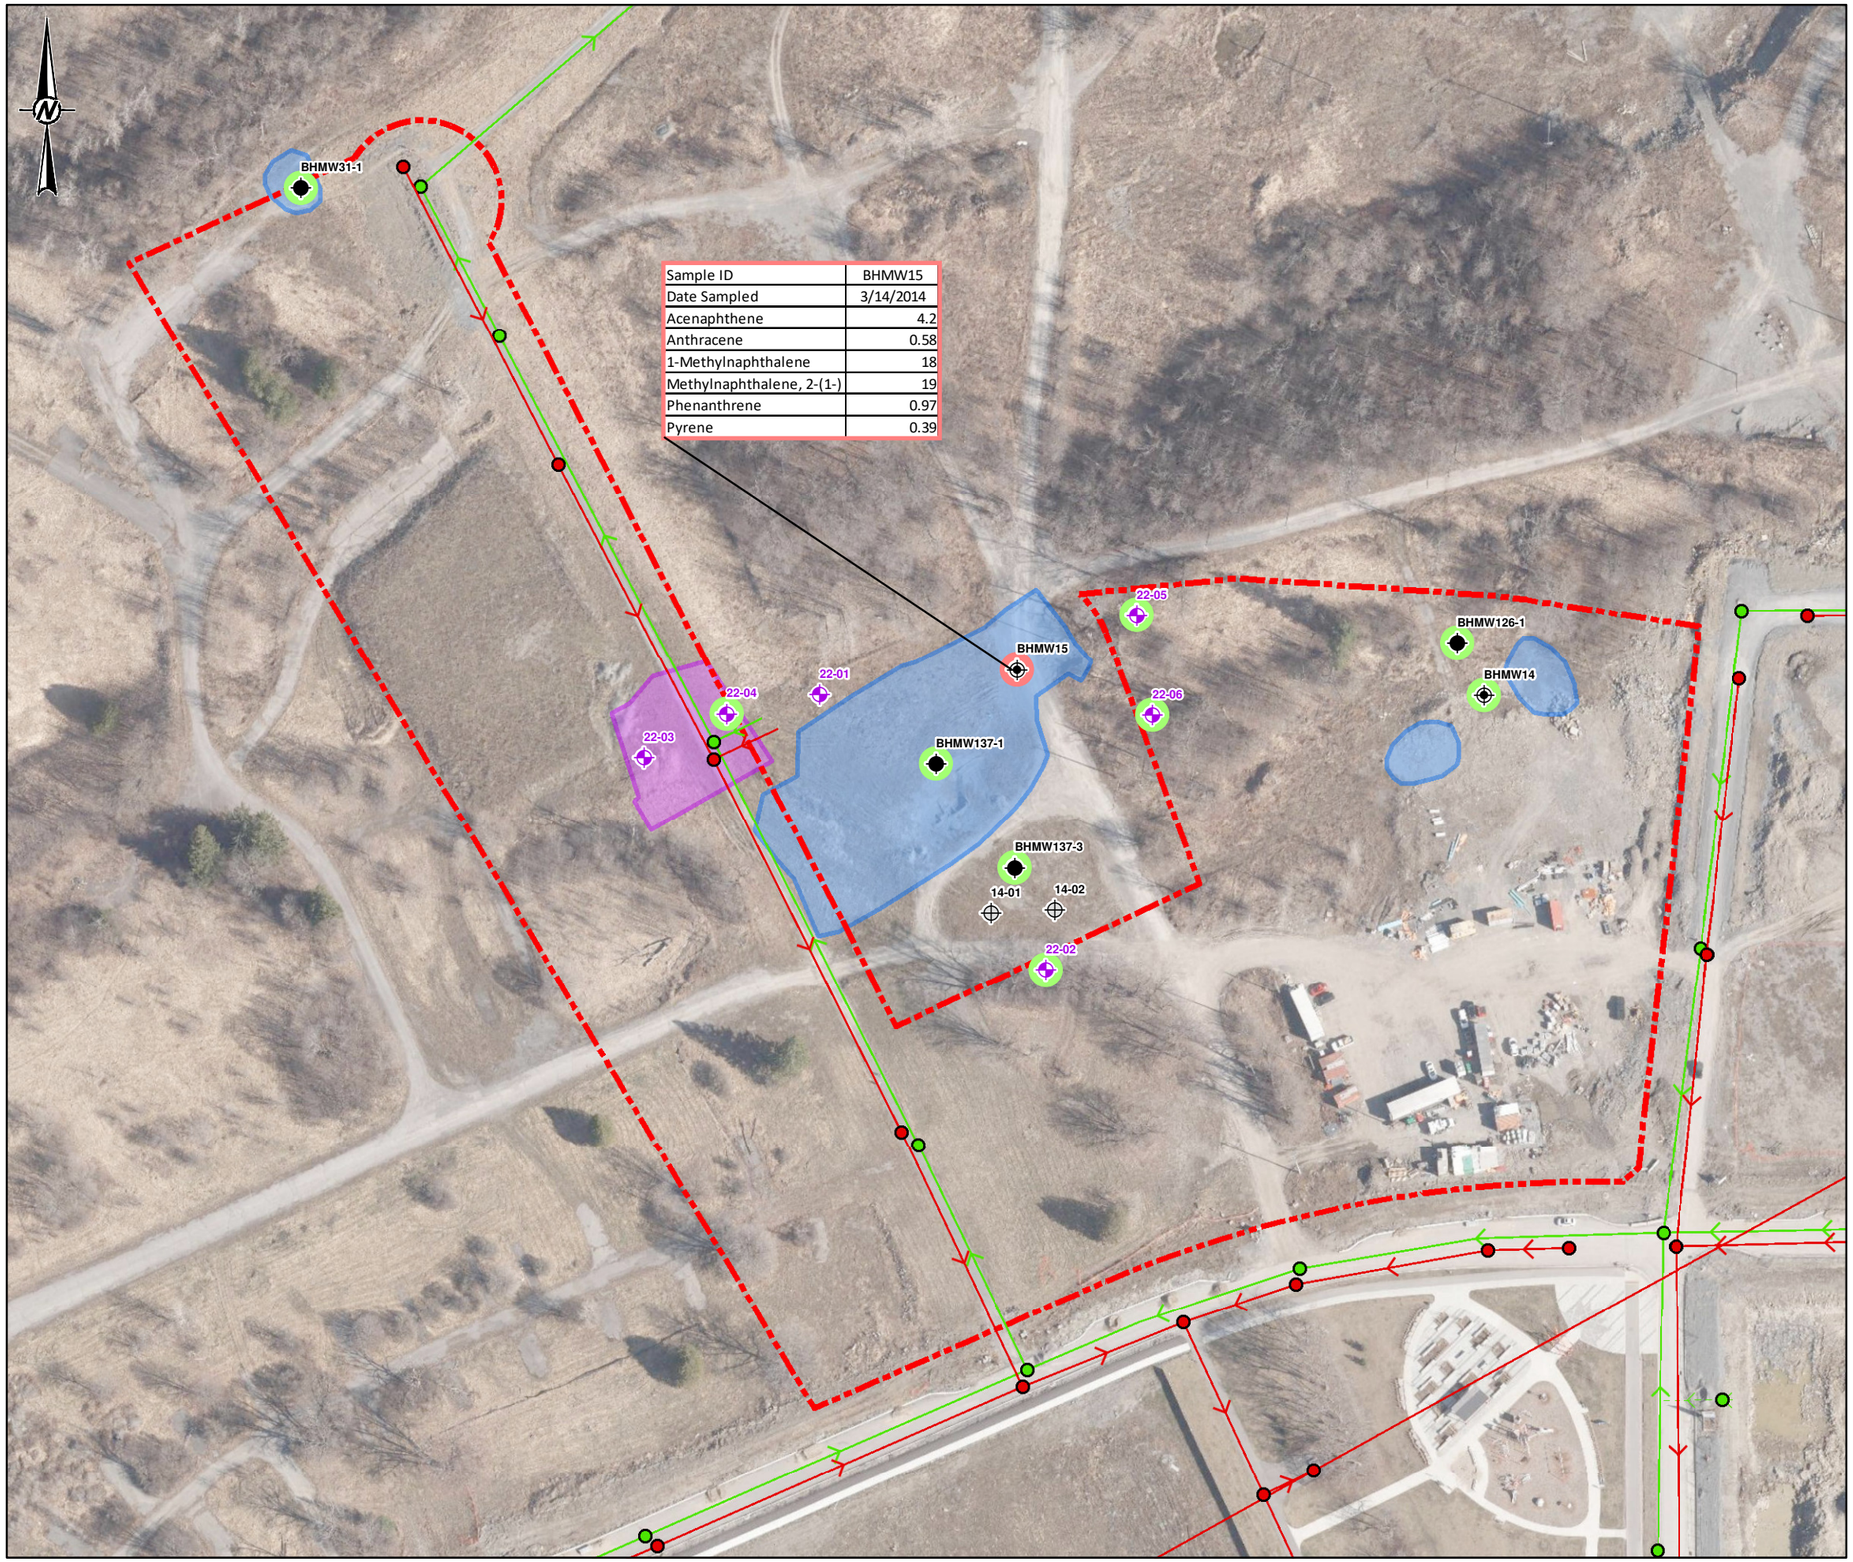
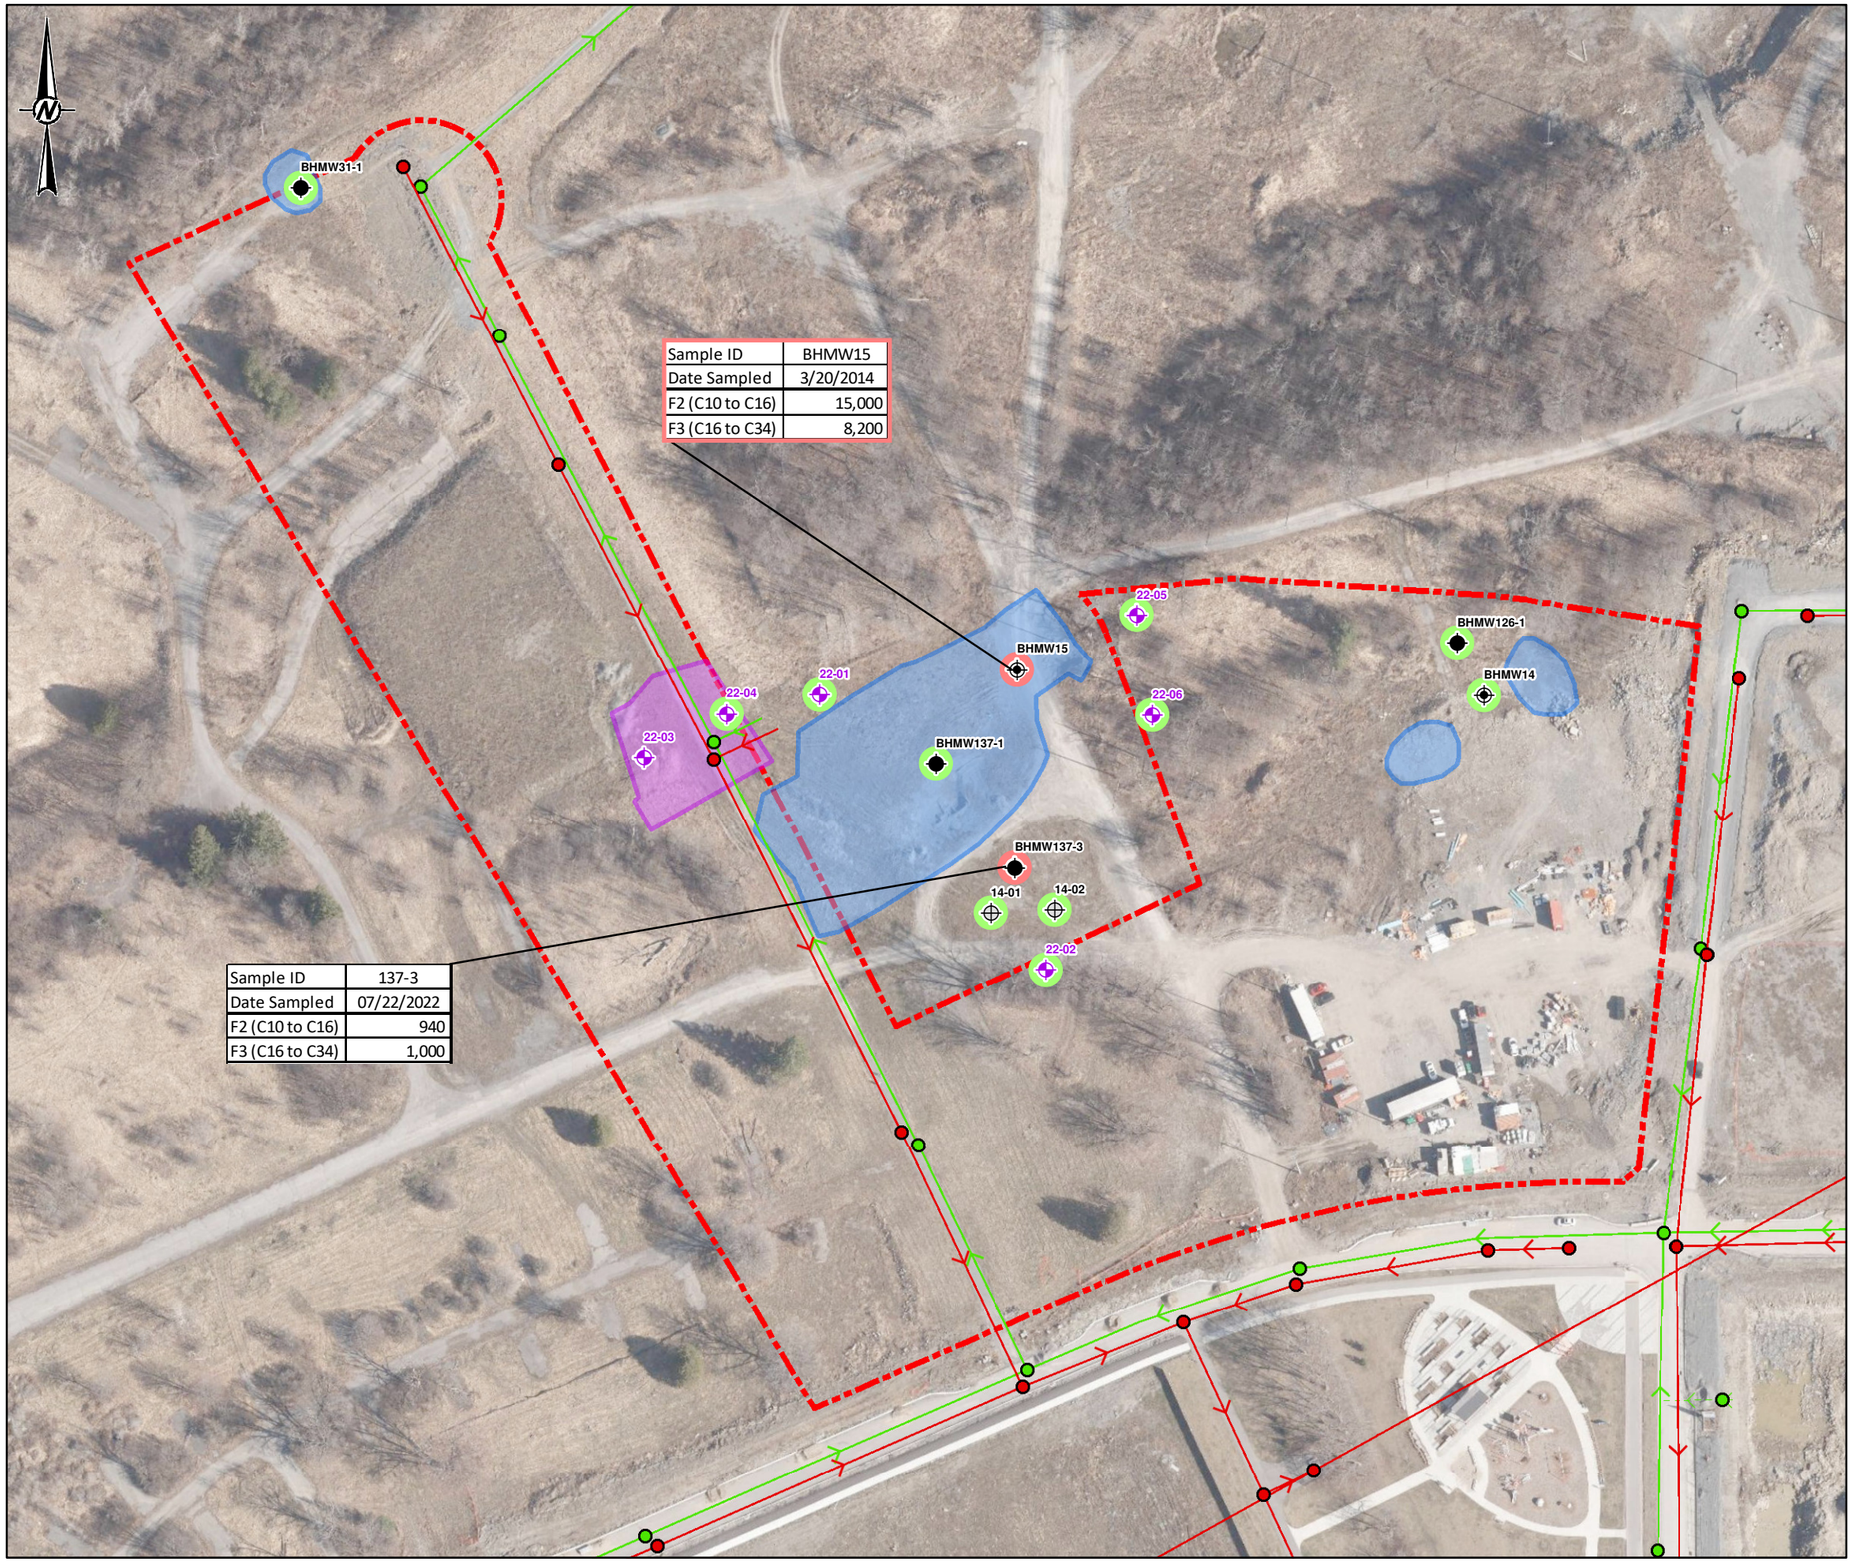
Groundwater quality assessment included sampling of 4 monitoring wells in 2022, which were installed around at the boundary of the RSC Property adjacent to the off-Site PCA. Table 4 summarized the groundwater analyses performed. Concentrations of PHC F1 to F4, BTEX, PAHs and metals in all the samples were below the applicable site condition standards.

These impacts were located entirely within the fill materials and were found at depths up to 3.8 mbgs.
- **Groundwater** – Groundwater quality assessment included sampling of 4 monitoring wells in 2022, which were installed around at the boundary of the RSC Property adjacent to the off-Site PCA. Table 4 summarized the groundwater analyses performed. Concentrations of PHC F1 to F4, BTEX, PAHs and metals in all the samples were below the applicable site condition standards.

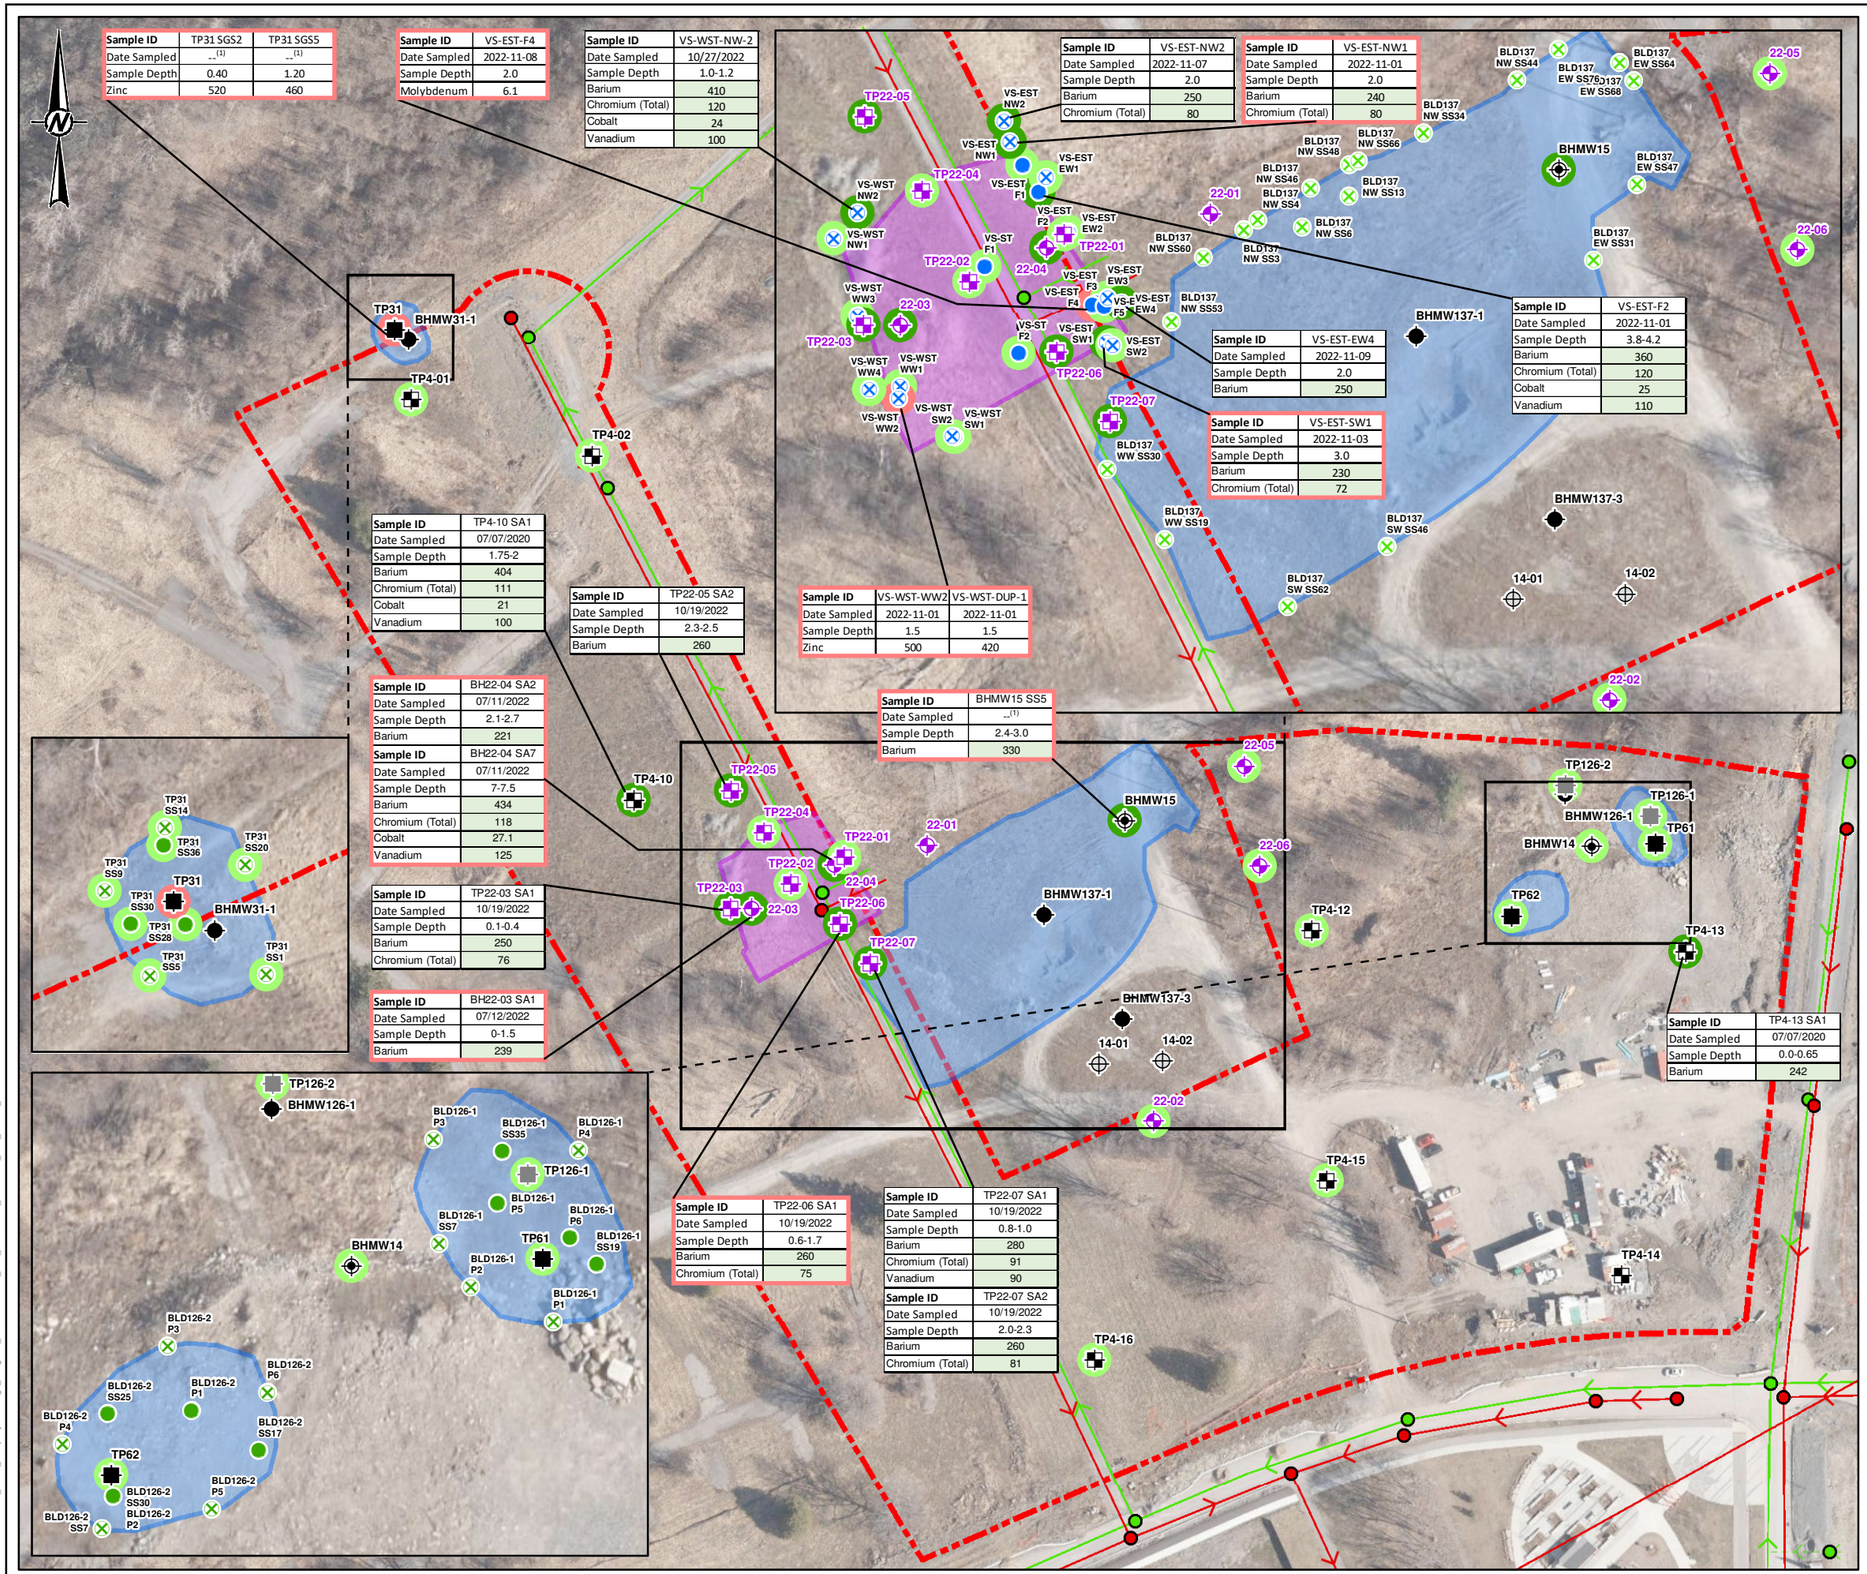
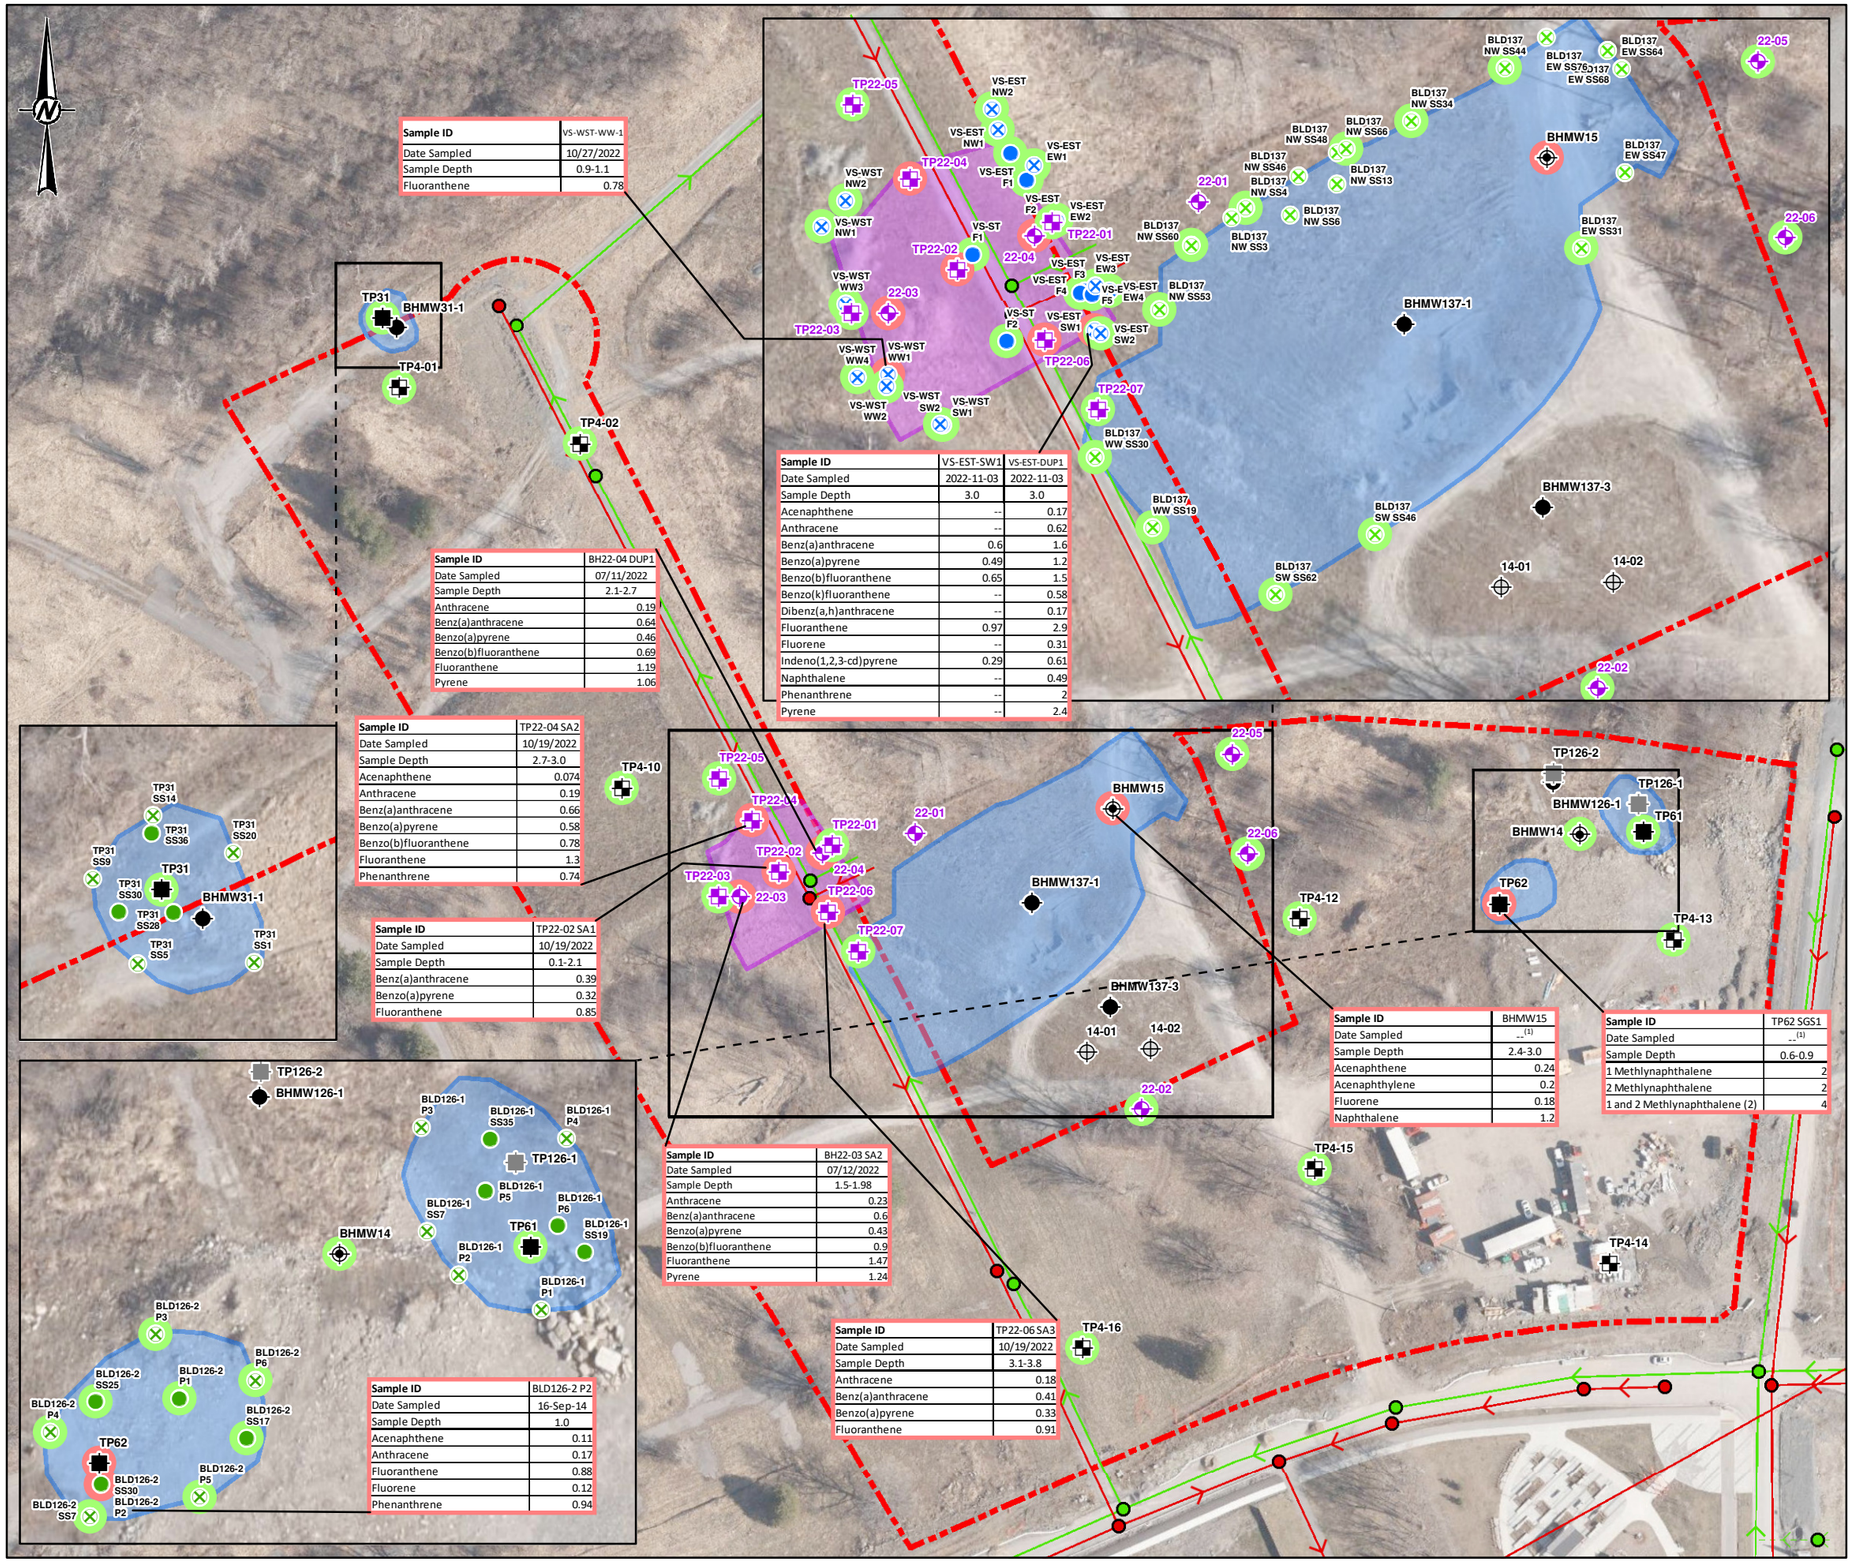
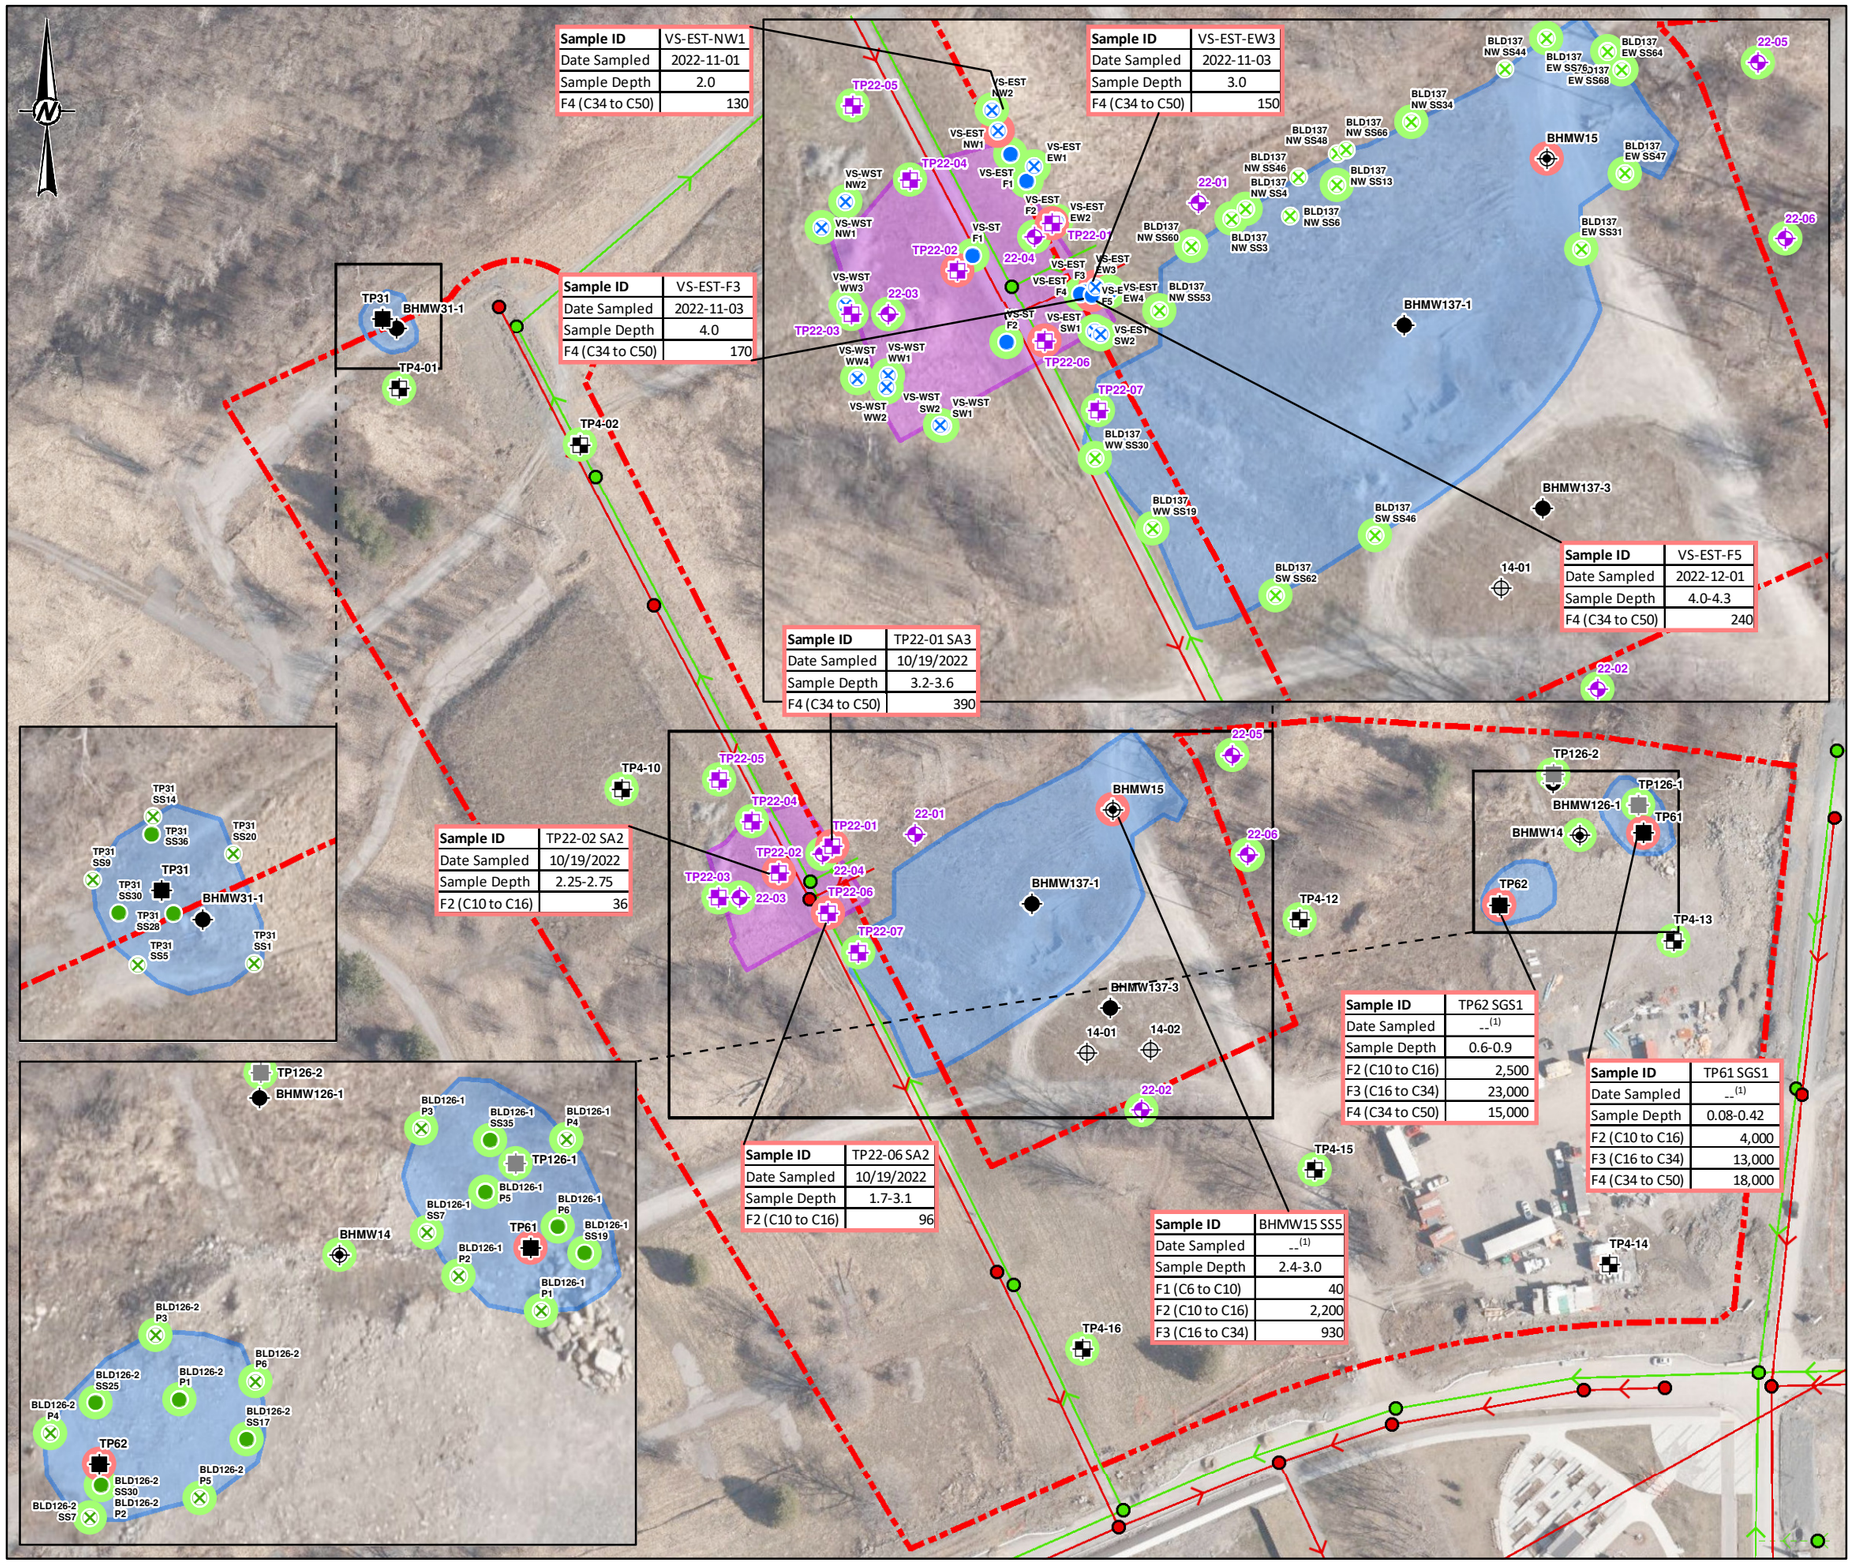
A summary of the number of soil samples analyzed and the number of soil samples exceeding the Table 1 site condition standards is provided below:

These impacts were located entirely within the fill materials and were found at depths up to 3.8 mbgs.

Exceedances of barium, chromium, cobalt, and vanadium in the soil samples were considered to have resulted from naturally occurring elevated concentrations due to the presence clay in the fill layer. The concentrations present were within the range of typical of the marine clays of eastern Ontario. As such the metals are considered to be natural in origin and within typical background levels for the Ottawa area and are therefore not an exceedance of the site condition standards. A rationale for such naturally occurring metals above the MECP Table 1 Standards is appended to this report (Appendix F). The qualified person has determined these exceedances do not exceed the naturally occurring range of concentrations typically found within the area where the property is located as outlined in Section 49.1.3 in O.Reg 153.

Following remediation, all contaminated soil was removed form the Site. The verification sampling program included the collection of samples as per the guidance for sampling and analysis frequency is provided in O. Reg 153/04, as amended, Schedule E, Table 3 (Minimum Confirmation Sampling Requirements for Excavation). All the validation samples met the applicable MECP Table 1 Standards. As a result, no contaminated soil above the applicable site conditions standards remains on the Site.
