REPORT

Phase Two Environmental Site Assessment

Wateridge Village Phase 4, Part of 1076 Hemlock Private, Ottawa, Ontario

19124906

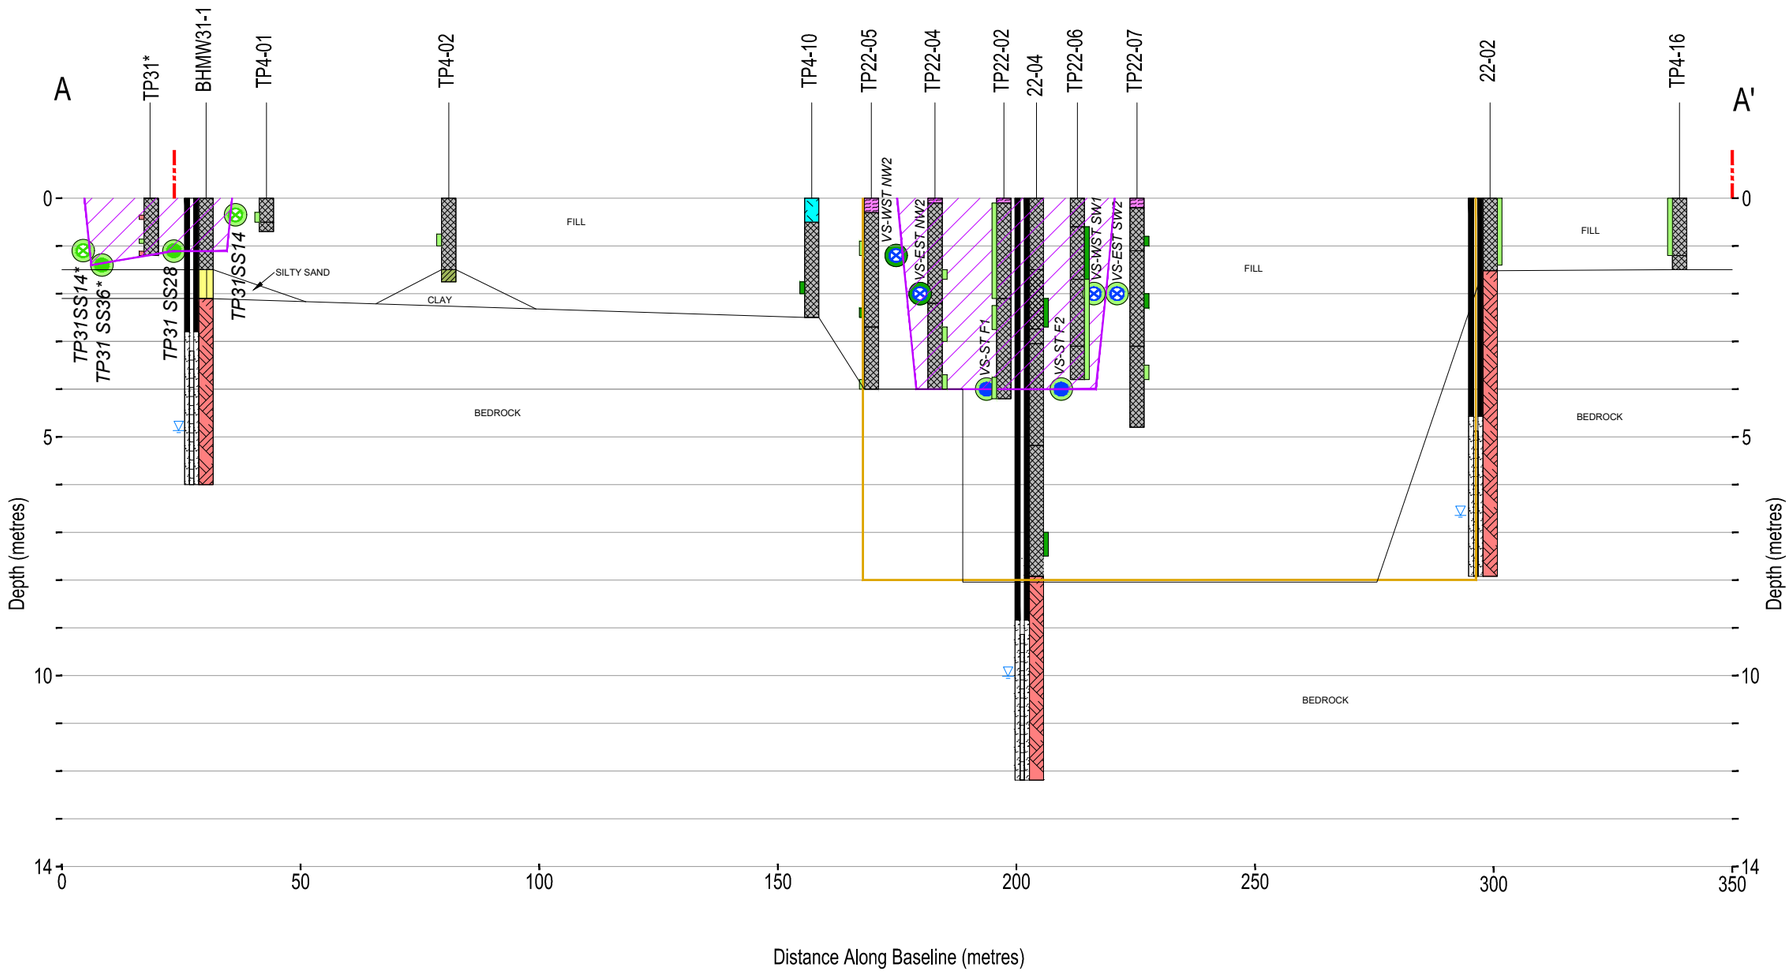
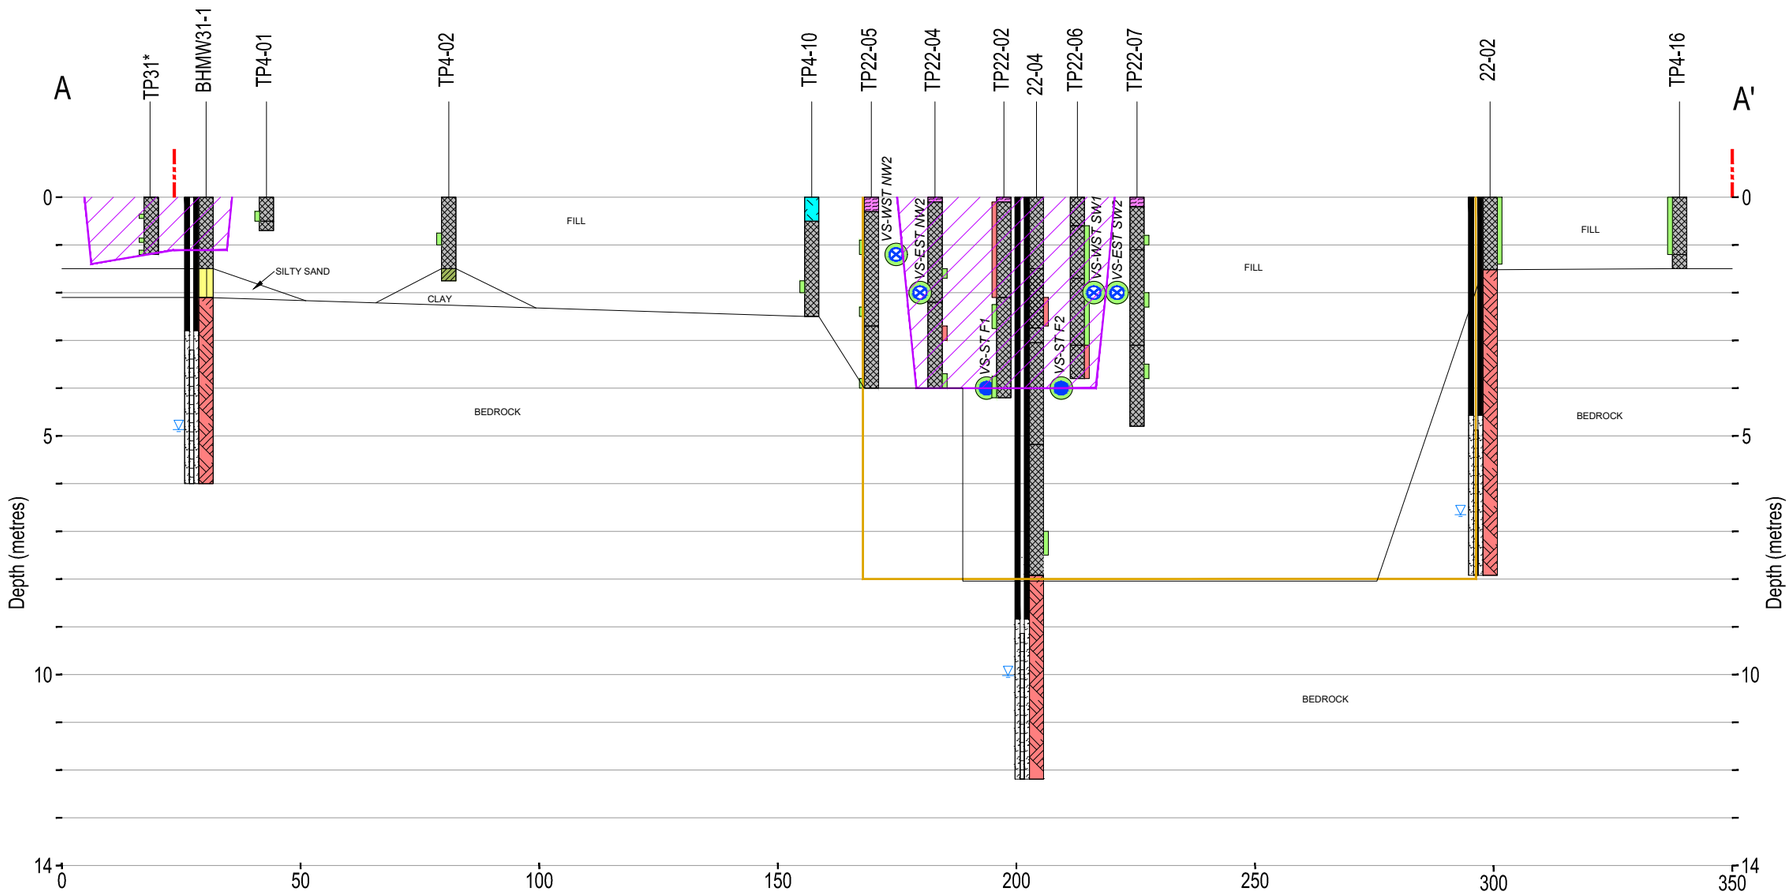
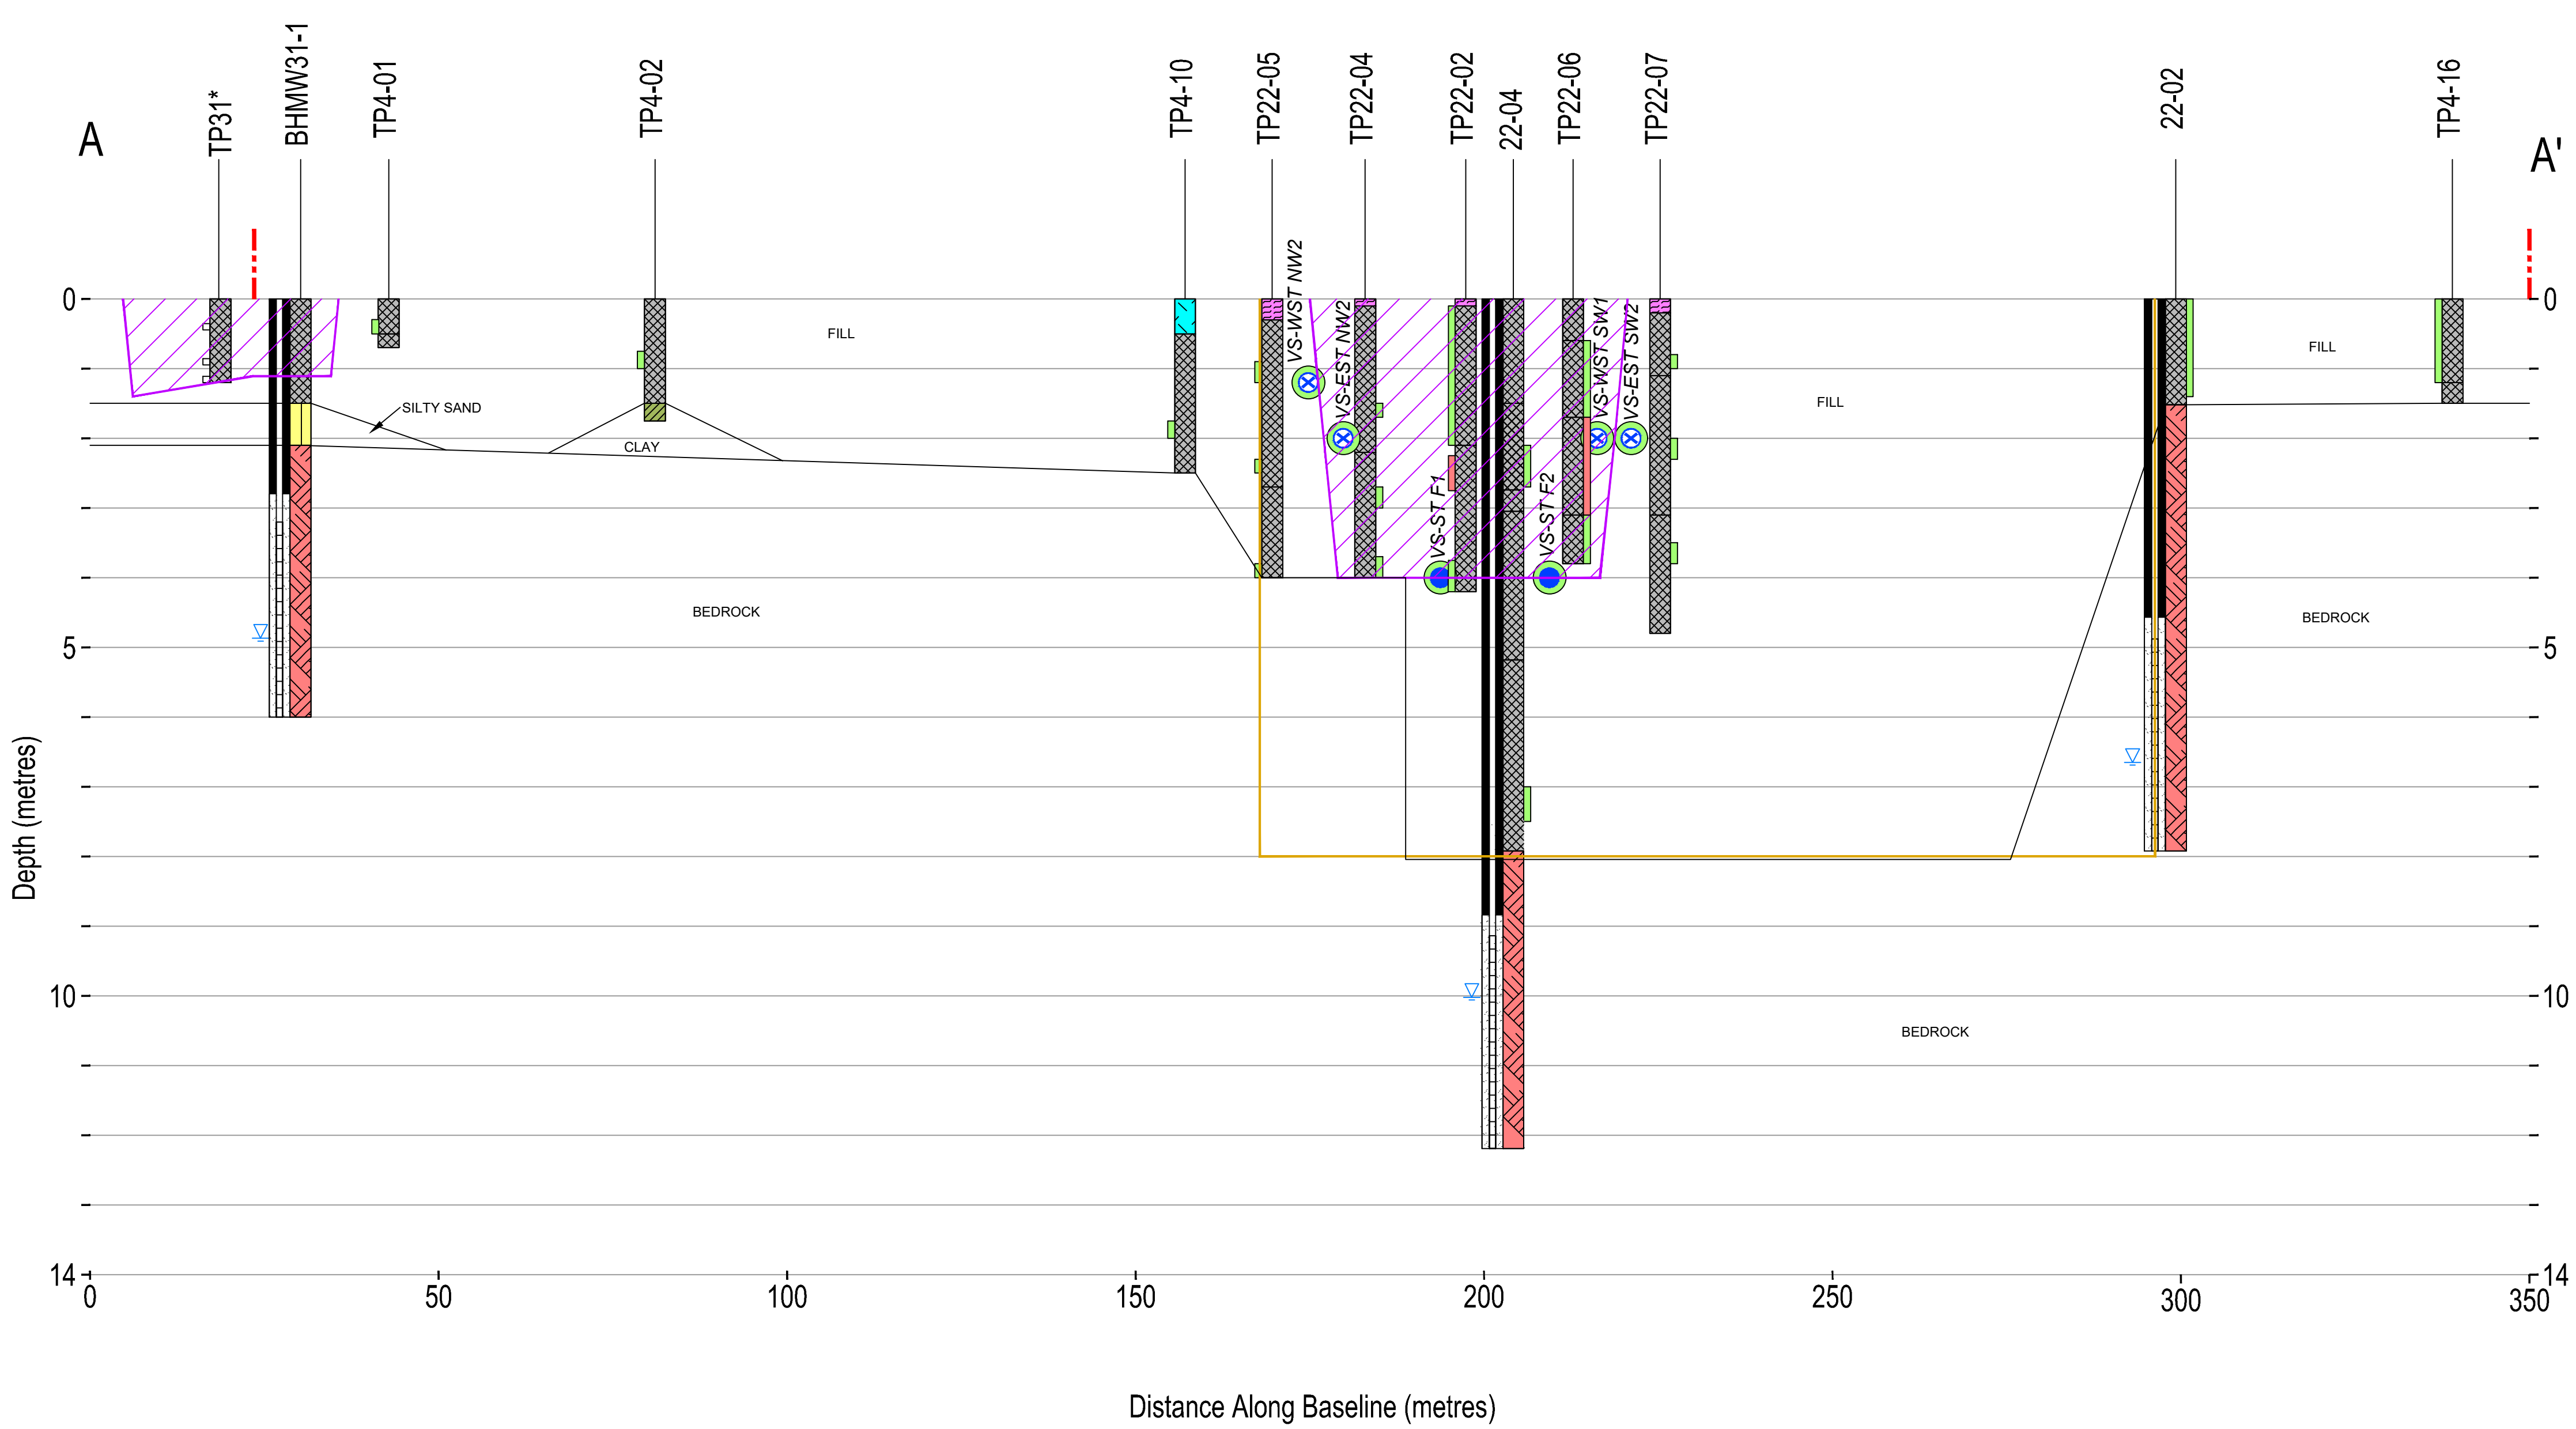
Figure 5A: Cross-Section A-A' (Interpreted geological and hydrogeological conditions) with metals analysis and exceedances in soil.

A representative geologic cross-section of the Site is presented in Figures 5A to 6C. In general, the subsurface soil conditions encountered in the boreholes and test pits consisted of surficial topsoil and fill of variable depths (up to 3.05 mbgs at borehole 22-04), with predominantly gravelly silty sand that extend to the maximum depth of investigation (7.92 mbgs at 22-04). At numerous investigation locations, silt and clays interbedded with sands and gravels were observed in the fill and glacial till layers.

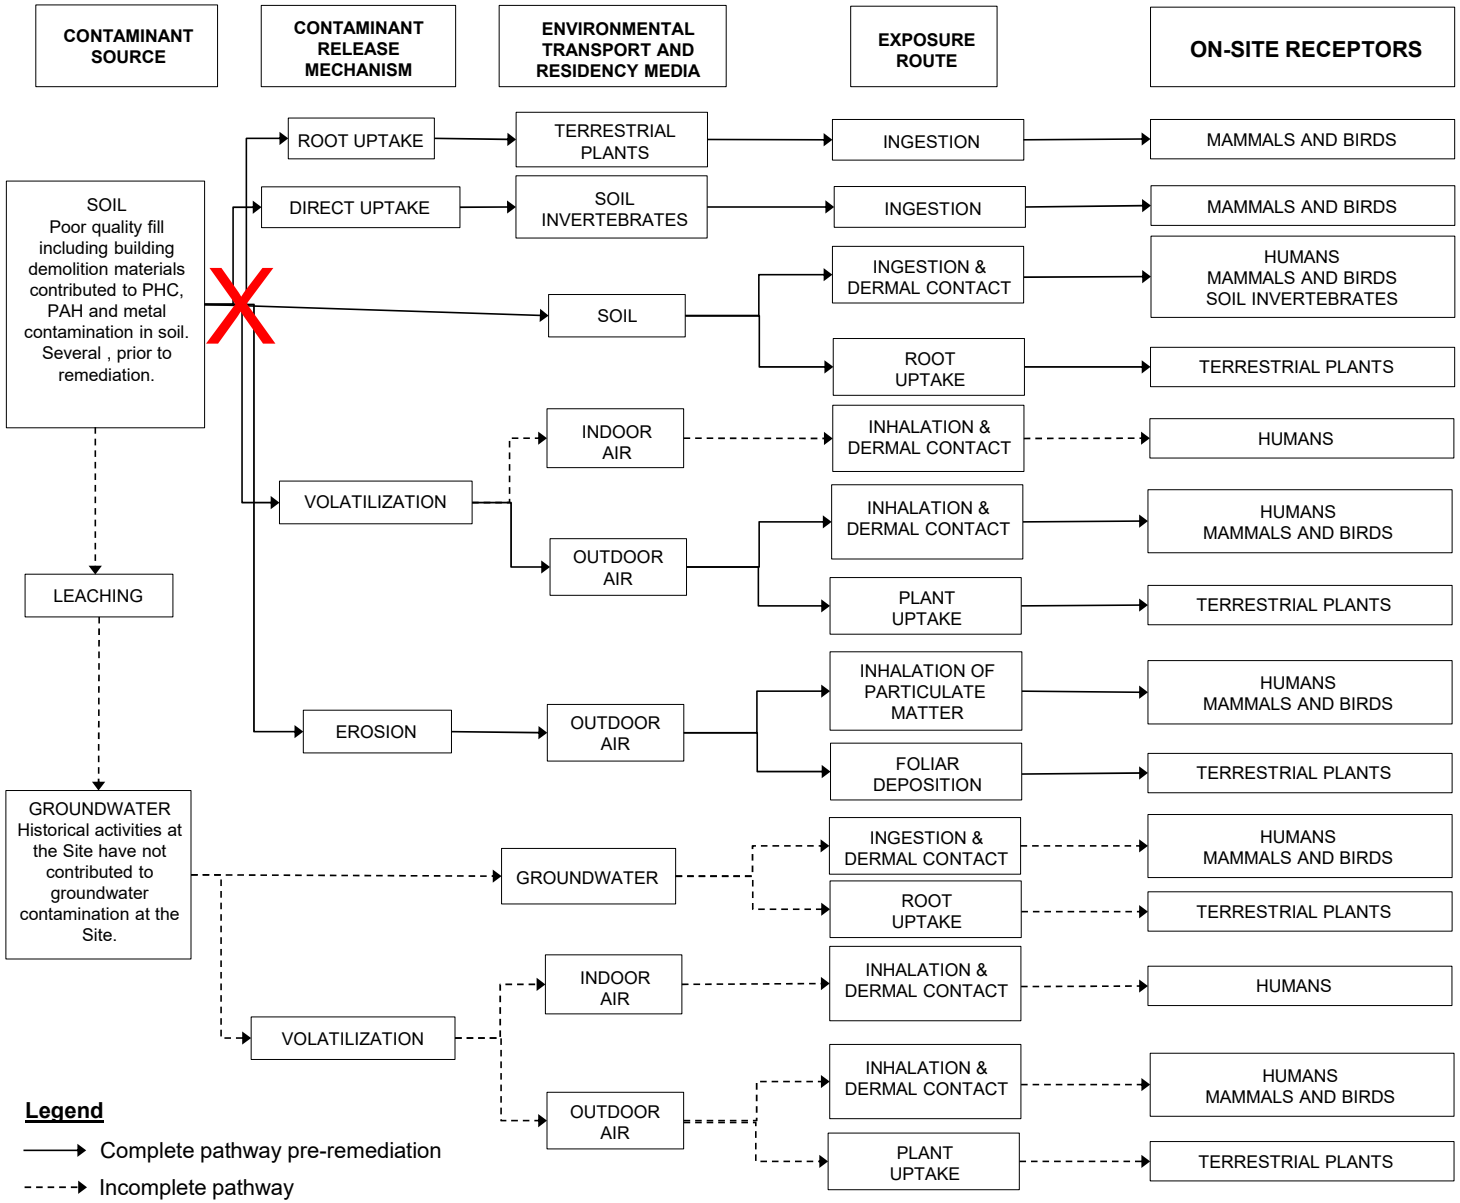
FIGURE 7

1. This diagram indicates all potential pathways which were considered to have the potential to result in exposure of contaminants by receptors at the Site pre-remediation.
2. Remediation at the Site consisted of the excavation of contaminated soil.
3. Post-remediation all soil related pathways are considered to be incomplete given that contaminated soil is no longer present at the Site, denoted by the "X".
