## Phase I Environmental Site Assessment

168 and 174 Murray Street
Ottawa, Ontario

June 9, 2022

Report: PE5717-1

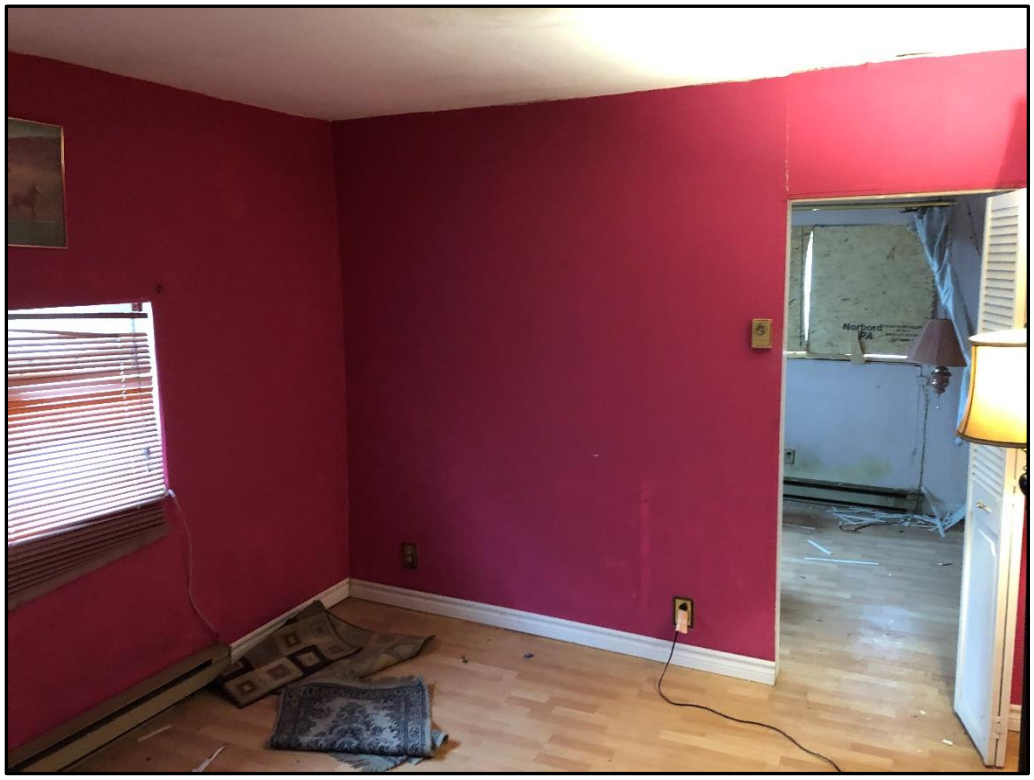
Photo 6: Second story interior of 168 Murray Street.
