Phase One Environmental Site Assessment

1010 Somerset Street West, Ottawa, Ontario

July 2021 – 21-1685

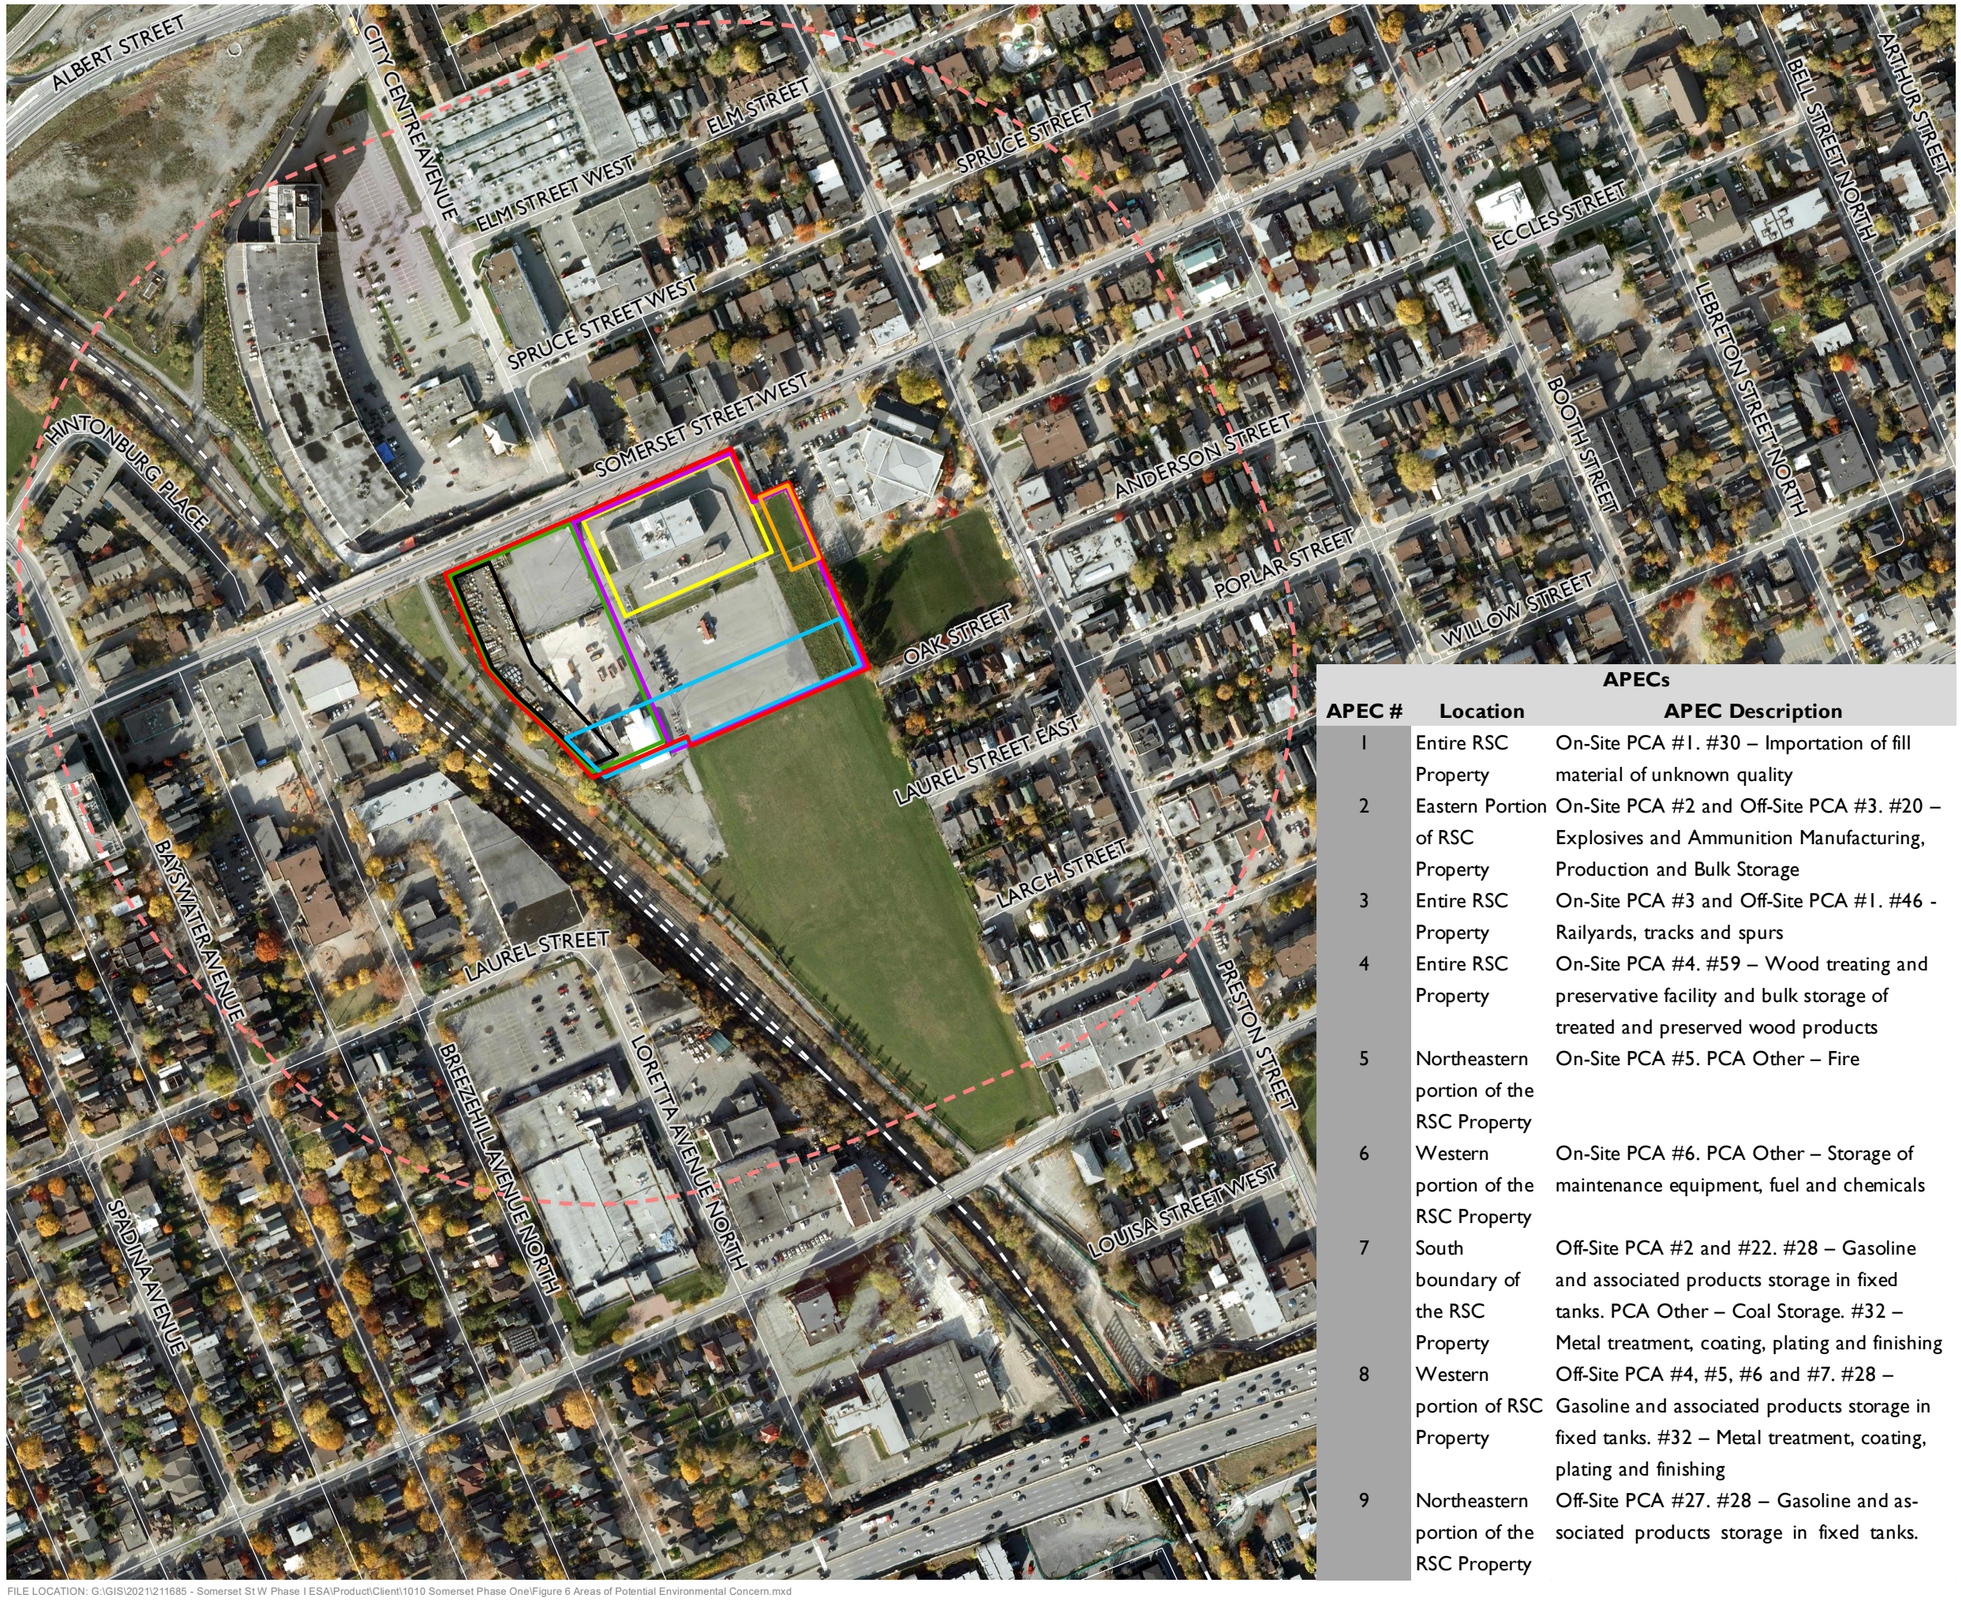
APEC #	Location	APEC Description
1	Entire RSC Property	On-Site PCA #1. #30 – Importation of fill material of unknown quality
2	Eastern Portion of RSC Property	On-Site PCA #2 and Off-Site PCA #3. #20 – Explosives and Ammunition Manufacturing, Production and Bulk Storage
3	Entire RSC Property	On-Site PCA #3 and Off-Site PCA #1. #46 - Railyards, tracks and spurs
4	Entire RSC Property	On-Site PCA #4. #59 – Wood treating and preservative facility and bulk storage of treated and preserved wood products
5	Northeastern portion of the RSC Property	On-Site PCA #5. PCA Other – Fire
6	Western portion of the RSC Property	On-Site PCA #6. PCA Other – Storage of maintenance equipment, fuel and chemicals
7	South boundary of the RSC Property	Off-Site PCA #2 and #22. #28 – Gasoline and associated products storage in fixed tanks. PCA Other – Coal Storage. #32 – Metal treatment, coating, plating and finishing
8	Western portion of RSC Property	Off-Site PCA #4, #5, #6 and #7. #28 – Gasoline and associated products storage in fixed tanks. #32 – Metal treatment, coating, plating and finishing

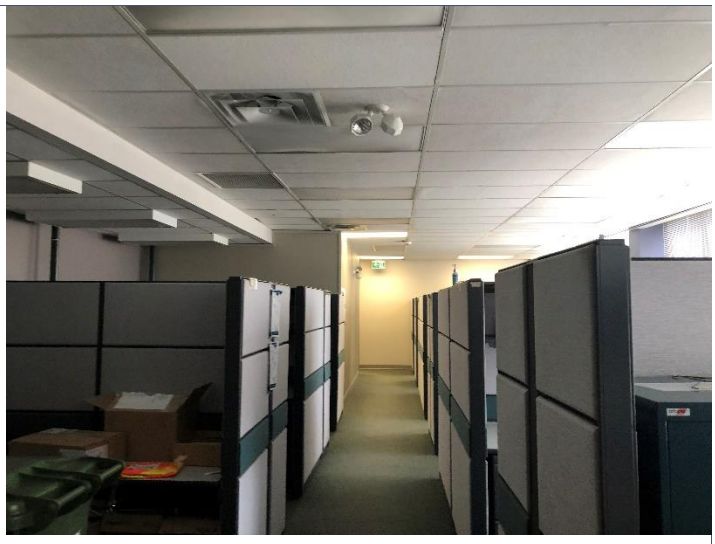
Picture 1 – Office Building on RSC Property (facing east)

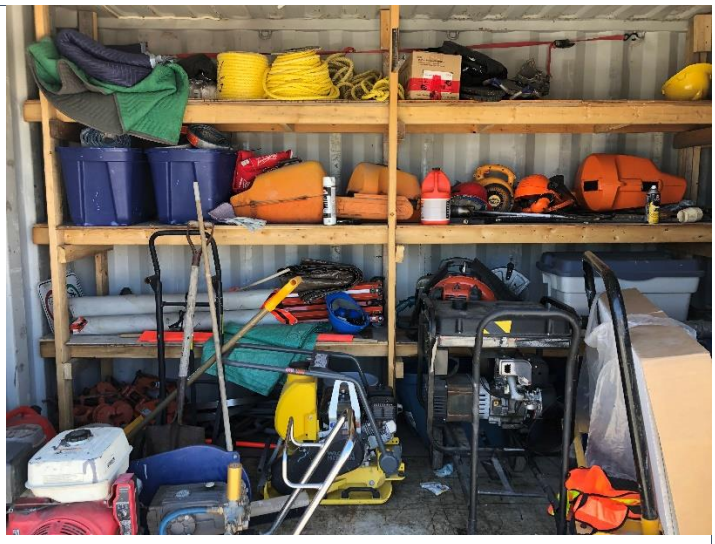
Picture 17 – Discarded Building Equipment in Public Works Yard (facing north)

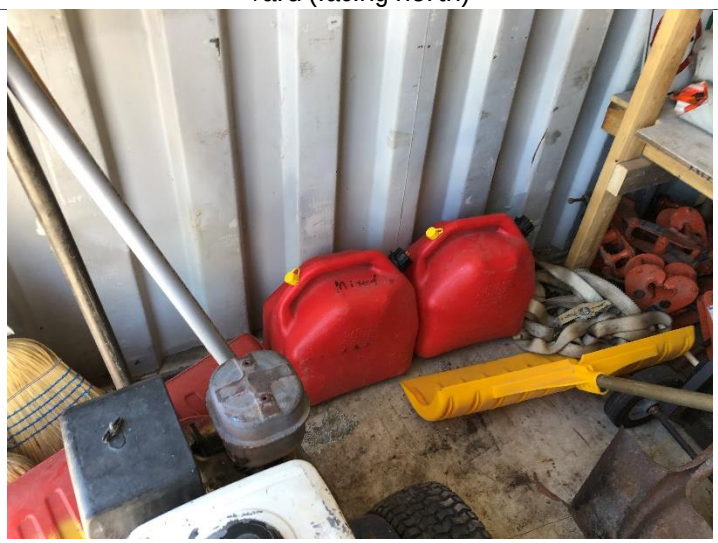
Picture 18 – Road Maintenance Equipment Storage Within Storage Locker in Public Works Yard

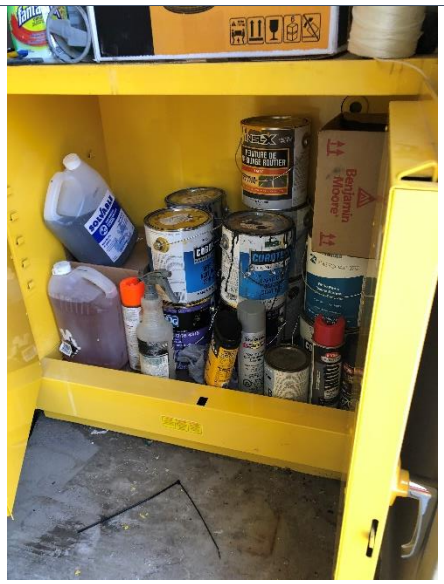
Picture 21 – Paint Cans and Chemicals Stored Inside Storage Locker in Public Works Yard
