FINAL REPORT

Phase I Environmental Site Assessment Update

30 Cleary Avenue, Ottawa, Ontario

CA0008376.9447-Rev0

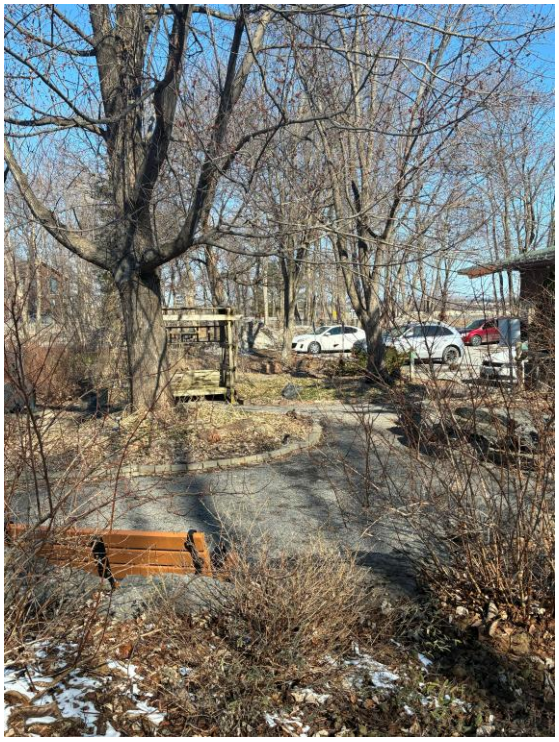
Photo 4 – Landscaped area between parking lots.
