September 4, 2026
File: PE5066-LET.06

Subject: **Phase I - Environmental Site Assessment Update**
Part of 1500 Merivale Road
Ottawa, Ontario

PHASE I - ENVIRONMENTAL SITE ASSESSMENT
1380, 1374 BASELINE ROAD, AND PARTS OF 1366 BASELINE ROAD
OTTAWA, ONTARIO

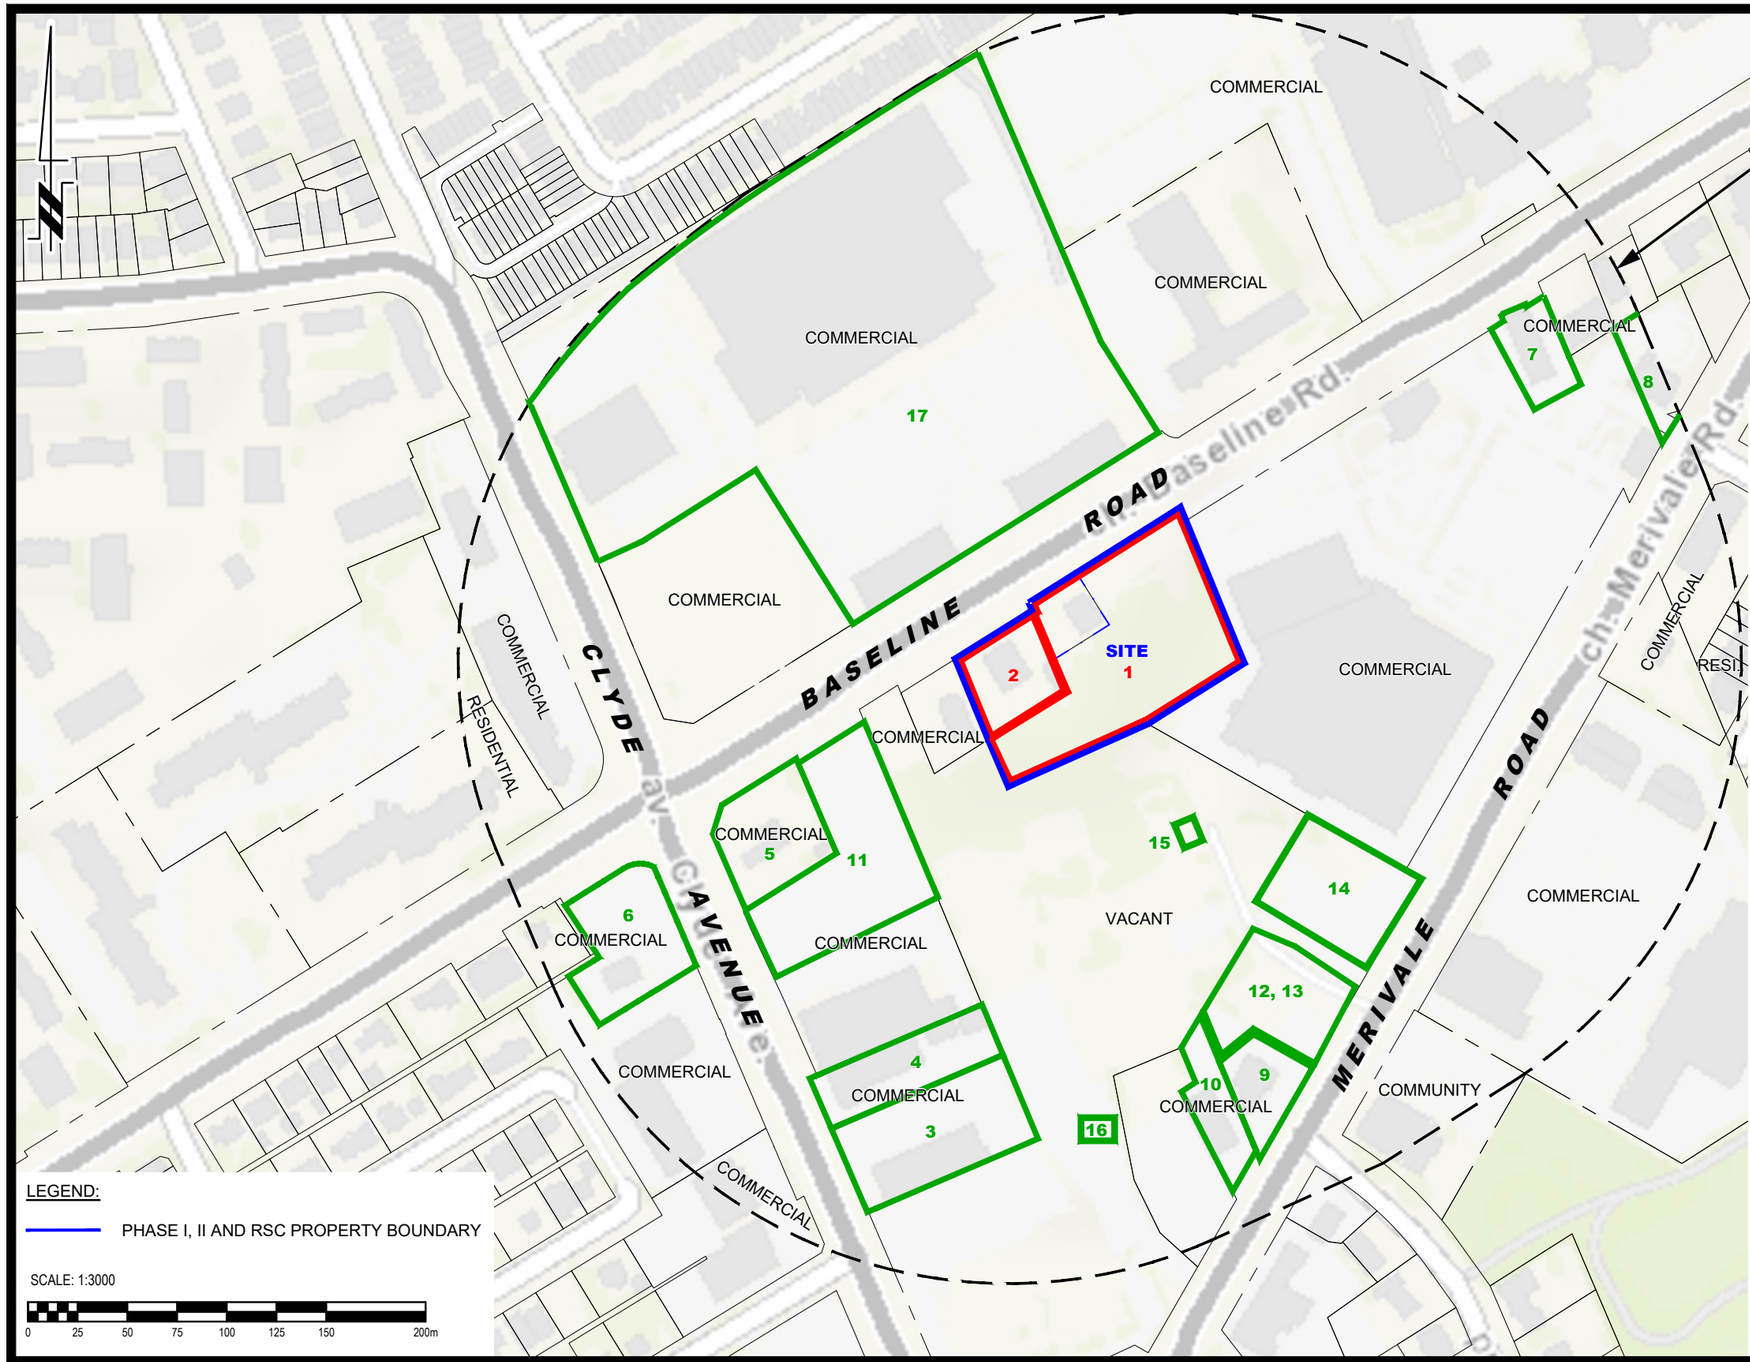
SITE PLAN

No evidence of current or former railway or spur lines was observed on the Phase I Property at the time of the site visit. The above-noted site features are shown on Drawing PE5066-1 - Site Plan.

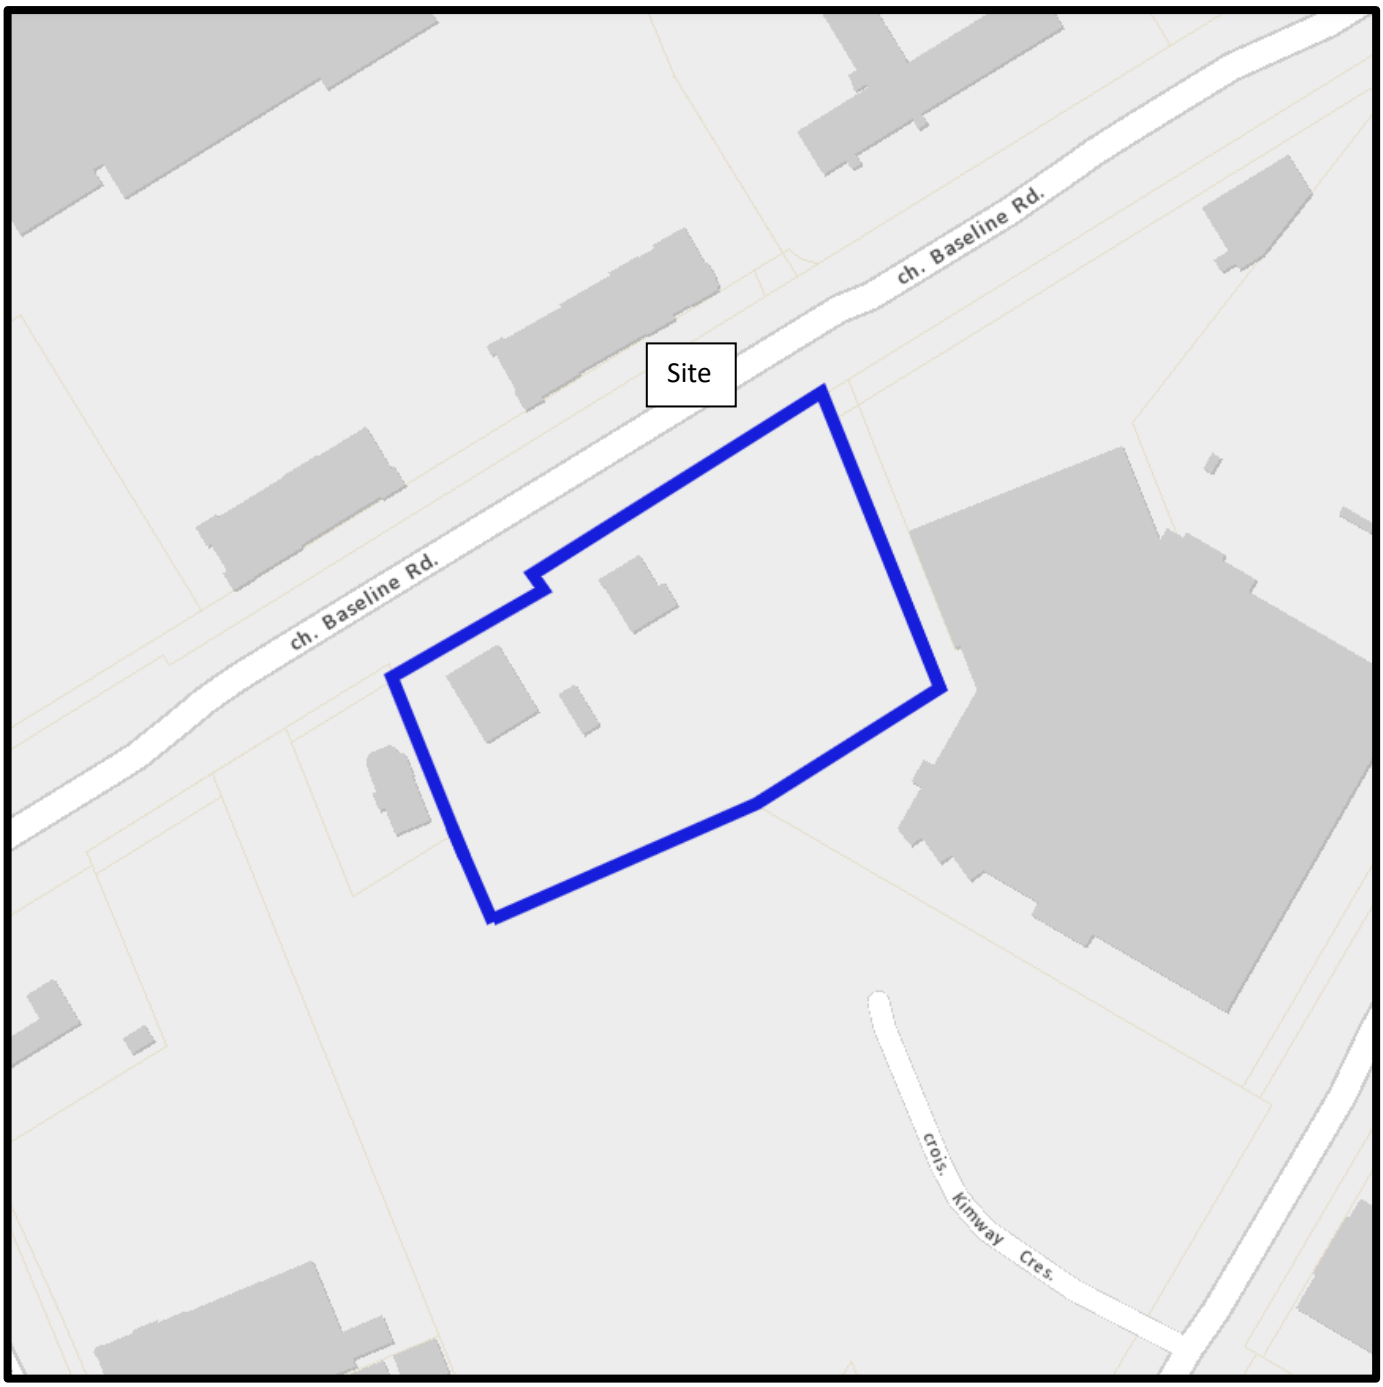
FIGURE 1

The Phase I ESA Property is located on the south side of Baseline Road, approximately 150 m east of the Clyde Avenue and Baseline Road intersection, in the City of Ottawa, Ontario, which is shown on Figure 1 - Key Plan, following the body of this report.
