PATERSON GROUP

# Geotechnical Investigation

## Proposed Commercial Building

**Report PG7250-1 Rev. 5 dated September 17, 2026**

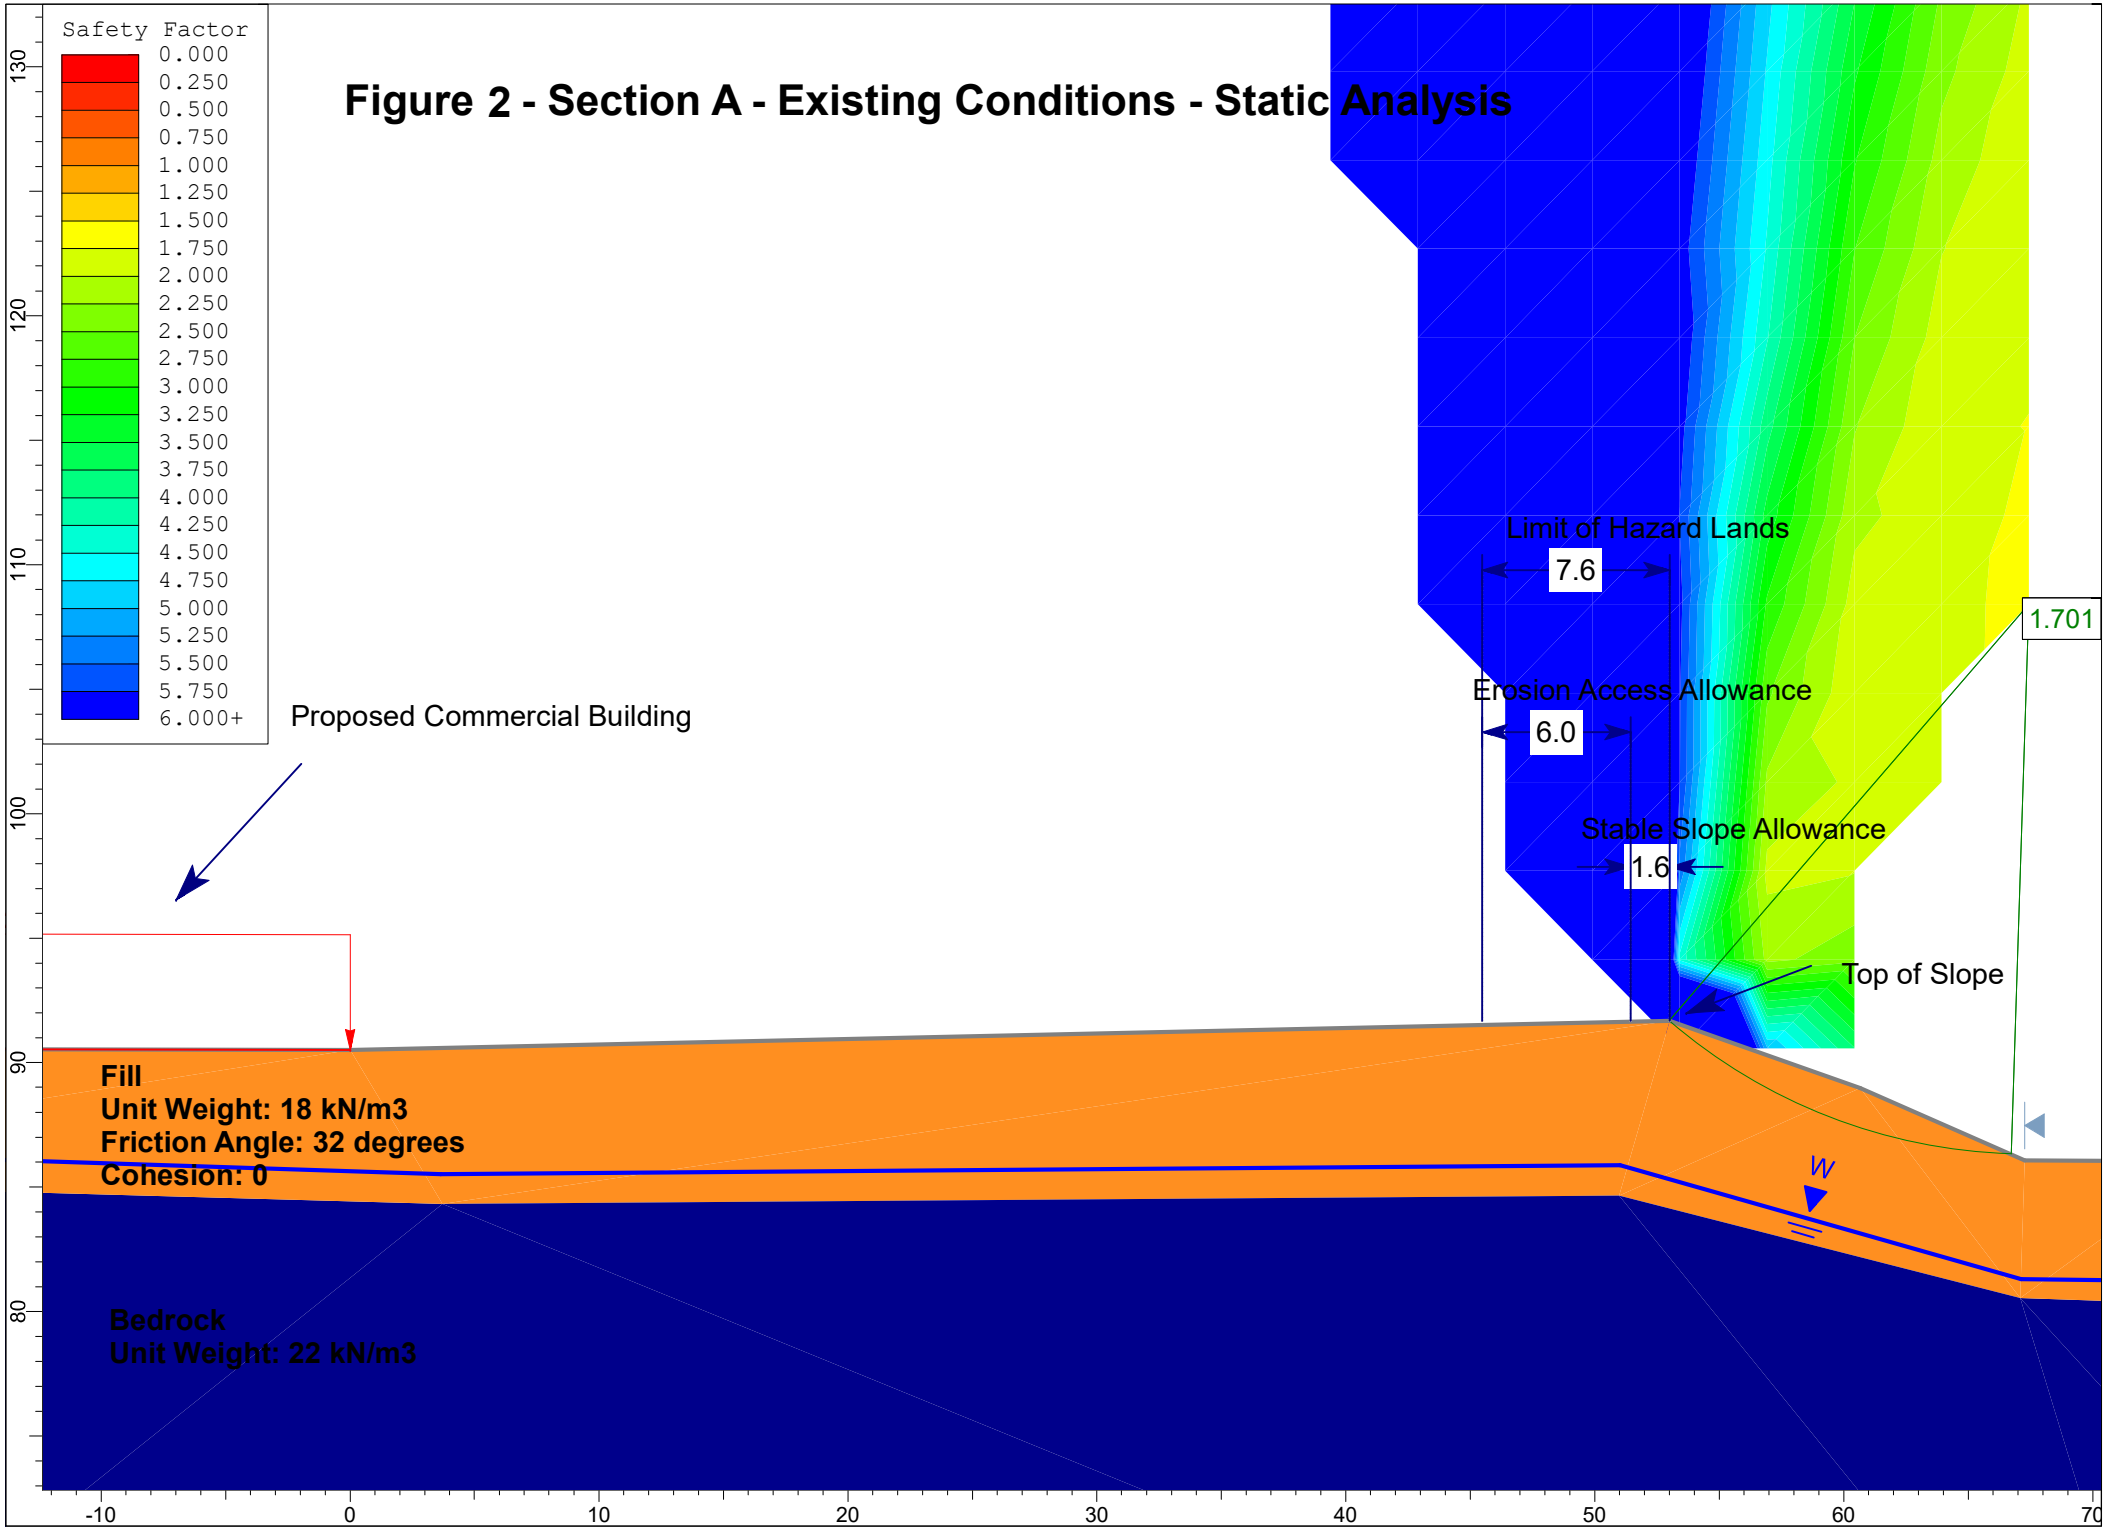
The static analysis results at slope cross-section A-A' using the Bishop's method and Morgenstern-Price method are presented in Figures 2 and 4, respectively, in Appendix 2. A factor of safety greater than 1.5 was noted for this analysis case.

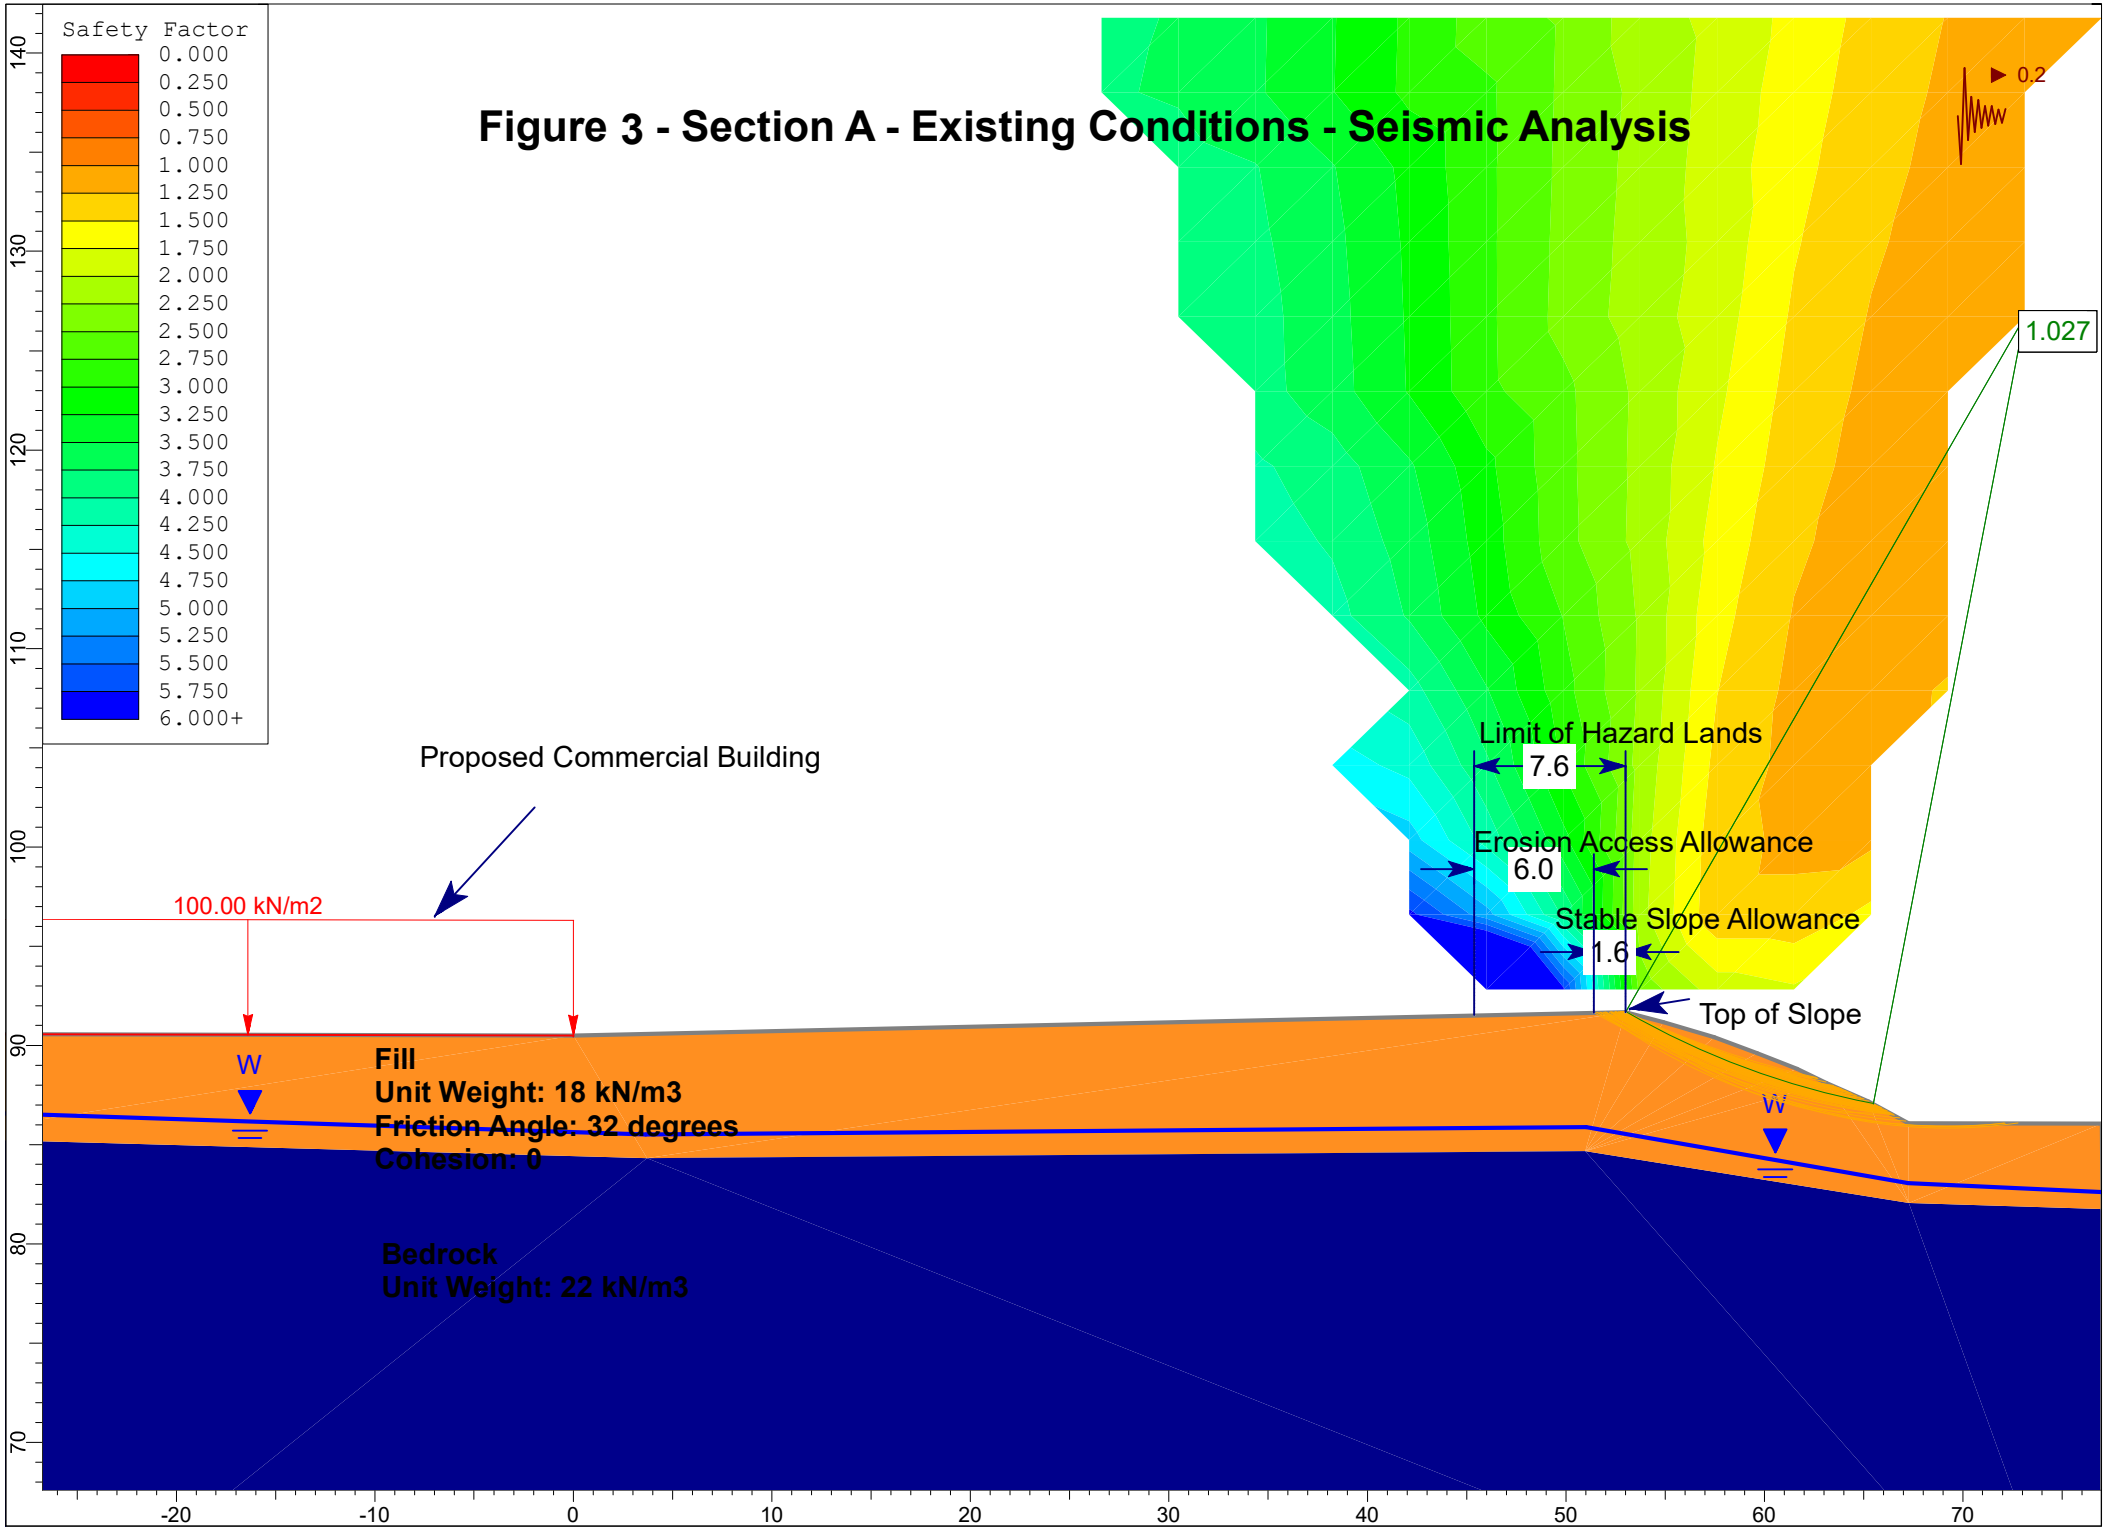
The results of the analyses with seismic loading at slope cross-section A-A using the Bishop's method and Morgenstern-Price method are shown in Figures 3 and 5, respectively, presented in Appendix 2. The factor of safety for the slope was noted to be less than 1.1 under seismic condition, therefore, a Stable Slope Allowance setback of 1.6 m is required.

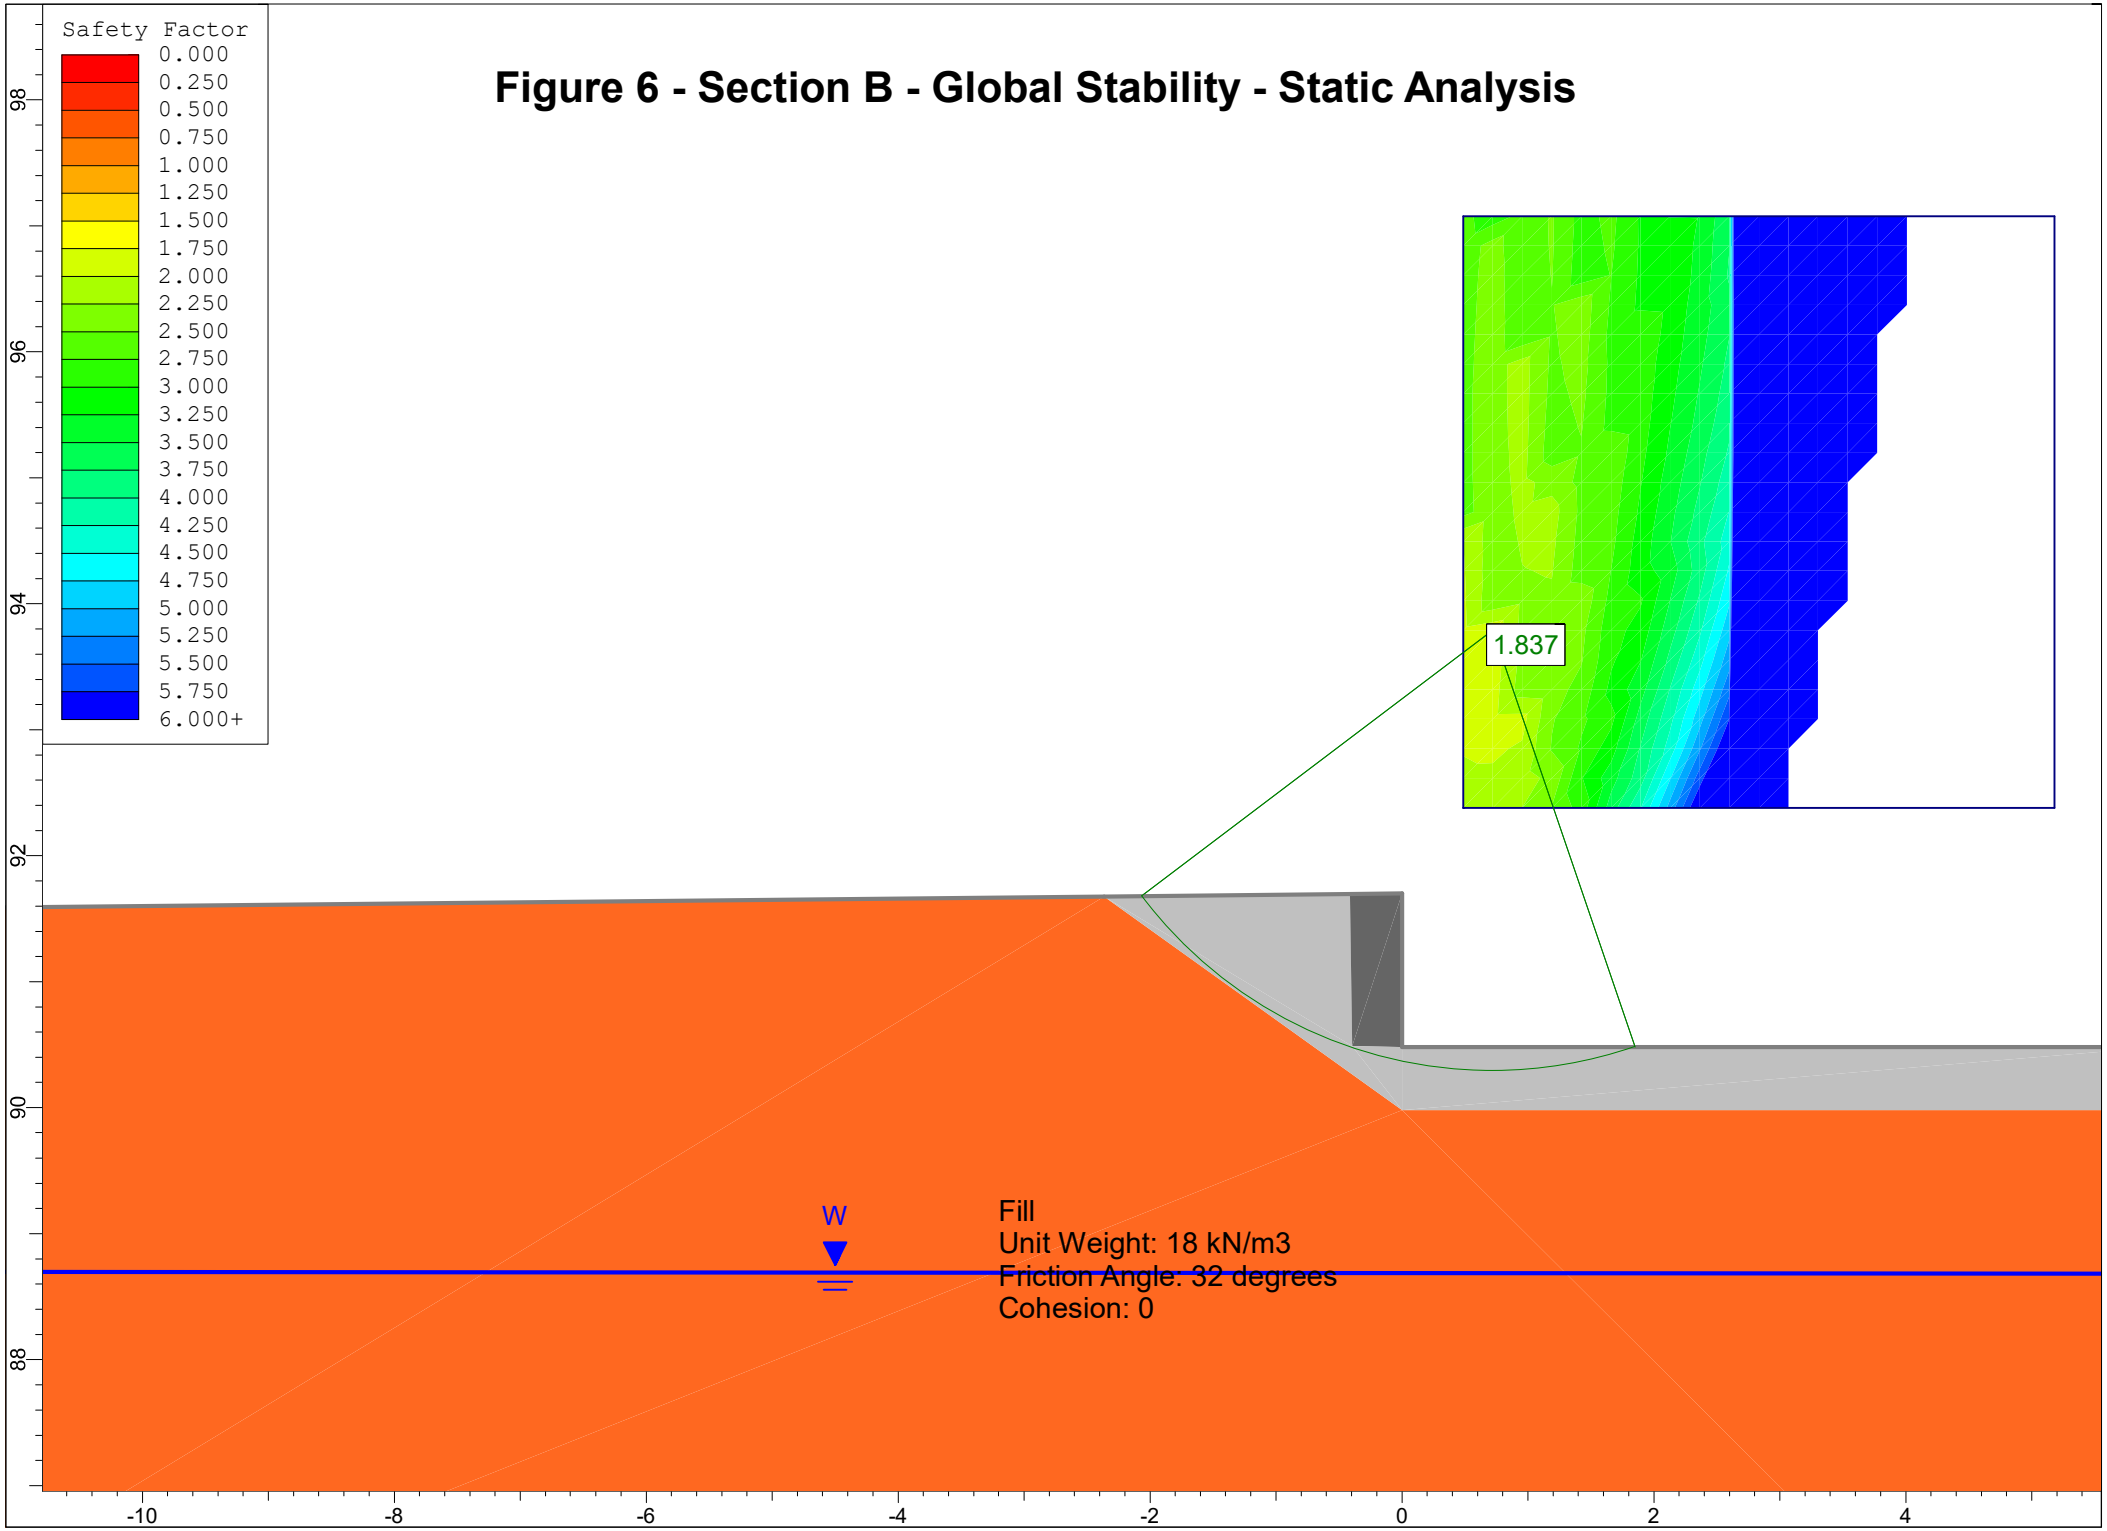
# Figure 6 - Section B - Global Stability - Static Analysis

The results of the global stability analysis, presented in Figures 6 and 7 in Appendix 2, indicate that the proposed retaining walls will have factors of safety exceeding 1.5 and 1.1 under static and seismic conditions, respectively. Therefore, the proposed retaining walls will be stable from a geotechnical perspective.

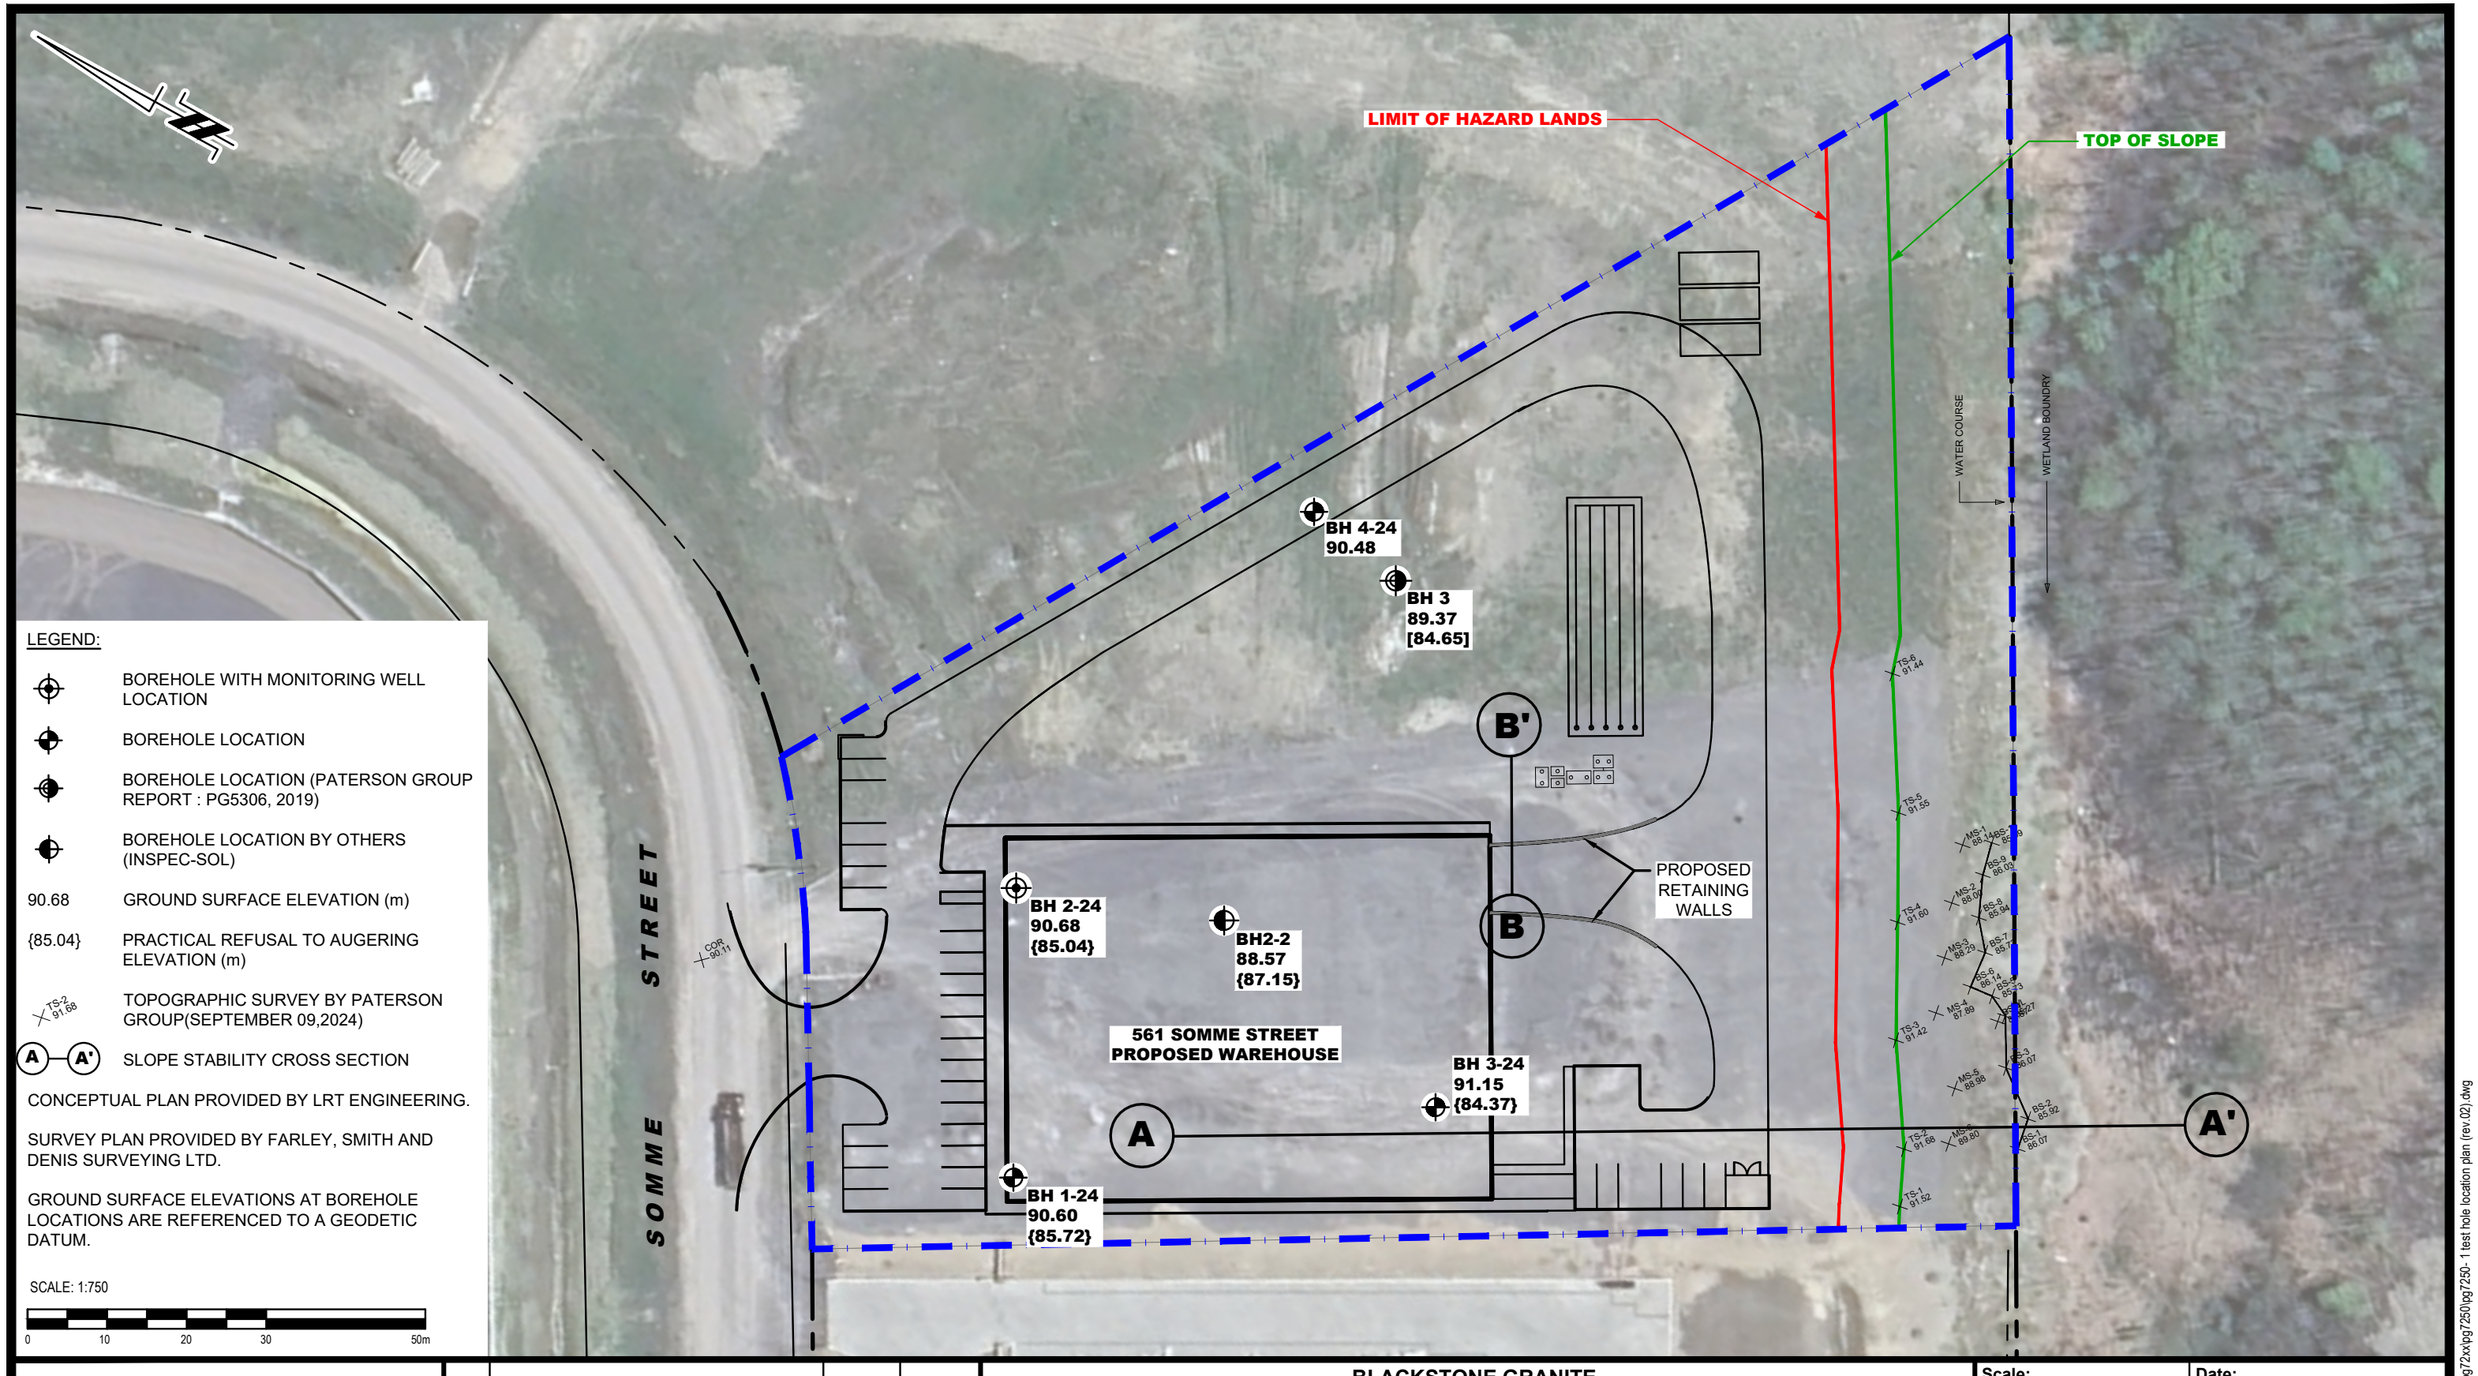
DRAWING PG7250-1 – TEST HOLE LOCATION PLAN

Based on the results of our field observations and slope stability analysis, a Limit of Hazard Lands was assigned from the top of the slope for the above-noted cross-section A-A. The cross-section locations and associated Limit of Hazard Lands setbacks are presented on Drawing PG7250-1 – Test Hole Location Plan in Appendix 2.

The results of the slope stability assessment indicate that a Limit of Hazard Lands setback of **7.6 m,** measured from the top of the slope, should be provided for any proposed development at the subject site. The Limit of Hazard Lands setback line is shown on the attached Drawing PG7250-1 – Test Hole Location Plan in Appendix 2.
