PATERSON GROUP

Phase II – Environmental Site Assessment

Tunney's Pasture (Block 5)

Report: PE6036-2R
January 24, 2025

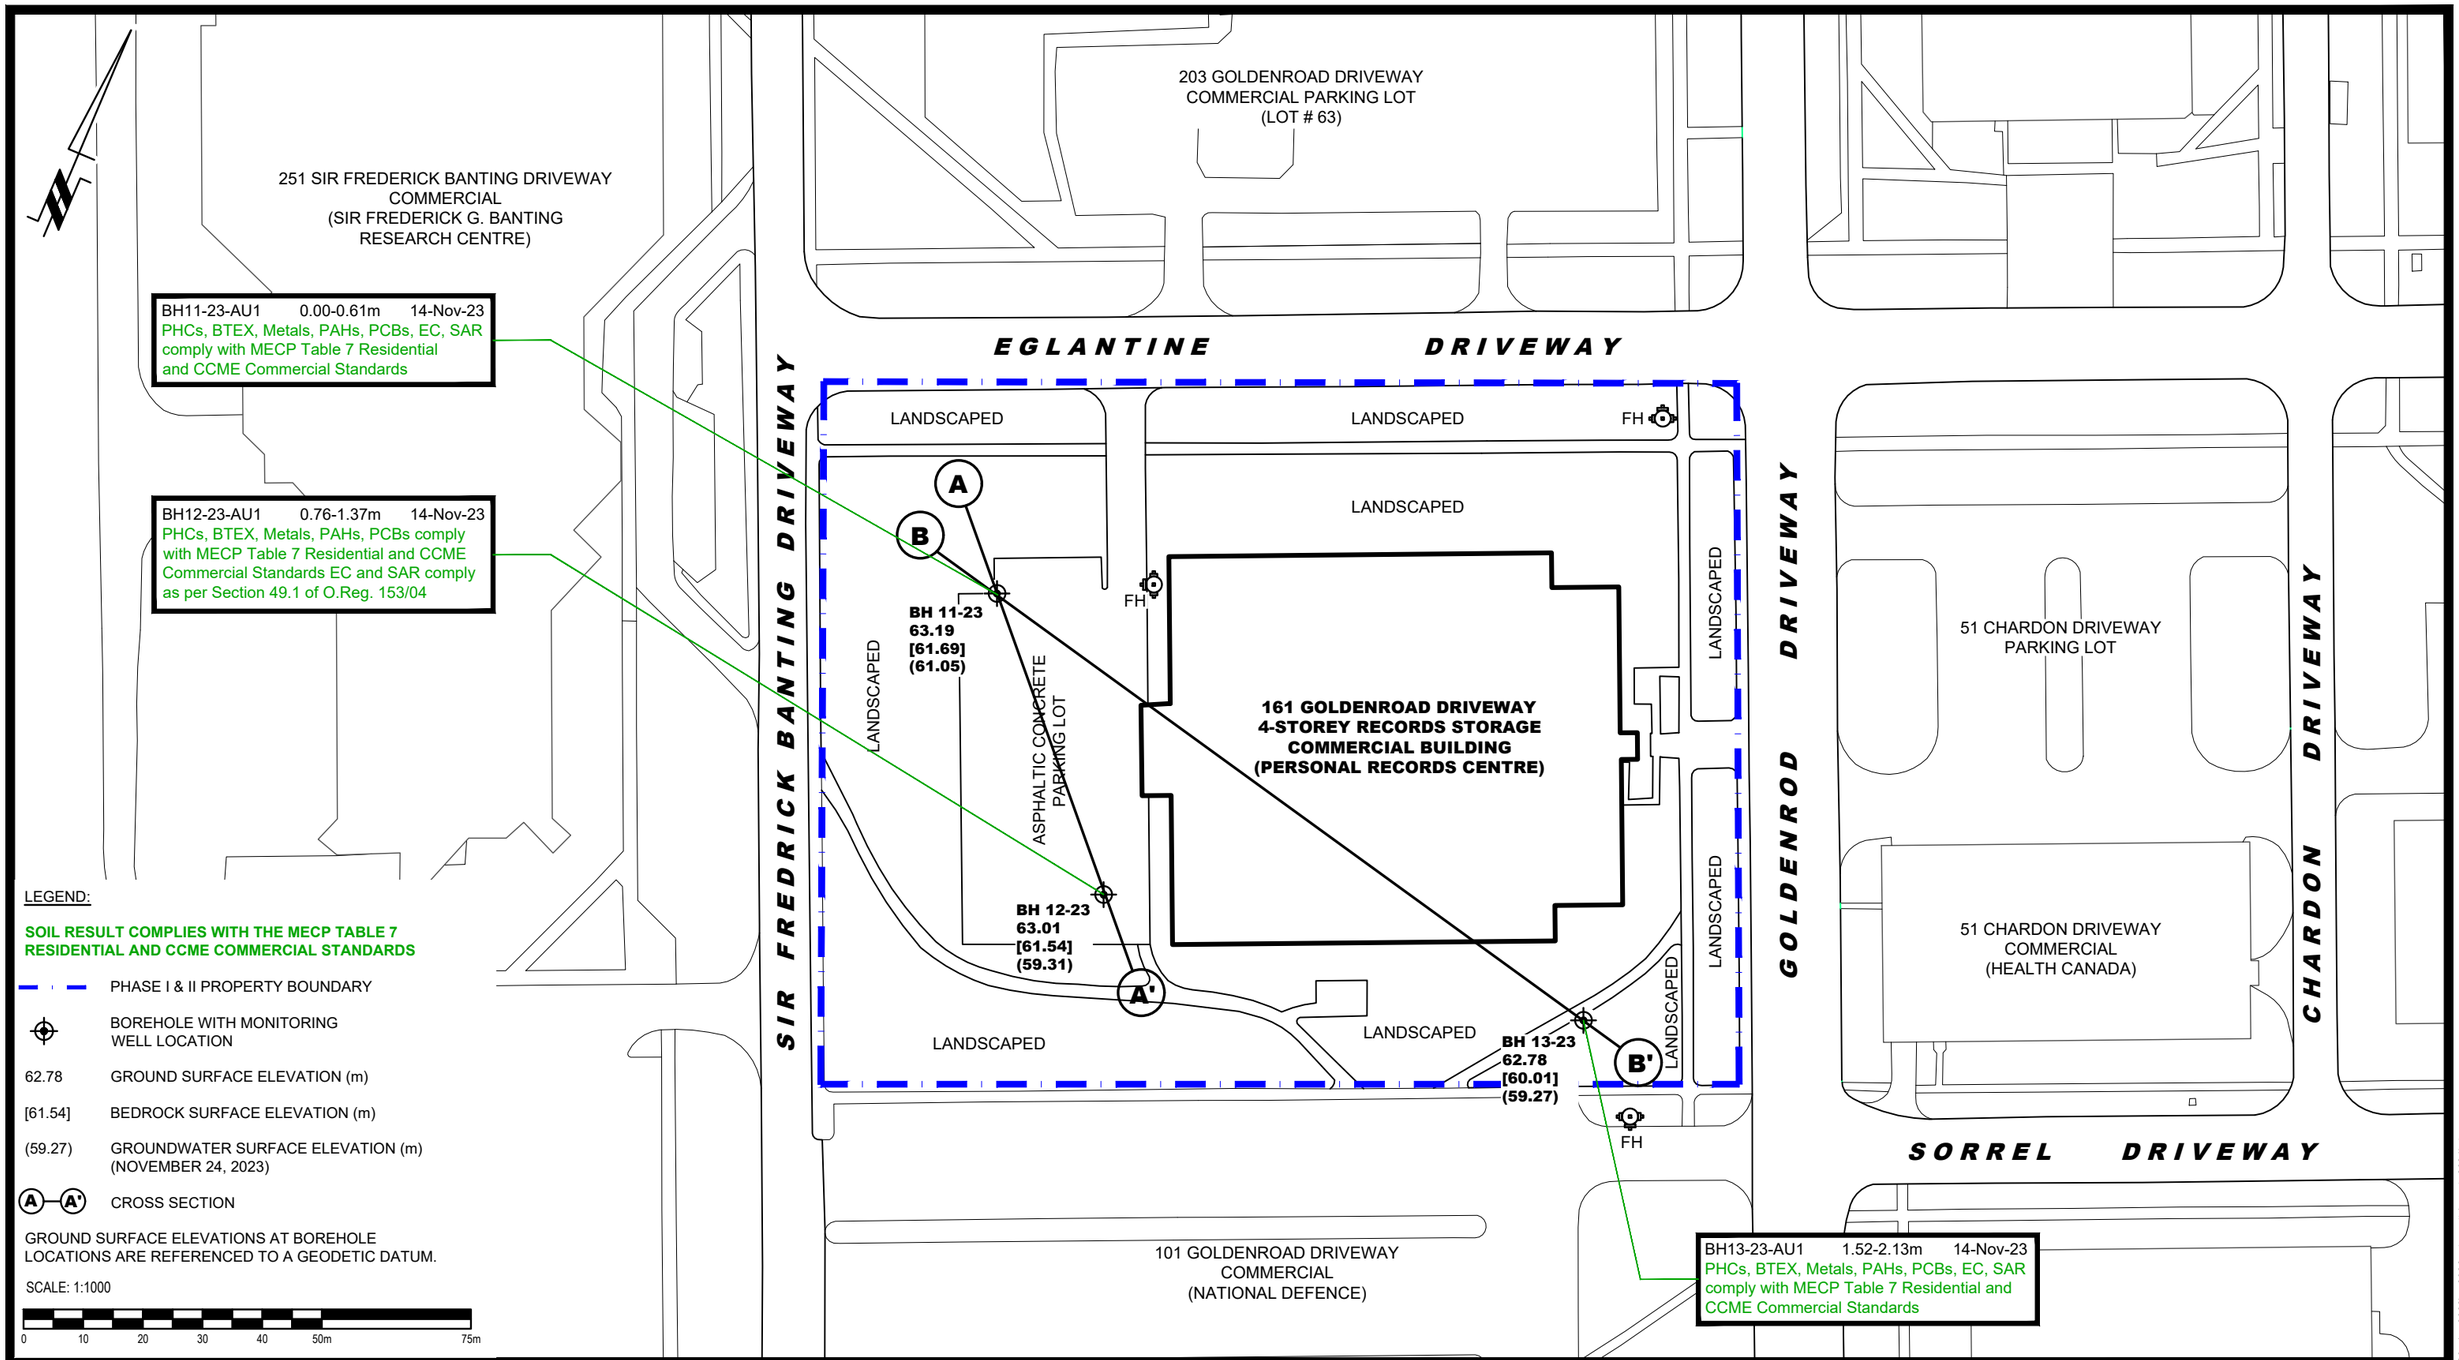
BH11-23-AU1 0.00-0.61m 14-Nov-23
PHCs, BTEX, Metals, PAHs, PCBs, EC, SAR comply with MECP Table 7 Residential and CCME Commercial Standards

BH12-23-AU1 0.76-1.37m 14-Nov-23
PHCs, BTEX, Metals, PAHs, PCBs comply with MECP Table 7 Residential and CCME Commercial Standards EC and SAR comply as per Section 49.1 of O.Reg. 153/04

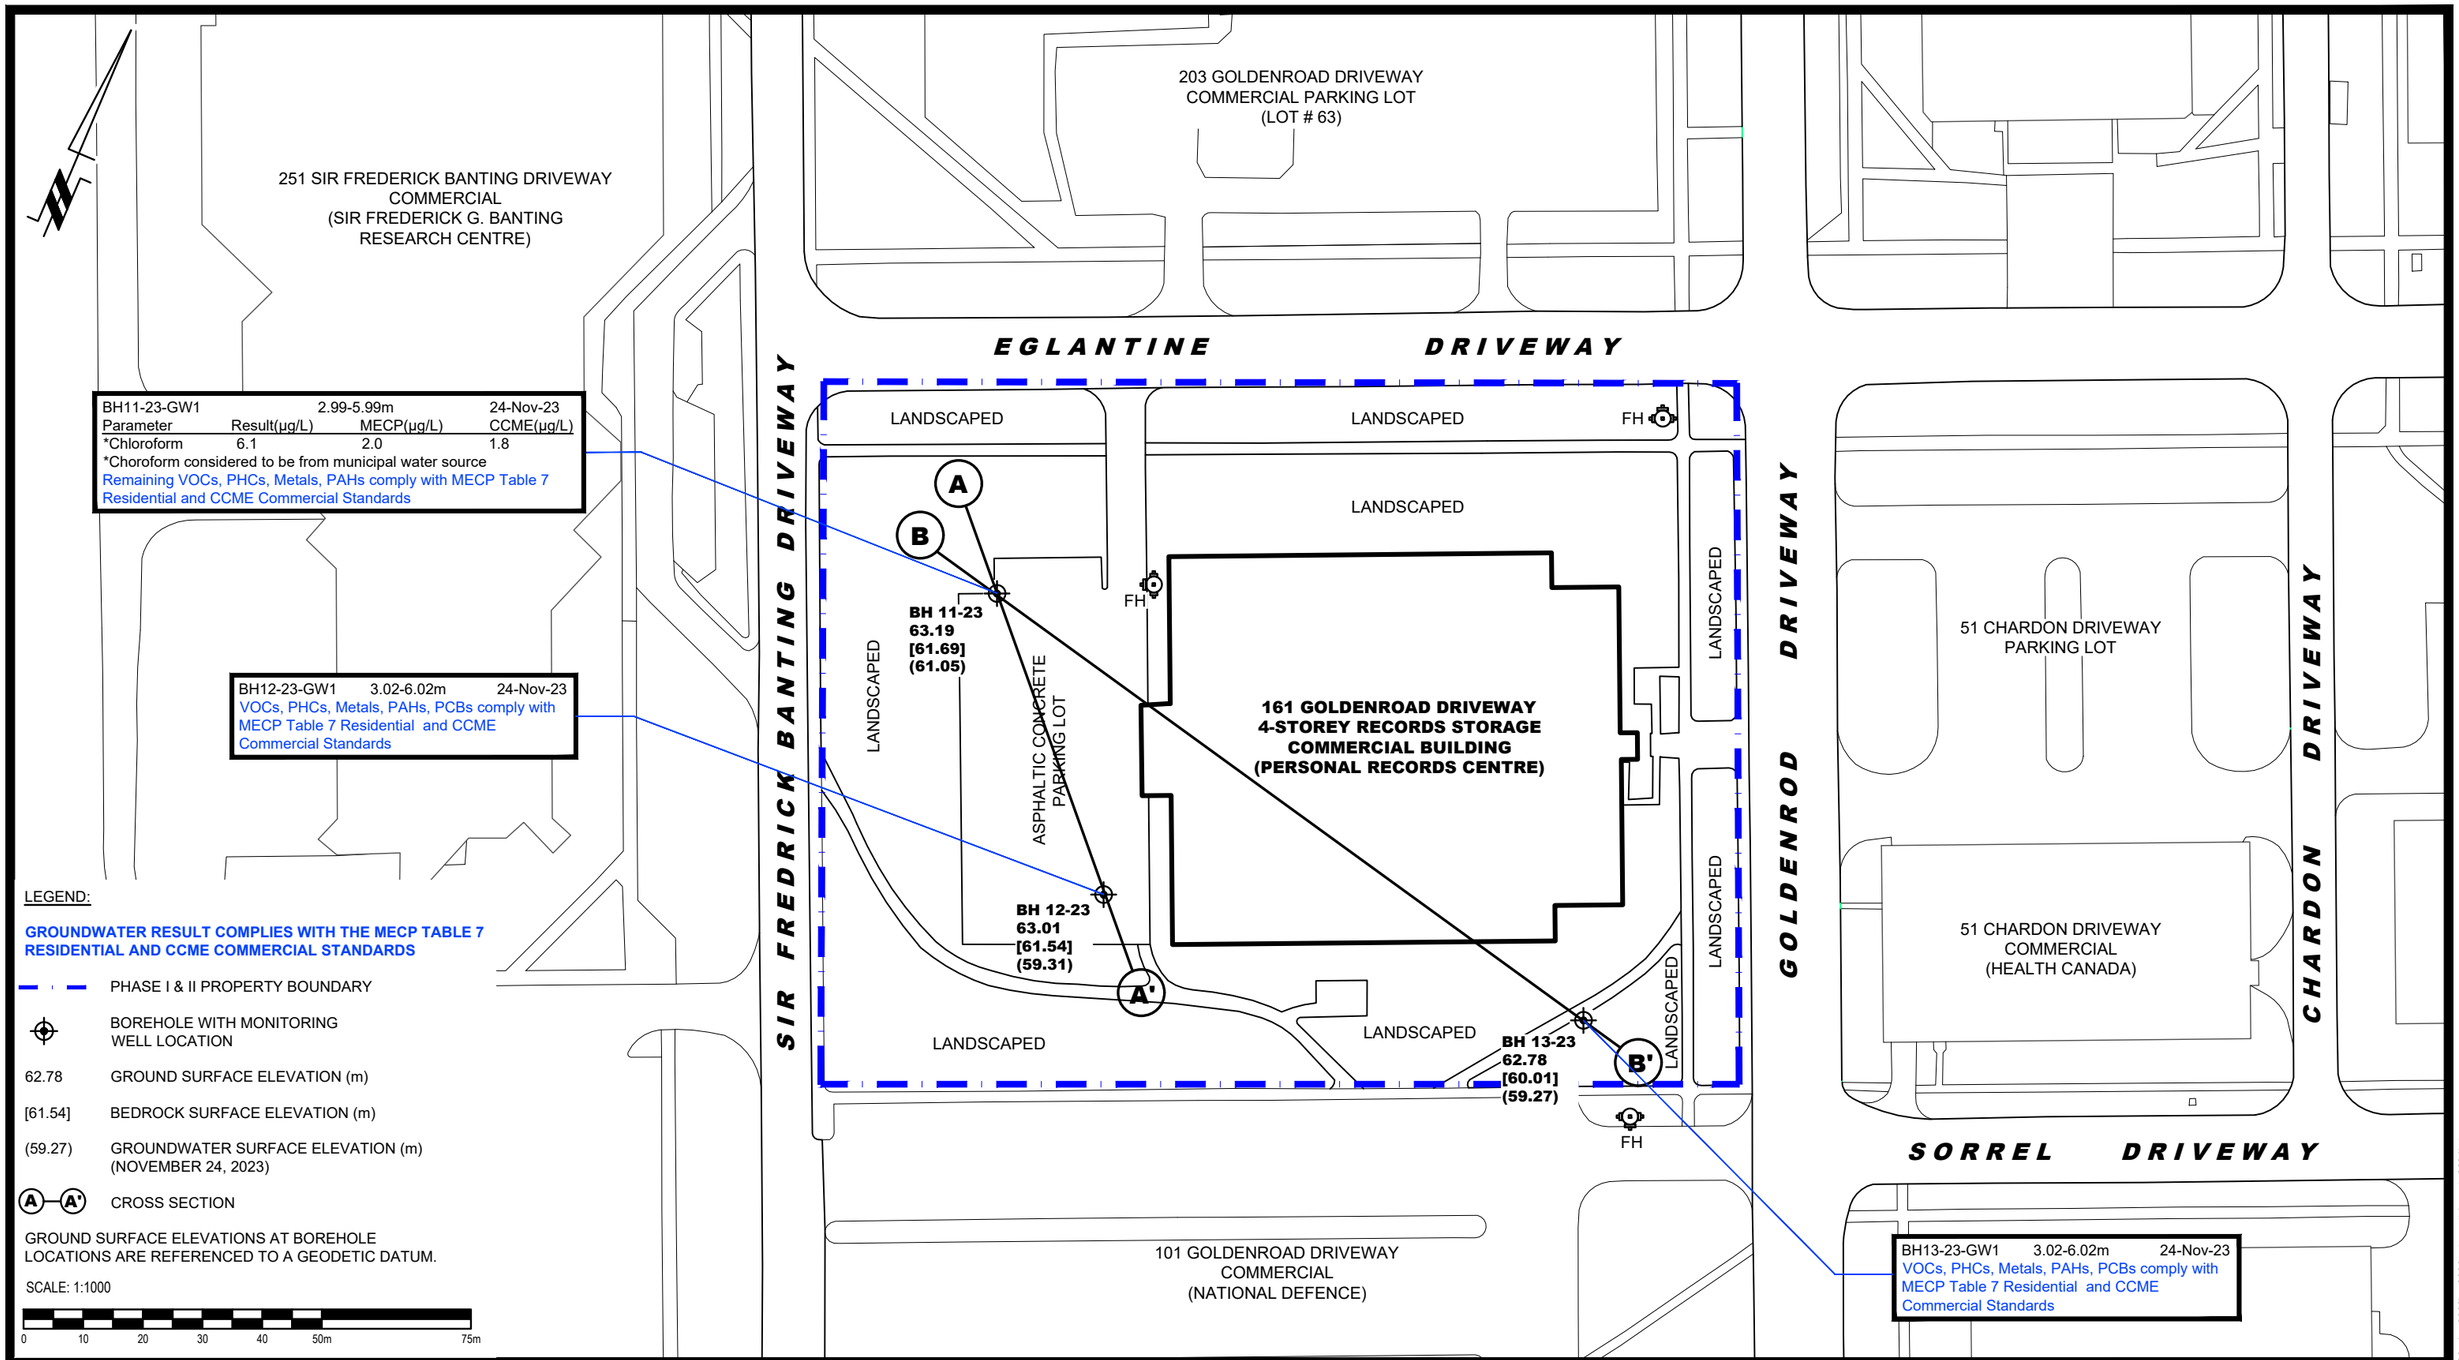
*Choroform considered to be from municipal water source
Remaining VOCs, PHCs, Metals, PAHs comply with MECP Table 7 Residential and CCME Commercial Standards

BH12-23-GW1 3.02-6.02m 24-Nov-23
VOCs, PHCs, Metals, PAHs, PCBs comply with MECP Table 7 Residential and CCME Commercial Standards
