Geotechnical Investigation

Project Name:
Geotechnical Investigation
Proposed Residential Development, 1740-1760 St. Laurent Boulevard
Ottawa, Ontario

Project Number:
OTT-00260579-A0

Date Submitted: 2021.02.02

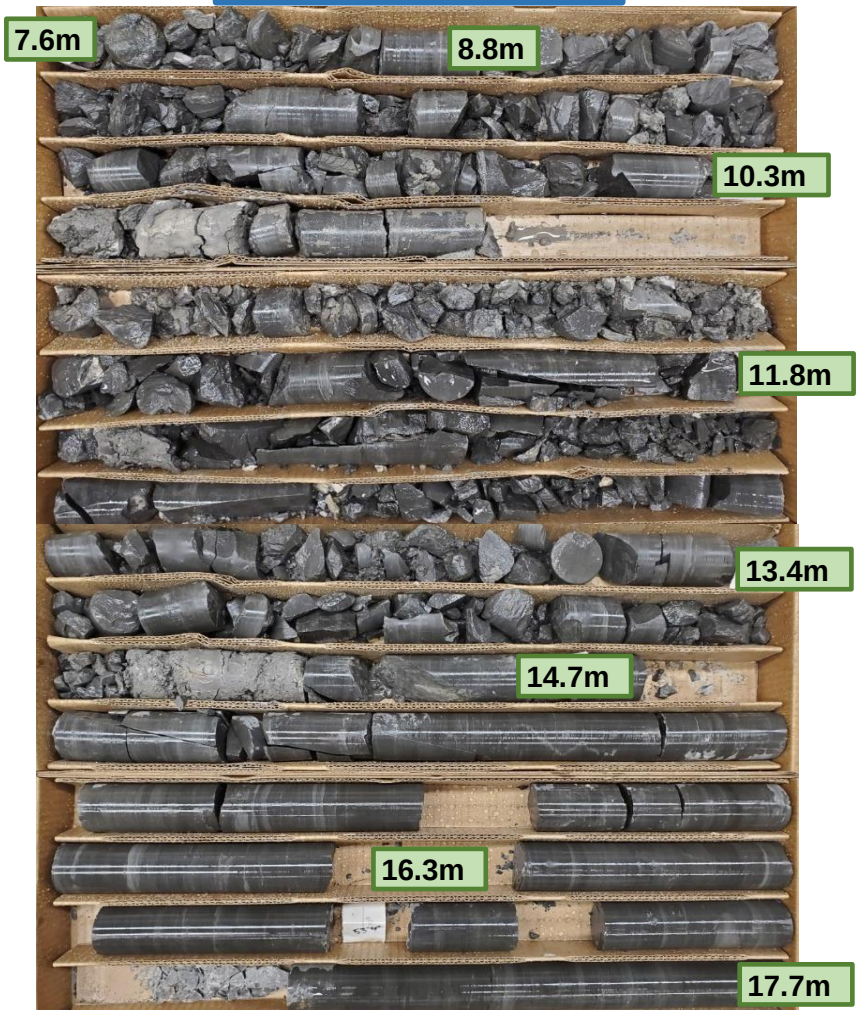
Based on a review of Table IX, the shale bedrock in Borehole No. 20-13 from its surface at a 7.0 m depth (Elevation 64.1 m) to a 14.7 m depth (Elevation 56.4 m) is of a very poor quality and is not considered capable of supporting footings designed for the factored ULS value of 2.0 MPa. It is not known whether there is a fault in this area or this is a localized condition. Therefore, all broken bedrock in the vicinity of this borehole will have to be sub-excavated below the anticipated design footing founding depth of approximately 9.5 m to competent bedrock expected at 14.7 m depth (Elevation 56.4 m) and the excavation backfilled using concrete (with a compressive strength of 25 MPa) to the design founding elevation of the footing and the footing cast on the concrete backfill. The lateral extent of the area requiring this treatment will be best established in the field during construction and should be allowed for as part of the construction budget.
