Geotechnical Investigation - Slope Stability Assessment

2164 Old Prescott Road,
Ottawa, ON

Project No. 121621894

July 2018

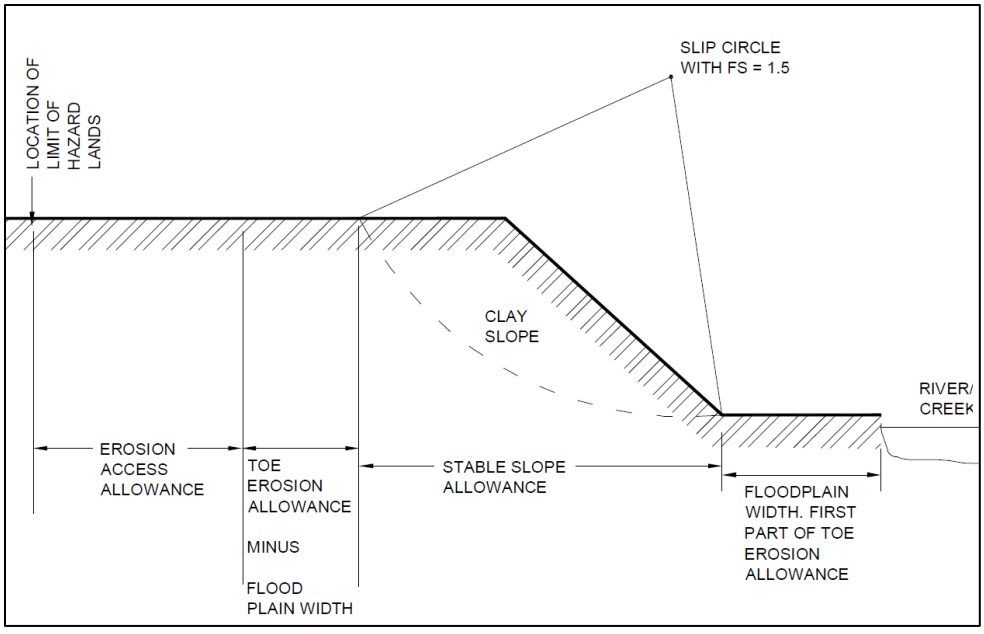
Figure from the City of Ottawa Slope Stability Guidelines displaying the location of the Limit of Hazard Lands

Is a set-back distance which provides room for equipment to access the slope to carry out any future repairs or stabilization treatments. The Access Allowance is typically specified as a 6 m set-back measured away from the Erosion Allowance.

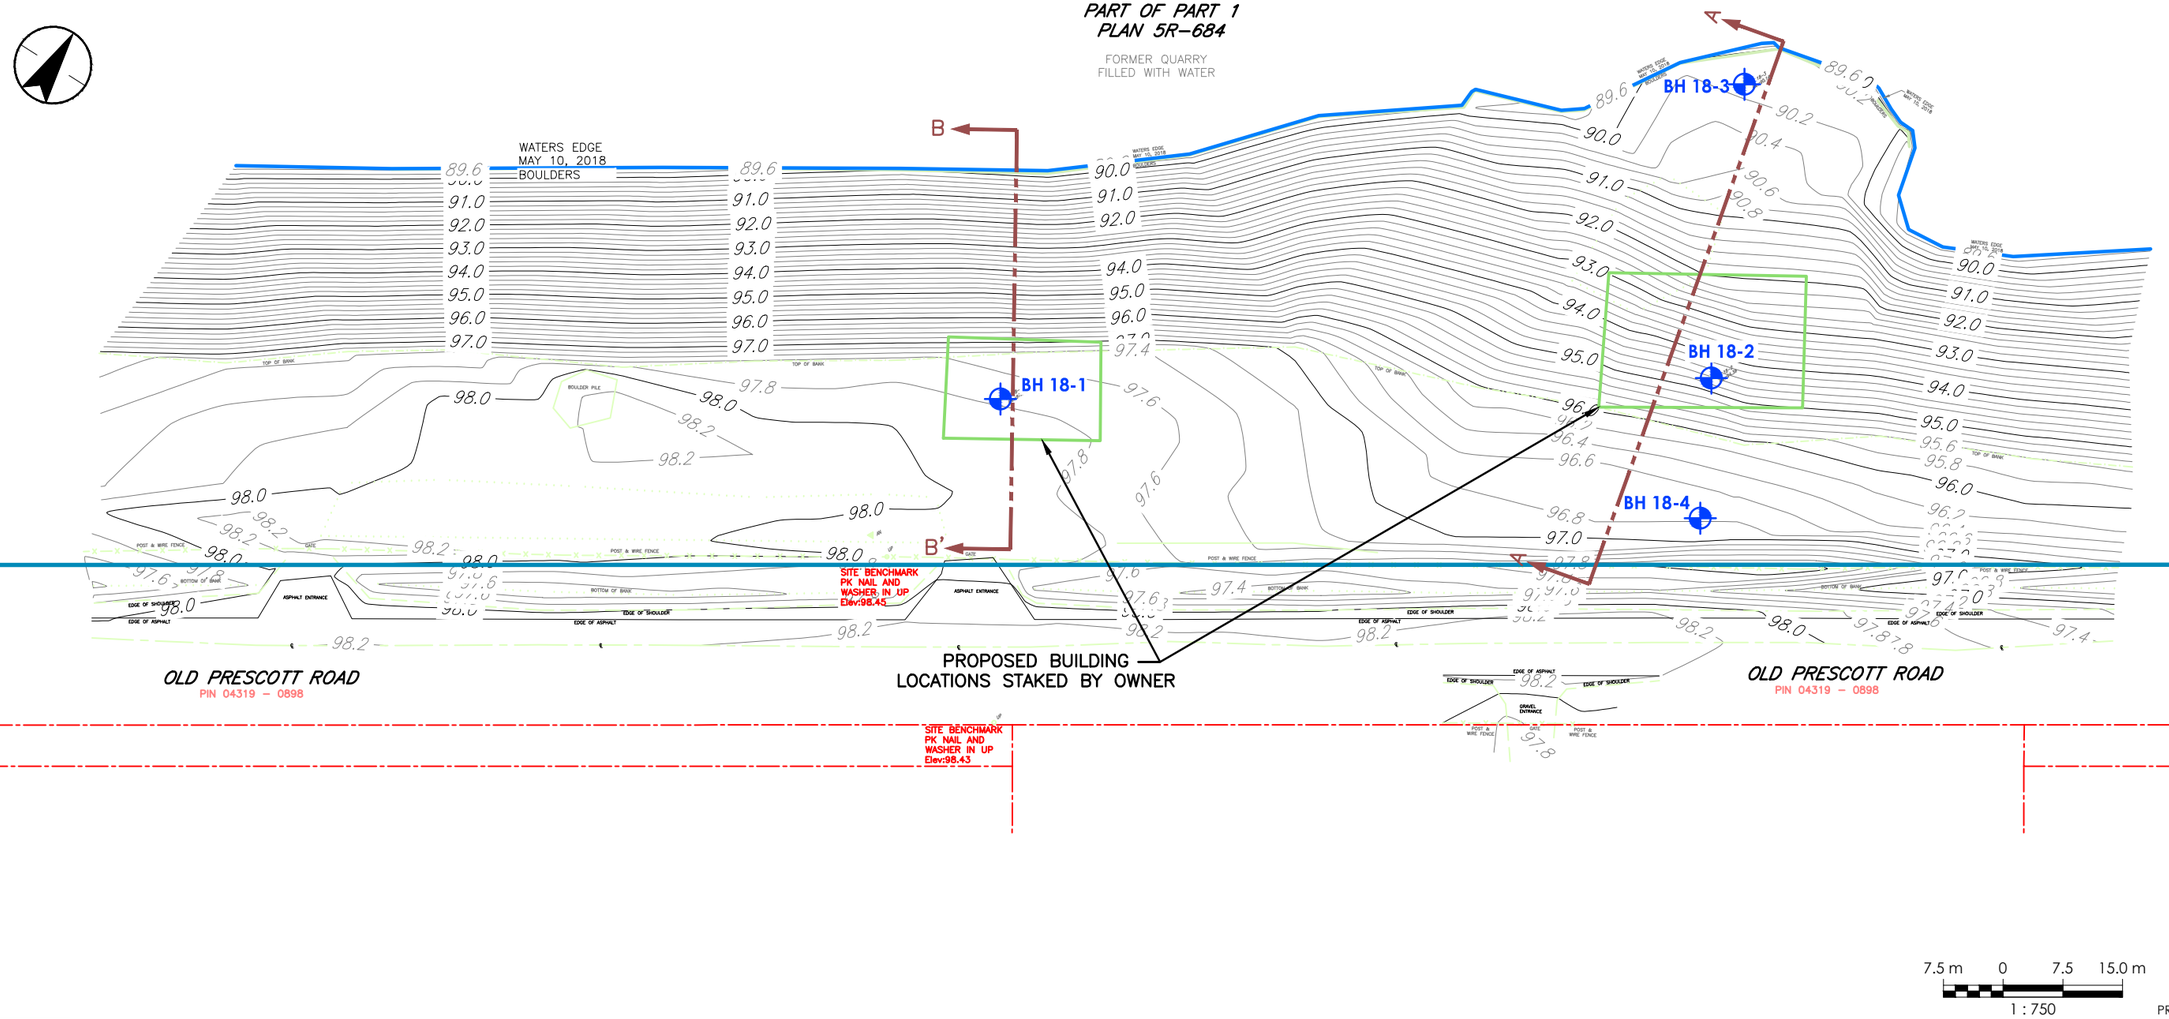
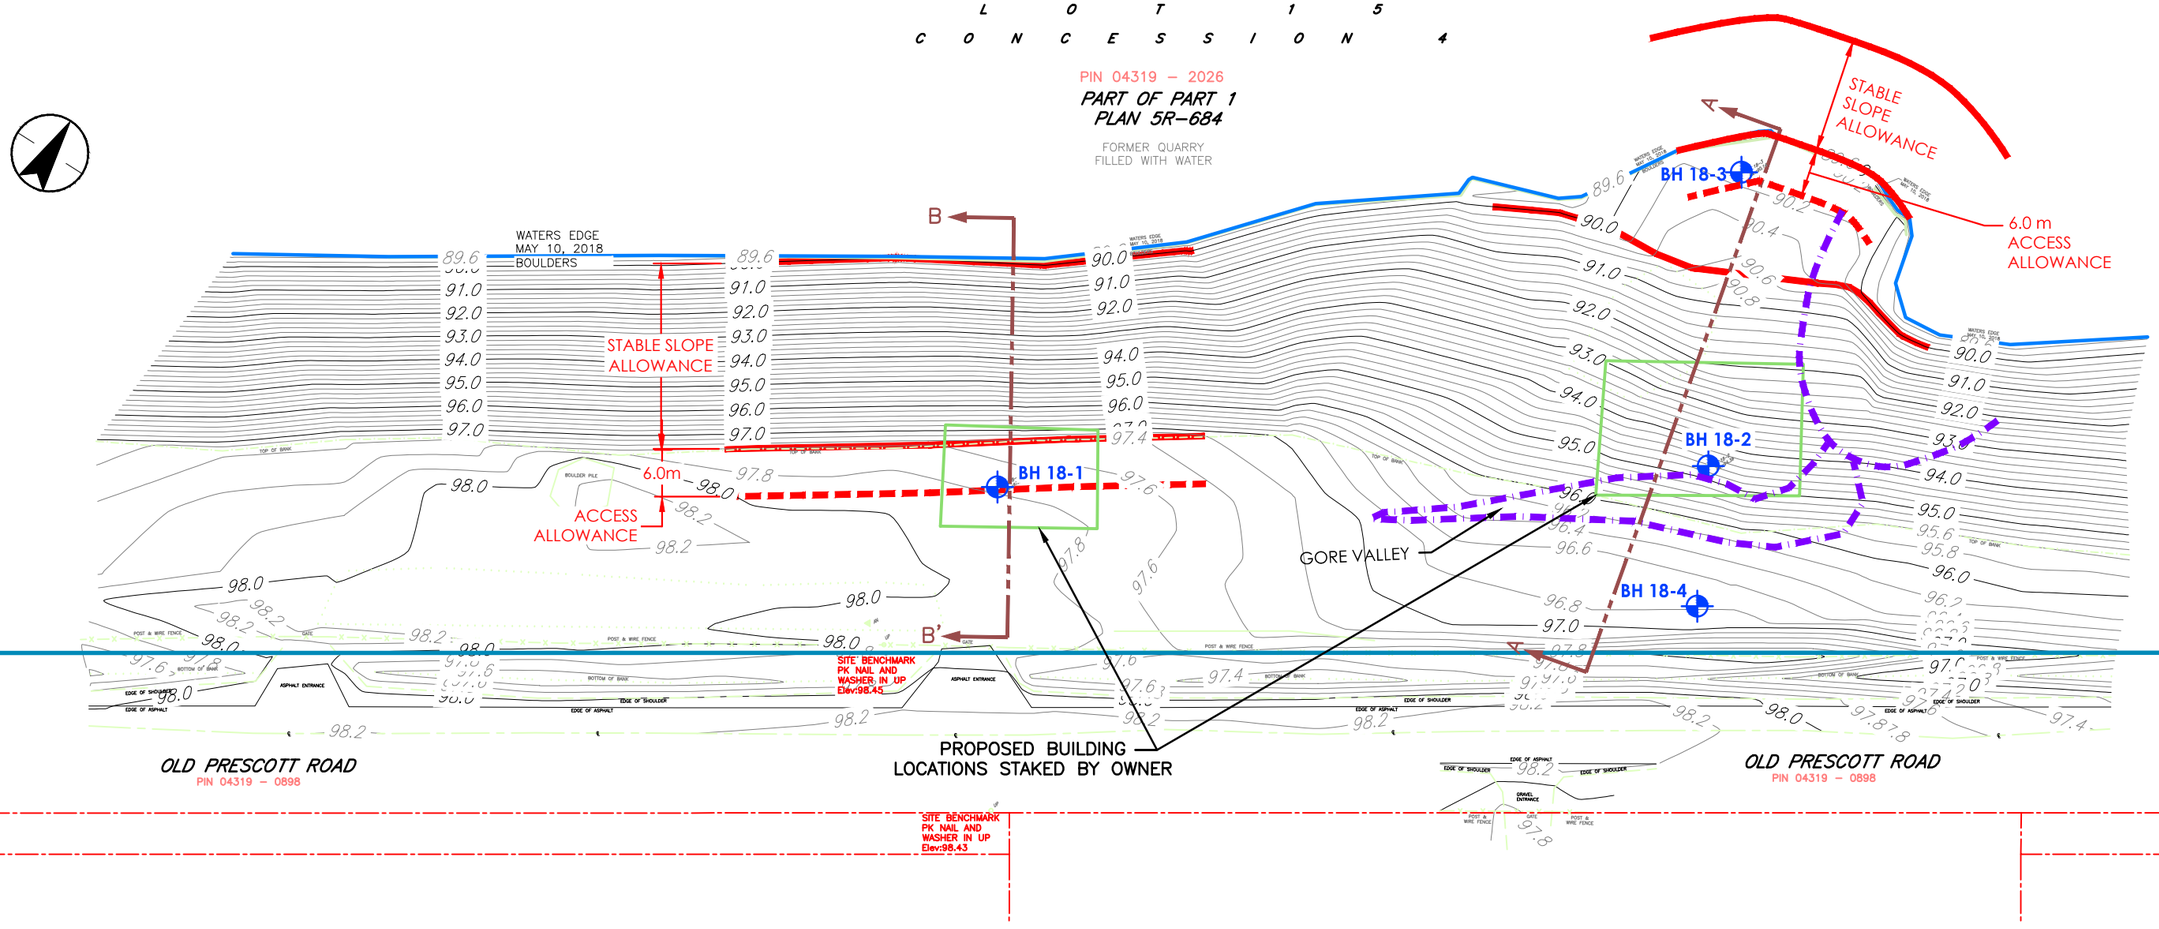
Drawing No. 3 – Limit of Hazard Land

For the sites the Limit of Hazard Land was calculated to be 6 m from the crest of the slip circle. Drawing No. 3 shows the limit. Our analysis indicated that the current footprint of the office is within the recommended Limit of Hazard Land. The building footprint should be relocated to outside the Limit of Hazard Land.

- The building footprints should be located outside of the Slope Stability Limit of Hazard Lands as indicated on Drawing No. 3 in Appendix B.
- The building footprints should also be located away from the previously excavated area where deeper fills are anticipated. Three alternatives are available:

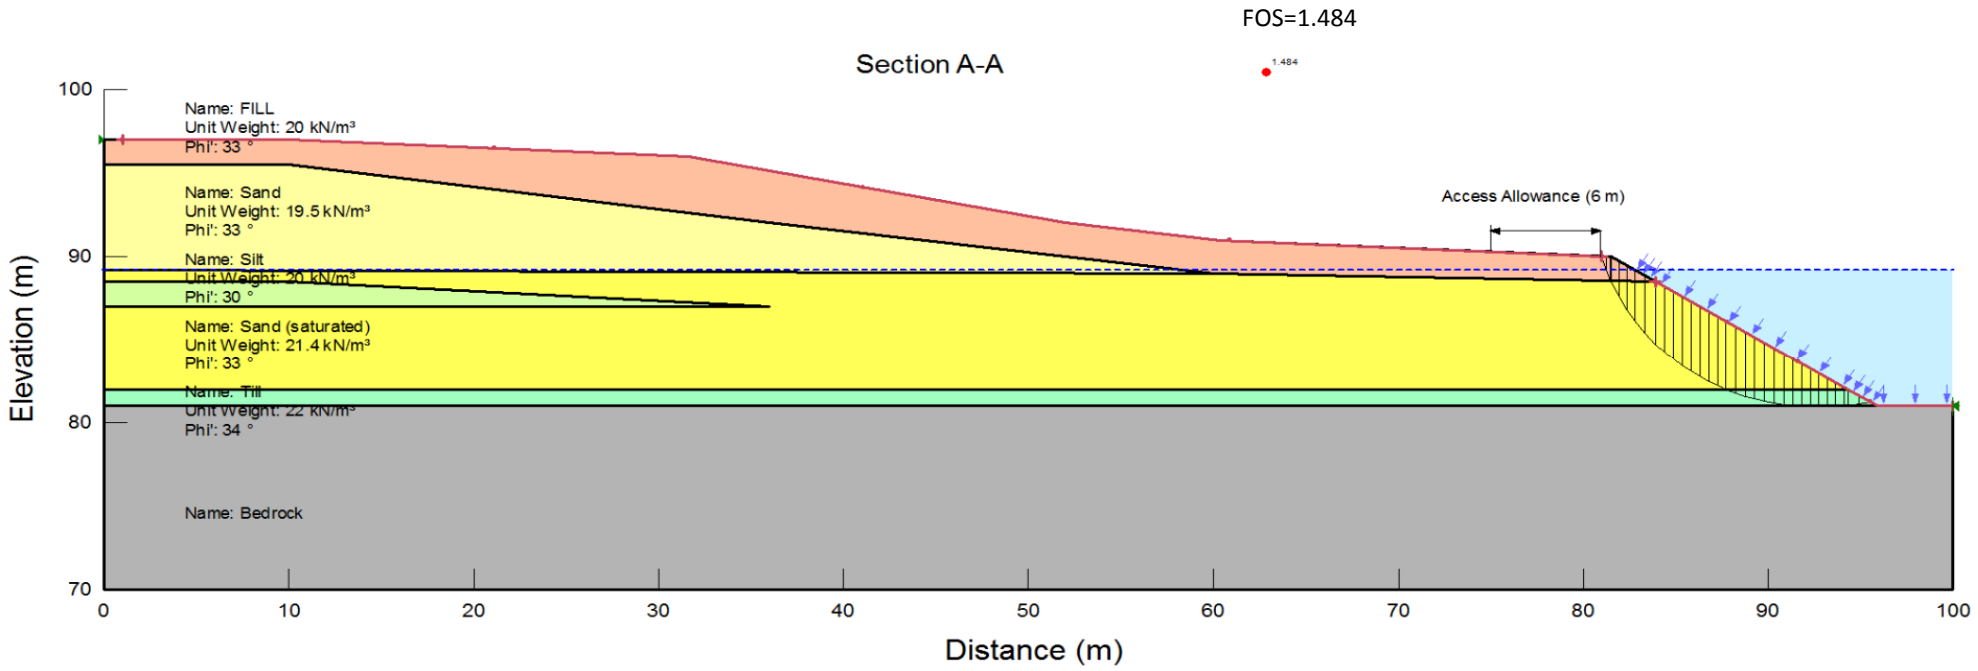
Figure E1

Section	Groundwater Condition	Approximate Side Slope	Static Factor of Safety		Seismic Factor of Safety		Conclusion
			Value	Figure	Value	Figure	
A-A	Existing	5.1H: 1V	1.484	E1	1.136	E2	Unstable
B-B	Existing	2.9H: 1V	1.549	E3	1.044	E4	Unstable

The results of the analysis indicate that the existing slopes at A-A and B-B are unstable. The figures presented in Appendix E show the slip circle with the required factor of safety of 1.5 for static conditions and 1.1 for seismic conditions.

Stantec's site observations and slope stability analysis indicate the proposed buildings should be set back as shown on the Limit of Hazard Land plan provided in Appendix B and discussed below.
