Phase One Environmental Site Assessment
4380 Trail Road, Ottawa, Ontario

Client:
Drain-All Ltd
2705 Stevenage Drive
Ottawa, Ontario

Project Name:
Phase One Environmental Site Assessment

Project Number:
OTT-21023795-A0

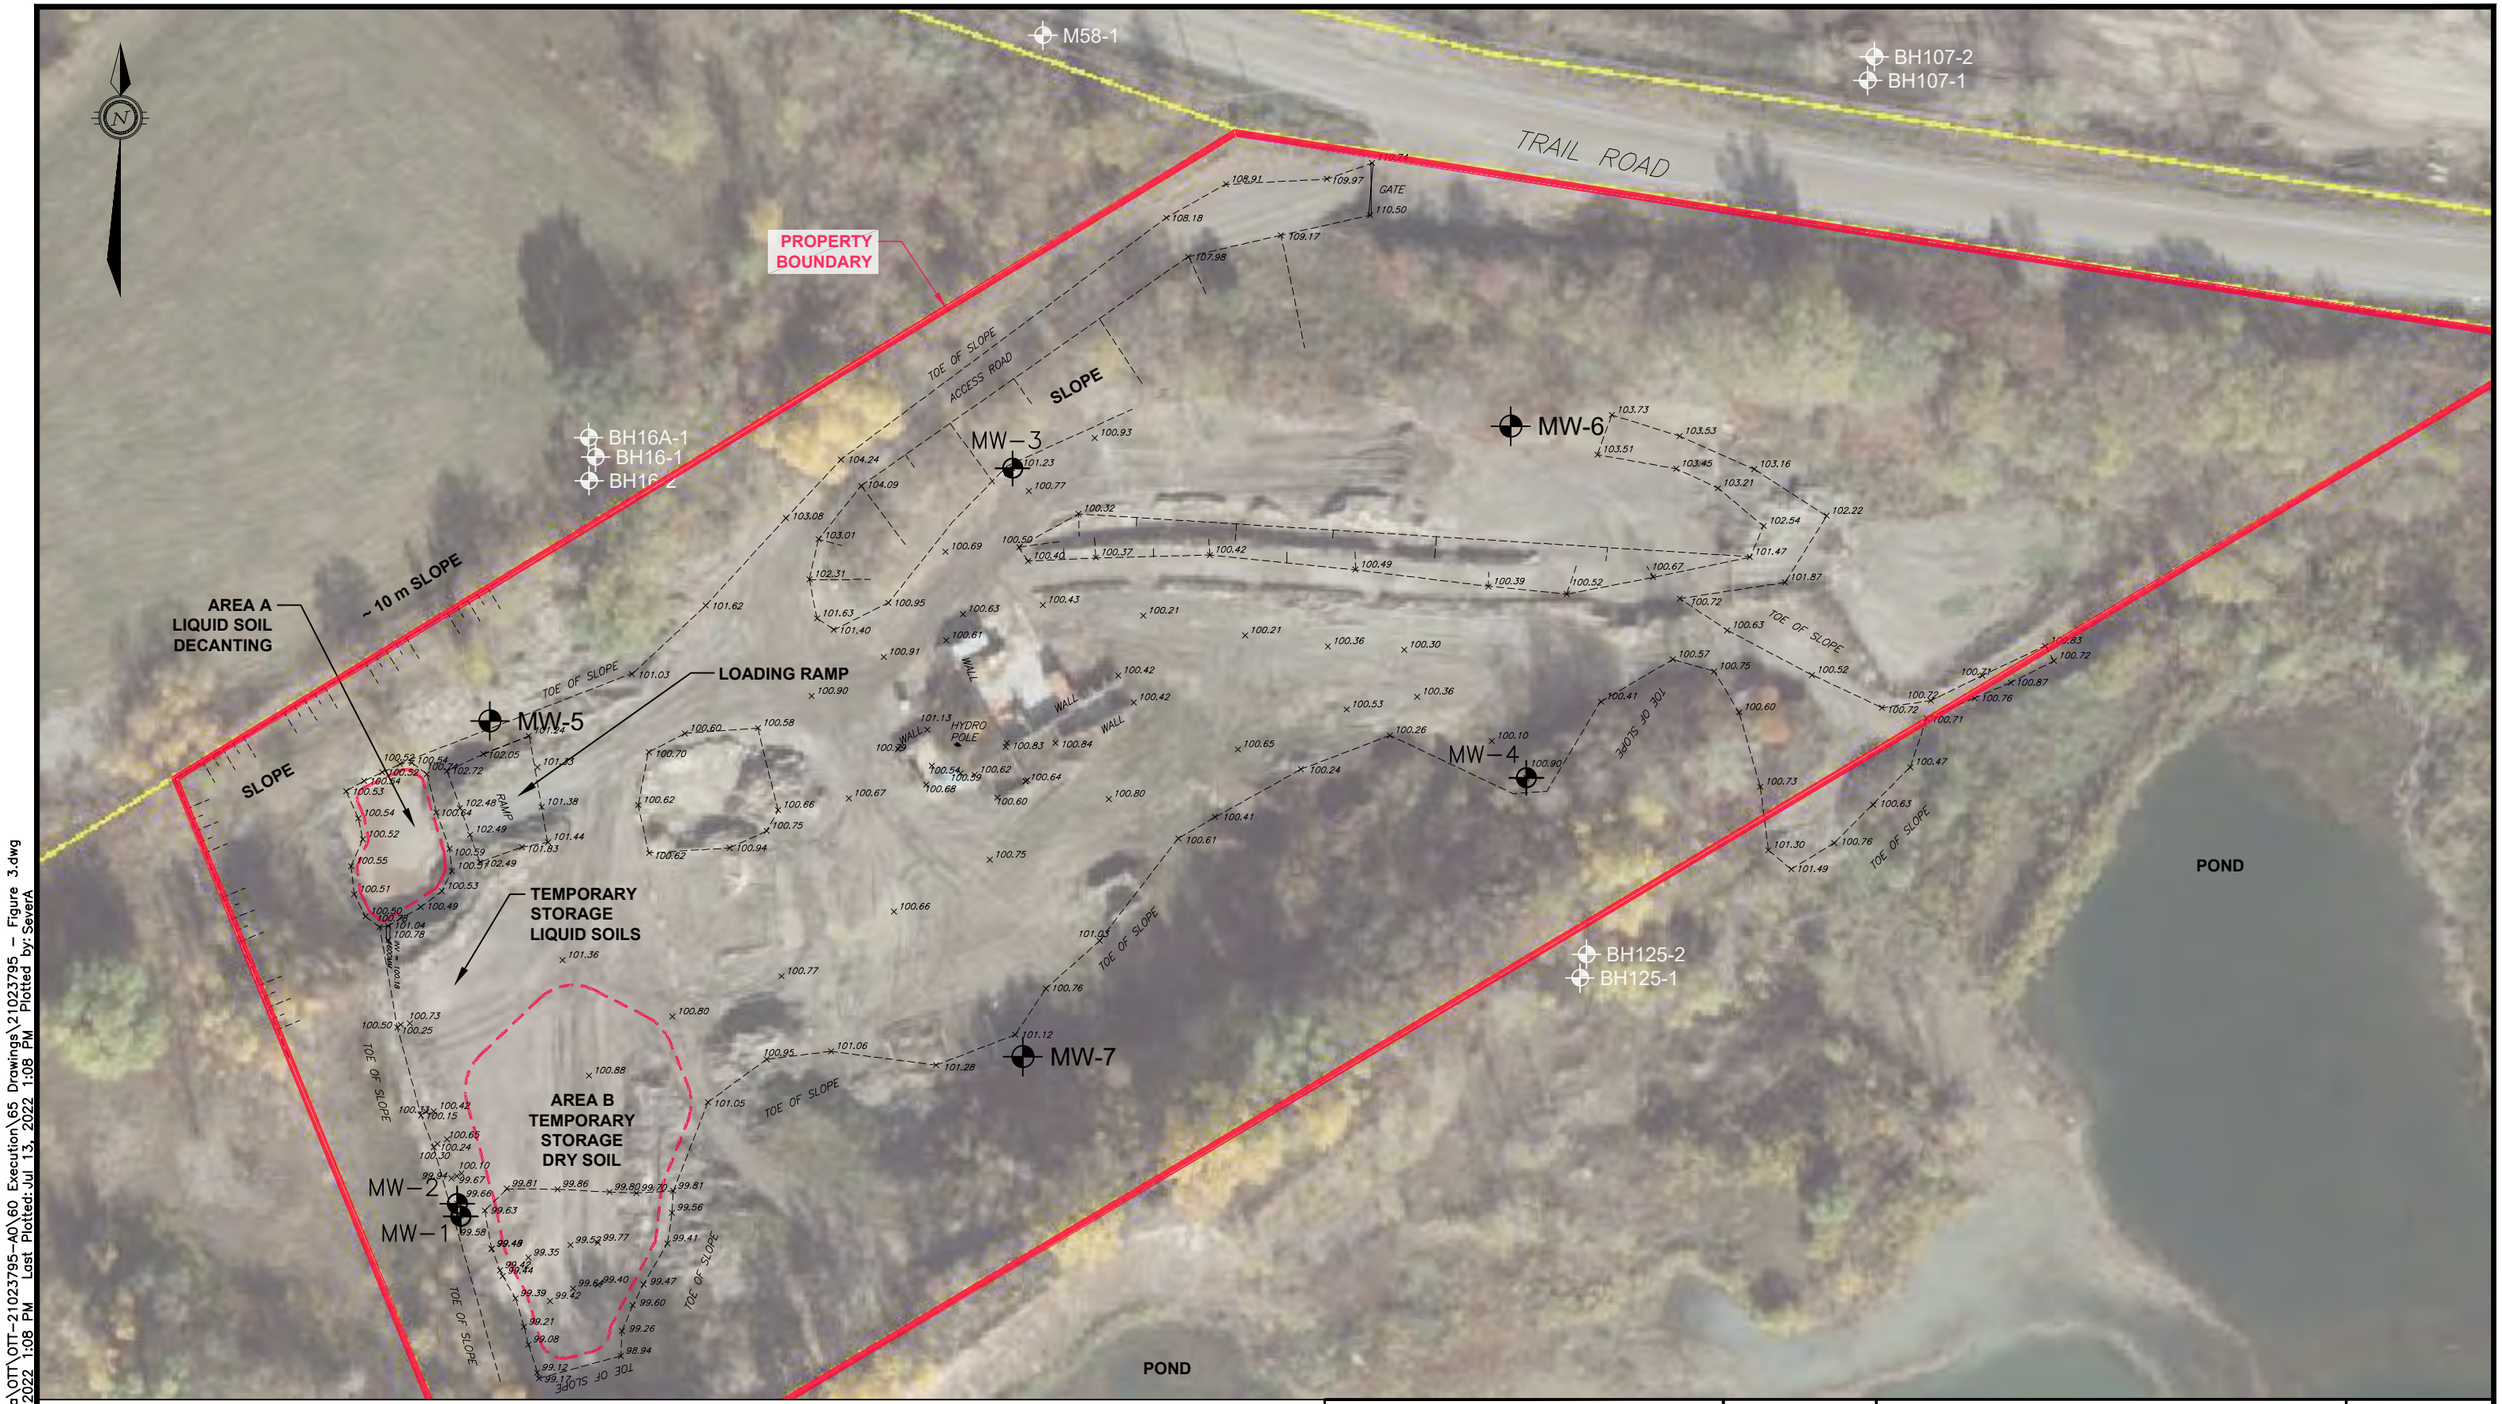
FIG 2

There are two areas where soil is stored on the Phase One property. Incoming excess soil is initially placed in either Zone A for liquid soils (for decanting) or Zone B for dry soils, shown on Figure 2. The soil is then sampled and analyzed for various parameters to confirm suitability for final placement on the Phase One property.

There are seven monitoring wells present on the Site. Two monitoring wells (P-1/MW-1 and P-2/MW-2) were installed as part of the Nepean Landfill monitoring program, two monitoring wells (MW-3 and MW-4) were installed prior to Drain-All's acquisition of the Phase One property but have not been involved in previous landfill monitoring programs, and three monitoring wells (MW-5, MW-6, and MW-7) were installed on the Phase One property in May 2022 as part of a new groundwater monitoring program at the Phase One property. The monitoring wells are shown on Figure 2.

To develop a conceptual model for the Phase One property, the following physical characteristics and pathways were considered. A conceptual site model (CSM) showing the topography of the site, inferred groundwater flow, general site features, APEC, and PCA is shown in Figure 2.
