FINAL REPORT

Phase Two Environmental Site Assessment

30 Cleary Avenue, Ottawa Ontario

CA0008376.9447-Rev0

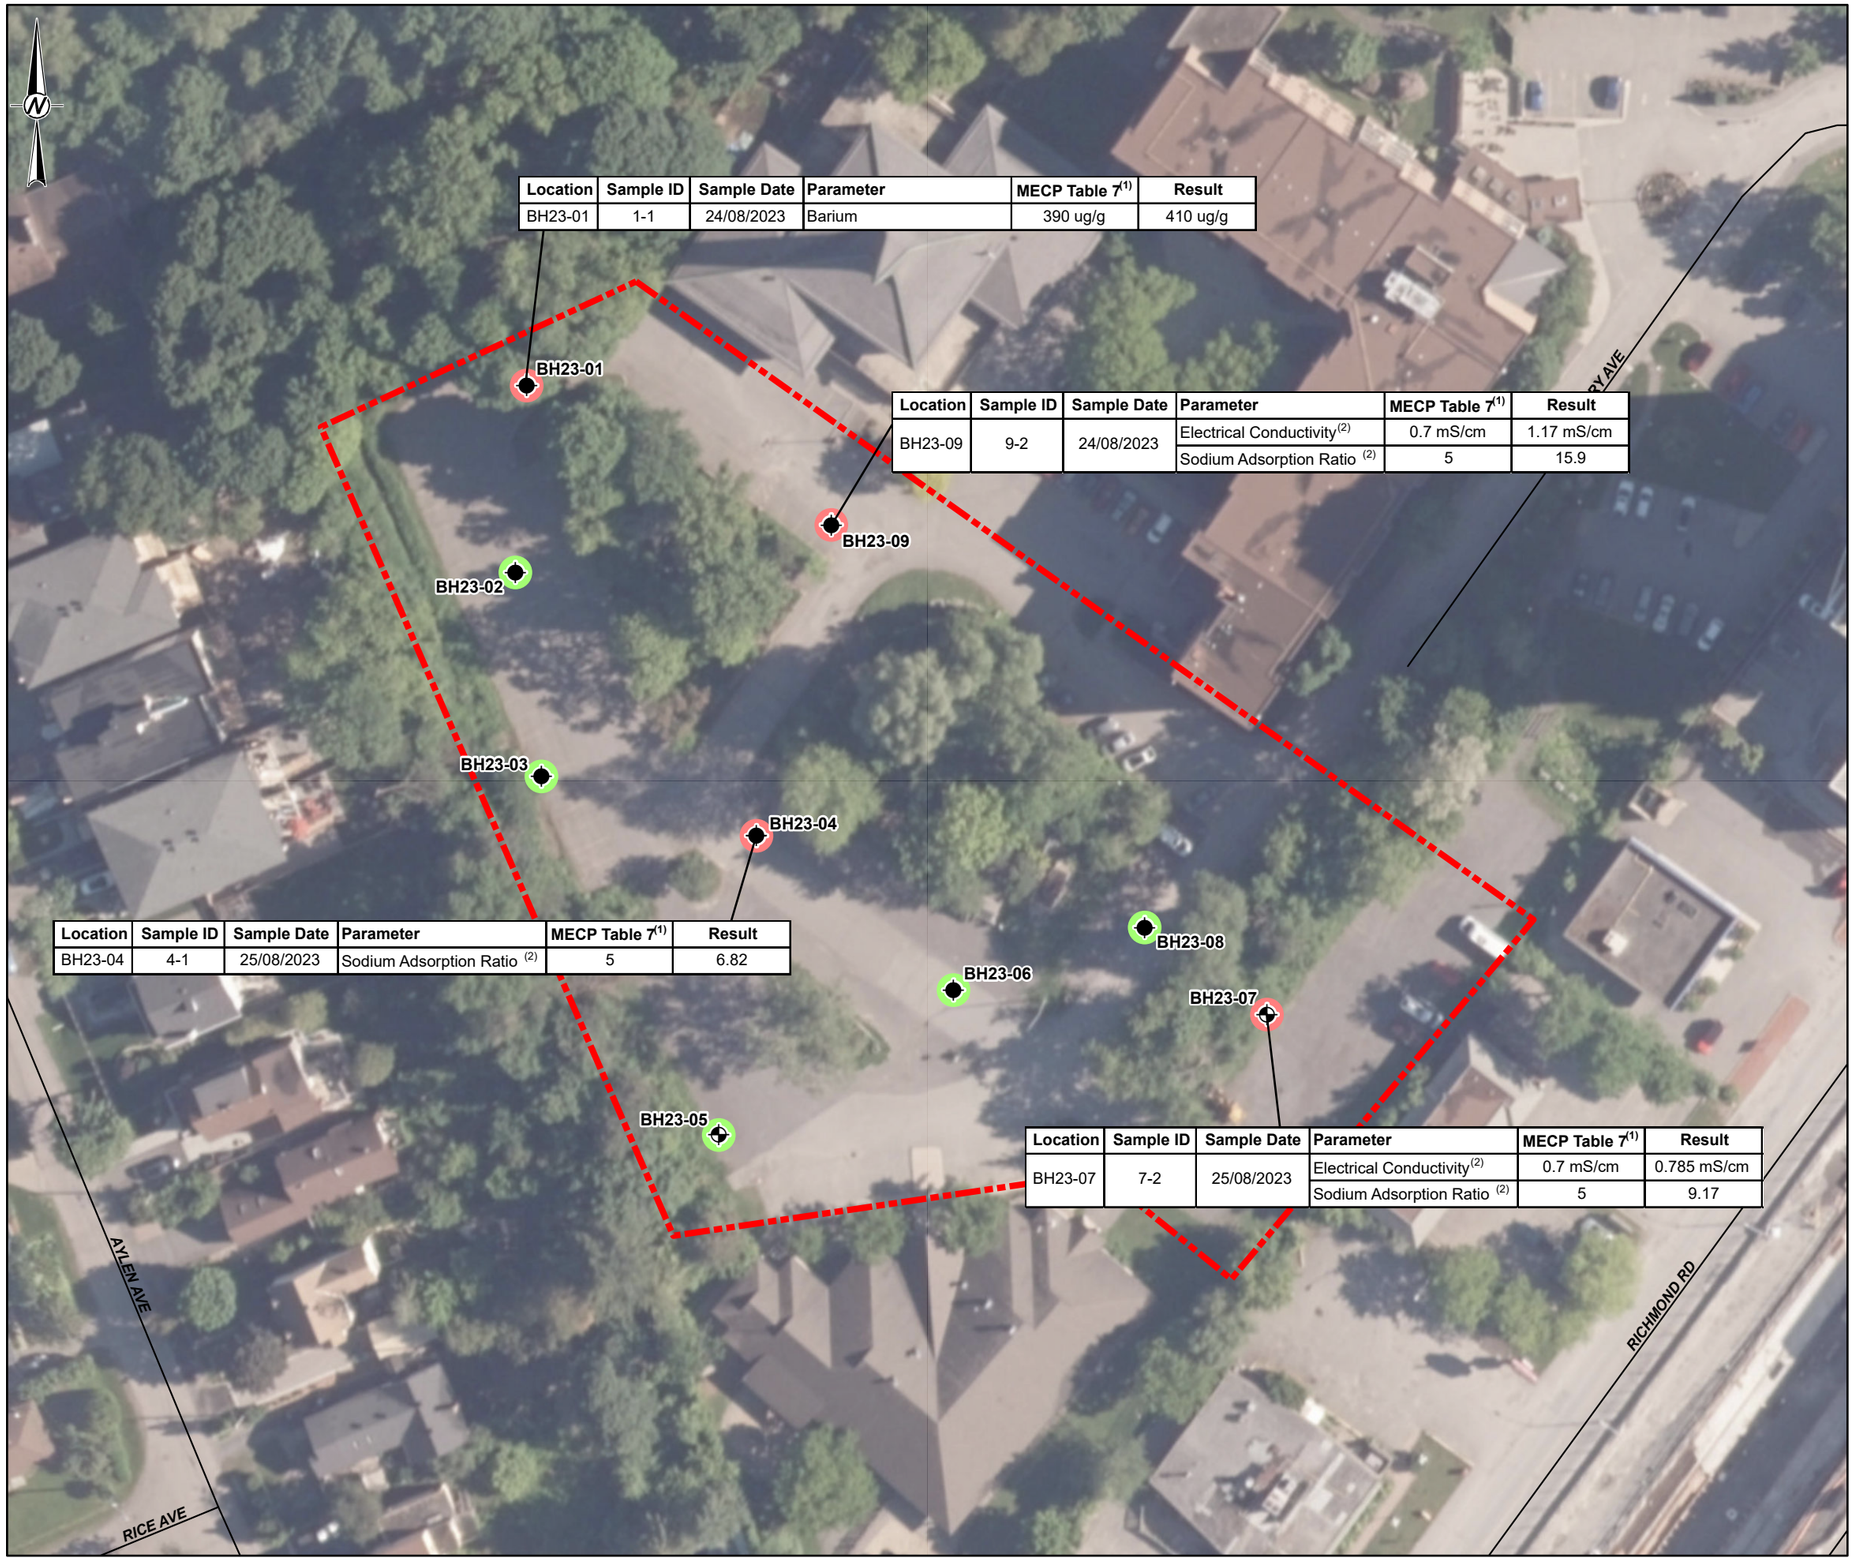
PROJECT NO.	CONTROL	REV.	FIGURE
CA0008376.9447	0003	0	5

Location	Sample ID	Sample Date	Parameter	MECP Table 7[1]	Result
BH23-01	1-1	24/08/2023	Barium	390 ug/g	410 ug/g

Location	Sample ID	Sample Date	Parameter	MECP Table 7[1]	Result
BH23-09	9-2	24/08/2023	Electrical Conductivity[2]	0.7 mS/cm	1.17 mS/cm
			Sodium Adsorption Ratio [2]	5	15.9
