FINAL Baseline Property Condition Assessment

151 Metcalfe Street, Ottawa,
Ontario

January 26, 2016

Pinchin File: 111978

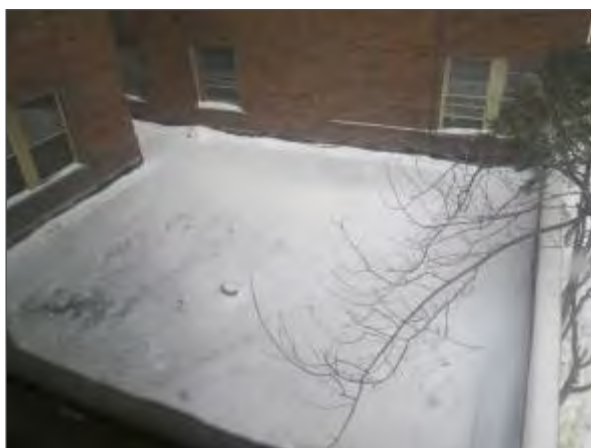
View of the snow covered roof system atop the UPG roof on the south portion of the building.

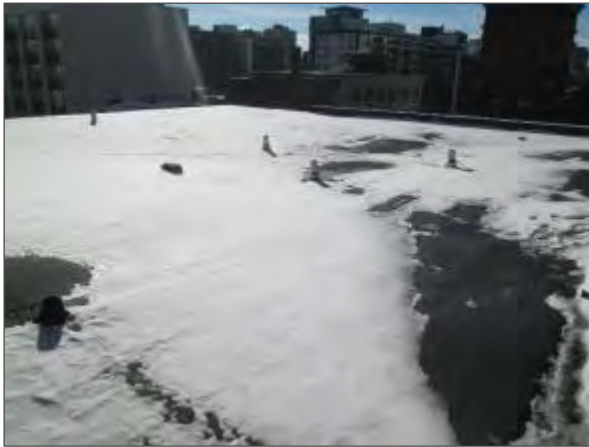
Findings	Remarks/Recommendations
<p>Major Deficiencies/Deterioration</p> <ul style="list-style-type: none"> Based on observations of the visible areas of the roof systems and the number of patch replacements observed, it is Pinchin's opinion that the roof systems have reached or exceeded their PUL. 	<ul style="list-style-type: none"> Pinchin has carried allowances for the replacement of the roof systems within the early portion of the term of the analysis.
<p>Minor Deficiencies/Deterioration</p> <ul style="list-style-type: none"> Cracking and deterioration was observed in the mop-on membrane atop the north portion of the UPG roof. 	<ul style="list-style-type: none"> Replace the mop-on membranes atop the roof decks of the UPG on the north and south portions of the building.
<ul style="list-style-type: none"> The various membranes atop the main roof system were noted to be deteriorated. 	<ul style="list-style-type: none"> Pinchin has included allowances to replace the main roof system within the early portion of the term.

View of a portion of the main roof system atop the fourth floor of the building.

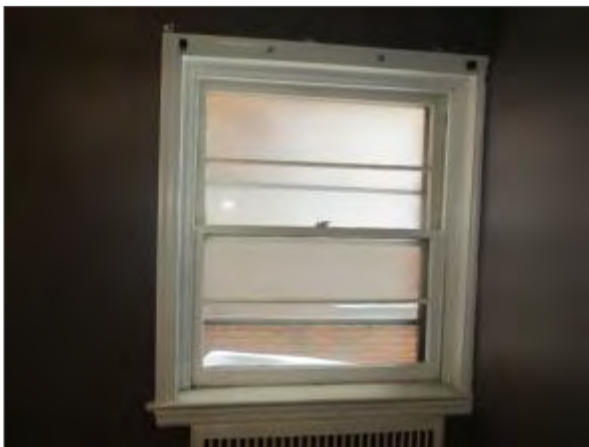
View of a typical older wood framed window serving the majority of the building.

- Immediate repairs of the loose brick masonry units on the south and west elevations;
- Repairs to the brick masonry walls as noted in the report;
- Consideration for the replacement of the older wood framed windows serving the building;

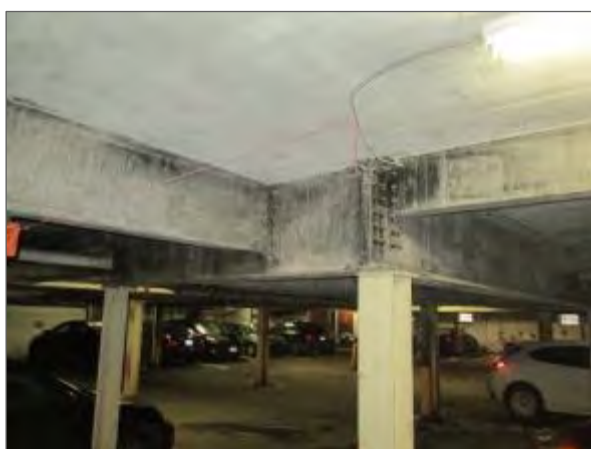
Findings	Remarks/Recommendations
<p>Major Deficiencies/Deterioration</p> <ul style="list-style-type: none"> Severe corrosion was noted at the base of the majority of the columns within the UPG. These columns support the steel beams which support the center portion of the building. 	<ul style="list-style-type: none"> Based on the advanced levels of corrosion, Pinchin recommends that these columns be inspected by a structural engineer to determine the requirements and associated costs with repairing these columns. Pinchin has included allowances for a structural review. It should be noted that cost estimates for repairs can only be determined by the findings of the structural investigation.
<p>Minor Deficiencies/Deterioration</p> <ul style="list-style-type: none"> Corrosion was observed on several steel beams in the basement areas of the building. 	<ul style="list-style-type: none"> These steel beams should be inspected as part of the structural investigation, however the corrosion appears to only be surface corrosion which could likely be removed and the steel beams refinished.

View of the steel beams and columns located in the UPG of the building which support the central portion of the building.

- A structural investigation of the corroded steel elements within the UPG and basement of the building to determine the appropriate method of repair and anticipated costs involved;

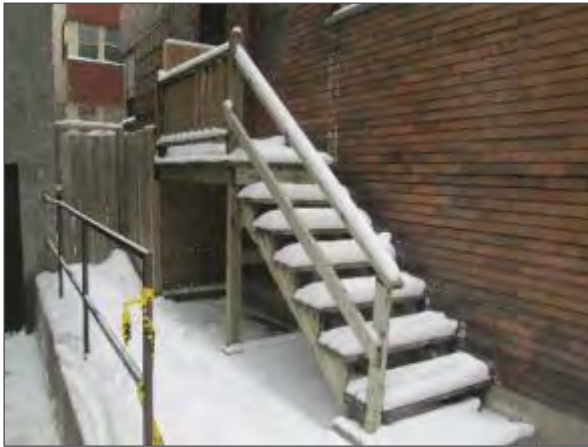
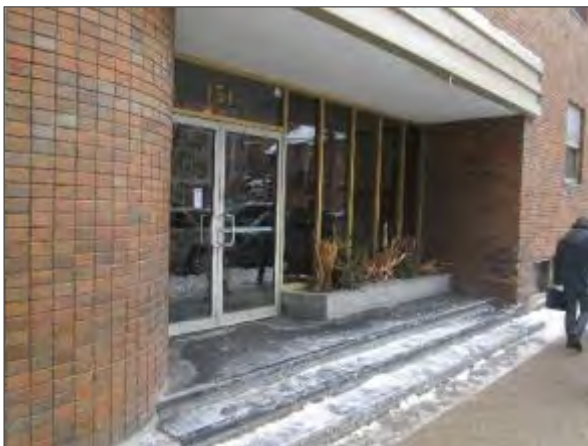
It should be noted that due to snow and ice covered conditions a thorough assessment of the Site features was not possible at the time of the Site visit. Pinchin recommends that the Site features be re-inspected when the weather permits. Pinchin also recommends that regular annual maintenance of the Site features be carried throughout the term of the analysis. Assessment of or comment upon concealed deficiencies and any buried/concealed utilities or components are outside the scope of work.

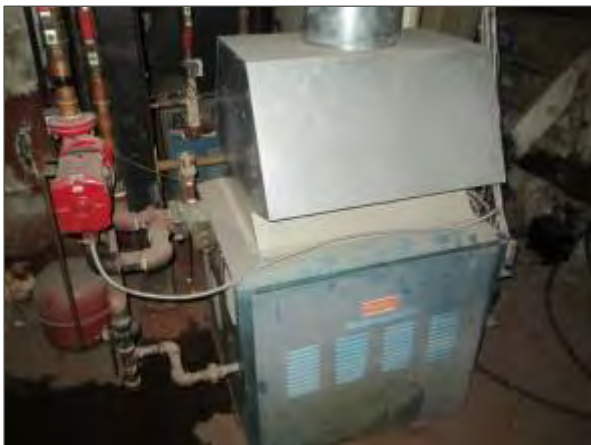
Findings	Remarks/Recommendations
Major Deficiencies/Deterioration <ul style="list-style-type: none">• None observed.	<ul style="list-style-type: none">• None required.
Minor Deficiencies/Deterioration <ul style="list-style-type: none">• The two heating boilers are approximately 25 years old and will exceed their PUL within the early portion of the term of the analysis.	<ul style="list-style-type: none">• Pinchin has carried allowances to replace the heating boilers in the early portion of the term of the analysis.
<ul style="list-style-type: none">• The DHW boiler is approximately 19 years old and will exceed its PUL in the mid-portion of the term of the analysis.	<ul style="list-style-type: none">• Pinchin has carried allowances to replace the DHW boiler in the mid-portion of the term of the analysis.
<ul style="list-style-type: none">• The DHW storage tanks are approximately 13 years old and will exceed their PUL in the latter portion of the term of the analysis.	<ul style="list-style-type: none">• Pinchin has carried allowances to replace the two DHW storage tanks in the latter portion of the term of the analysis.

View of the first heating boiler serving the Site Building.

- Replacement of the two heating boilers in the early portion of the term;
- Replacement of the Domestic Hot Water (DHW) boiler in the mid-portion of the term and replacement of the two insulated storage tanks in the latter portion of the term of the analysis;

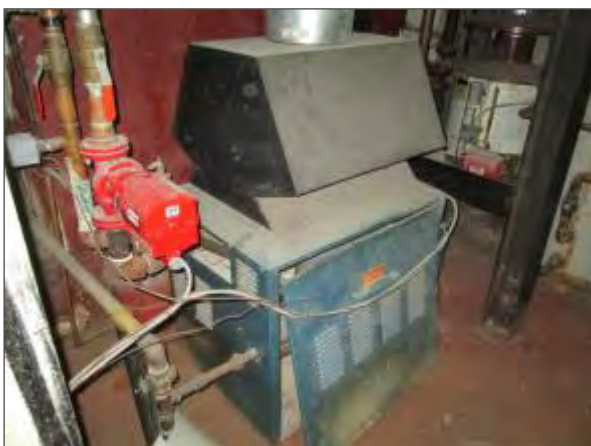
View of the second heating boiler serving the Site Building.

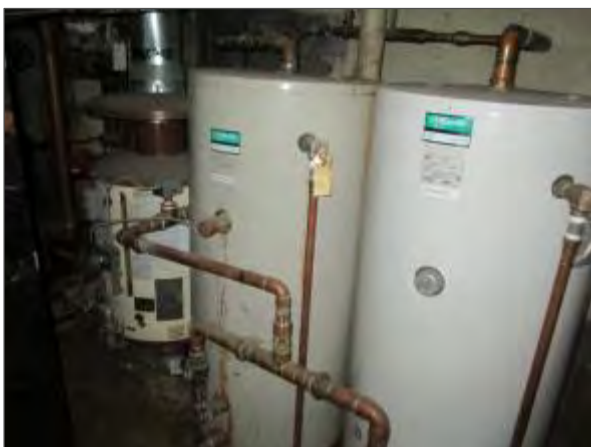
View of the DHW boiler and the two associated storage tanks.

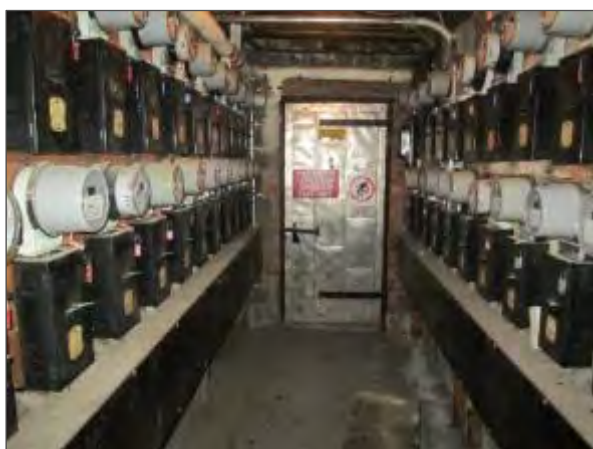
General view of the main electrical room in the basement of the building.

- Replacement of the likely original main electrical disconnect switch serving the building;
- Inspection and repairs to the emergency exit lights throughout the building;

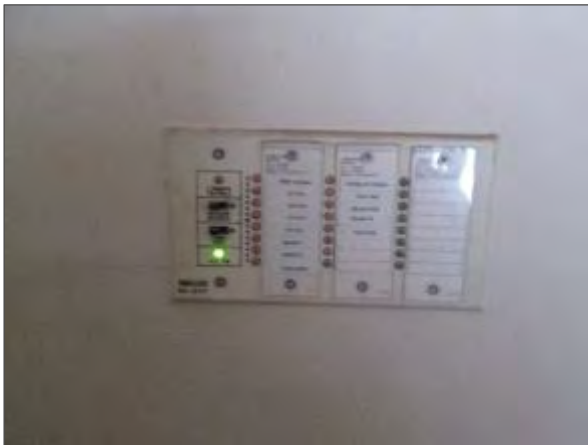
View of the annunciator panel which is located in the main entrance lobby area.

- Replacement of the main and annunciator fire alarm panels; and
- Replacement of the glass fuse plug style electrical panels within the suites and the electrical room.
