DRAFT **Baseline Property** **Condition Assessment**

240 Montreal Road, Ottawa,
Ontario

March 8, 2018

Pinchin File: 218394

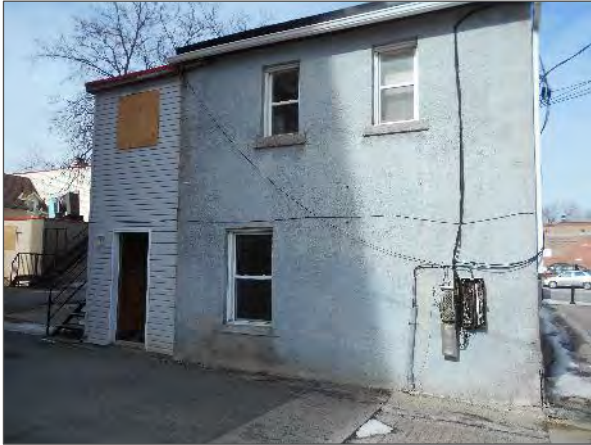
General view of the wall cladding on the south elevation of the Site Building.

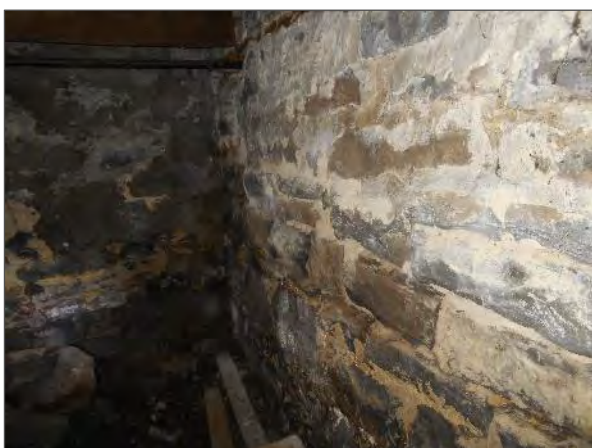
Table 3.4 – Structural Elements	
Findings	Remarks/Recommendations
Major Deficiencies/Findings	
<ul style="list-style-type: none"> Slab heaving was noted within the commercial unit on the northwest elevation of the Site Building. 	<ul style="list-style-type: none"> Pinchin has carried an allowance for structural/geotechnical review to determine the cause of the heaving and providing repair methods.
<ul style="list-style-type: none"> Vertical misalignment was noted in floors of first and second floor apartment units. 	<ul style="list-style-type: none"> Repair the floors under the supervision of a structural engineer.
Minor Deficiencies/Findings	
<ul style="list-style-type: none"> Water infiltration noted within the basement area. 	<ul style="list-style-type: none"> Refer to section 3.6 for mould investigation.

View of stone foundation wall within the basement area of the east portion of the Site Building.

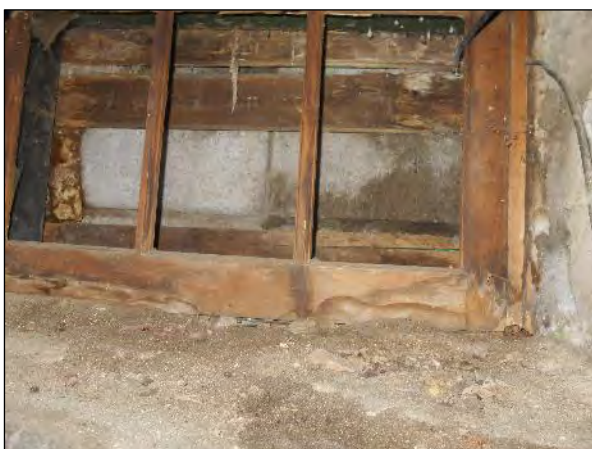
View of concrete block masonry foundation wall for the northwest portion of Site Building.

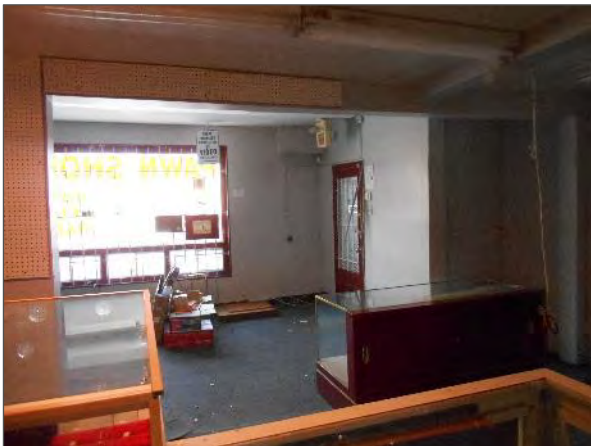
General view of the interior finishes within the commercial unit on the northeast elevation of the Site Building.

The interior finishes within the Site Building were generally observed to be in poor condition with many areas of damaged finishes and graffiti. Pinchin has included allowances for replacement and re-finishing of the damaged components. Water infiltration and mould growth was noted within the basement area.

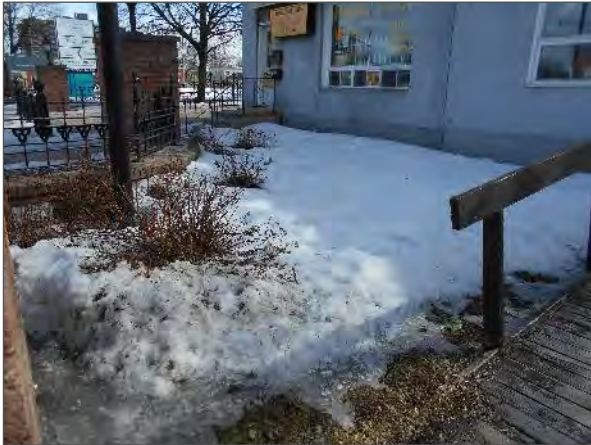
Table 3.7 – Site Features	
Findings	Remarks/Recommendations
Major Deficiencies/Findings	
<ul style="list-style-type: none">Corroded metal treads noted on the metal stair case.	<ul style="list-style-type: none">Replace the metal stair case.
Minor Deficiencies/Findings	
<ul style="list-style-type: none">A leaning railing noted on the wheel chair access ramp on the northwest corner of the Site Building.	<ul style="list-style-type: none">Repair/replace the affected railing.

General view of the Site features on the north portion of the Site.

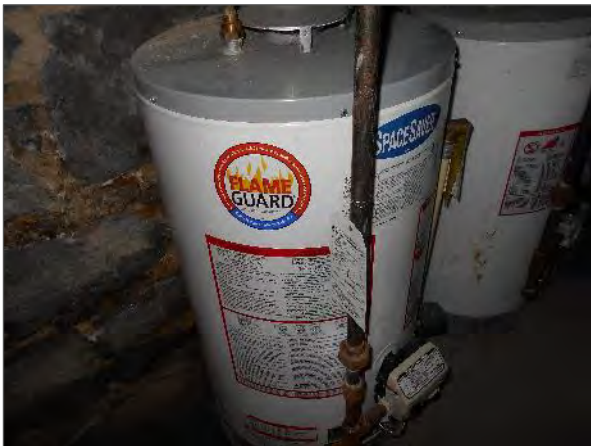
Table 3.8 – Mechanical Systems (including HVAC, DHW, Plumbing, and Fire Protection)	
Findings	Remarks/Recommendations
Major Deficiencies/Findings	
<ul style="list-style-type: none">Fire extinguishers were not observed in the commercial units.	<ul style="list-style-type: none">Fire extinguishers should be installed prior to re-occupancy of the commercial units.
Minor Deficiencies/Findings	
<ul style="list-style-type: none">The "Series 6" DHW unit is approaching its PUL.	<ul style="list-style-type: none">Replace the hot water tank within the early portion of the term of analysis.

View of the hot water tanks within the basement of the Site Building.
