Building Condition Report

**12, 14, 16 and 18 Hawthorne Avenue
Ottawa, Ontario**

Issued August 1, 2023

CJEL Reference No. 23-1216

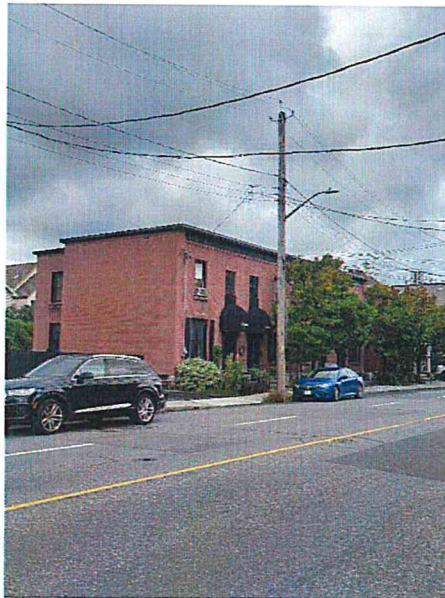
Typical Foundation Deterioration

The stone foundation walls were found to be exhibiting moderate to extensive deterioration of the mortar joints. It is recommended that all walls be repointed.

Estimated Foundation Structural Repair Cost: \$75,000 plus HST
