A Cultural Heritage Impact Statement

100 Argyle Avenue, Ottawa

SUBMITTED TO: Colonnade BridgePort
PREPARED BY: Commonwealth Historic Resource Management
Revised 1 January 2019

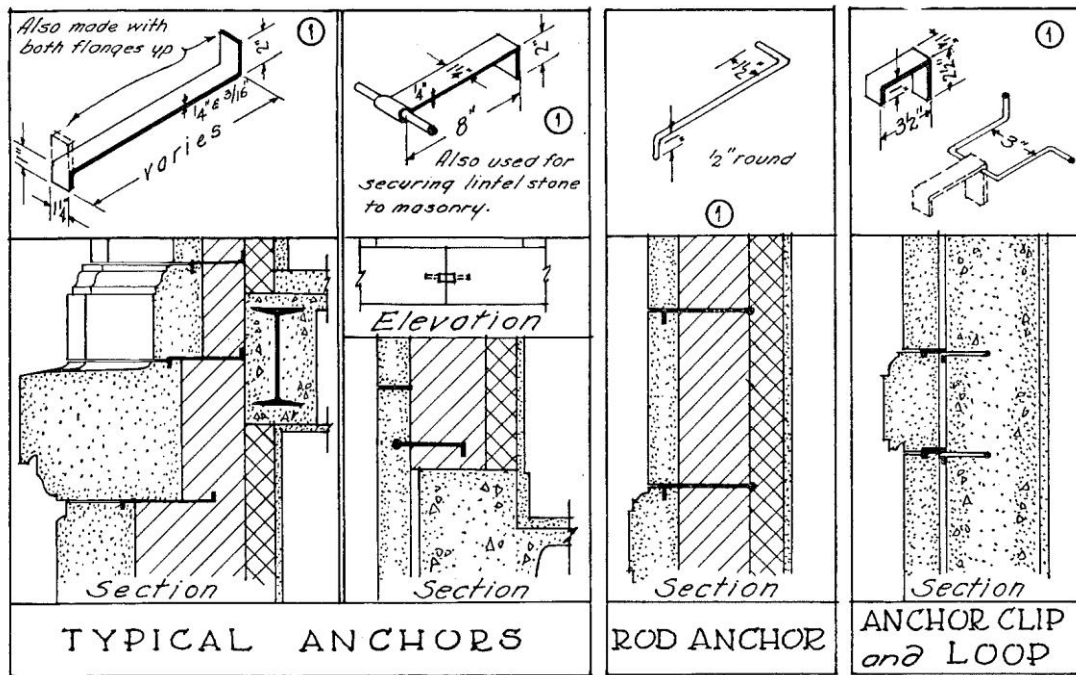
Figure 1: Typical anchors used to secure cut stone facing to an assortment of back-up walls. The flat steel bar with upturned or downturned ends to the left the image, and the rod anchor would both be suitable

to the relatively simple stone application on the facades. Source: *Traditional Details for Building Restoration, Renovation, and Rehabilitation. 1932-1951 Editions Architectural Graphic Standards* pg. 63. Ramsey Sleeper. John Wiley and Sons Inc.

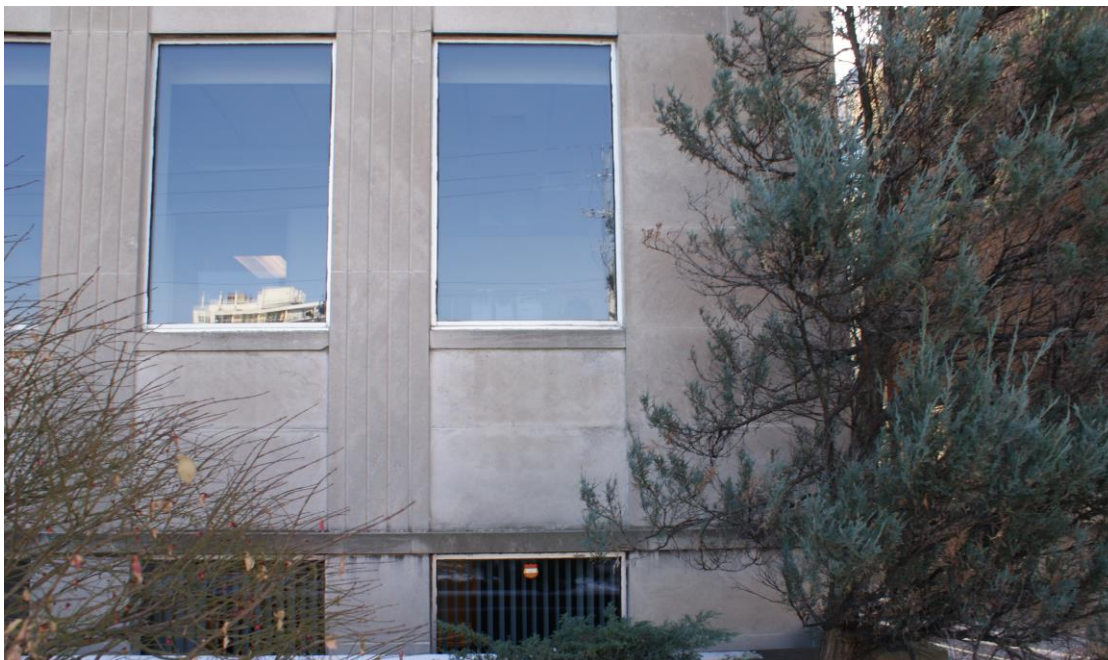
Figure 6: Detail view of north elevation. Note the vertical reeded blocks, and the recessed panels below the first and second floor windows. Source: CHRML.

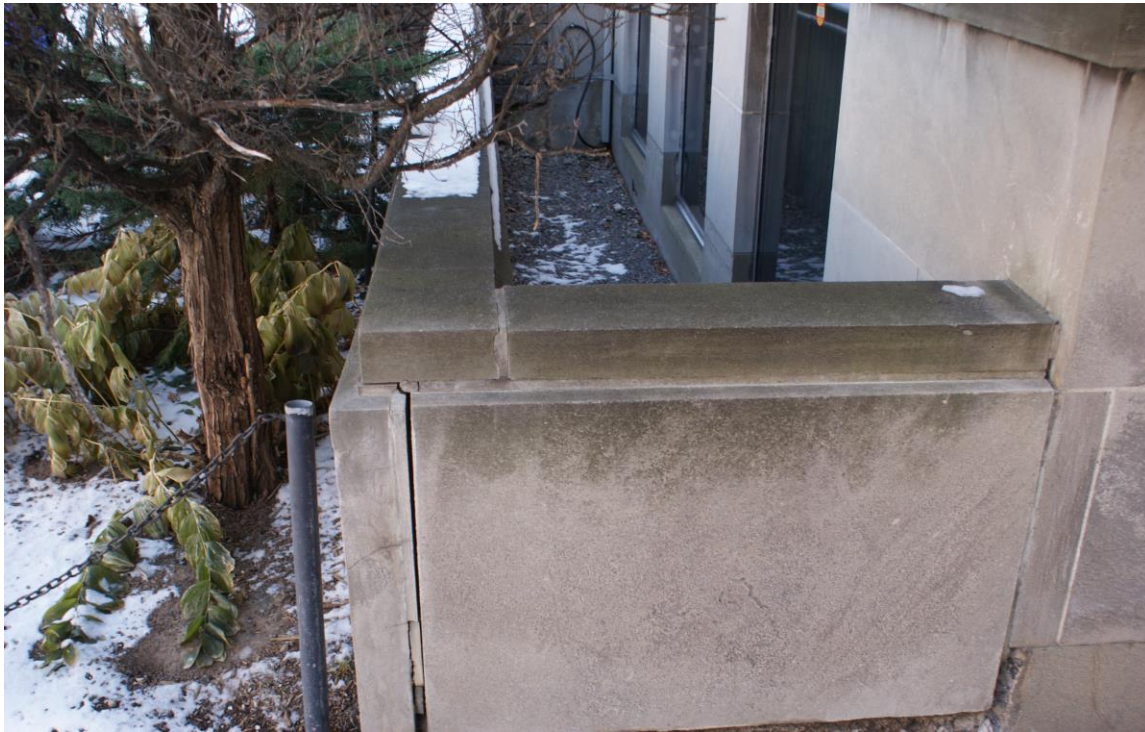
Figure 7: View of limestone clad area wall and coping. Note that the basement windows are set into the foundation wall. Source: CHRML.

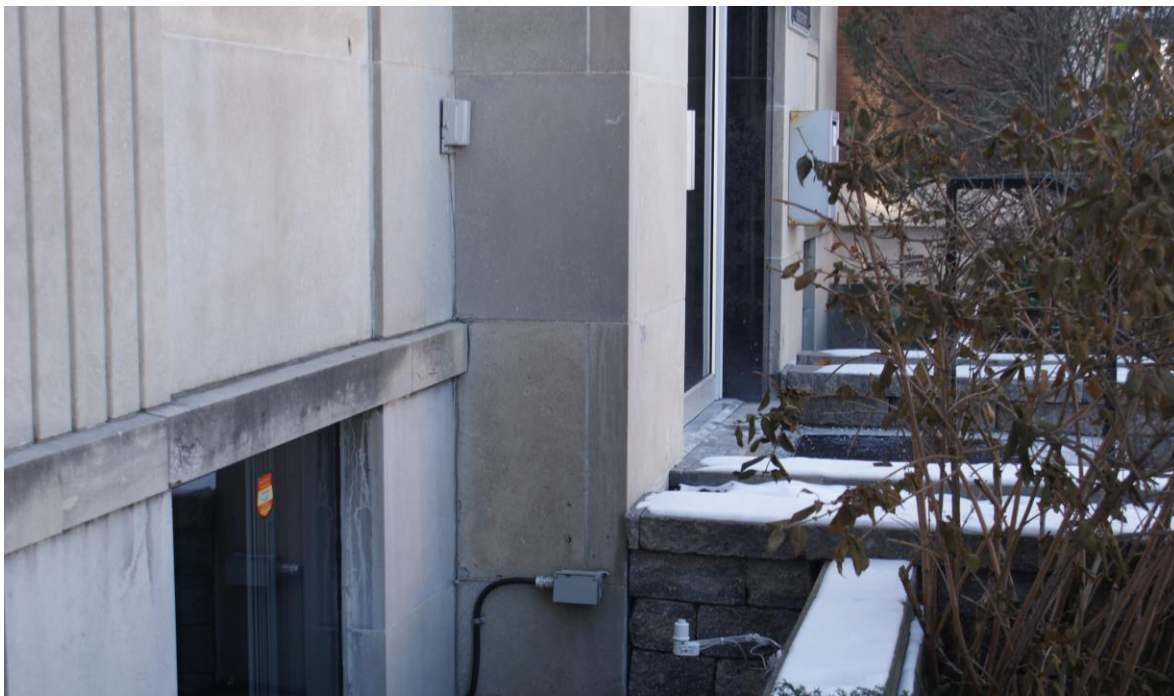
Figure 8: View of the projecting entrance bay. Note the reeded panel to the left and recessed panels below the first floor window. Source: CHRML.

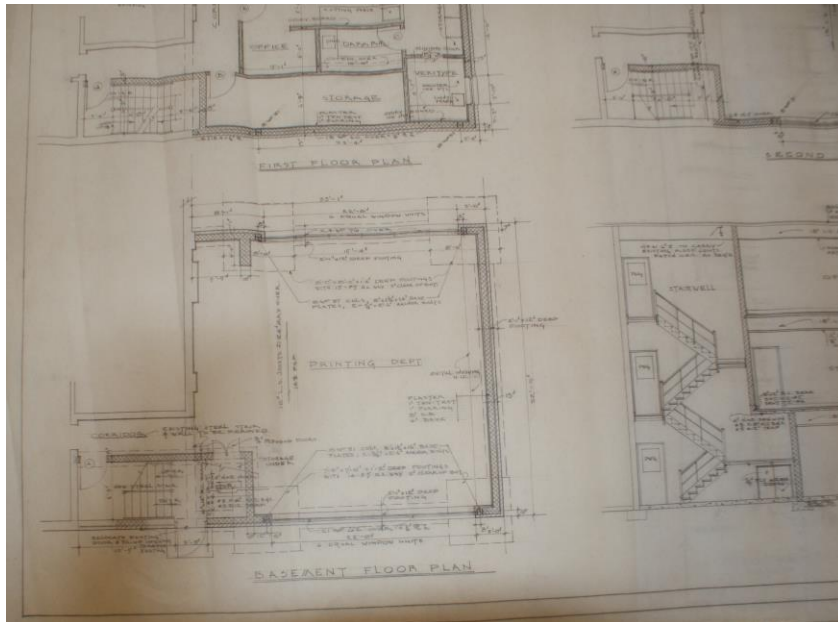
Figure 16: Partial drawing for the 1959 addition. The addition and the main building were completed within 5 years of each other. The likelihood is that the same construction methods and techniques were used in the main building and the addition. Note how the floor slabs are shown penetrating the interior concrete back-up wall, which should be documented during the demolition of the floor plates. Similar wide flange steel beams specified in the 'Notes' may have been used in the main building to support the masonry above the main entrance and other locations. Source: LAC Lithwick Collection Mikan No. 4002312.

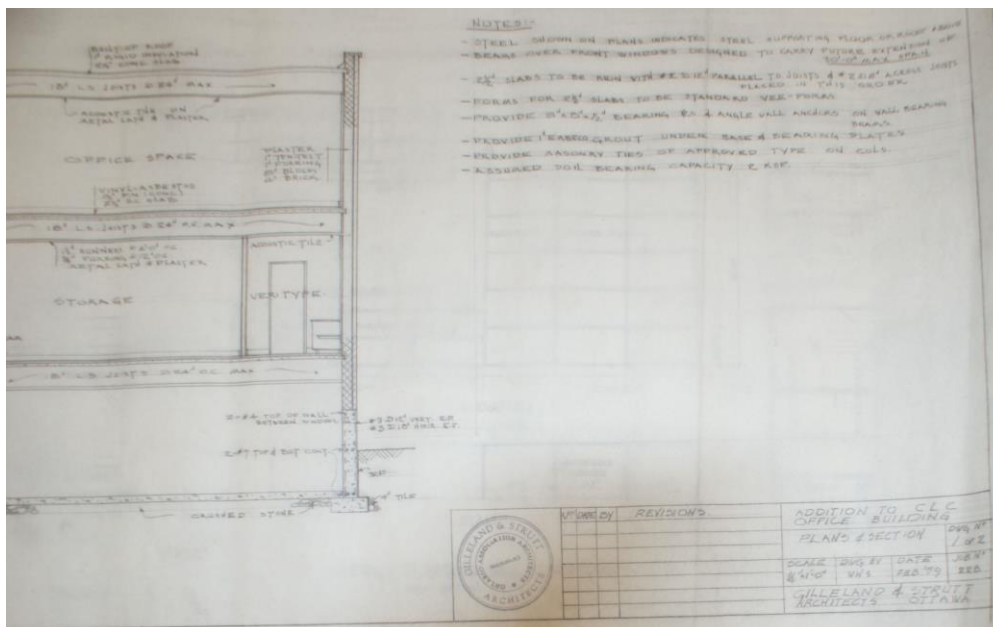
Figure 17: Partial plan and section of the 1959 addition. Note the steel columns embedded in the concrete block walls. Additionally, note the wide flange beams sizes supporting masonry walls above fenestrations as well as other locations. Source: LAC Lithwick Collection.
