CONSERVATION PLAN 359 Kent Street, 436 & 444 Maclaren Street, Ottawa

March 2023 Application File Number: D02-02-21-0095 [ZBLA] & D01-01- 21-0015 [OPA]

1.0 MATERIAL CONSERVATION PLAN

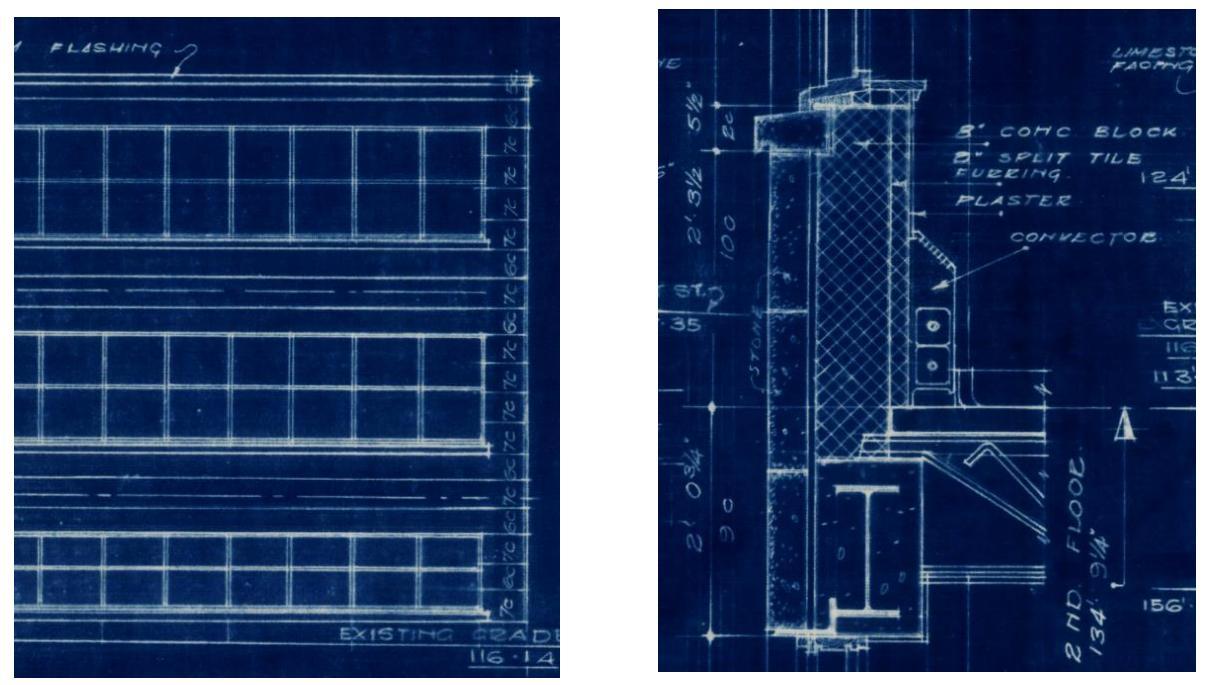
Figure 4 (left): Detail section through the walls clad in limestone illustrating the structural frame and materials and their relationships. Note the window sill that is supported on the masonry back-up wall as well as the relationship of the aluminium window sill to the limestone sub-sill. Source: 1955 Architectural Drawing Set A4.

Figure 5 (right): Detail of the Gilmour Street façade where the coursing height pattern is noted that vary consistently between two heights (6C and 7C). Source: 1955 Architectural Drawing Set A4.

Condition: The limestone cladding is in good condition generally with a few stones at grade level that have been adversely affected by de-icing salts. A number of stones have surface defects or concretions that have not weathered well; however, they are limited in number. A detailed condition assessment of each stone panel will be completed as part of the dismantling process. There are a number of stone panels where the mortar is missing from the joints particularly in the area of the introduced Kent Street entrance providing a general sense of how difficult the removal of the mortar from the units may be during the salvage process.

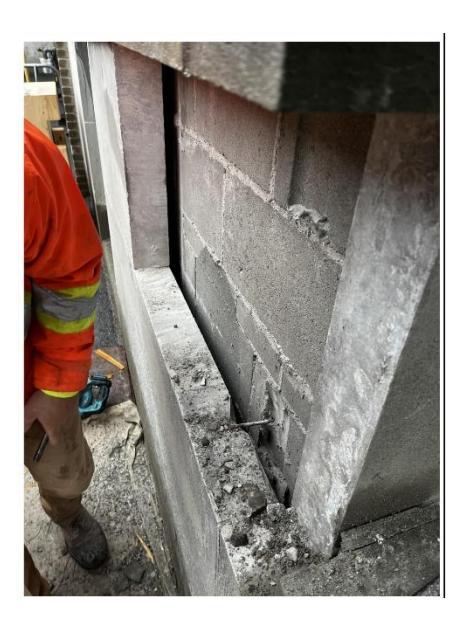
Figure 6: View of a test removal panel from a building at 100 Argyle constructed circa 1955 using a similar limestone cladding material as 359 Kent. The limestone cladding units are secured to the concrete block backup wall with a single metal anchor centred on the width of the panel. Source: Heritage Grade Test Removal Report, 100 Argyle.

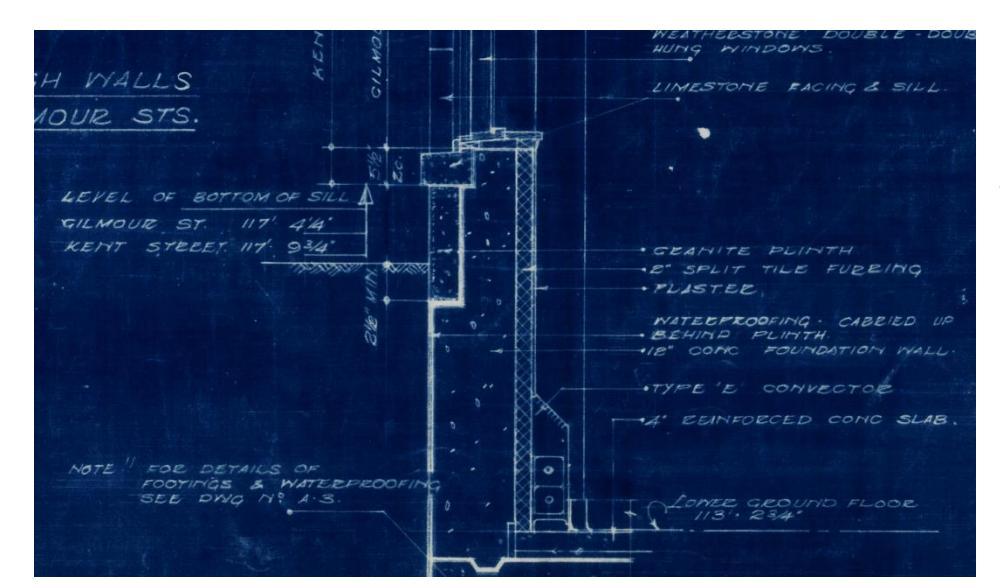
Condition: The granite sill on the Kent Street window is in good condition. The condition of the granite plinth course buried below grade has not been determined.

Figure 17: Detail section through the Kent and Gilmour Street façades. A 100mm thick granite plinth is detailed in the drawing. Source: Original 1955 Drawing Set A4.

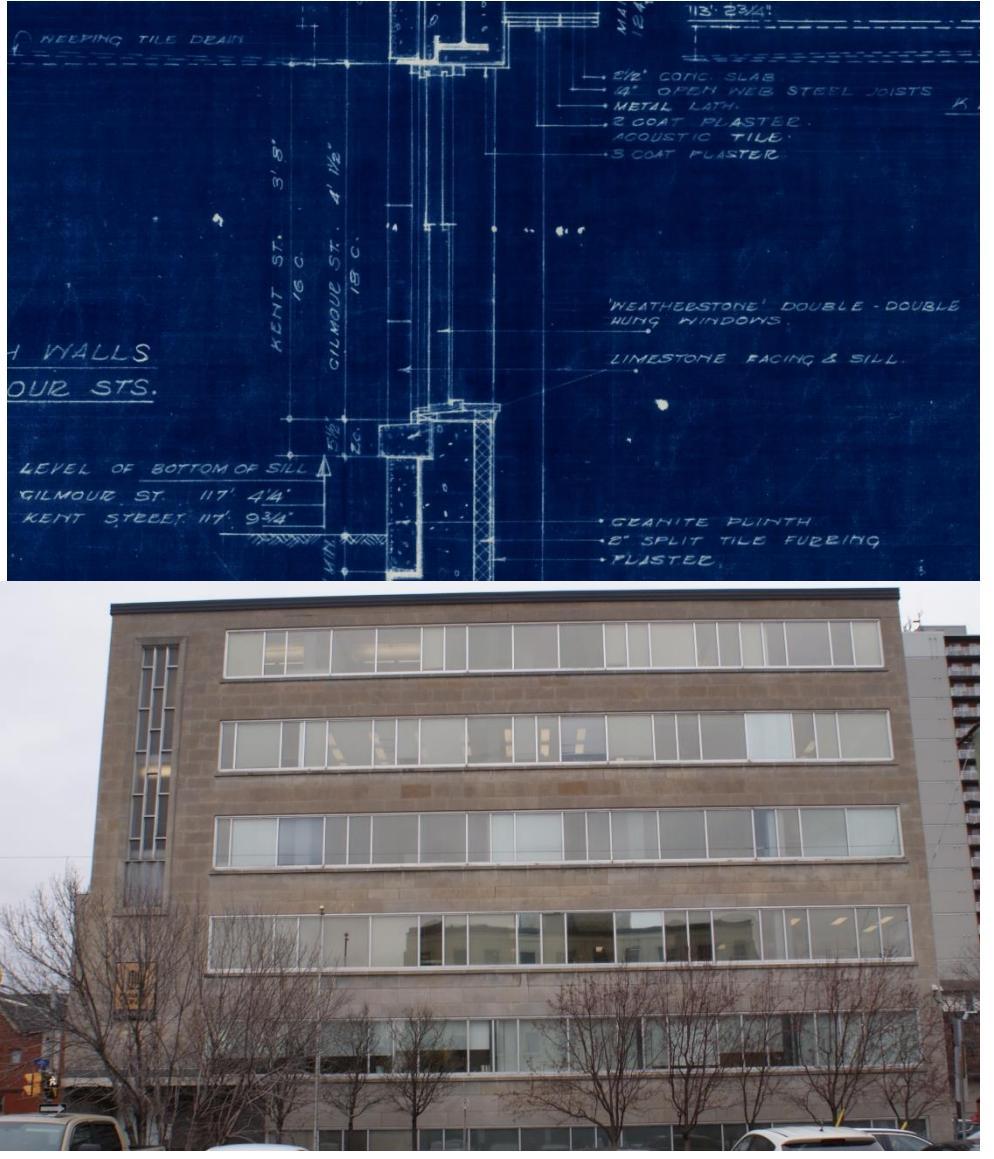
Condition: The existing windows are being replaced with new aluminium thermal units. The original vertical and horizontal division of the lights will be replicated in the three-storey windows on the Kent and Gilmour façades.

Figure 22: Detail section through the Kent and Gilmour Street facades illustrating the horizontal placement of the window assemblies within the exterior walls. The varying window heights between the Kent and Gilmour façades are related to the differing grades. Source: Original 1955 Drawing Set A4.

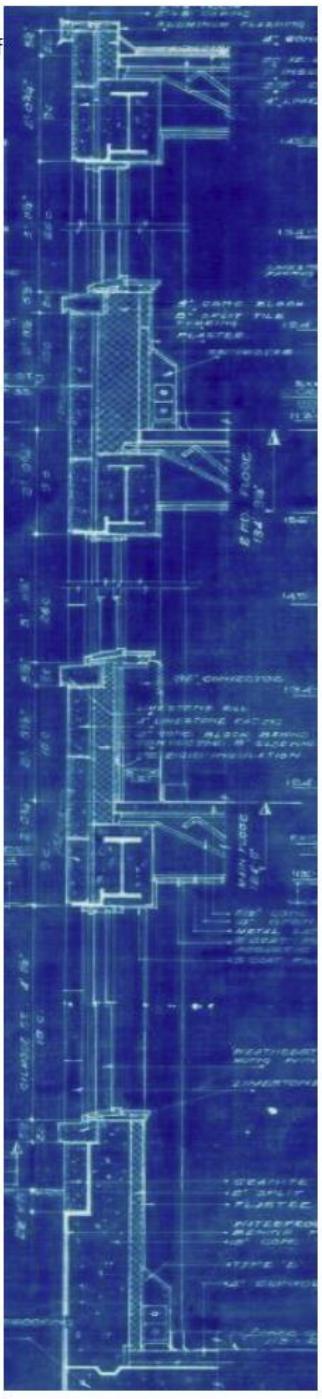
Figure 3. Wall Section

As shown, at right, in Figure 3, the 4" limestone veneer is supported by steel shelf angles at the suspended floor levels and on the concrete foundation wall, at the base. A concrete block wall is identified as the back-up to the stone veneer and would be relied upon to provide the lateral support to the limestone veneer. There is no indication of insulation or a significant air space, which are important features of cavity wall design.

The concrete masonry wall is only 4" thick at the ventilators but 8" thick, otherwise. The veneer and back-up walls are not bonded to act as one. The ties connecting the stone veneer to the concrete block back-up and the shelf angles are likely to be corroded after 66 years of service life. The condition of these important elements would need to be verified. There is no insulation in the wall and energy efficiency of the perimeter wall system would be very poor.

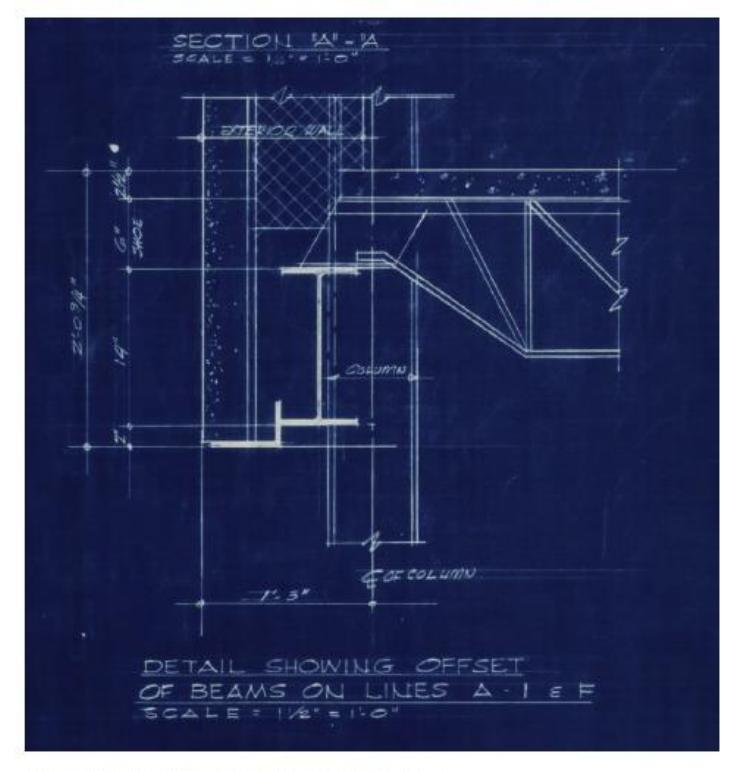
Figure 4. Typical Off-Set Beam Detail at GL 1 and F.

The existing floor joists bear on an offset beam on the gridlines considered for retention. The joist shoe is connected to an offset beam and the beam is cast in concrete for fire proofing purposes. The veneer and back-up masonry block wall bear on this concrete-encased at each floor and induce torsion on the beam (see Figure 4 for the typical detail). The joists brace the beam and provide resistance to the torsion created by the eccentric masonry loads. Removal of the interior joists will require compensating construction to deal with the eccentric loads and this complicates in situ retention of the facade.

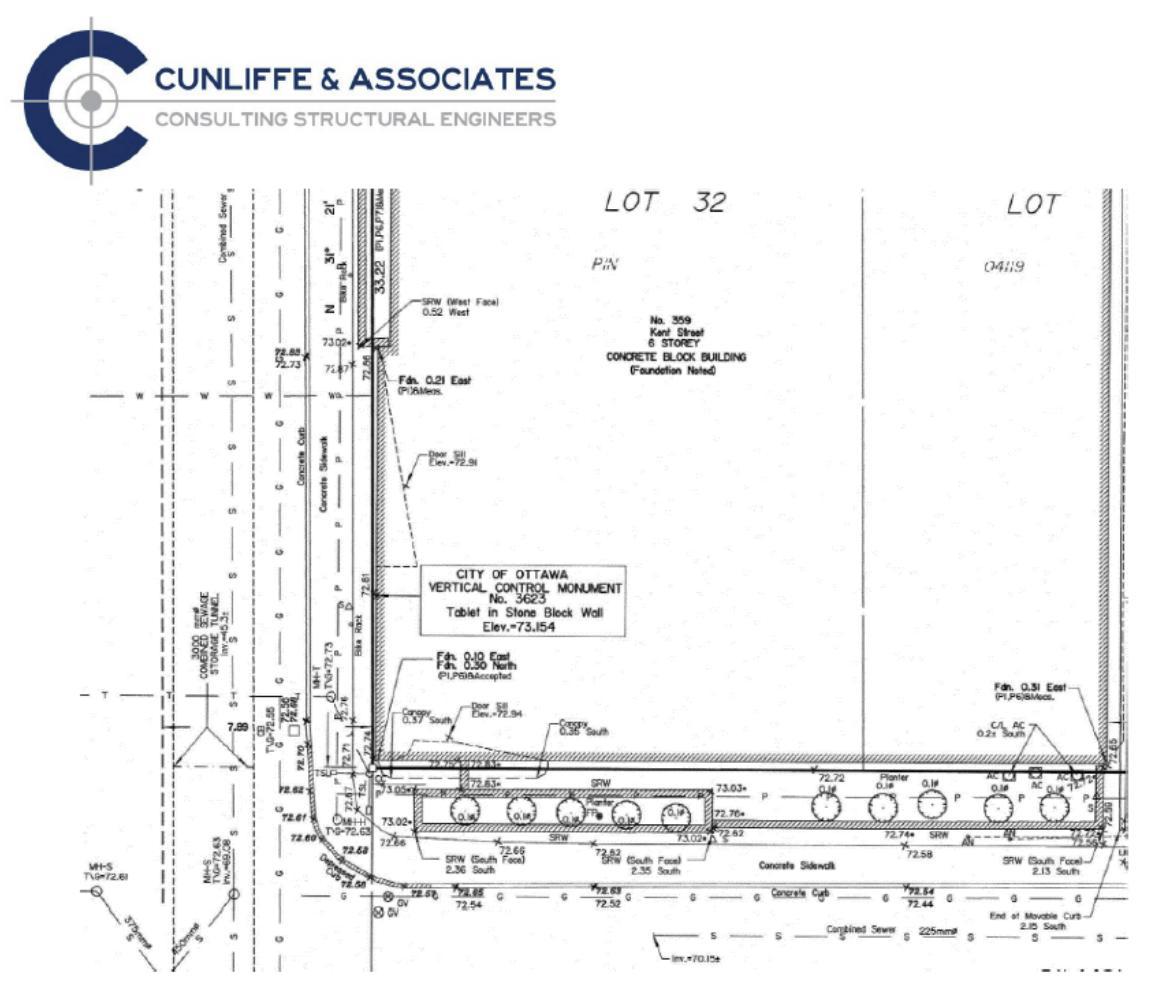
Figure 5. Survey of 359 Kent Showing Underground Services (2021).

We understand that there is significant infrastructure within the footprint of the bracing system which would greatly complicate piling and lengthy sidewalk and lane closures could be expected. We leave it to the Civil Engineers to further evaluate the interference with respect to the underground services.

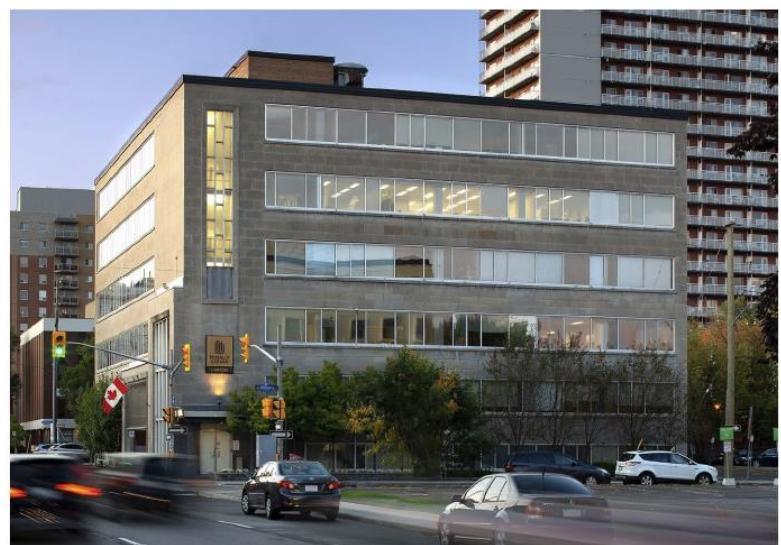
The notable south and west building facades are punctuated by long horizontal linear windows. This linear limestone expression is interrupted at the southwest corner by a vertical gesture, highlighting the main entrance. It is important to note that level one is depressed by roughly five feet, requiring an elevator to provide barrier-free access. This issue of accessibility will be addressed in the new proposal. The north and east elevations are clad with brick masonry and will not be retained.

Figure 2 - Current condition, 2022, of Legion House

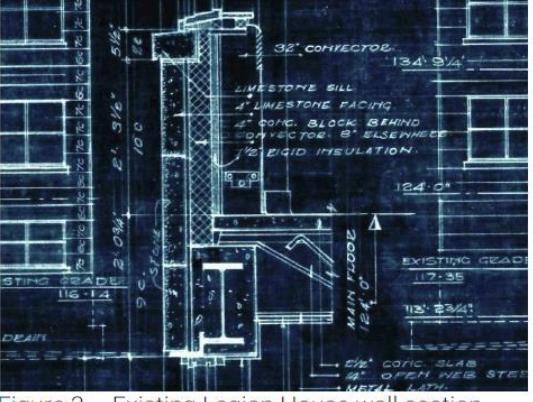
As described in the structural engineering feasibility review letter, dated October 11th 2022, prepared by Cunliffe & Associates, the Legion House was erected using a steel structure with poured concrete floors supported by open web steel joists. As depicted in Figure 3, the south and west exterior walls are composed of a limestone masonry finish and supported by block masonry wall behind. The exterior wall assembly offers only 1.5 inches of rigid insulation; the R-vaue of this wall assembly is estimated to be as low as R5 to R8.

Figure 3 – Existing Legion House wall section

Additionally, the minimal 1.5 inches of rigid insulation shown in Figure 3 does not provide a sufficient insulation value to meet today's energy performance standards set out in the Ontario Building Code Supplementary Standards, SB-12. We would propose a new wall assembly that would offer a more robust insulation thickness to meet or exceed the current building code requirements, while also considering future requirements.
