Project:  
**Gladstone and Loretta**

Drawing:  
**TREE CONSERVATION REPORT**

| Project Number: | 1987-01 | Sheet Number: | TCR 1.0 |

| Project Number:<br>1987-01 | Sheet Number:<br>TCR 1.1 |

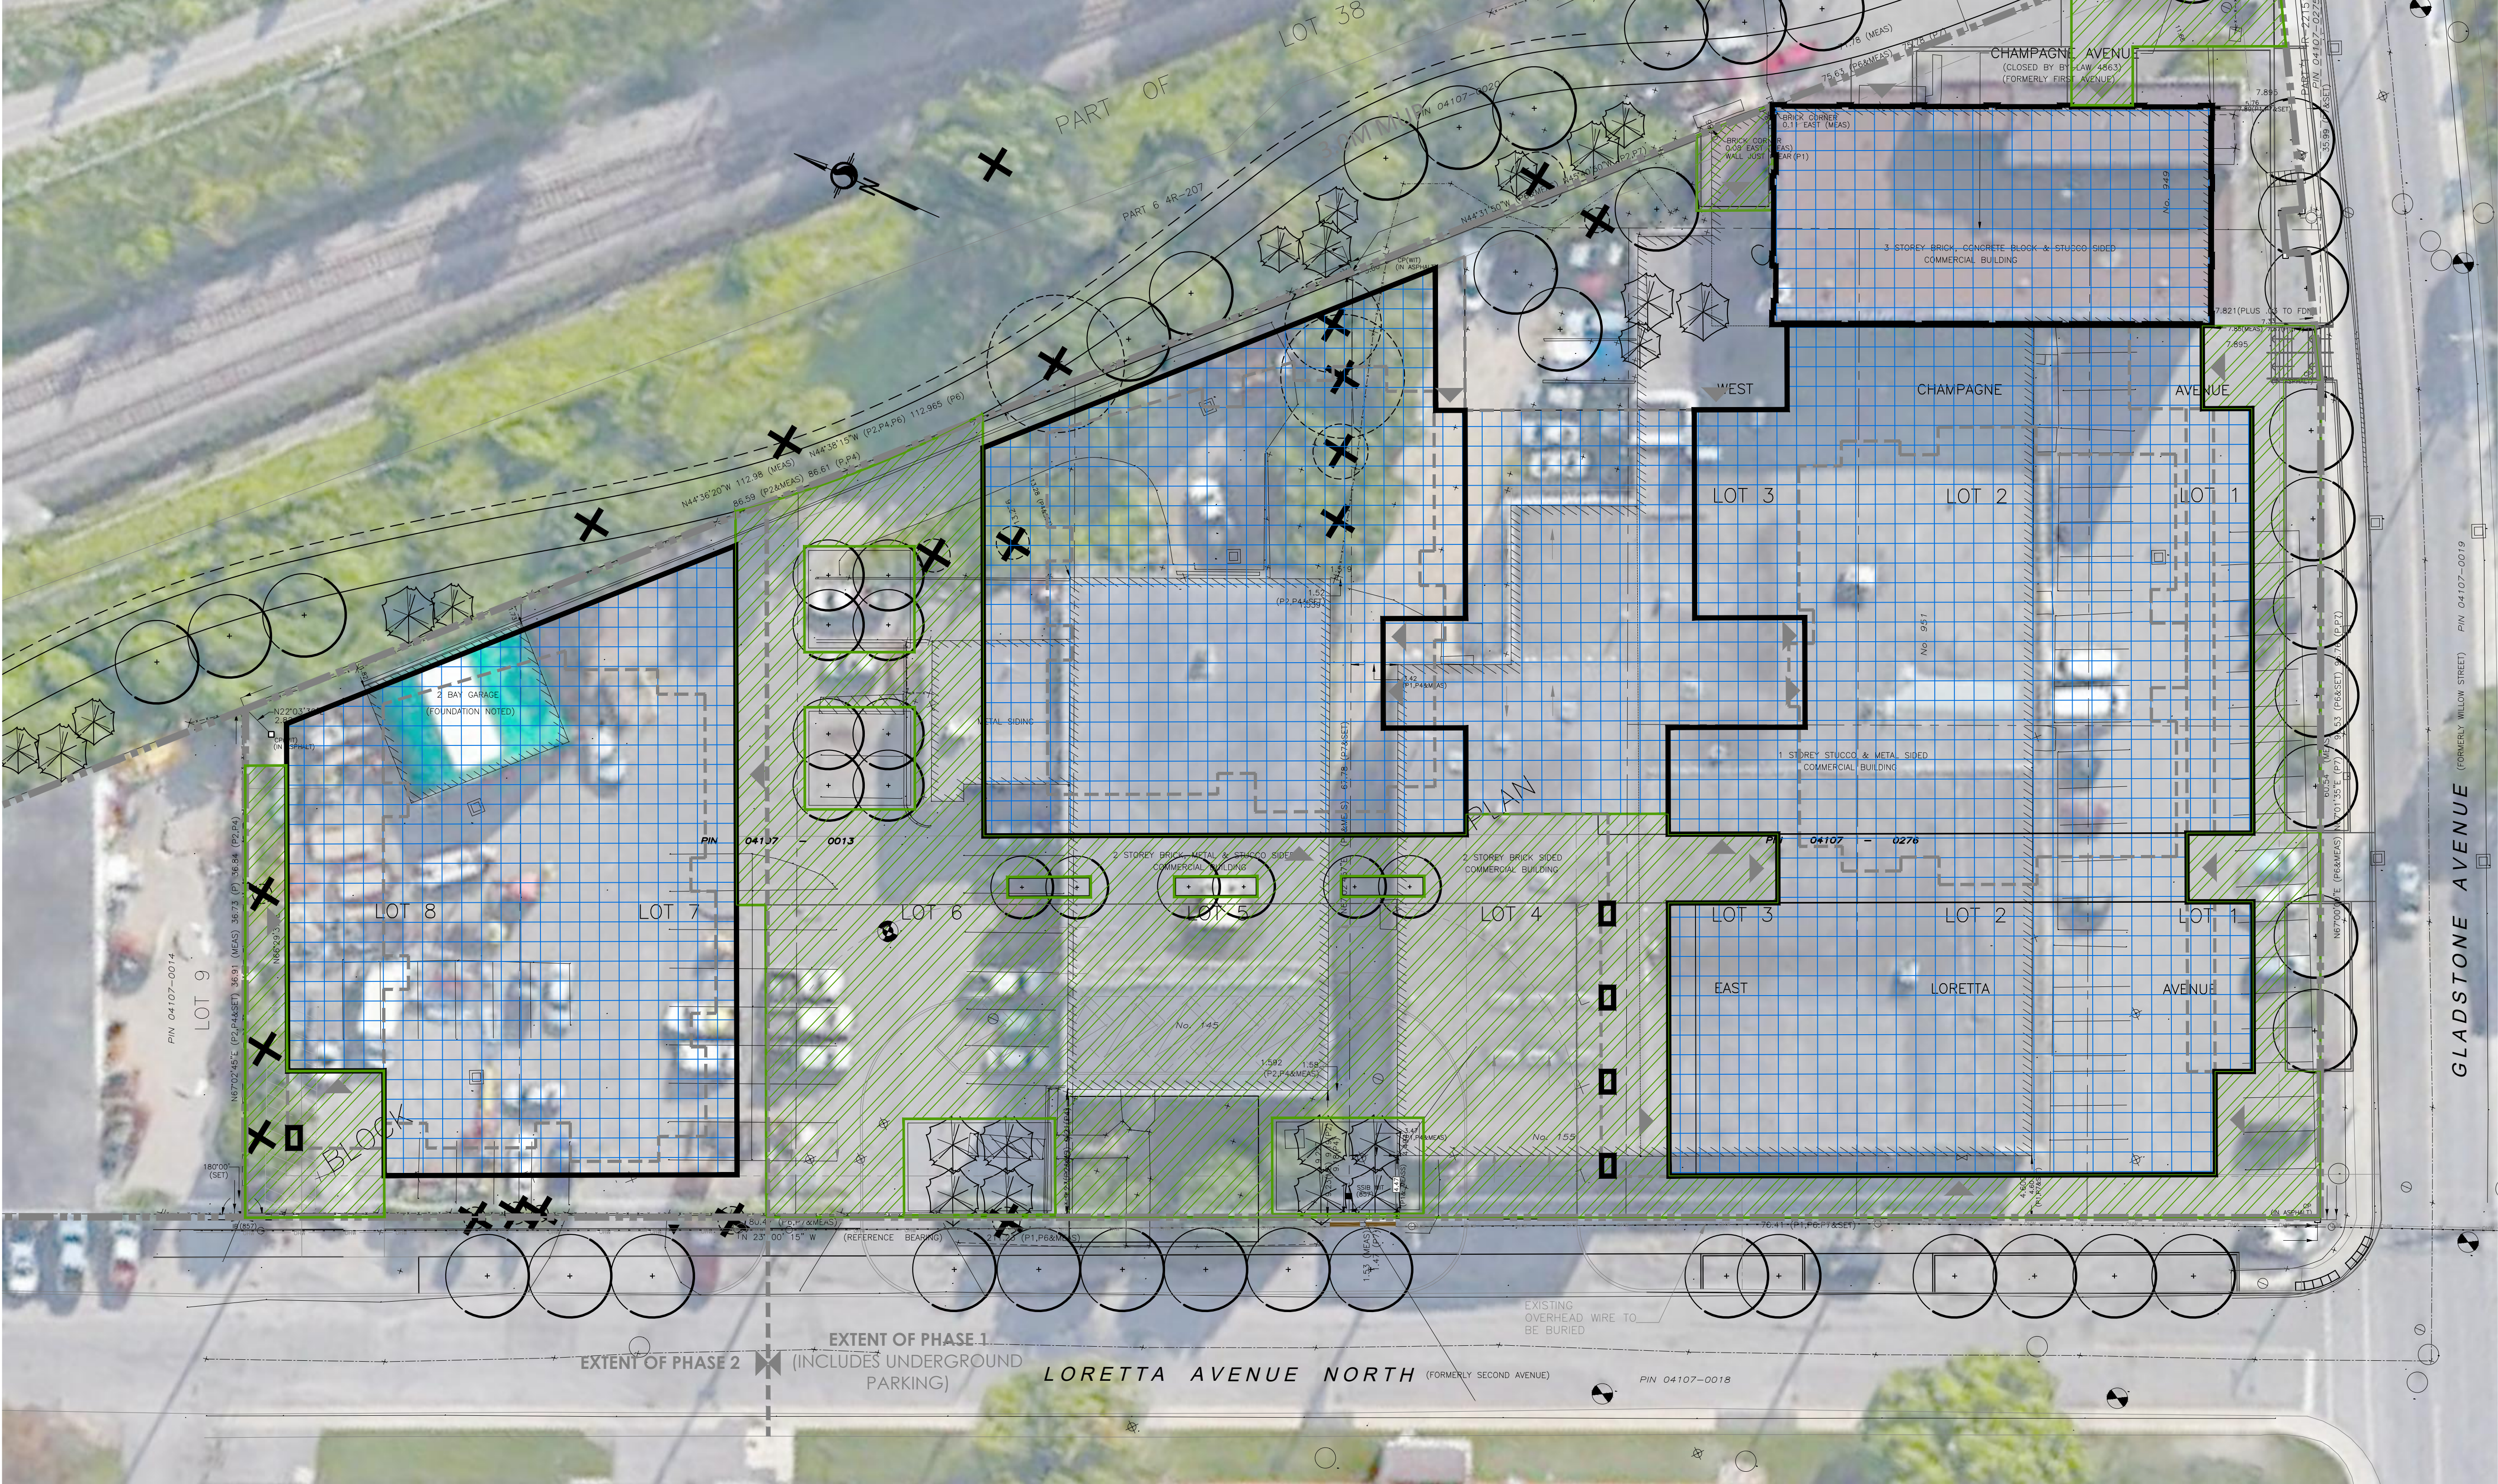
THIS IS AN EXISTING COMMERCIAL SITE USED PRIMARILY AS BUSINESS SPACE FOR MULTIPLE TENANTS. MUCH OF THE SITE IS CURRENTLY OCCUPIED BY ASPHALT PARKING LOT. THE MAJORITY OF TREES ON SITE ARE AT THE PERIMETER EDGES. WITH THE EXCEPTION OF THE STREET TREES ALONG LORETTA AVE, MOST TREES HAVE ESTABLISHED POORLY AND ARE ILL SITUATED ALONG FENCE LINES OR DIRECTLY AT RETAINING WALLS.

THE LINEAR LANDSCAPE AREA NORTHEAST OF THE SITE RUNS ADJACENT TO THE EXISTING O-TRAIN TRACKS. THIS AREA IS SEPARATED FROM THE COMMERCIAL PROPERTIES WITH CHAIN LINK FENCE AT THE TOP OF A SLOPE. THE AREA IS DENSE WITH INVASIVE PLANTS SUCH AS MANITOBA MAPLE, WILD GRAPE VINE AND VIRGINIA CREEPER. THE AREA HAS A GREAT DEAL OF DEAD TREES AND MISCELLANEOUS DEBRIS MAKING THE AREA DIFFICULT TO ACCESS.

THE SITE LACKS SIGNIFICANT TREES OF VALUE. THE PRESENT TREES OFFER LITTLE BENEFIT TO THE SITE IN TERMS OF ECOLOGY, CHARACTER, OR SHADE VALUE. THE GENERAL CONDITION OF THE SITE'S TREES ARE POOR WITH A DECLINING STATE OF HEALTH.
