AZURE URBAN DEVELOPMENTS INC.

254 ARGYLE AVENUE

Church Relocation Scenarios Analysis

Project Number: 2023-049-2

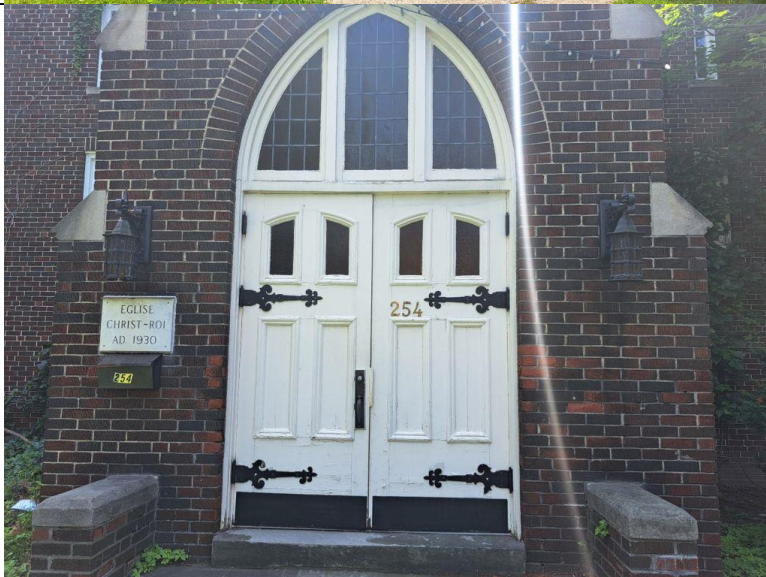
Photo 2
Main entrance, wood door, Gothic style

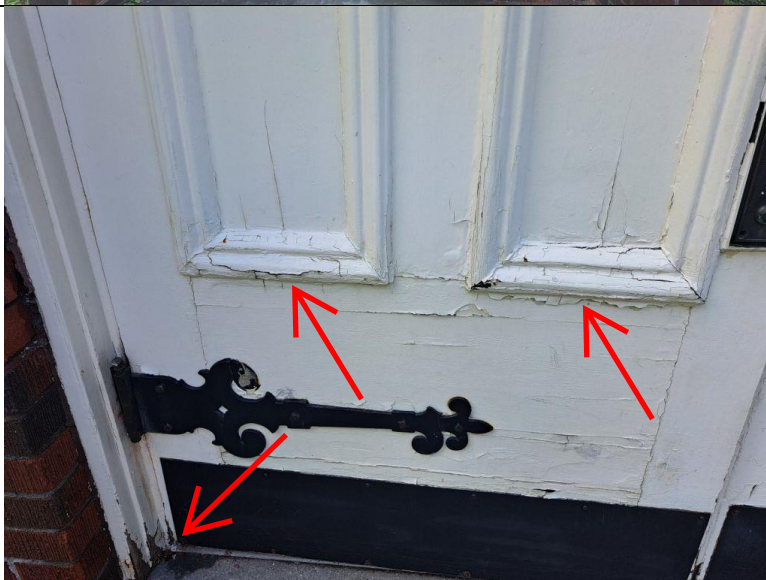
Photo 3
The main door needs intense maintenance work

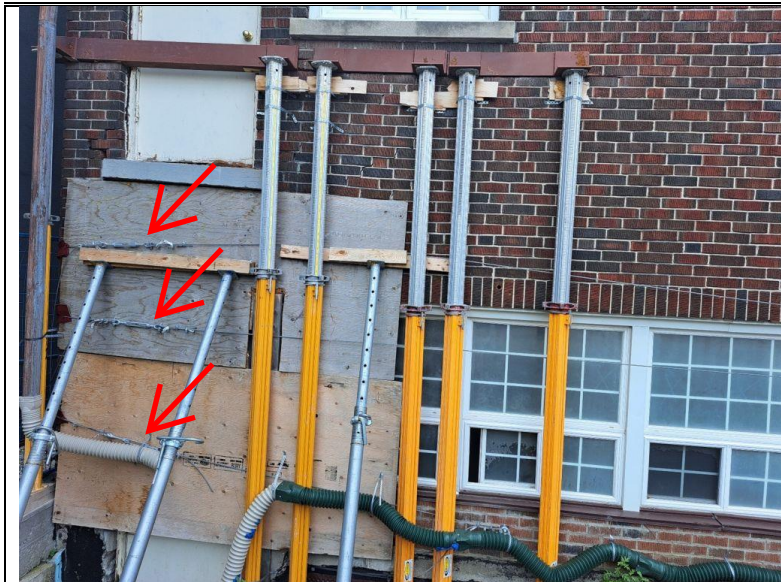
Photo 13

- Downspouts empty too close to the building, concentrating water against the foundation, a very likely source of basement water entry (see Photo 13).
- The staircase to the doorway on the main floor was removed (see Photo 13).

- Sheets of plywood are fastened to the brick cladding in the south-east corner with Tapcon fasteners at regularly spaced intervals to prevent further brick movement in that area. The plywood is secured tight to the building face by three cables (see Photos 11, 12, 13).

- Vertical supports are provided as temporary measures to prevent the whole south-east corner separating from left and back walls (see Photos 11, 13).
- The wall is leaning outwardly by 1cm for every meter (see Photos 15, 16).

The southeast corner is secured by fastening plywood to the brick and three cables

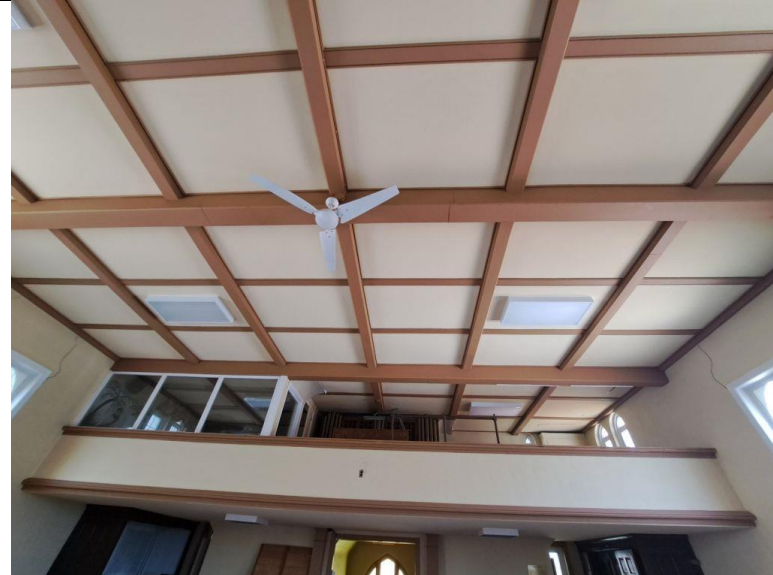
The ceiling does not suffer from any visible cracks, water stains, deflection, or peeling paint (see Photos 44, 45).

Photo 44
General view of the ceiling, no damage noted

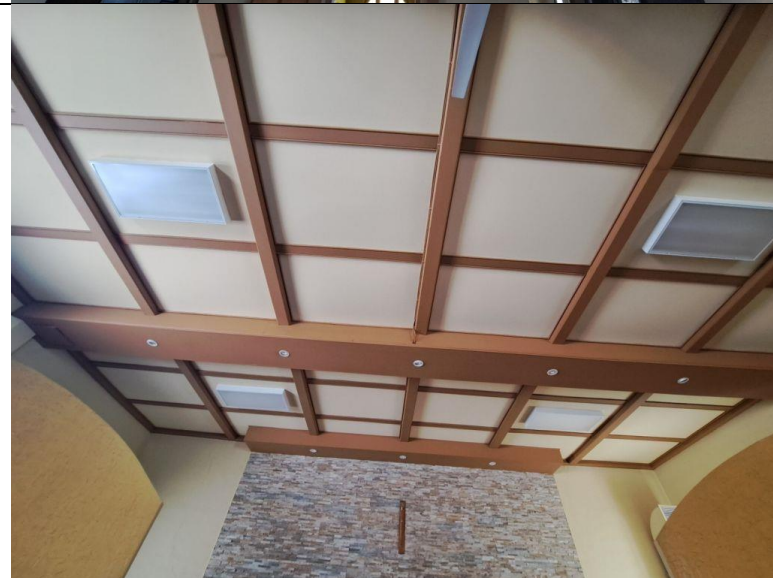
Photo 45
General view of the ceiling, no damage noted

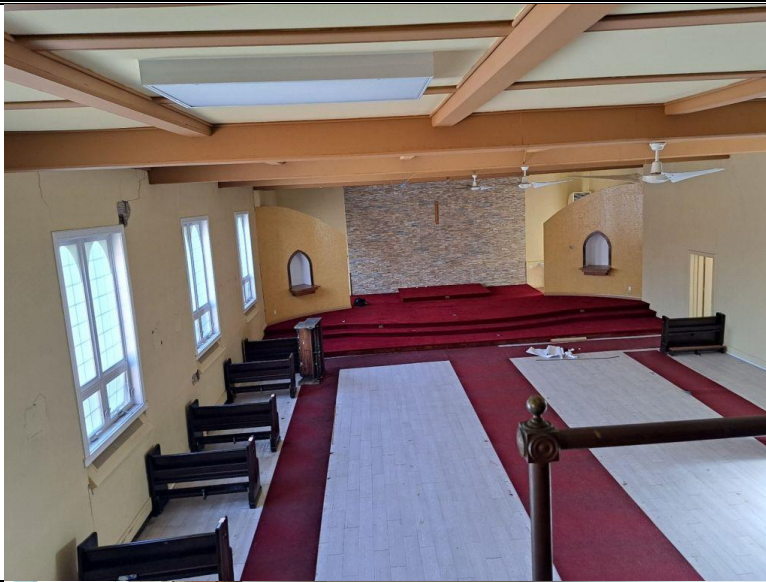
The carpet and laminated wood floor are in fair condition (see Photo 46). No structural concerns are present.

Photo 46
General view of the floor, the floor is laminated wood planks and carpet

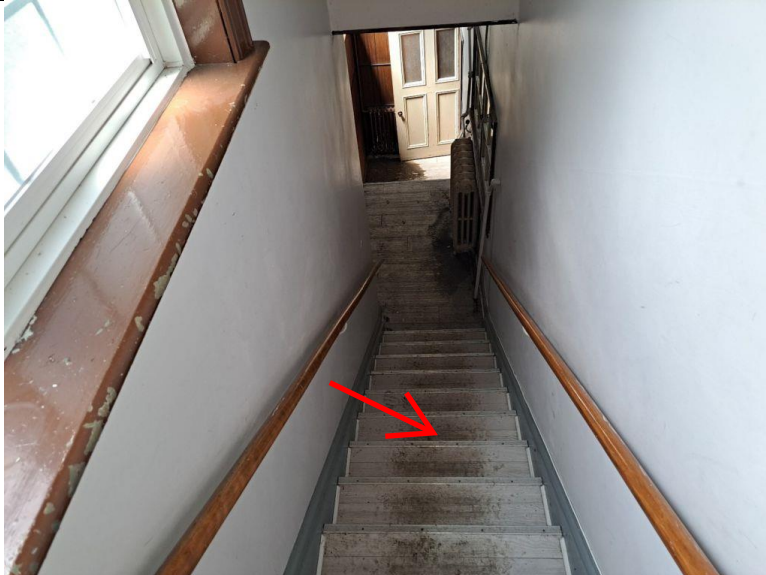
The stairs are covered with laminated wood boards of poor quality which were wet and dirty at the time of the inspection. A side door to exit at the right side of the building is located at the landing between the main floor and the basement (see Photos 47, 48).

Photo 47
Staircase to the basement, covered with laminated wood

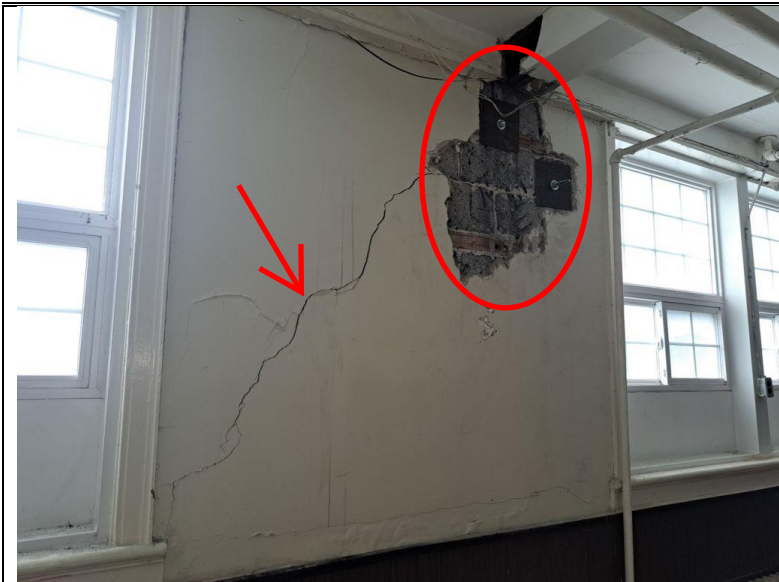
A diagonal crack of 4mm width was spotted on the left wall (see Photos 49 - 50). There were also windows with broken glass indicating excessive movement in that region likely caused by the settlement (see Photo 51). There is severe damage to the southeast corner similarly to the main floor above (see Photos 52, 53).

Photo 49
The left side (South side) wall at the basement

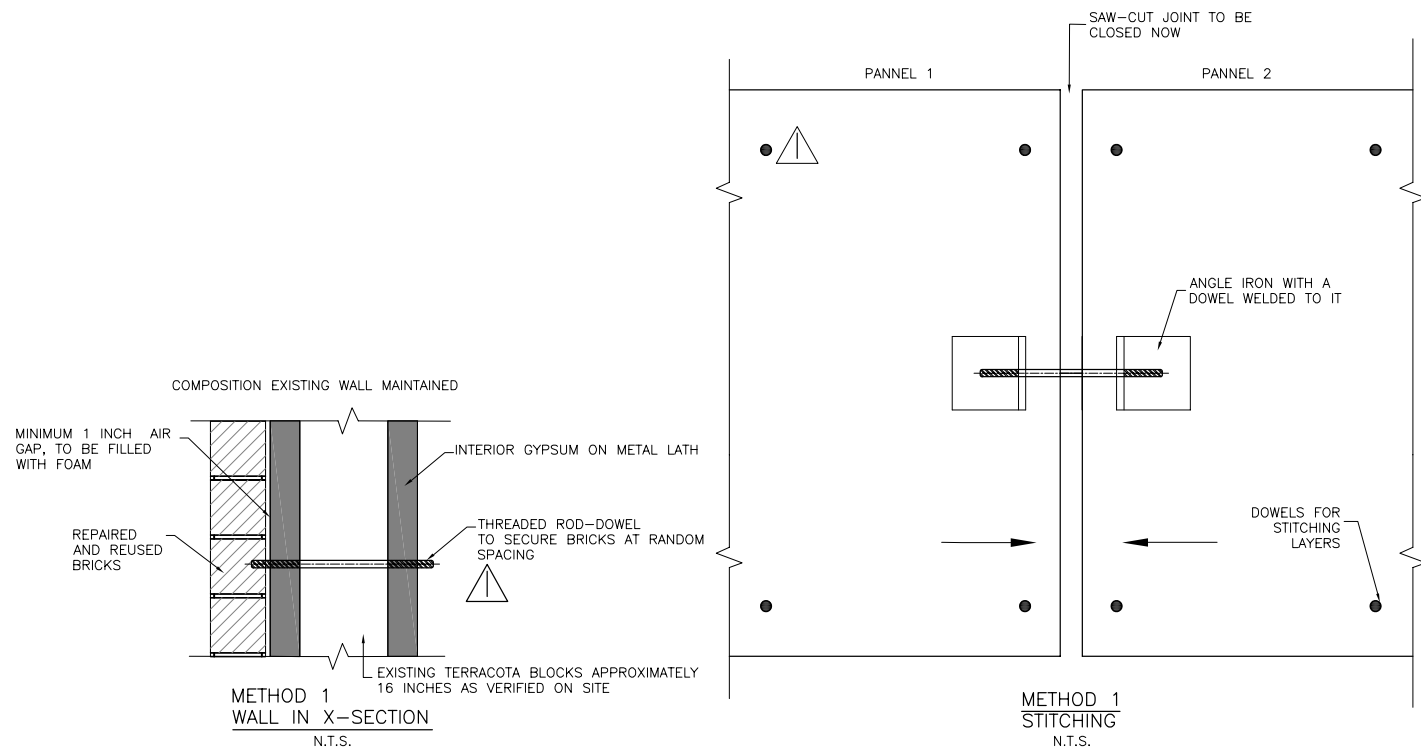
EXISTING WALL COMPOSITION:

- BRICK VENEER
- AIR GAP
- TERRACOTTA BLOCKS

NEW DOWELS/CINTEC ANCHORS OR EQUIVALENT TO TIE BRICK VENEER TO OLD TERRACOTTA WALL. SPACING TO BE DETERMINED.
