SOMERSET HOUSE
HERITAGE IMPACT ASSESSMENT
352 SOMERSET STREET WEST, OTTAWA

COMMONWEALTH HISTORIC RESOURCE MANAGEMENT
Version 4. JULY 2023

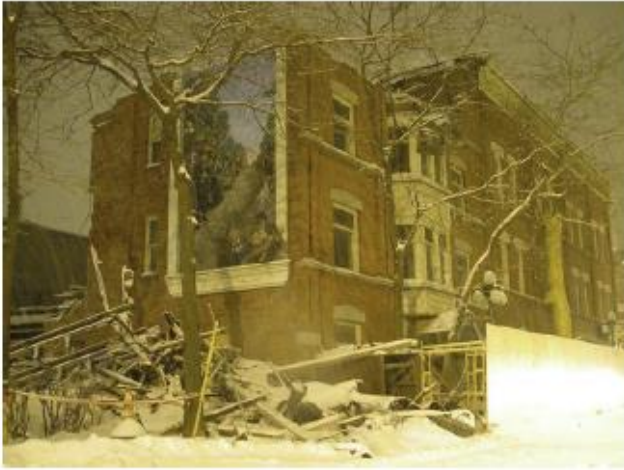
Figure 3: Somerset House after 2007 partial demolition

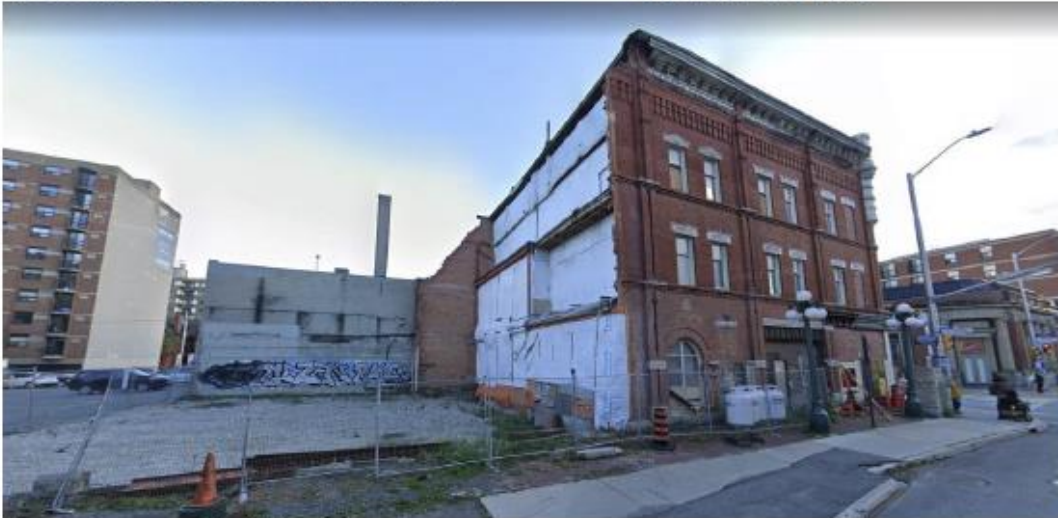
In the late 1970's the building was in poor condition, and was renovated again to house a jazz club in the basement and two pubs above. The exterior was also cleaned, the threshold along Bank Street was removed, and the cast iron details were uncovered. In 2007, construction in the basement of the addition damaged one of the columns and led to a partial collapse. At this point, the City determined that the building was structurally unsound. After consultations with John G. Cooke & Associates, the 1902 addition was demolished with the exception of the Somerset Street façade which was retained and stabilized with steel bracing. However, the building remained vacant and continued to deteriorate until 2016 when the City reluctantly agreed to an application to demolish the remaining unstable masonry façade along Somerset Street due to the health and safety risk. As of the date of this report, only the three westernmost bays of the original portion of the building remains, and the opening has been covered with Tyvek (see Figure 5 below).

Figure 5: Current state of the building

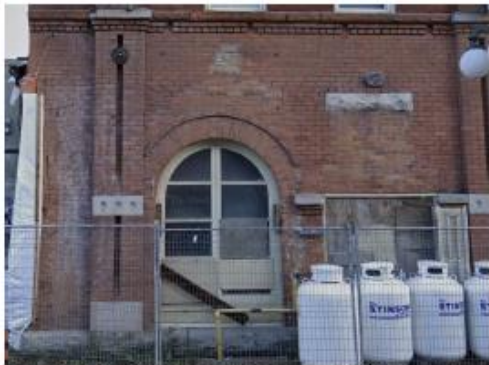
Figure 6: Brick efflorescence and debonded joints above the window on the north façade.

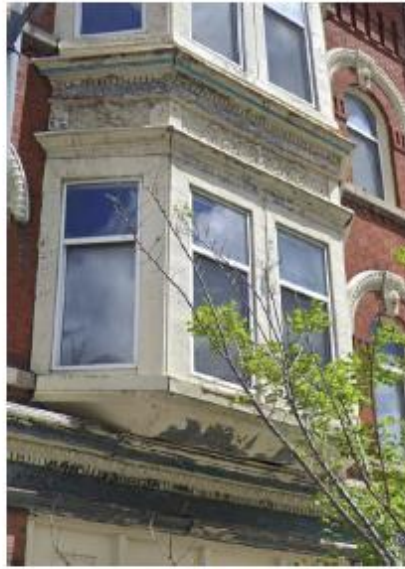
Figure 22: Exterior of the bay window on the west façade.

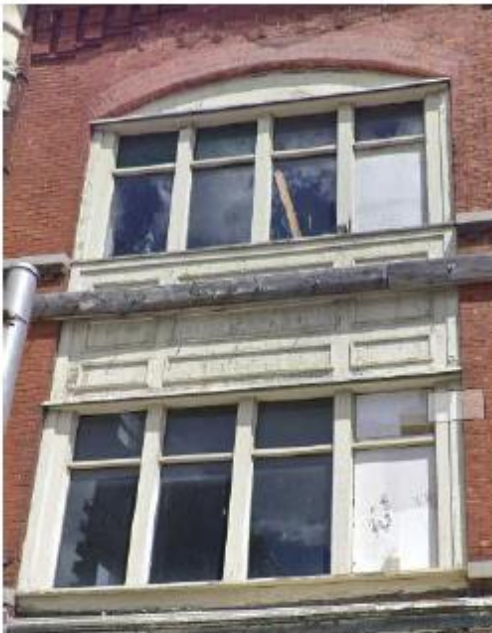
Figure 23: Exterior of the large, fixed windows on the west façade.

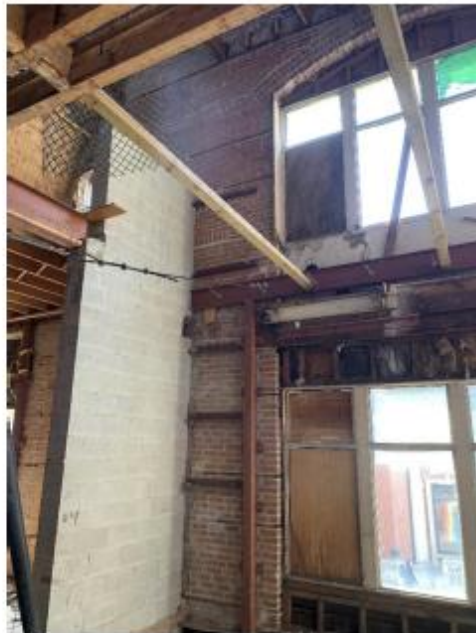
Figure 24: Interior of the large, fixed windows on the west façade.

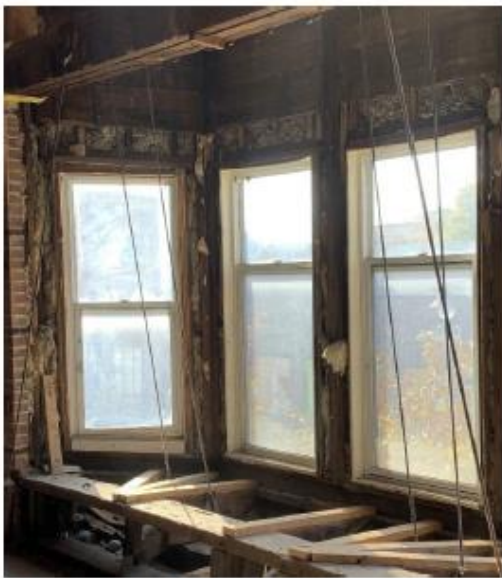
Figure 27: Interior side of the first floor bay window.

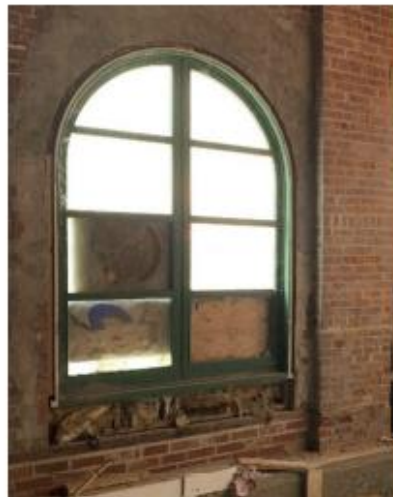
Figure 30: Interior of arched window on the north façade.

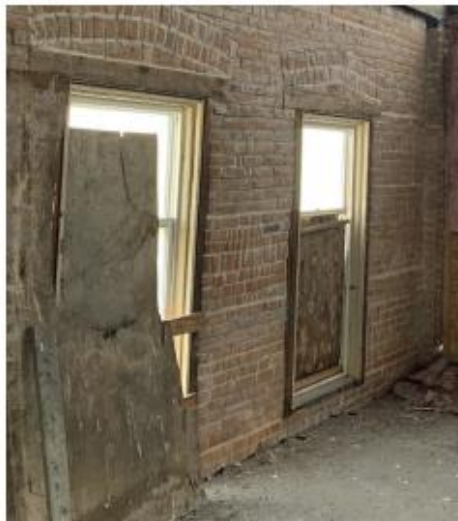
Figure 31: Interior of third floor windows on the north façade.

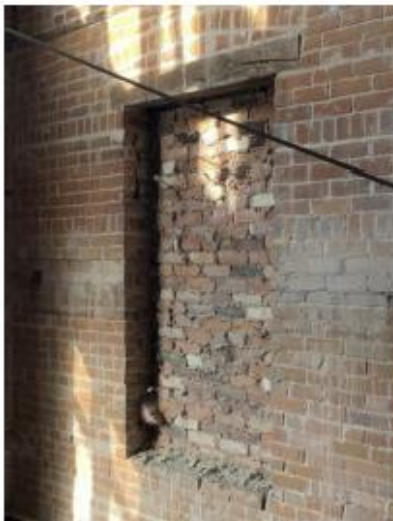
Figure 32: Infilled window on the second floor of the north façade.

- Perform repairs to deteriorated woodwork (e.g. sills, wood frames) to prevent further deterioration. Perform Dutchmen or epoxy repairs for any rotten/damage wood. Repaint/touch-up paint.
- Ensure the joint between the windows frames and the masonry is sealed tight.
- Provide a more durable, and more aesthetically compatible solution for keeping the weather out at the locations where the structural cables run through the windows. (e.g. install wood blocking, cut to size, with neoprene gaskets around the cables).
- To ensure weather-tightness, durability, and to clean-up the look of the building, it is recommended to remove the plugs and reinstall the missing glass panes.

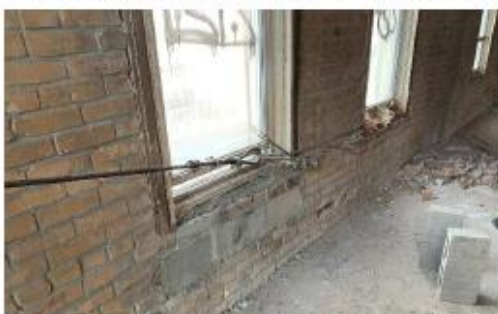
Figure 33: Interior of second floor windows on the north façade.

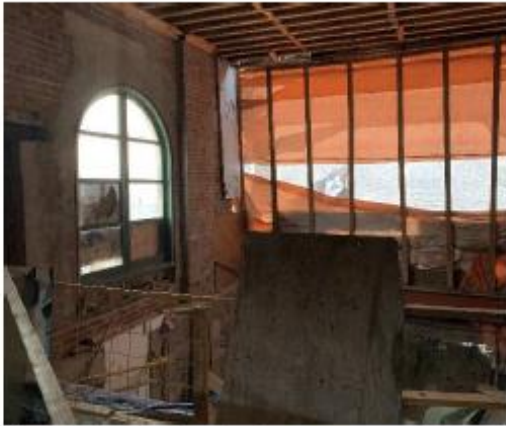
Figure 39: Interior of northeast corner.

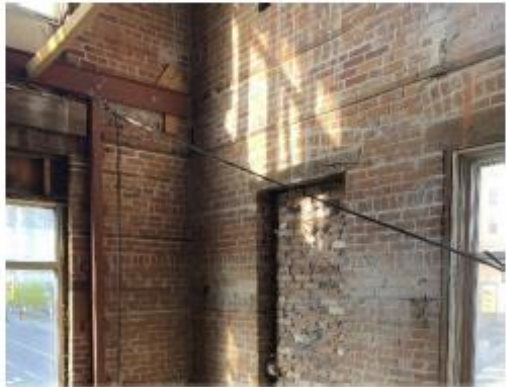
- Water staining was observed on the interior walls and in the center of all the floors from roof drain.
- On the second floor, a steel rope connecting the brick pier between two windows to the steel beam on the third floor appears to be loose.

Figure 41: Steel cable at northwest corner
