TCR  
TREE  
CONSERVATION  
REPORT

2487 INNES  
ROAD OTTAWA

May 4, 2020

**RE: TREE CONSERVATION REPORT FOR 2487 INNES ROAD, OTTAWA**

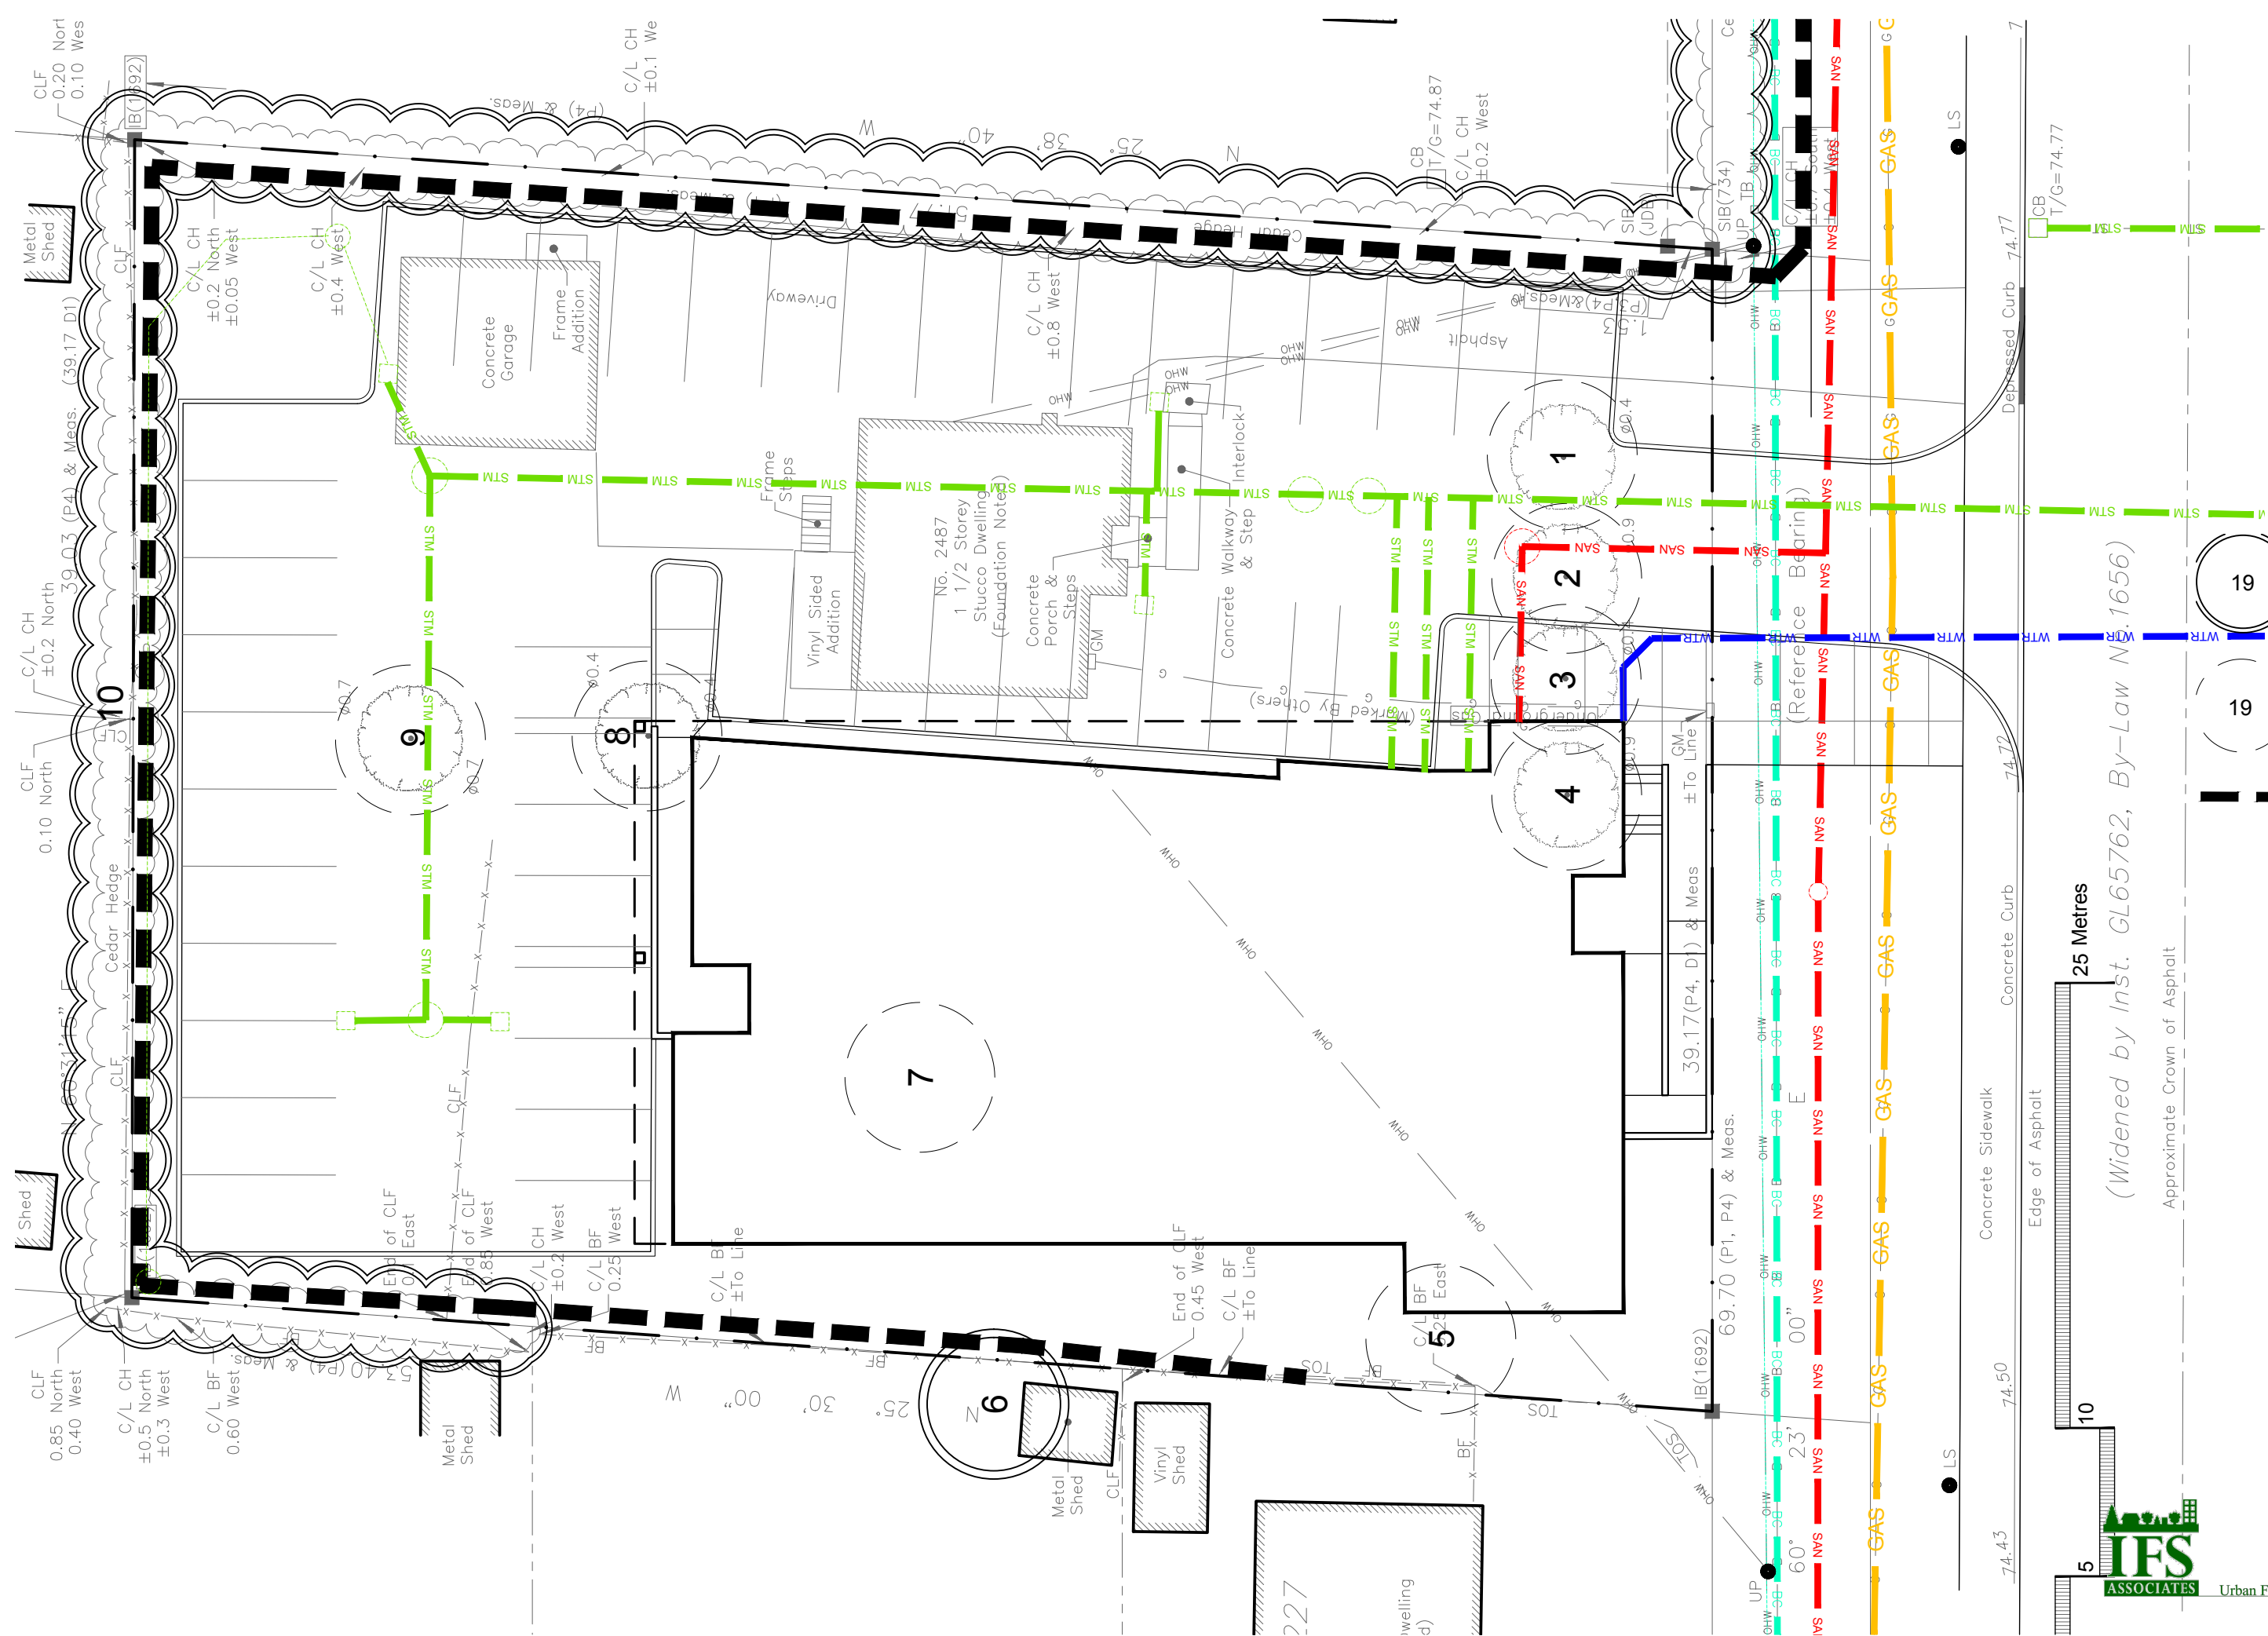
TO BE  
READ IN  
CONJUNCTION  
WITH IFS  
ASSOCIATES  
REPORT  
"TREE  
CONSERVATION  
REPORT  
"2487  
INNES  
ROAD  
OTTAWA"

Existing Tree  
to Remain

Existing Tree to  
be Removed

Protection for  
Existing Trees
