STAGE II CULTURAL HERITAGE IMPACT STATEMENT & CONSERVATION PLAN

145 Loretta Avenue & 951 Gladstone Avenue, Ottawa,
Ontario

PREPARED BY: COMMONWEALTH HISTORIC RESOURCE MANAGEMENT

Revision V5 January 2022

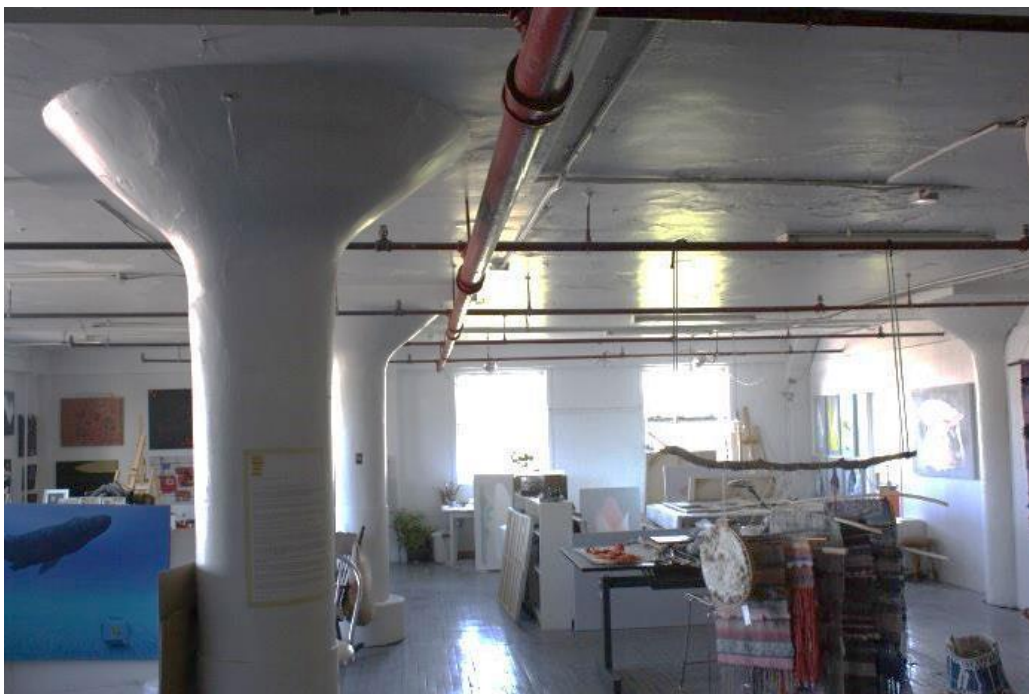
Figure 10: Interior view of the mushroom columns. Source: Commonwealth 2021

On the interior the mushroom columns found on all three floors interiors are listed as part of the character defining elements of the property and will be preserved.

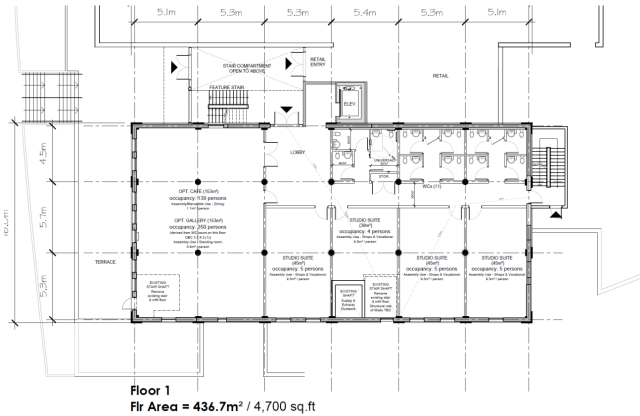
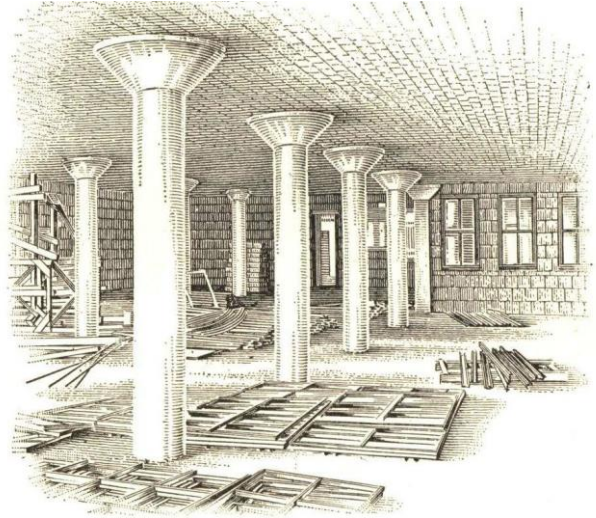
FIG. 63

Figure 22: Ground floor plan illustrating the mushroom columns establishing the grid pattern.

Figure 23: Concrete Mushroom Columns are a character defining feature. Source: Fig. 63 illustration from *Plain and Reinforced Concrete Construction*.

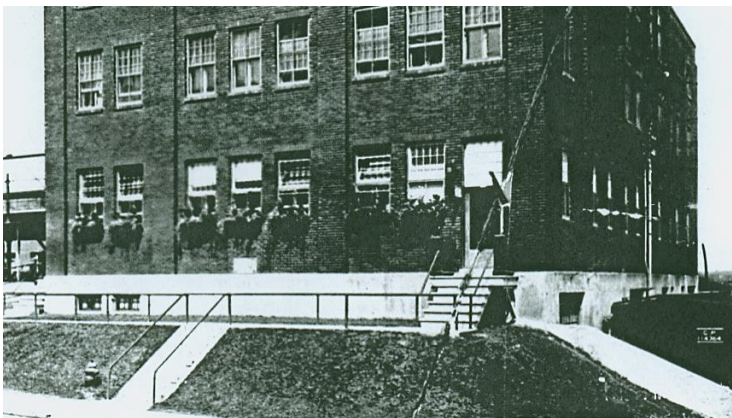
Figure 29: The 1930 view of the front entrance with a stairway leading from Gladstone and an entrance on the right-hand side of the building are defining features.

The design of the landscaping / streetscape in front of the Standard Bread building on Gladstone Street and its interface with the building has been developed based on historic photographs that document the location of the main entrance to the building as a character-defining feature. The historic entrance is interpreted from the street with stairs leading to the linked entrance from the public sidewalk.

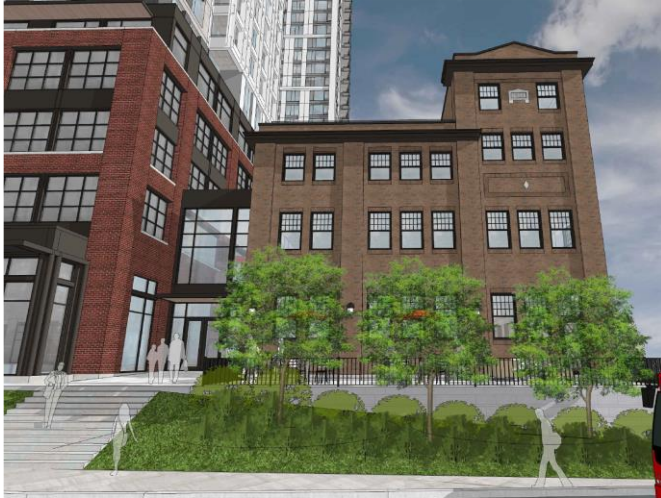
Figure 30: A rendering of the entrance treatment with the transition from the street level to the link entrance. A terrace in front of the Standard Bread serves the traditional entrance, a character defining attribute. Source: Hobin Architecture. 2021.
