Tree Disclosure Information

Address: 216 McArthur Ave Date: November 21, 2021

Prepared by: Andrew Clifford, ISA Certified Arborist ON-1997A

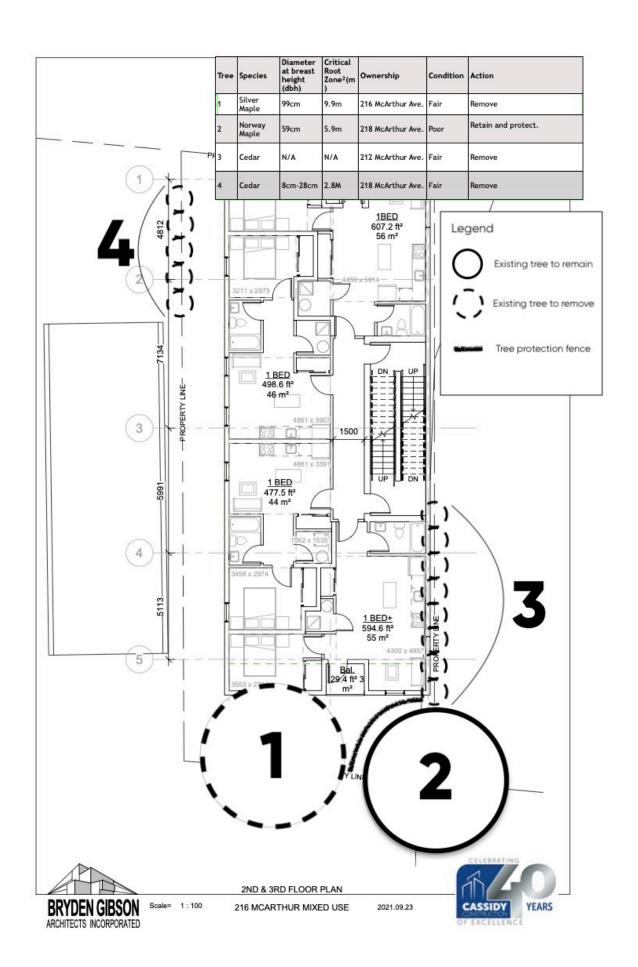
Tree no. 4 Cedar Hedge

Tree no. 4 is a row of Cedar trees ranging from 8cm-28cm DBH. Trees are within the new build and will therefore need to be removed.
