February 14, 2022

## **RE: TREE CONSERVATION REPORT FOR 180 KANATA AVENUE, OTTAWA**

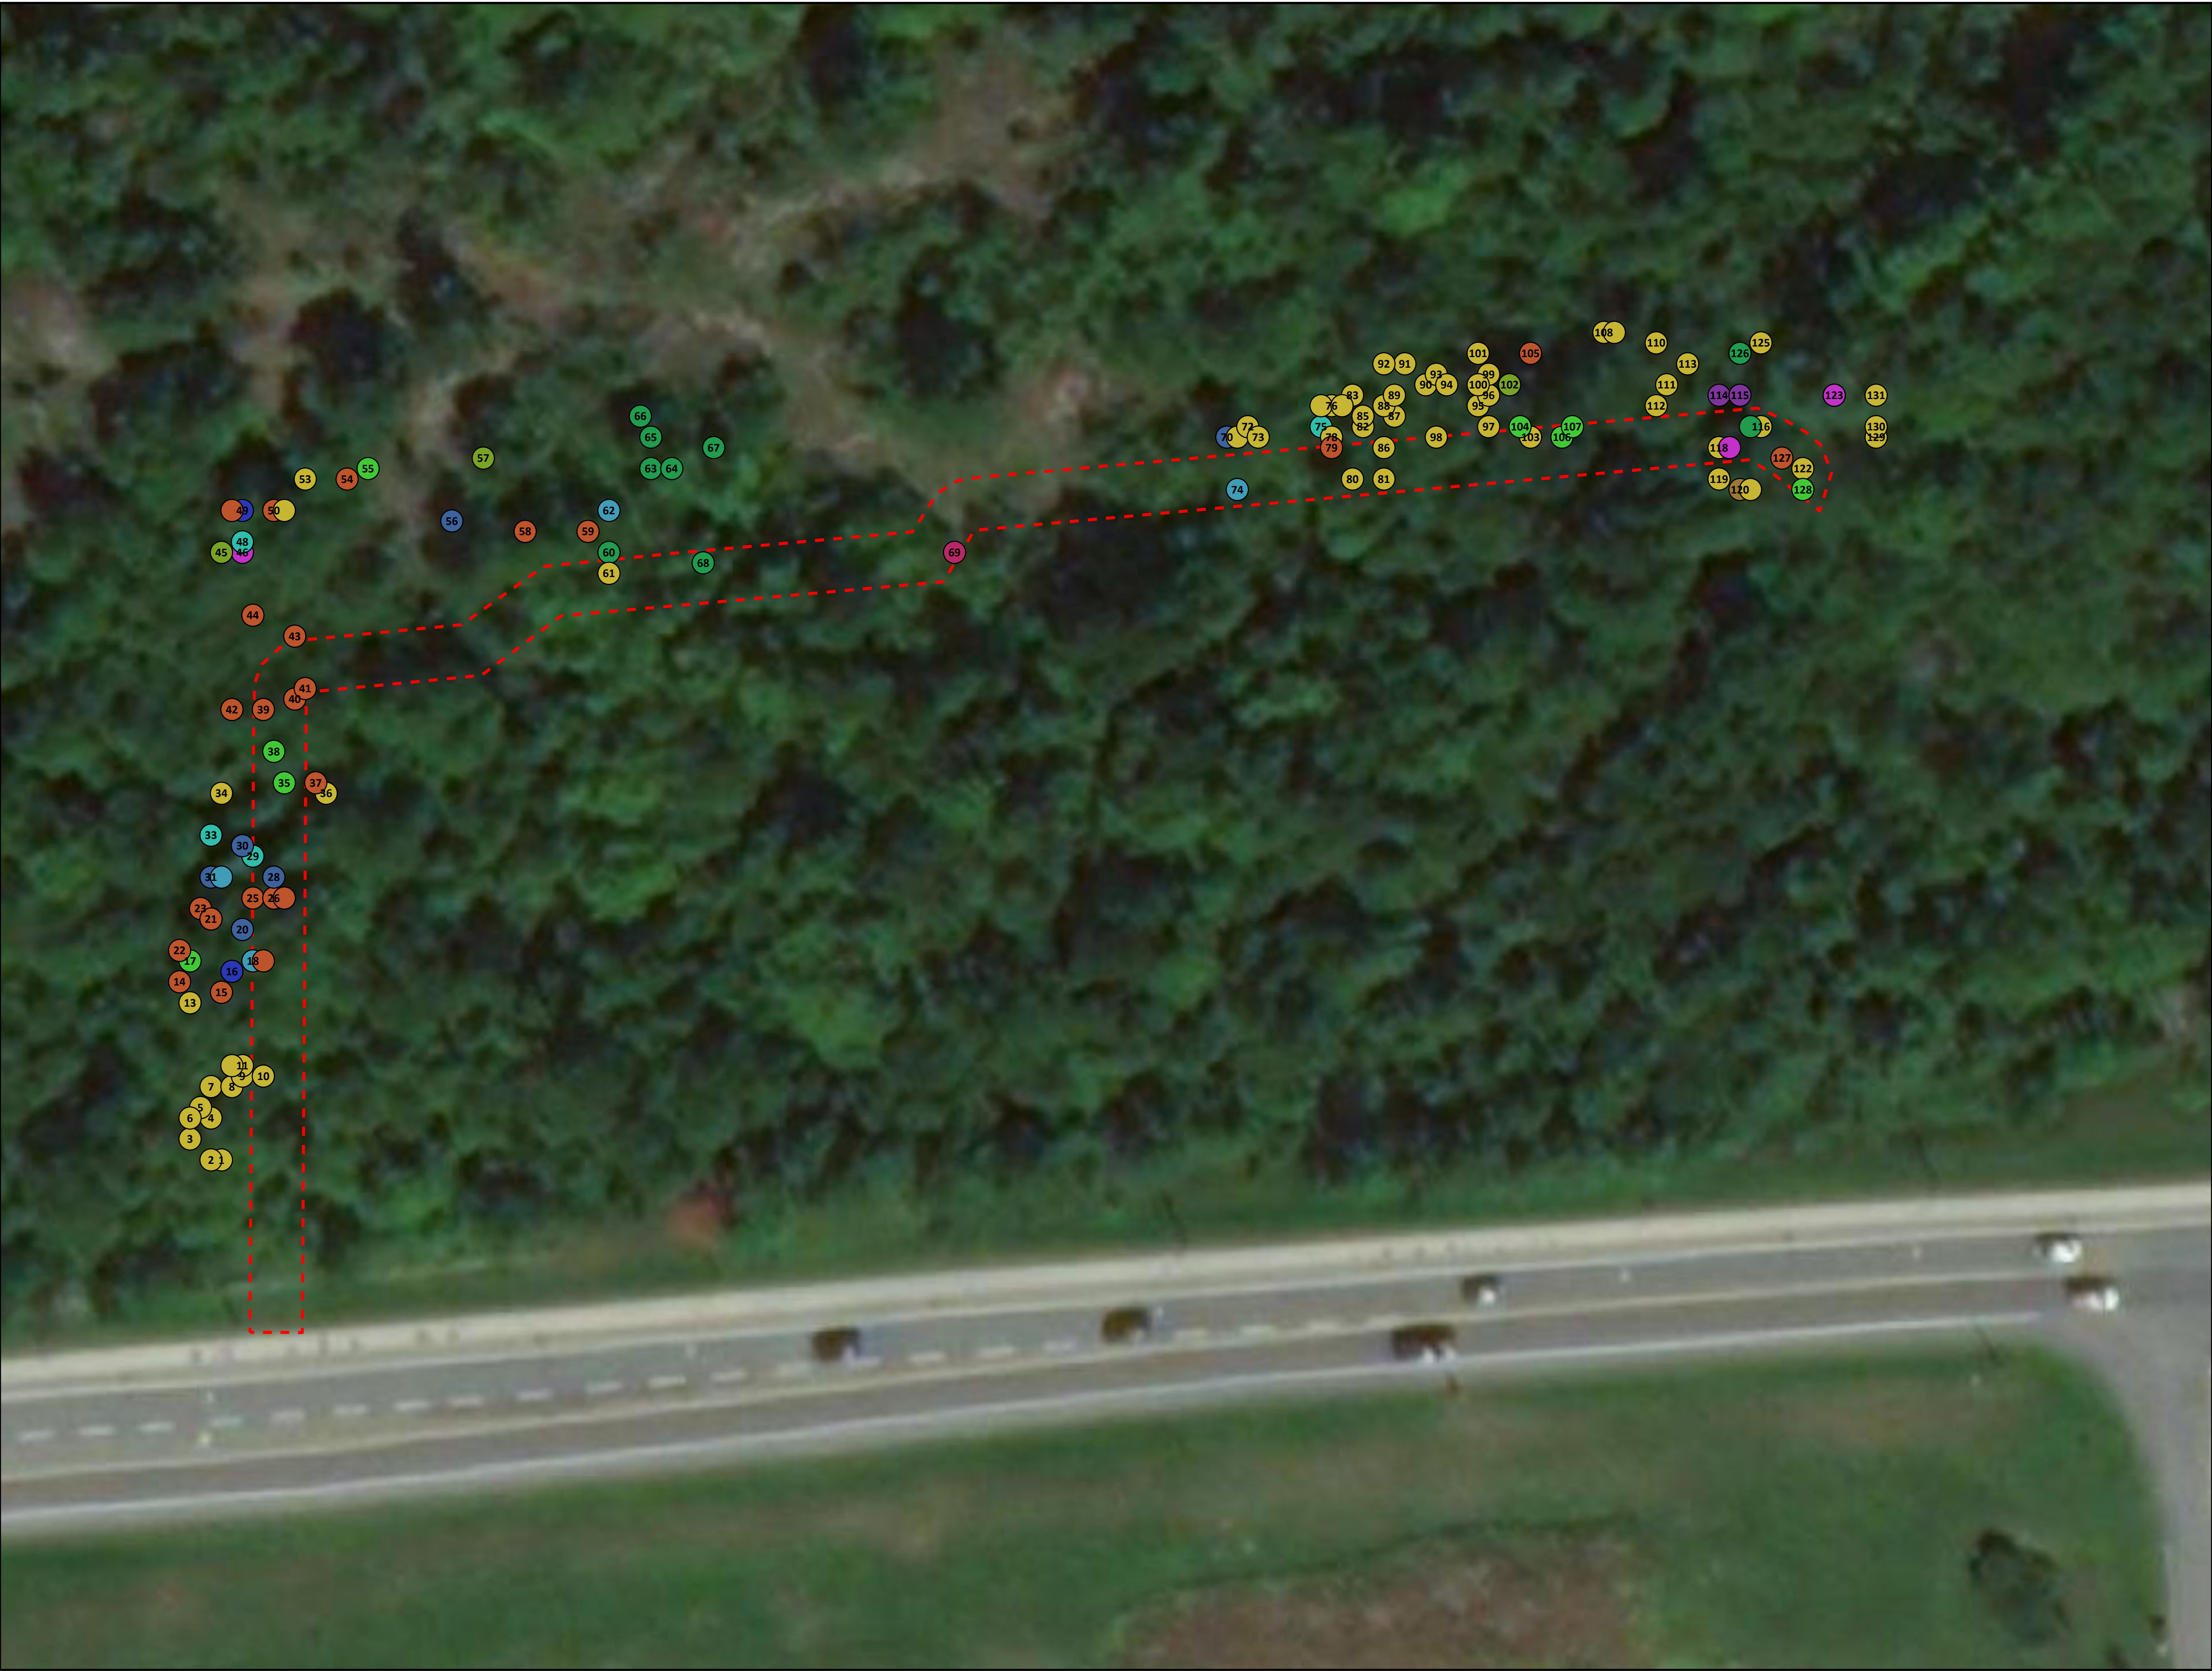
180K

Blasting will be necessary to remove bedrock as grades are dropped throughout the site. If not done carefully this work will have far-reaching consequences for retained trees as their root-soil interfaces will likely be disturbed by vibrations travelling through the substrate. It is these intimate interfaces which allow for the absorption of moisture and nutrients from the soil. To this end a survey of trees on City property within the vicinity of the shared western and northern property lines was undertaken. All trees 10cm and greater in diameter were located (via GPS) and assessed for health (poor/fair/good). A total of 132 such trees were found. Table 3 below details the findings of the survey and the aerial plan on page 16 shows locations and species of trees surveyed on City property.
