Tree Conservation Report

1600 James Naismith Drive

May 10, 2022

TREE CONSERVATION REPORT

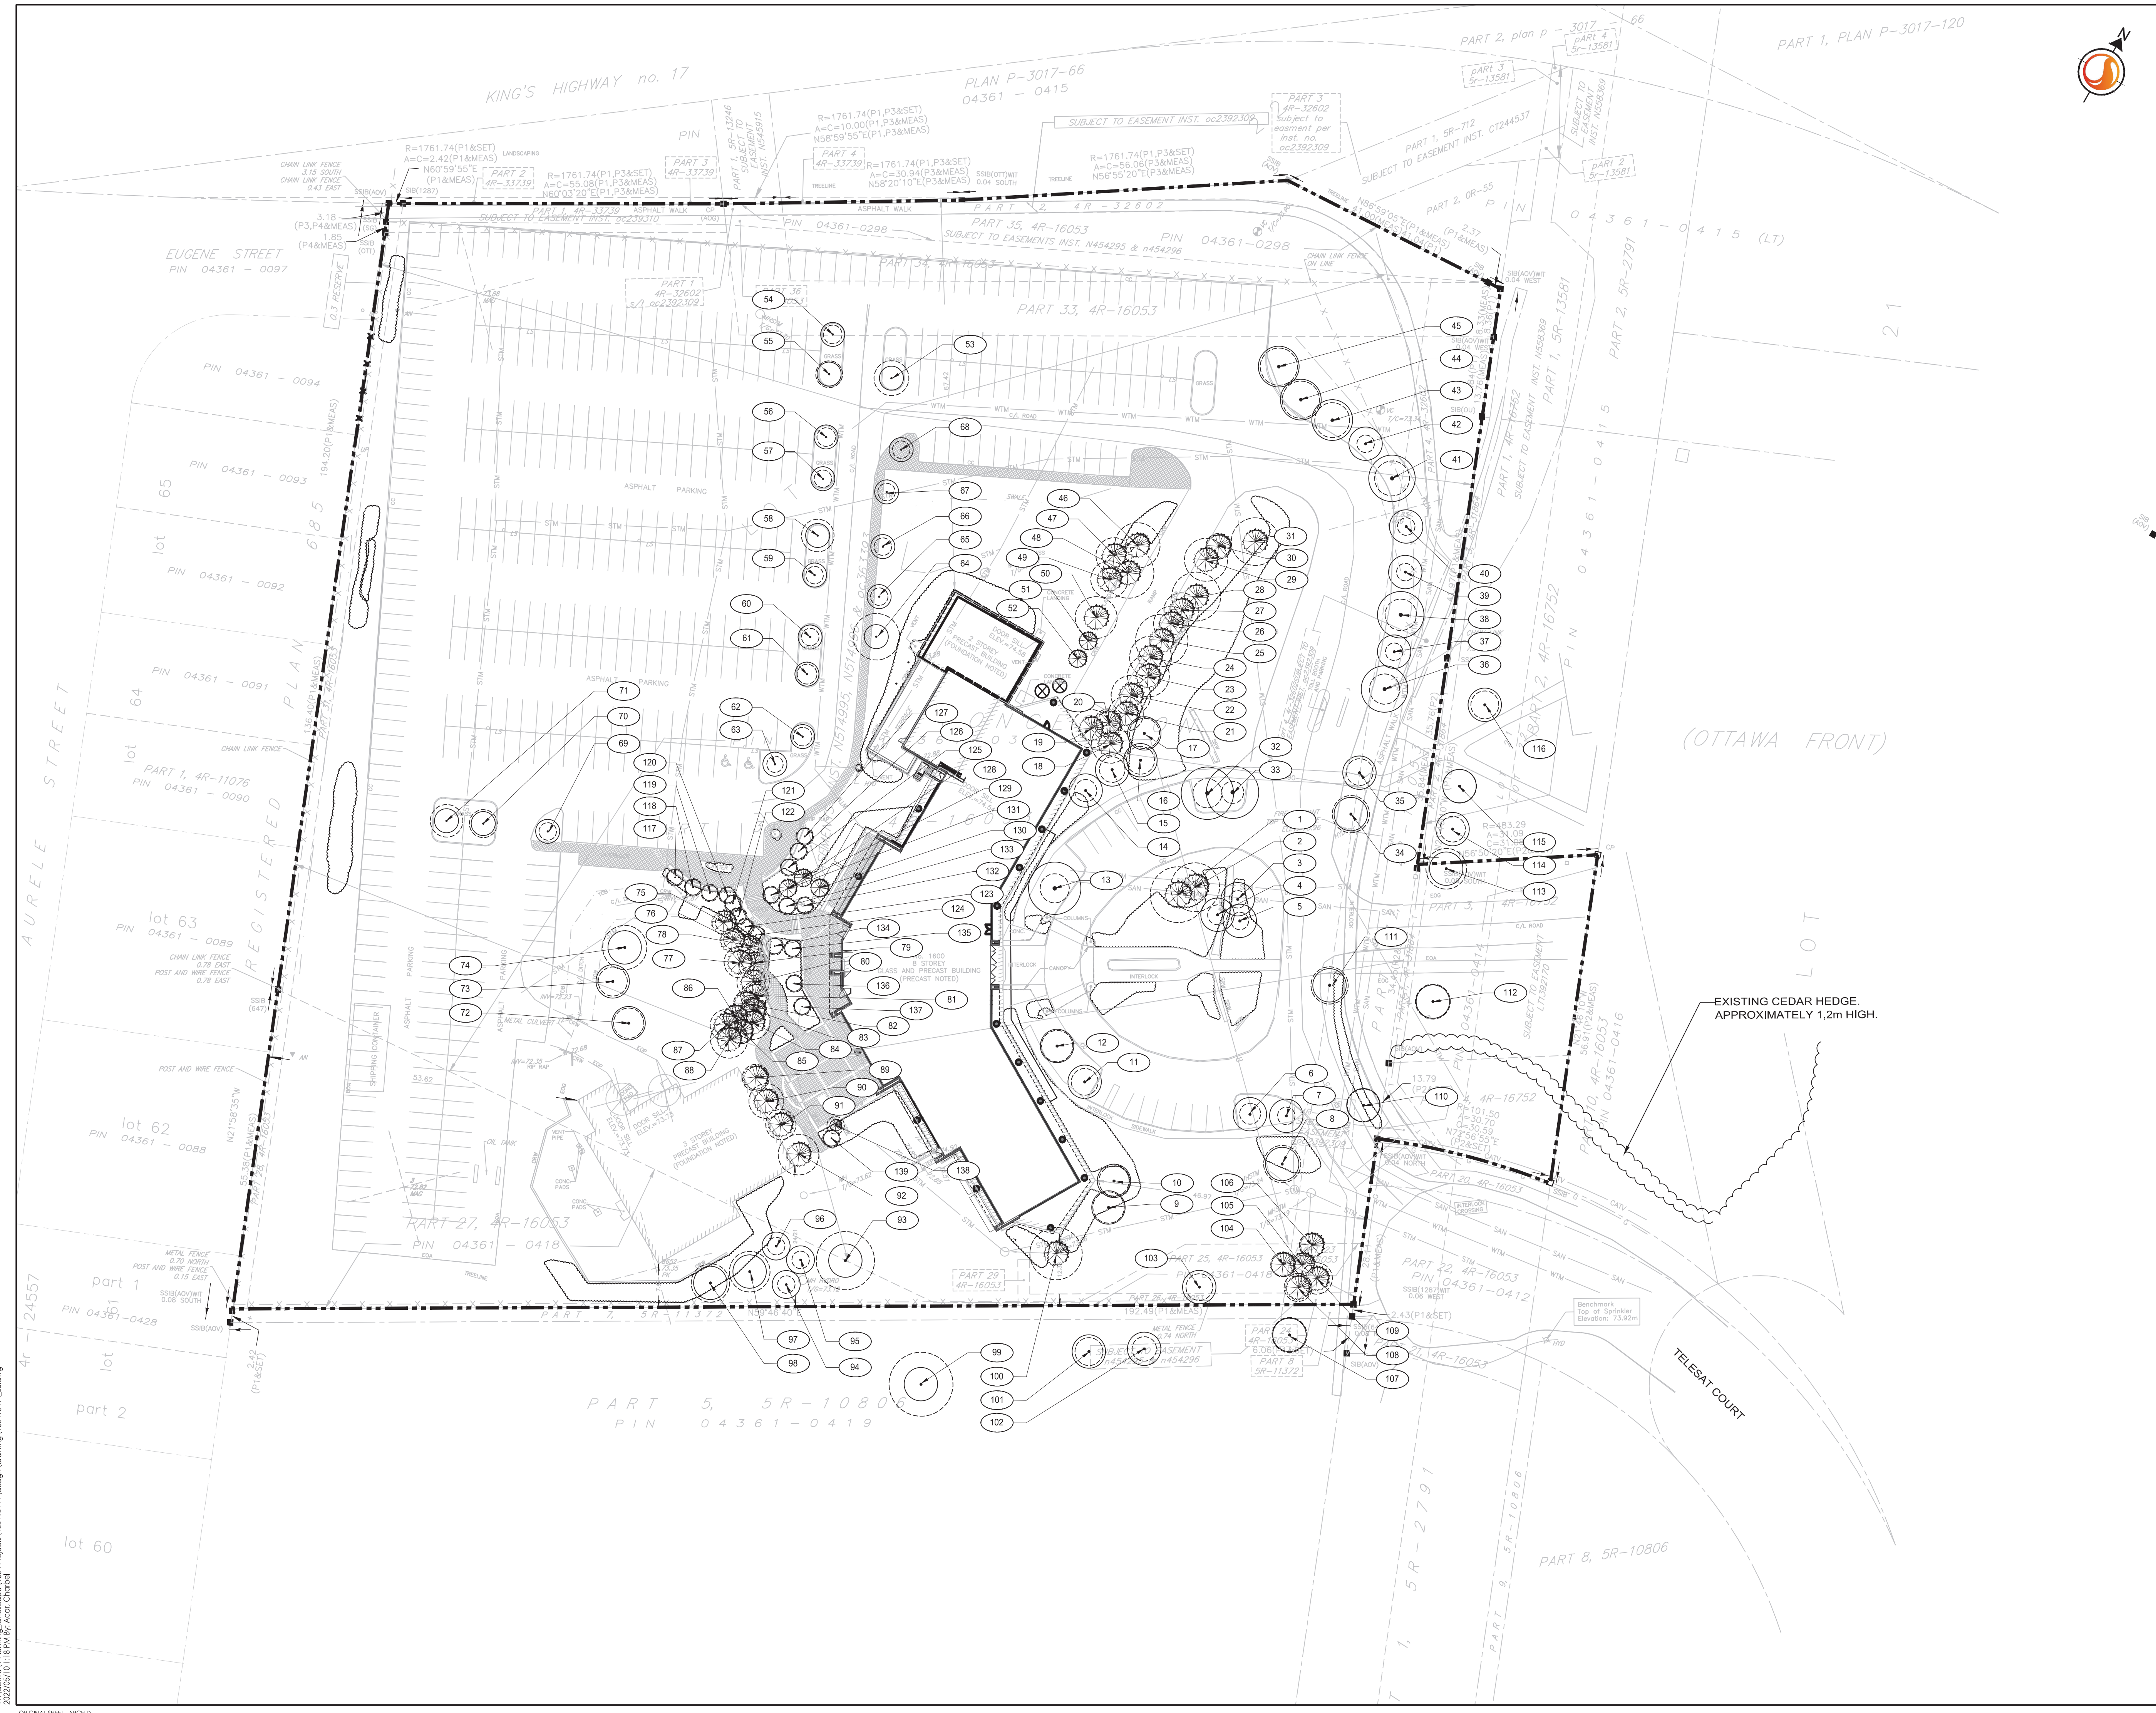
Project No.	Scale	0 5 15 25m
160410414	1:500	
Drawing No.	Sheet	Revision
TC01	1 of 4	3

125	<i>Acer ginnala</i>	Amur Maple	<10	Good	Private Multistem.
126	<i>Acer ginnala</i>	Amur Maple	<10	Good	Private Multistem.
127	<i>Acer ginnala</i>	Amur Maple	<10	Good	Private Multistem.
128	<i>Picea pungens</i>	Colorado Spruce	18	Good	Private
129	<i>Picea pungens</i>	Colorado Spruce	13	Good	Private
130	<i>Picea pungens</i>	Colorado Spruce	15	Good	Private
131	<i>Amelanchier canadensis</i>	Serviceberry	<10	Good	Private Tree stakes and rubber hoses were not removed. Rubber hoses are starting to impact tree health.
132	<i>Amelanchier canadensis</i>	Serviceberry	<10	Good	Private Tree stakes and rubber hoses were not removed. Rubber hoses are starting to impact tree health.
133	<i>Amelanchier canadensis</i>	Serviceberry	<10	Good	Private Tree stakes and rubber hoses were not removed. Rubber hoses are starting to impact tree health.
134	<i>Amelanchier canadensis</i>	Serviceberry	<10	Good	Private Tree stakes and rubber hoses were not removed. Rubber hoses are starting to impact tree health.

135	<i>Amelanchier canadensis</i>	Serviceberry	<10	Good	Private Tree stakes and rubber hoses were not removed. Rubber hoses are starting to impact tree health.
136	<i>Malus spp.</i>	Crab Apple	<10	Good	Private Tree stakes and rubber hoses were not removed. Rubber hoses are starting to impact tree health.
137	<i>Malus spp.</i>	Crab Apple	<10	Good	Private Tree stakes and rubber hoses were not removed. Rubber hoses are starting to impact tree health.
138	<i>Thuja occidentalis fastigiata</i>	Pyramidal white cedar	<10	Good	Private
139	<i>Malus spp.</i>	Crab Apple	<10	Good	Private
