**Project:**  
**70 RICHMOND ROAD DEVELOPMENT**

**Drawing:**  
**TREE INFORMATION REPORT**

Scale: 1:150	Date: 2021 08 10
Design By: JM	Drawn By: HP/PG
Project Number: 2067-01	Sheet Number: TIR 01

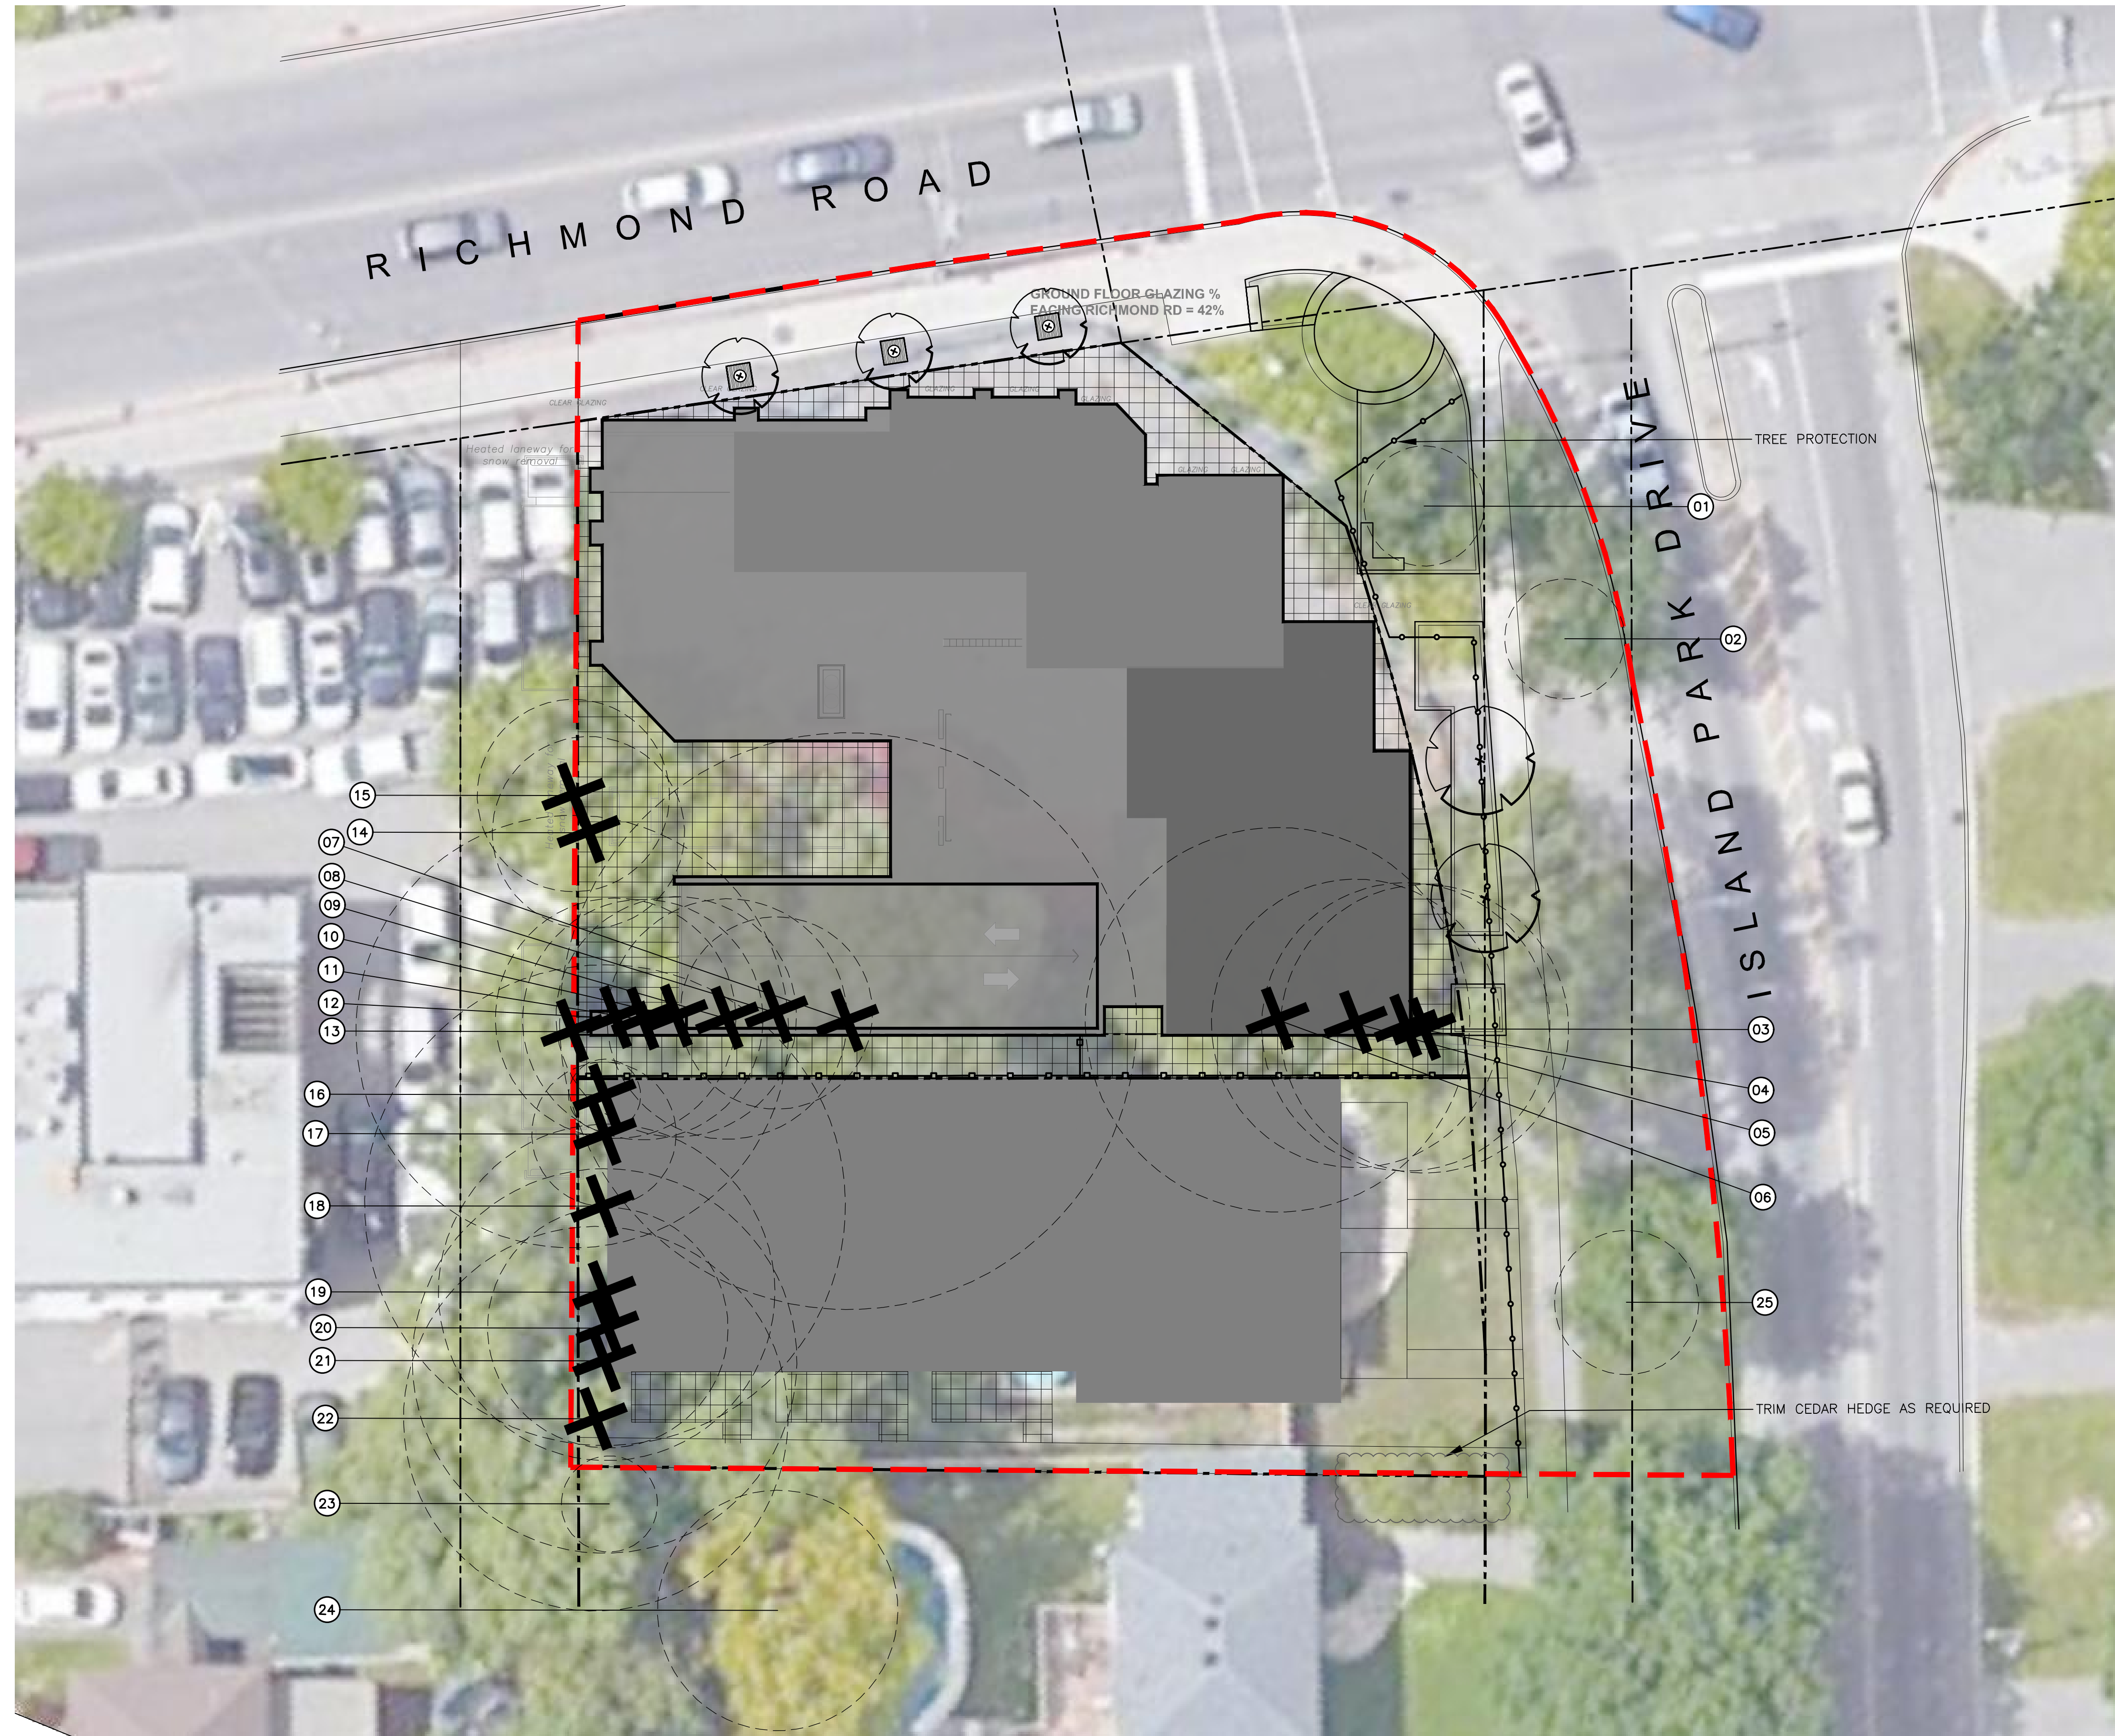
- GENERALLY, THE TREES ON THE PROPERTY ARE IN MODERATE TO POOR CONDITION WITH NEARLY ALL SPECIES BEING INVASIVE.
  - 25 TREES WERE INVENTORIED WITHIN OR IN PROXIMITY TO THE PROJECT.

- THE TWO TREES IN THE ISLAND PARK DRIVE RIGHT-OF-WAY WILL BE SIGNIFICANTLY IMPACTED WITH CONSTRUCTION UP TO THE PROPERTY LIMIT.
  - THE TREES ARE OF MODERATE SIZE WITH SOME POSITIVE IMPACTS TO THE USERS ALONG ISLAND PARK DRIVE.

- BOTH TREES HAVE MINOR AFFLICTIONS THAT WILL PRESENT AS MORE SERIOUS STRUCTURAL PROBLEMS AS THE TREES CONTINUE TO MATURE.
