TREE CONSERVATION REPORT

2920 Sheffield Rd

Tree Conservation Report submitted as
Partial Requirements for a Site Plan
Control Application, December 14, 2021

Date: December 14, 2021

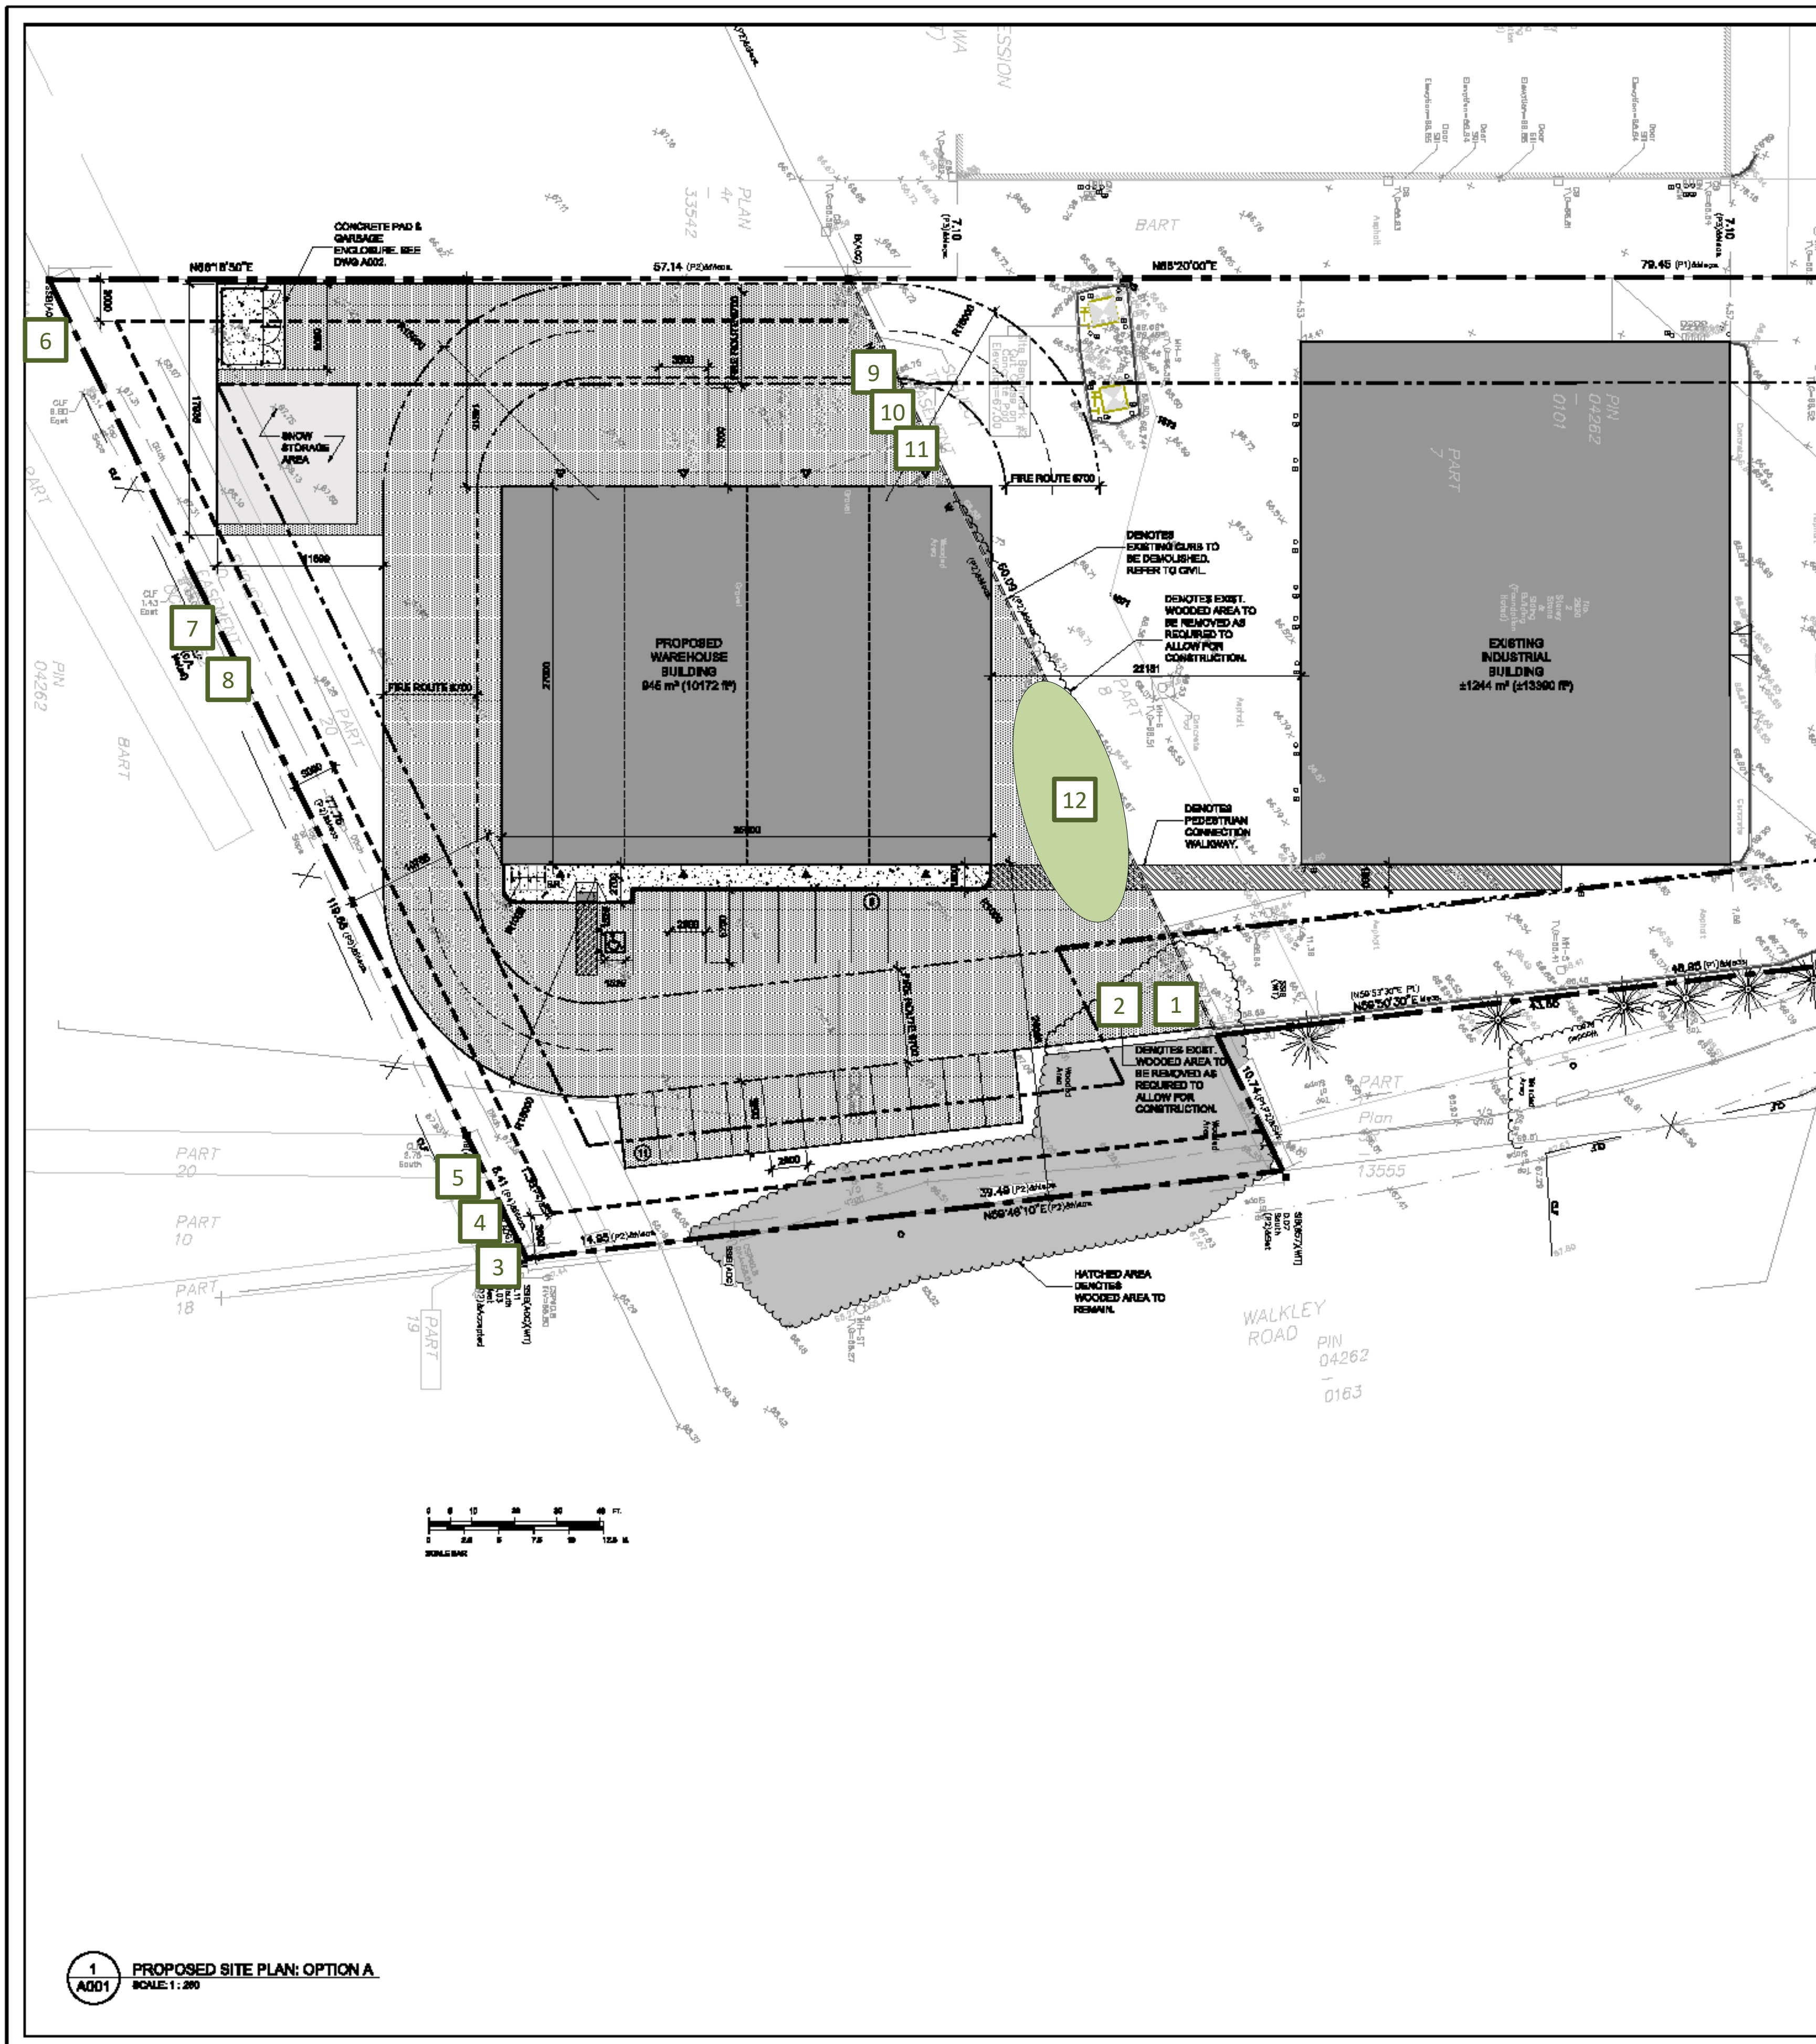
PROPOSED SITE PLAN OPTION A	
PROJECT No: 000	REVISION: 02
DRAWN: GL	DATE: AUGUST 2021
APPROVED: 000	SCALE: AS SHOWN
A001

Tree ¹	Species	Diameter at breast height (dbh)	Action
1	Ash (<i>Fraxinus spp</i>)	26, 25 cm	Remove; no permit required
2	Ash (<i>Fraxinus spp</i>)	38, 28 cm	Remove; no permit required
3	Manitoba maple (<i>Acer negundo</i>)	16, 18, 9 cm	Retain or remove with permission from adjacent property owner
4	Trembling aspen (<i>Populus tremuloides</i>)	15 cm	Retain or remove with permission from adjacent property owner
5	Trembling aspen (<i>Populus tremuloides</i>)	13 cm	Retain or remove with permission from adjacent property owner
6	Trembling aspen (<i>Populus tremuloides</i>)	13, 16 cm	Retain or remove with permission from adjacent property owner
7	Trembling aspen (<i>Populus tremuloides</i>)	13 cm	Retain or remove with permission from adjacent property owner
8	Trembling aspen (<i>Populus tremuloides</i>)	16, 15, 15, 15, 12 cm	Retain or remove with permission from adjacent property owner
9	Trembling aspen (<i>Populus tremuloides</i>)	26 cm	Remove; hazardous and in conflict with new building and fire route

Note that the tree layer has been added to the original site plan supplied by the client in pdf format. This layer refers to the trees only, and the original site plan has not been altered in the process.
Note: tree locations are estimations only and are not accurate
