McINTOSH PERRY

COMBINED LATERAL SEWER CCTV INSPECTION

**637 CUMMINGS AVENUE
OTTAWA, ONTARIO**

Tuesday, May 17, 2022

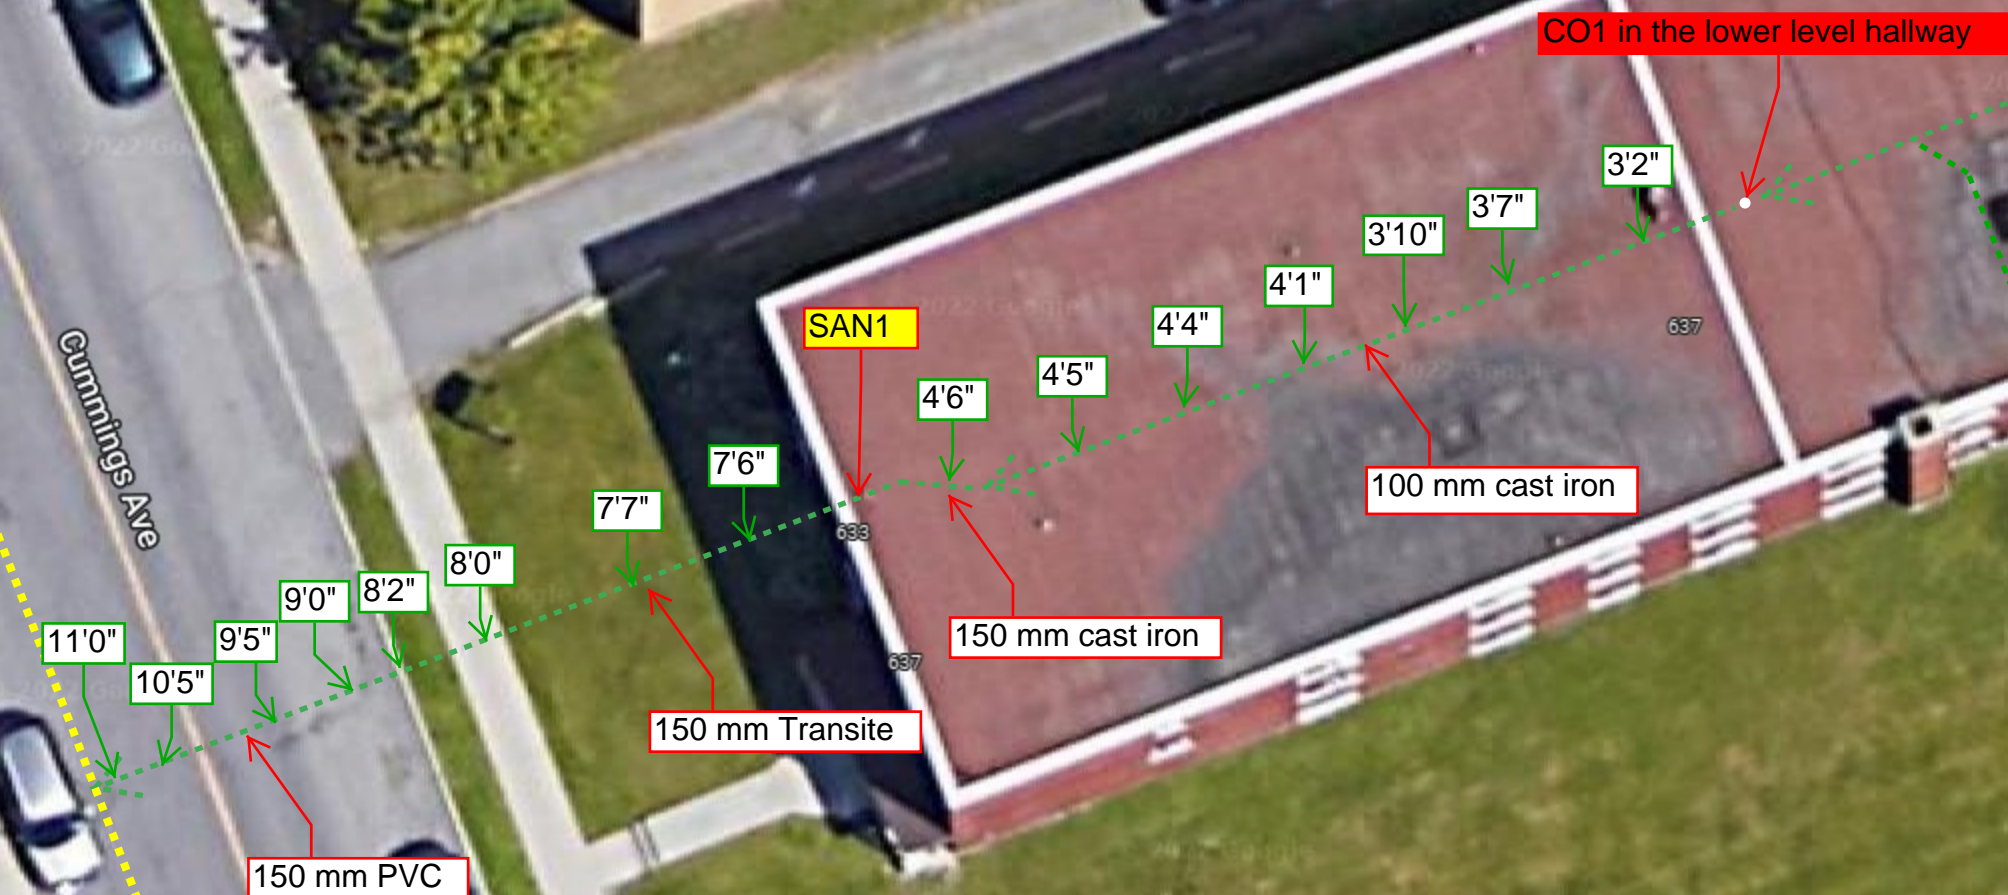
Roof Drain Access For Combined Sewer Confirmation (Dropped second mini camera inside and recorded visual confirmation in the electrical room stack)

Electrical Room Stack (Basement) - Made visual confirmation of second mini camera, then proceeded to CO1 to confirm that this (roof drain) line is connected to the sanitary.
