# STAGE II CULTURAL HERITAGE IMPACT STATEMENT & CONSERVATION PLAN

145 Loretta Avenue & 951 Gladstone Avenue,  
Ottawa, Ontario

**PREPARED BY: COMMONWEALTH HISTORIC RESOURCE MANAGEMENT**

**Revision V5 October 2022**

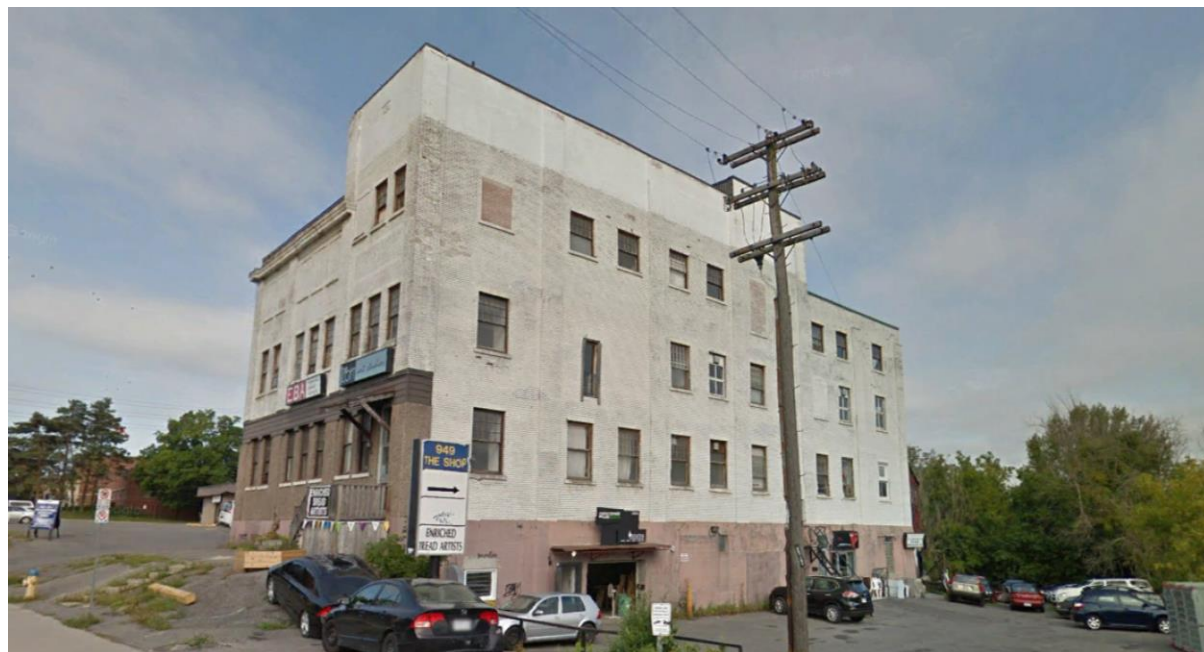
Figure 3: View looking west along Gladstone to the development site. Note the fenestration pattern on the east elevation (left) which characterizes its light industrial use with doors occurring on the second and third-floor levels and the location of an internal hoist to move material between floor levels. Source: Google Earth.

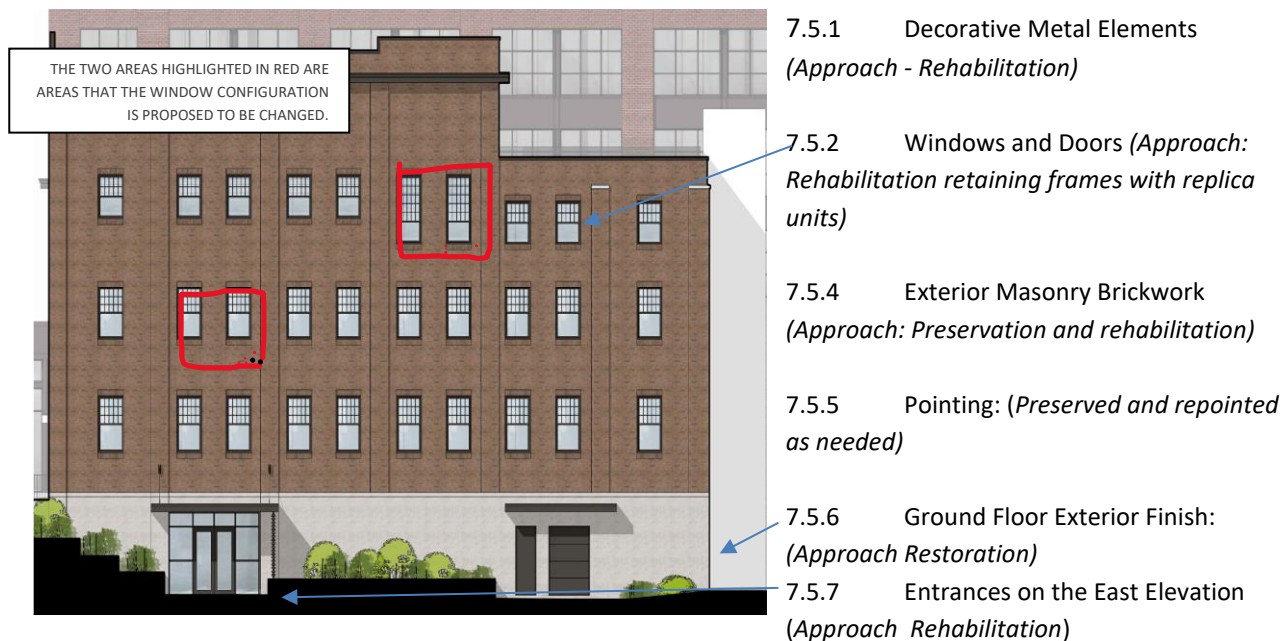
East Elevation

The gabled brick and metal parapets are in poor condition (figure 30) and will require restoration and for whole sections, the flashing and cornice profile details will have to be fabricated based on the photographs and remaining elements.

*Figure 30: The gabled brick and metal parapets will be re-instated to their original form and design. The height of the parapet can be determined from period photos. The original colour of the brick is evident in areas where the paint has worn off. Bricked-in windows will be opened and reglazed retaining the glazing pattern.*
