June 15, 2021

RE: TREE CONSERVATION REPORT FOR 155 IBER ROAD, OTTAWA

This report details a pre-construction tree conservation report (TCR) for the above-noted property in Ottawa. The need for this TCR is related to the proposed construction of a stand-alone single storey warehouse and associated loading zone at the rear of the property. A realigned entranceway into the property, relocated parking spaces and the addition of bicycle parking are also proposed.

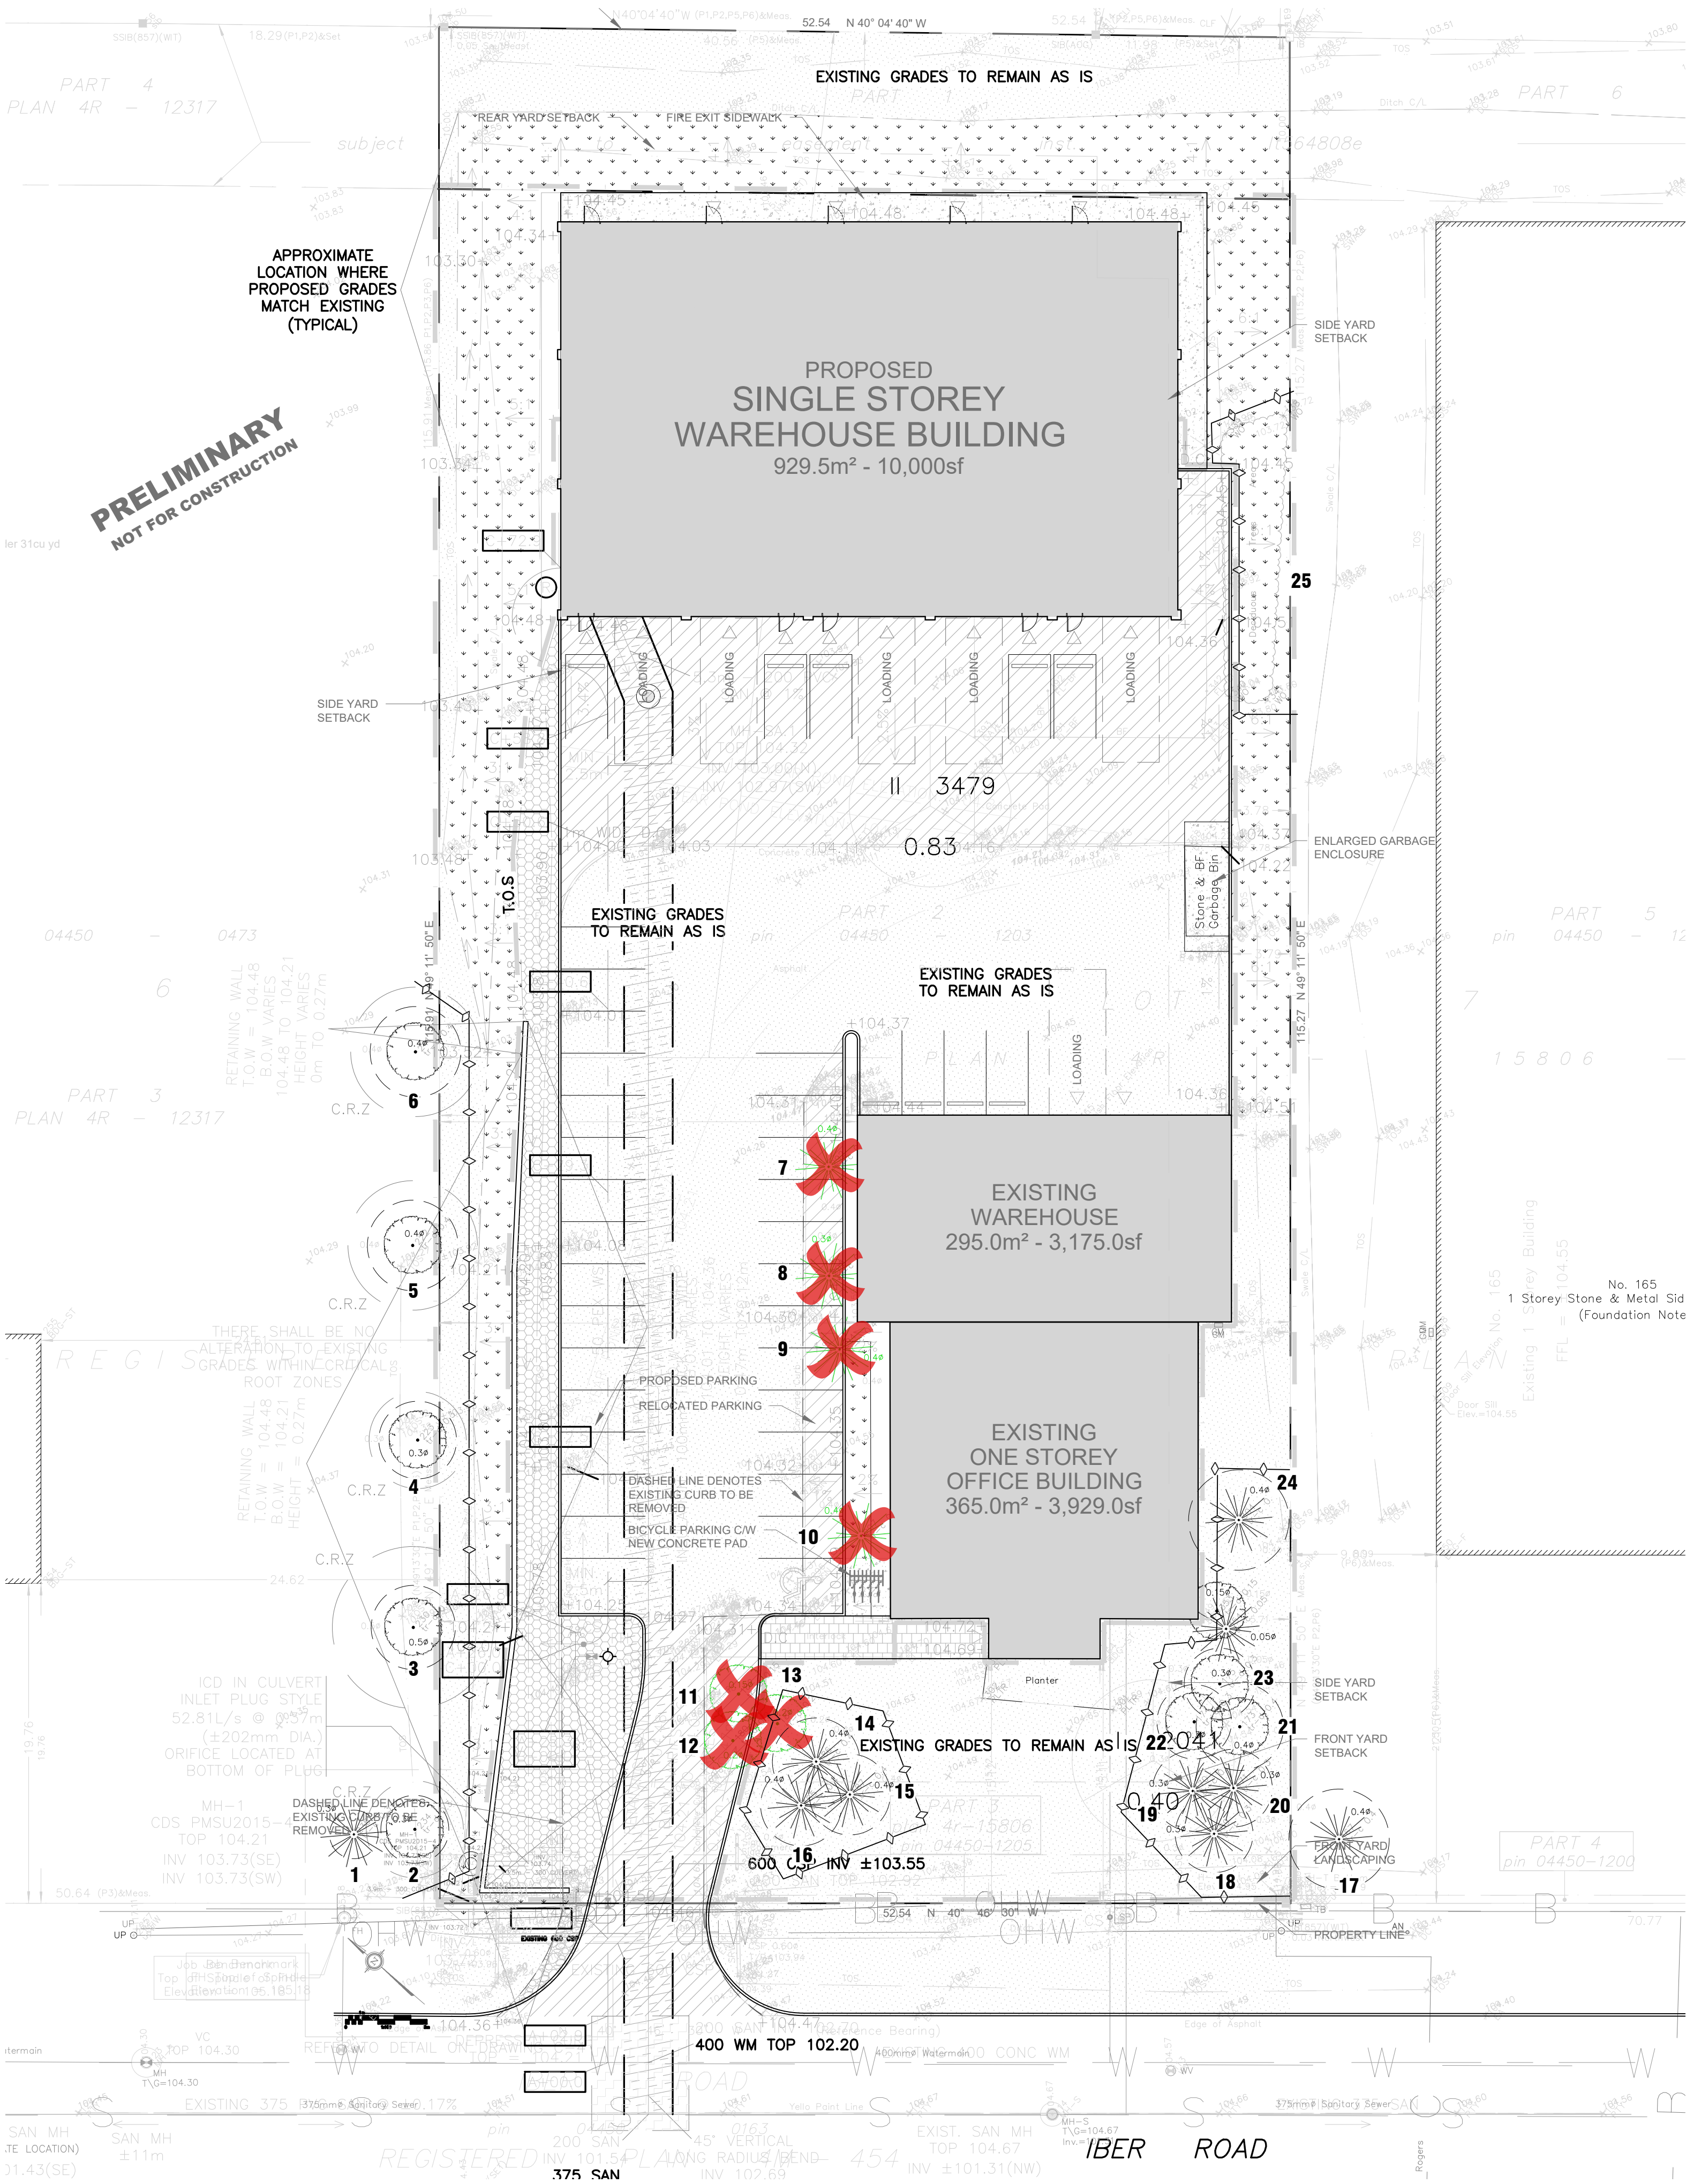
1 TREE CONSERVATION PLAN

NO.	SPECIES	CONDITION	D.B.H. ¹ (cm)	OWNERSHIP	TREE CONDITION	STATUS ²	CRZ ³ (m)
1	Colorado spruce (Picea pungens)	GOOD	15.0	NEIGHBOUR	Maturing; very good crown density, growth increment and needle colour; lower branches broken by snow piling; introduced species; to be preserved and protected	To be retained	1.5
2	Little-leaf linden (Tilia cordata)	FAIR	20.6	NEIGHBOUR	Maturing; central dominant main stem for entire height; heavy basal sprouting; introduced species; to be preserved and protected	To be retained	2.1
3	Norway maple (Acer platanoides)	GOOD	26.3	NEIGHBOUR	Mature; central dominant main stem with suppressed laterals starting at 1.5m from grade; broad dense crown; introduced invasive species; to be preserved and protected	To be retained	2.6
4	Norway maple (Acer platanoides)	POOR	24.2	NEIGHBOUR	Mature; central stem with dominant lateral at 2m on northwest; eutypella canker (Eutypella parasitica) at 0.1-1m on west side of main stem; to be preserved and protected	To be retained	2.4

5	Norway maple (Acer platanoides)	GOOD	27.5	NEIGHBOUR	Mature; central main stem with suppressed laterals starting at 1.5m from grade; broad dense crown; spiral seam at 0.1-1.4m on south side of main stem has healed; to be preserved and protected	To be retained	2.8
6	Norway maple (Acer platanoides)	GOOD	28.2	NEIGHBOUR	Mature; central main stem with suppressed laterals starting at 1.5m from grade; broad dense crown; lower lateral on north side broken by snow plow; to be preserved and protected	To be retained	2.8
7	Colorado spruce (Picea pungens)	GOOD	23.2	PRIVATE	Mature; good crown density, growth increment and needle colour; restricted rooting area close to side of building; to be removed (conflicts with proposed new parking)	REMOVE	2.3
8	Colorado spruce (Picea pungens)	GOOD	24.1	PRIVATE	Mature; good crown density, growth increment and needle colour; restricted rooting area close to side of building; to be removed (conflicts with proposed new parking)	REMOVE	2.4

REFER TO RECOMMENDATIONS IN REPORT PREPARED BY IFS ASSOCIATES FOR TECHNIQUES TO PRESERVE TREES.
