July 11, 2022

RE: TREE CONSERVATION REPORT FOR 2700 SWANSEA CRESCENT, OTTAWA

Table 1. Species, condition, size (diameter) and status of trees at 2700 Swansea Crescent

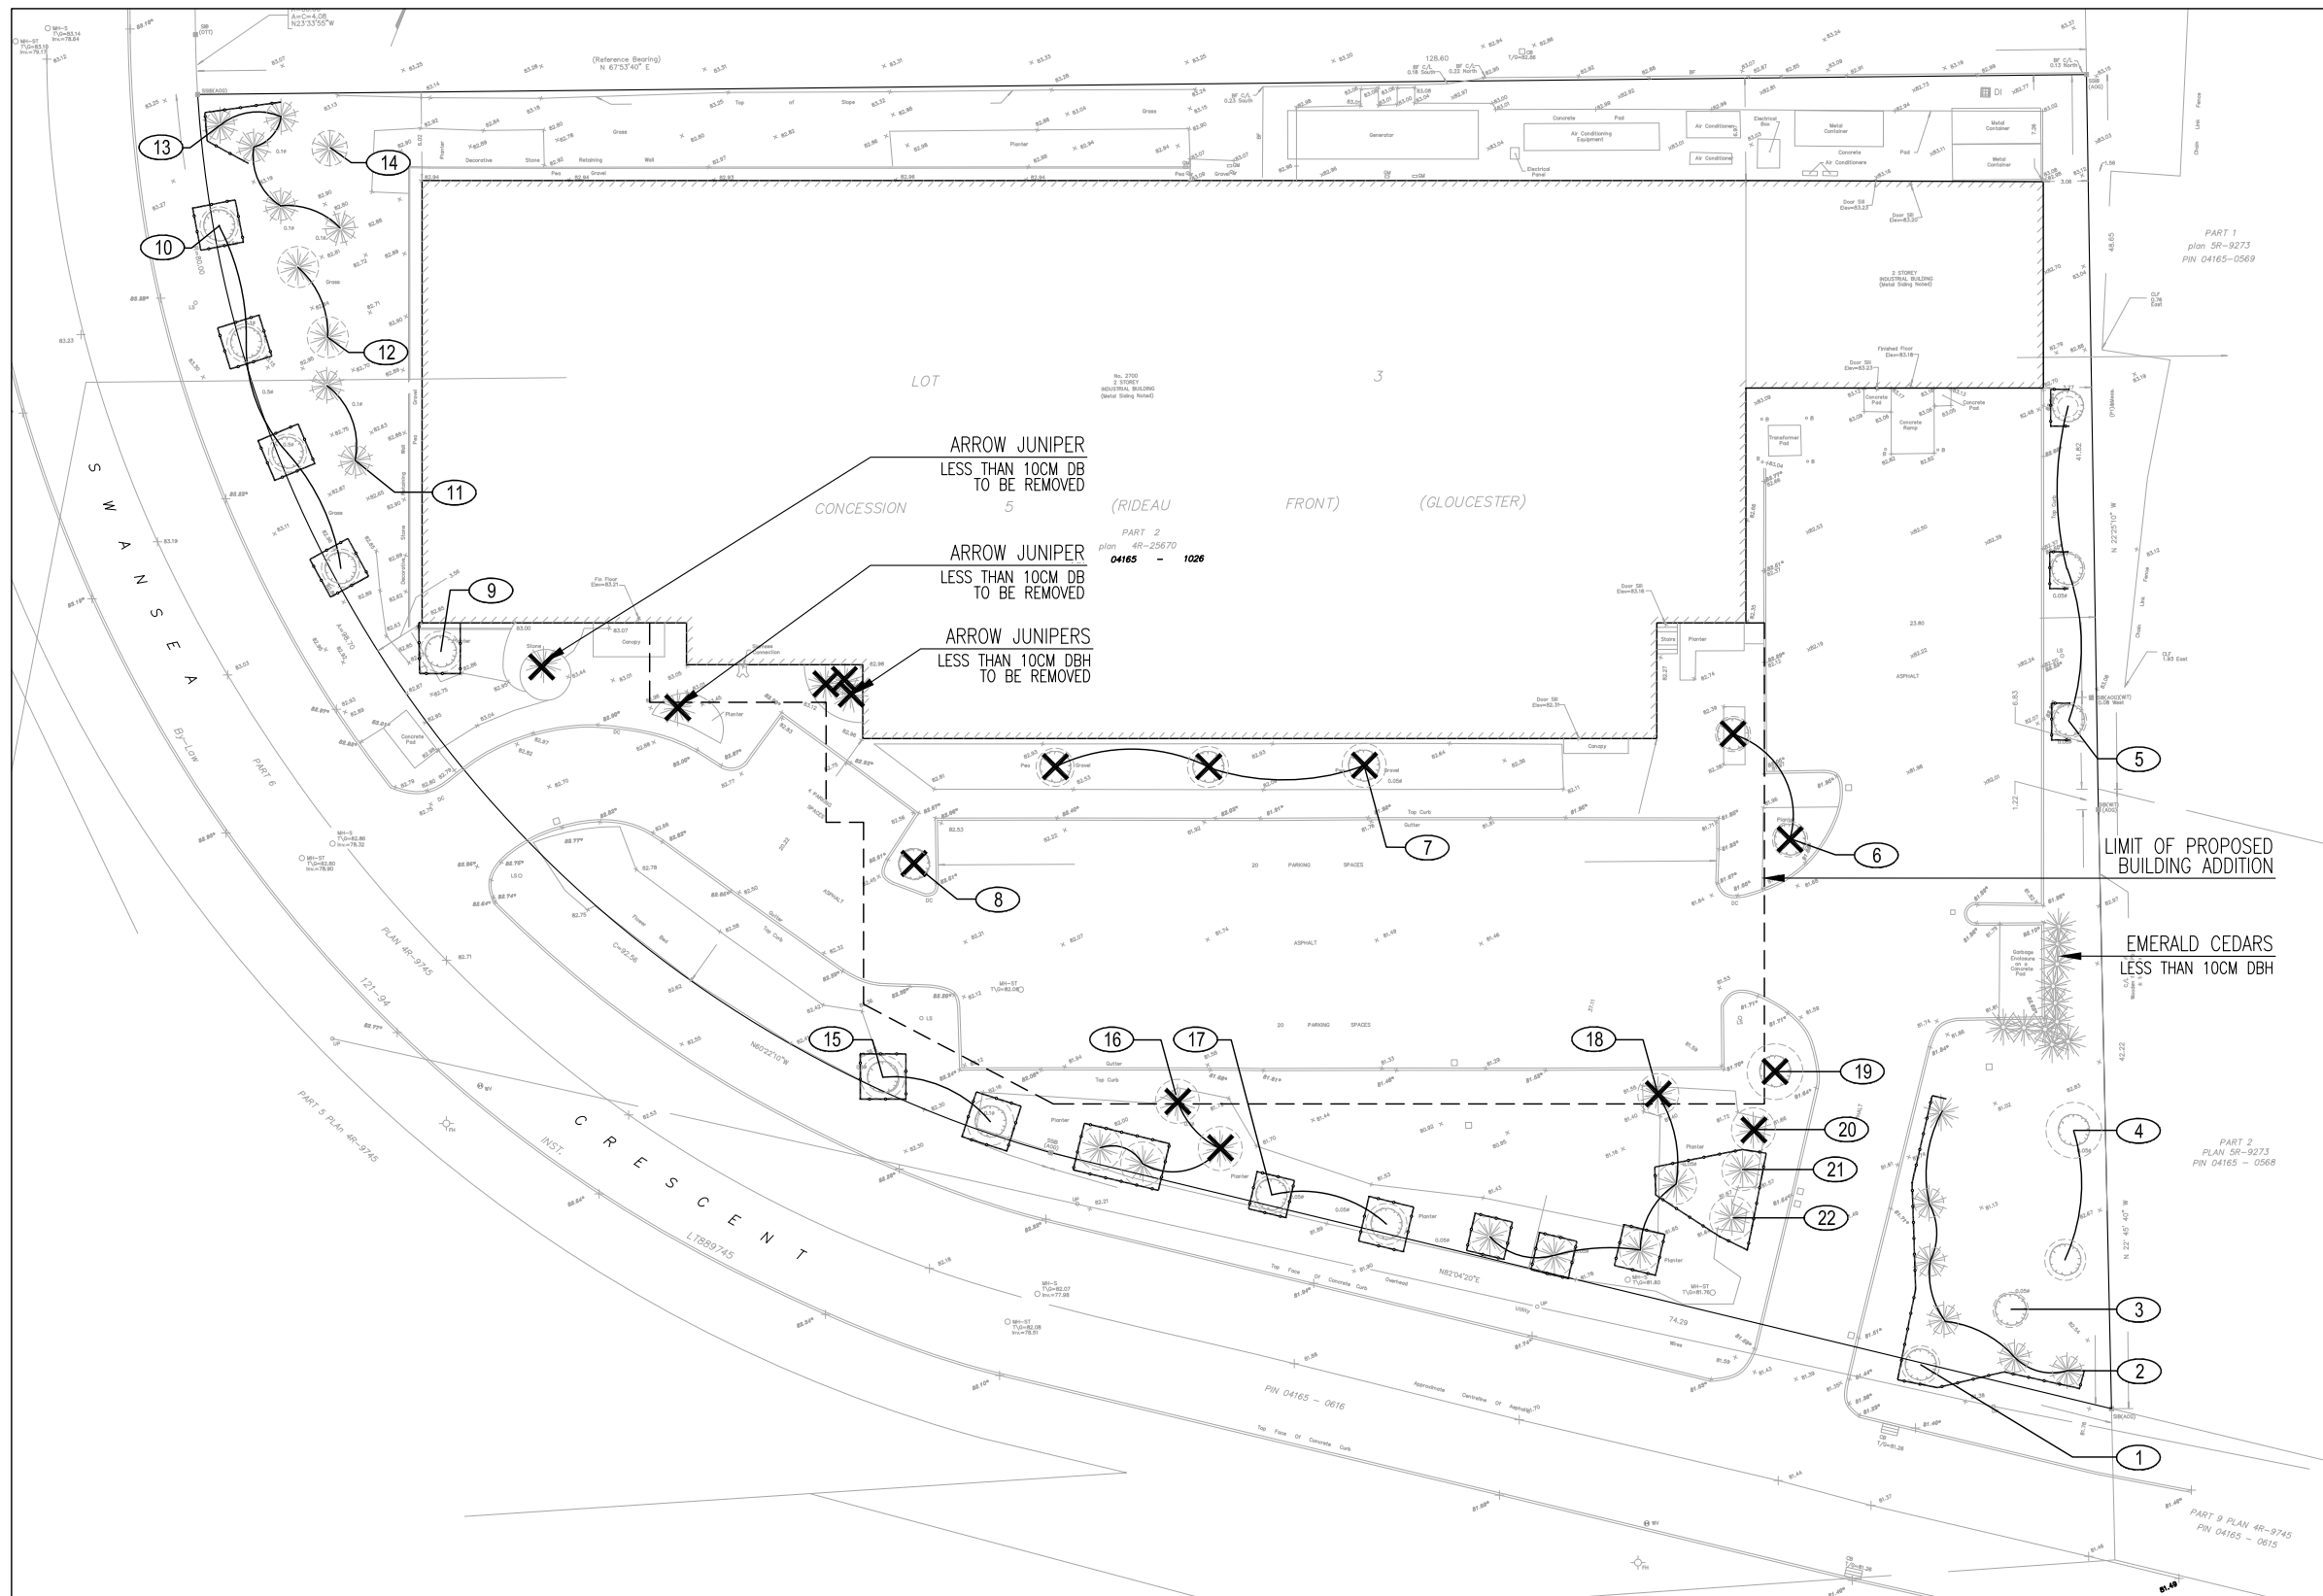
drawing MAP # 1A - CURRENT VEGETATION	
scale 1:500	date OCT 18, 2022
drawn by MR	checked by MR
project no. 22-1677	revision no. 1
dwg. no. MAP 1A

REFER TO MAP # 1B FOR TREE PROTECTION DETAIL

1. Erect a fence at the critical root zone (CRZ¹) of trees;
2. Do not place any material or equipment within the CRZ of the tree;
3. Do not attach any signs, notices or posters to any tree;
4. Do not raise or lower the existing grade within the CRZ without approval;
5. Tunnel or bore when digging within the CRZ of a tree;
6. Do not damage the root system, trunk or branches of any tree;
7. Ensure that exhaust fumes from all equipment are NOT directed towards any tree's crown.
