# TREE CONSERVATION REPORT

**1983 Carling Ave**

Tree Conservation Report submitted as Partial  
Requirements for a Site Plan Control Application

January 28, 2022

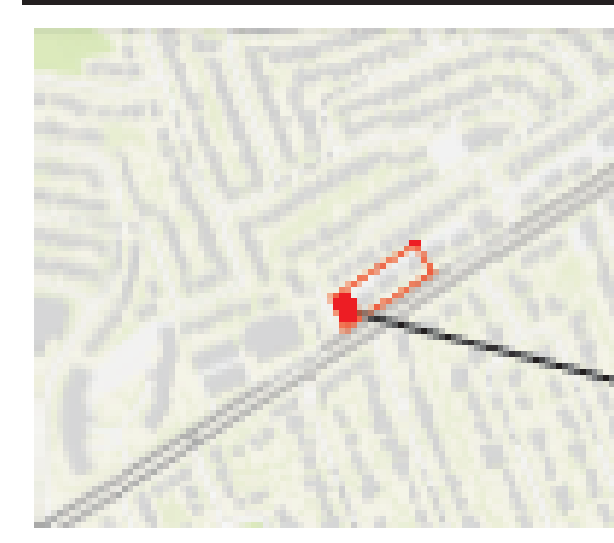
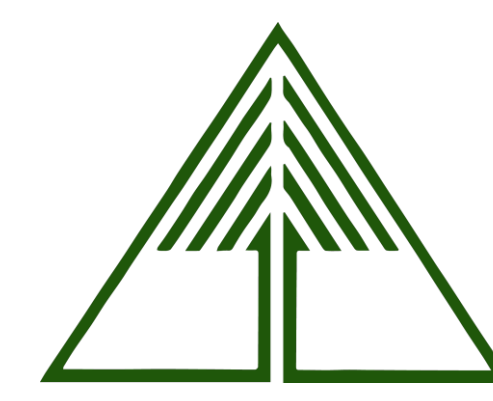
Tree Conservation Report – 1983 Carling Ave  
 Proposed Development and Conserved Vegetation (excavation zone)  
 Tree layer prepared by Dendron Forestry Services  
 Version 1.0, January 27, 2022  
 For more information, please contact [info@dendronforestry.ca](mailto:info@dendronforestry.ca)

The large bur oak located close to the sidewalk and along Carling Avenue is the tree of concern that will be most impacted by the proposed development. This tree has a diameter of 111 cm, and its root system likely extends at least 11 m in all directions, except for where there is infrastructure such as the road and building. Although the tree appears in good health, it does have some health concerns to note. The crown is extensive, but since this tree is overhanging a major thoroughfare, it has been damaged by salt spray which is visible along the south side. Also, there is a large cavity at the base of the tree that measures 80 cm long; 15 cm wide; and 40 cm deep. A metal rod was inserted and extended past the cavity wall an additional 30 cm. Therefore, the decay and cavity extend 70 m into the trunk at the widest point. The extent of decay is over 1 m up the tree in the centre of the decay column – the 1 m rod did not reach the end. These observations on decay were made using tools for a basic assessment. To understand better the extent of internal decay in this tree, a Level 3 risk assessment would be required using an advanced technique such as sonic topography or resistance drilling. These tools can map out the decay in the stem at different heights up the trunk and are relatively non-invasive. Combining these results with a good understanding of the dynamics of how internal decay impacts large oak trees would help to assess the structural integrity of the tree. Although extensive decay can give the impression of structural weakness, this may not always be the case. Trees can learn to adapt to weaknesses by refocusing their growth on strengthening their stem and reducing the crown weight naturally.

Based on the impacts to the tree as noted above, tree removal is the recommended option.
