December 9, 2022

**RE: TREE CONSERVATION INVENTORY FOR 5254 BANK STREET, OTTAWA**

Table 1. Species, ownership, diameter, condition and status of trees at 5254 Bank Street

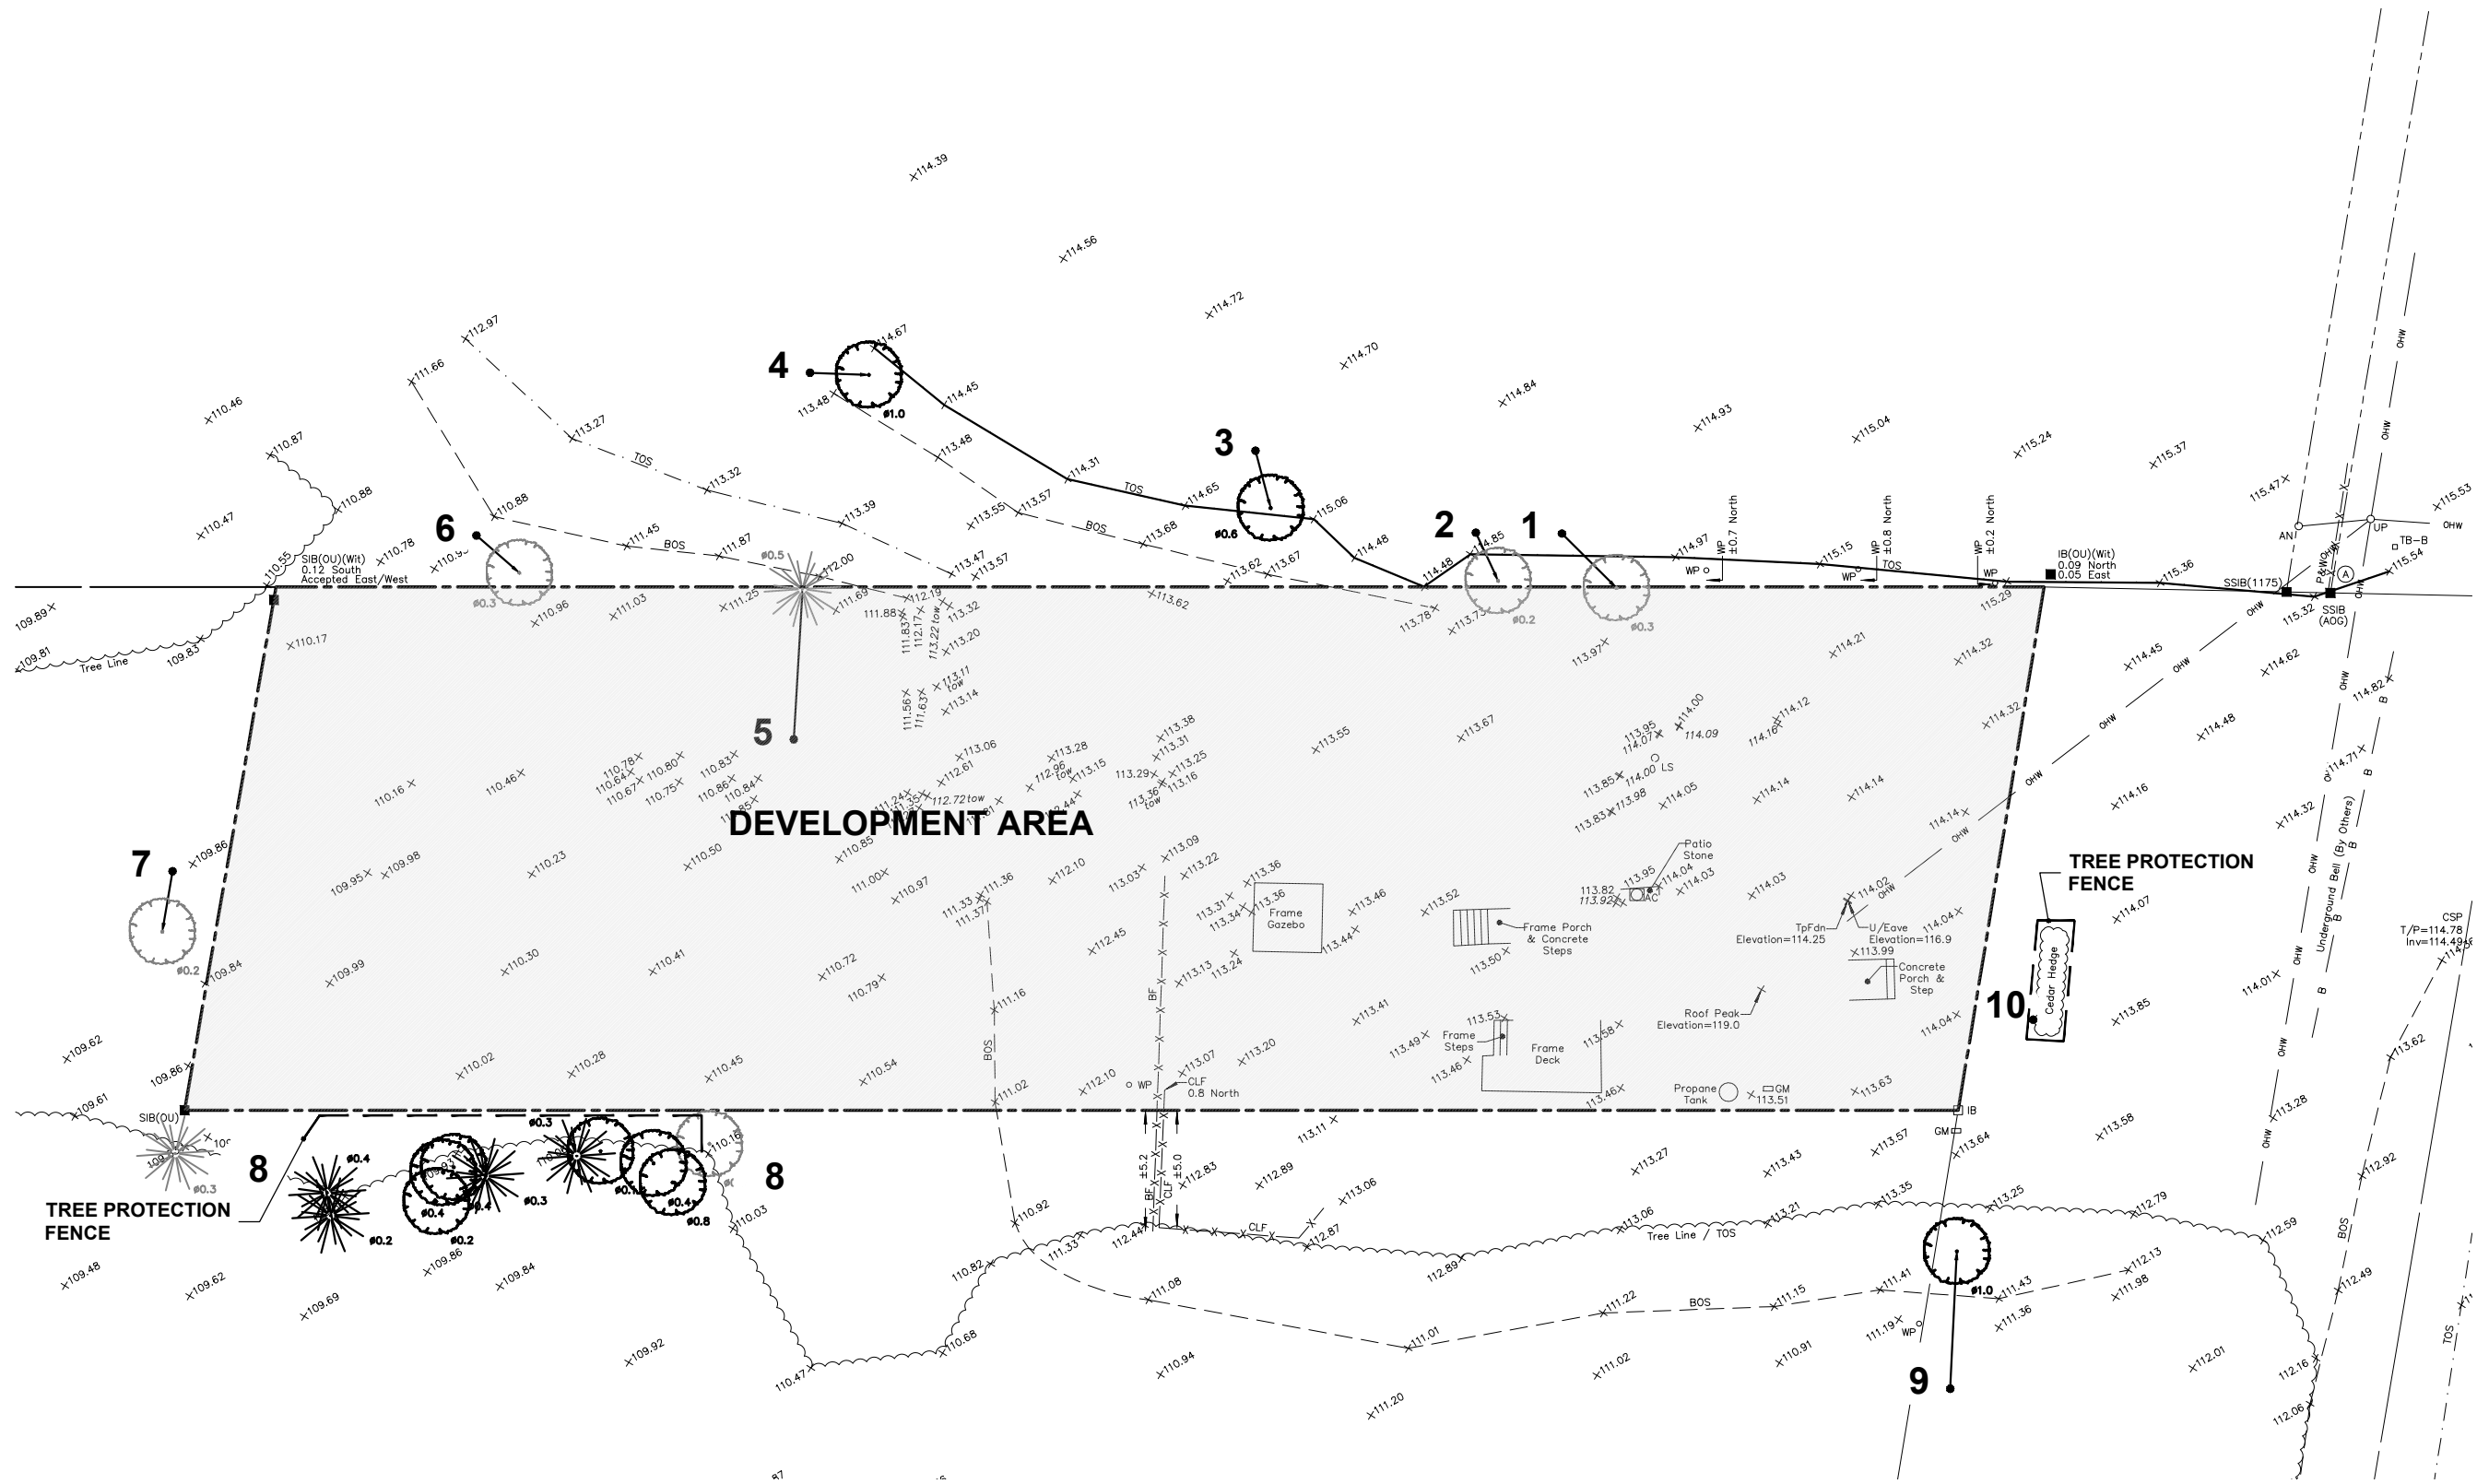
Table 1 below details the species, ownership, size (diameter), condition and status of the individual and groups of trees on the subject and adjacent properties. Each of these trees is referenced by the numbers plotted on the tree conservation plans on pages 4 (existing trees) and 5 (proposed retention) of this report.
