**PATERSON
GROUP**

July 19, 2022
File: PE4937-LET.04

Subject: **Phase I - Environmental Site Assessment Update
Navan at Renaud Road
Ottawa, Ontario**

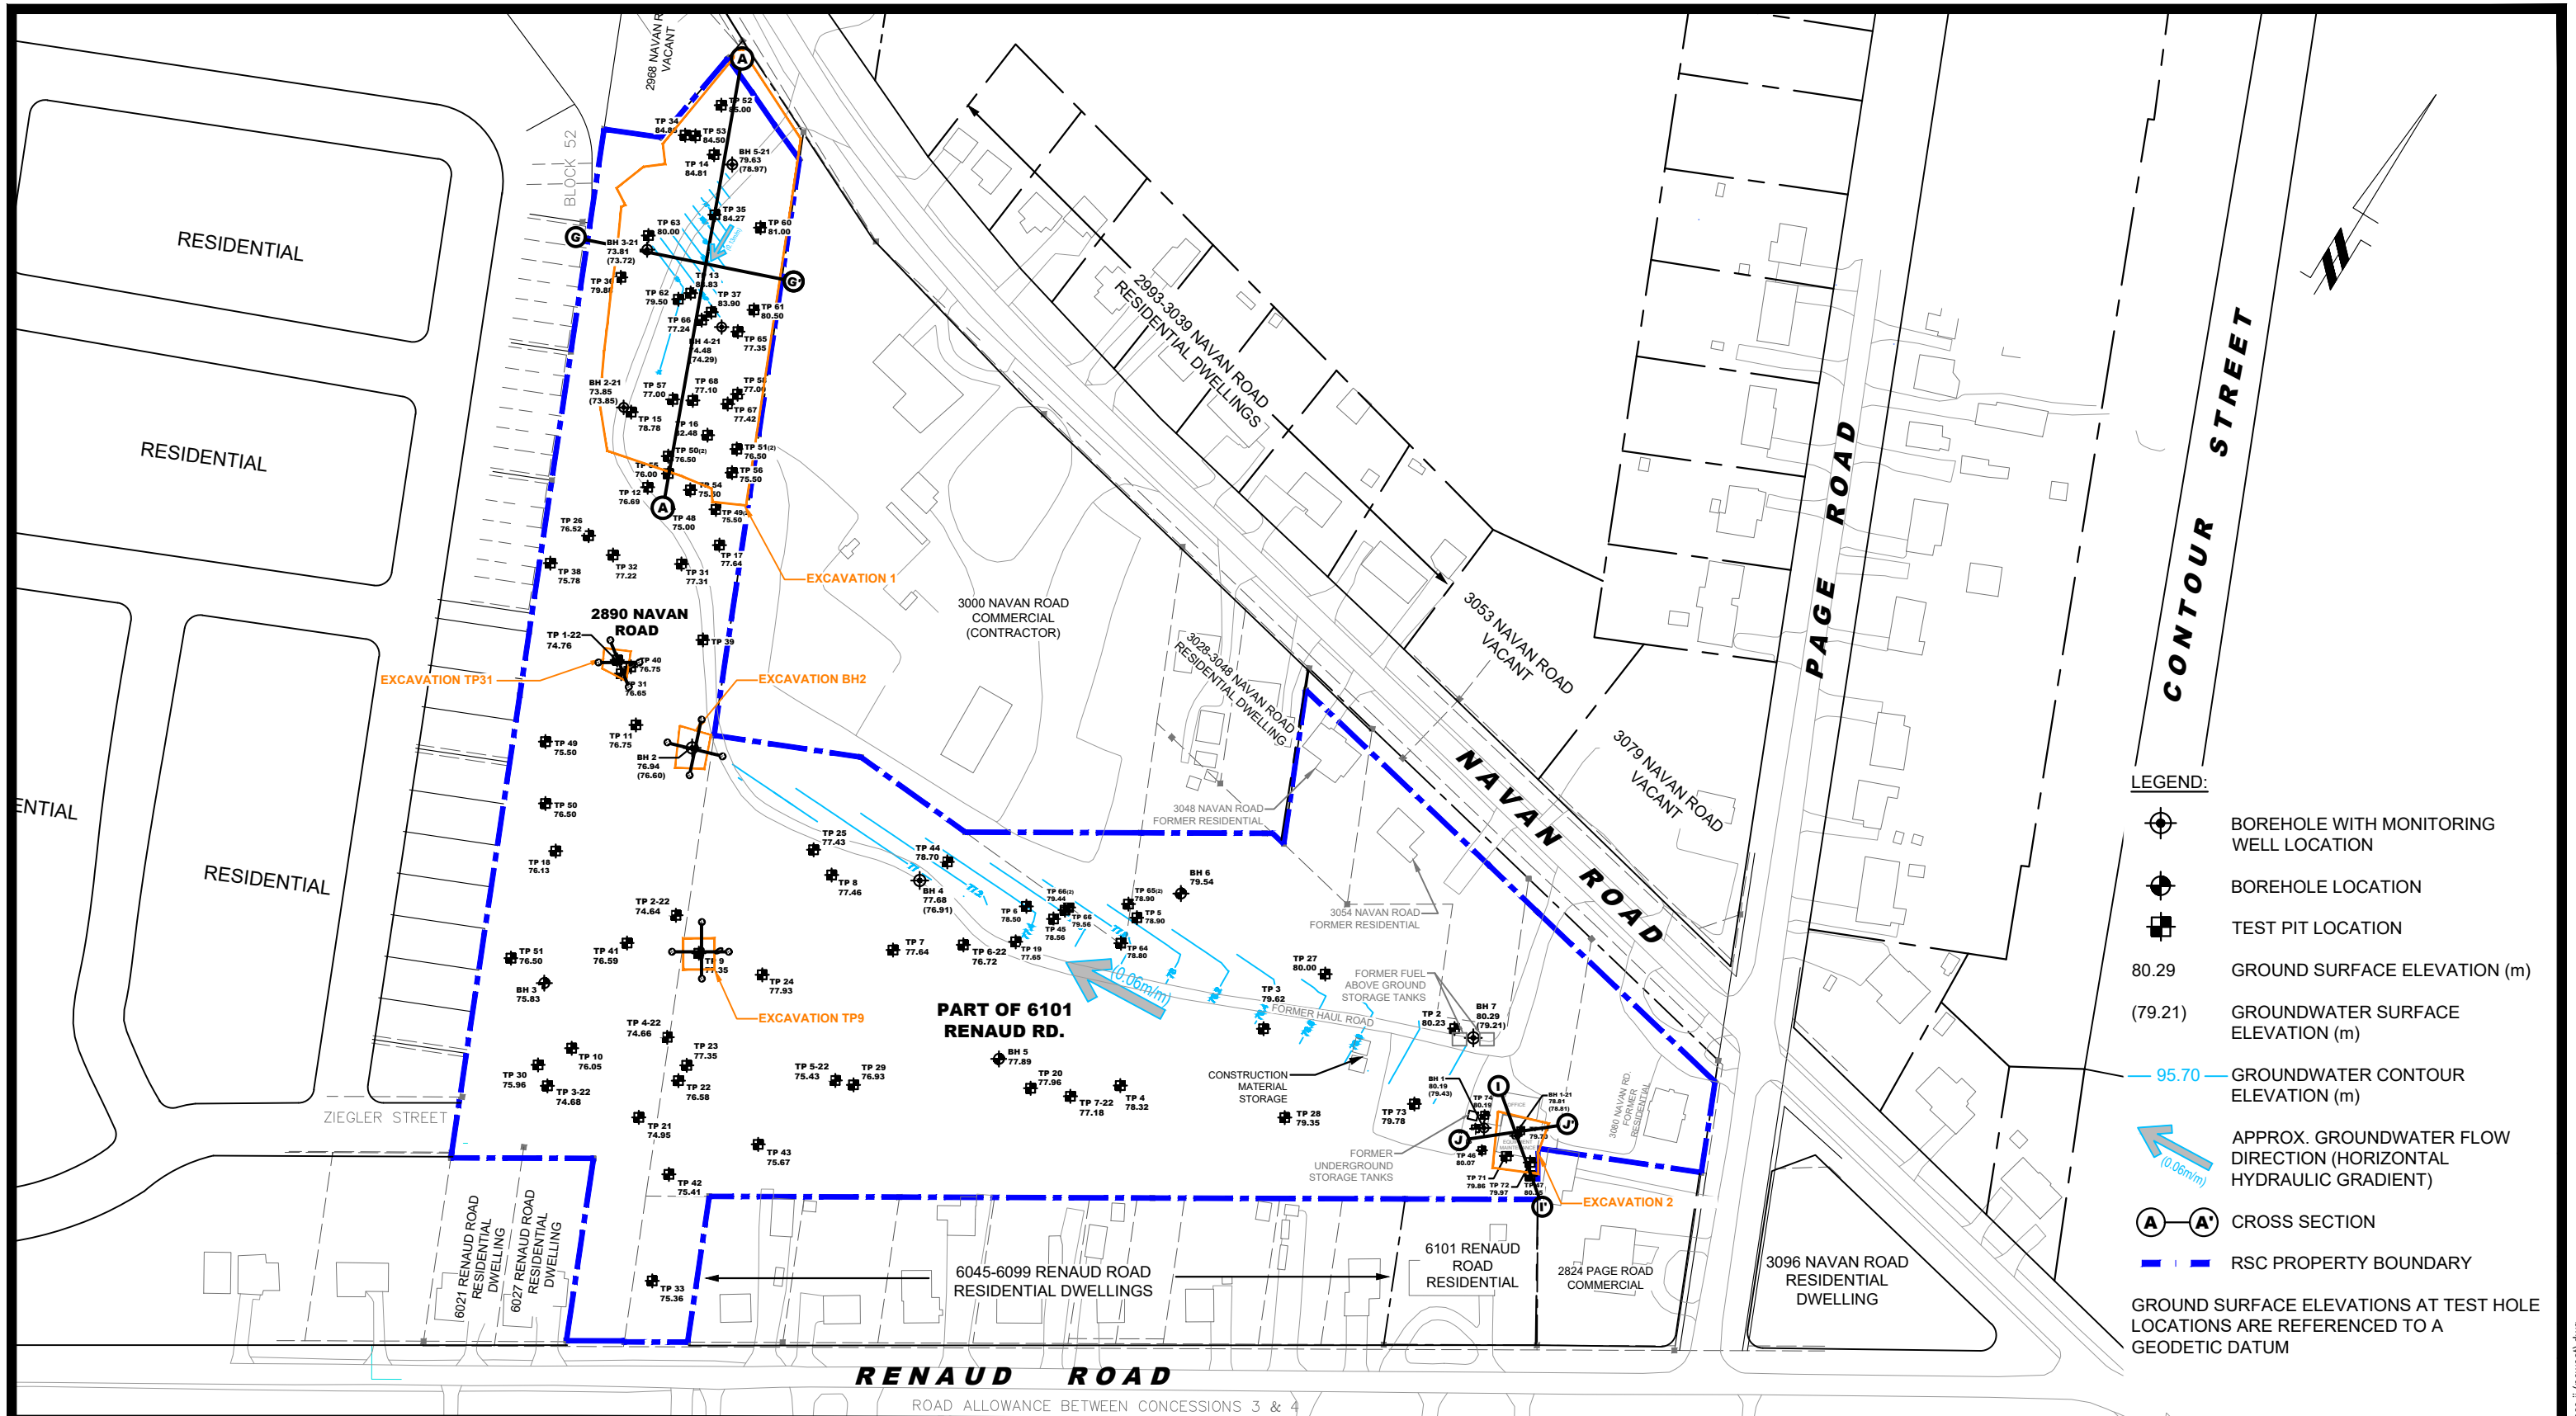
Scale: 1:1000	Report No.: PE4937
Drawn by: RG	Drawing No.:
Checked by: JC	PE4937-4
Approved by: MB	Revision No.: 0
Date: 03/2021

As shown on Drawing PE4937-4, samples from across the RSC property exceeded the Site Condition Standards (SCS) for Barium, Cobalt, and Vanadium, however the remaining metals parameters listed above only exceeded the site condition standards in the northwest corner of the RSC property.
