# UPDATED CONSERVATION PLAN CHAMPLAIN OIL COMPANY SERVICE STATION 70 RICHMOND ROAD OTTAWA, ONTARIO

SUBMITTED TO: TRINITY DEVELOPMENT GROUP INC.

PREPARED BY: JOHN STEWART, COMMONWEALTH HISTORIC RESOURCE MANAGEMENT

Updated V5 April 2023

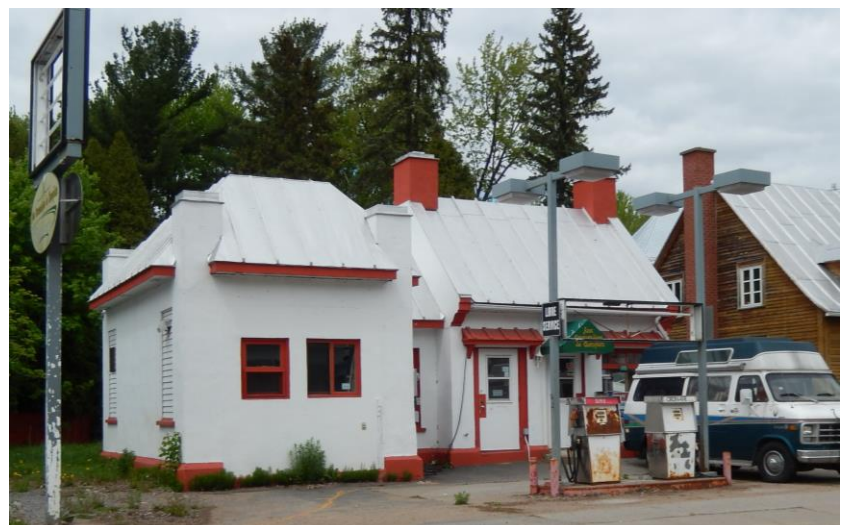
Below the example from the Municipality of Champlain near Trois-Rivieres has a similar cottage form but only a single service bay and no display section. The cottage form with standing seam metal roofs would appear to be a branding feature. The garage door has been infilled.

Figure 3 & 4: The images are two comparative examples of former Champlain Service Stations.

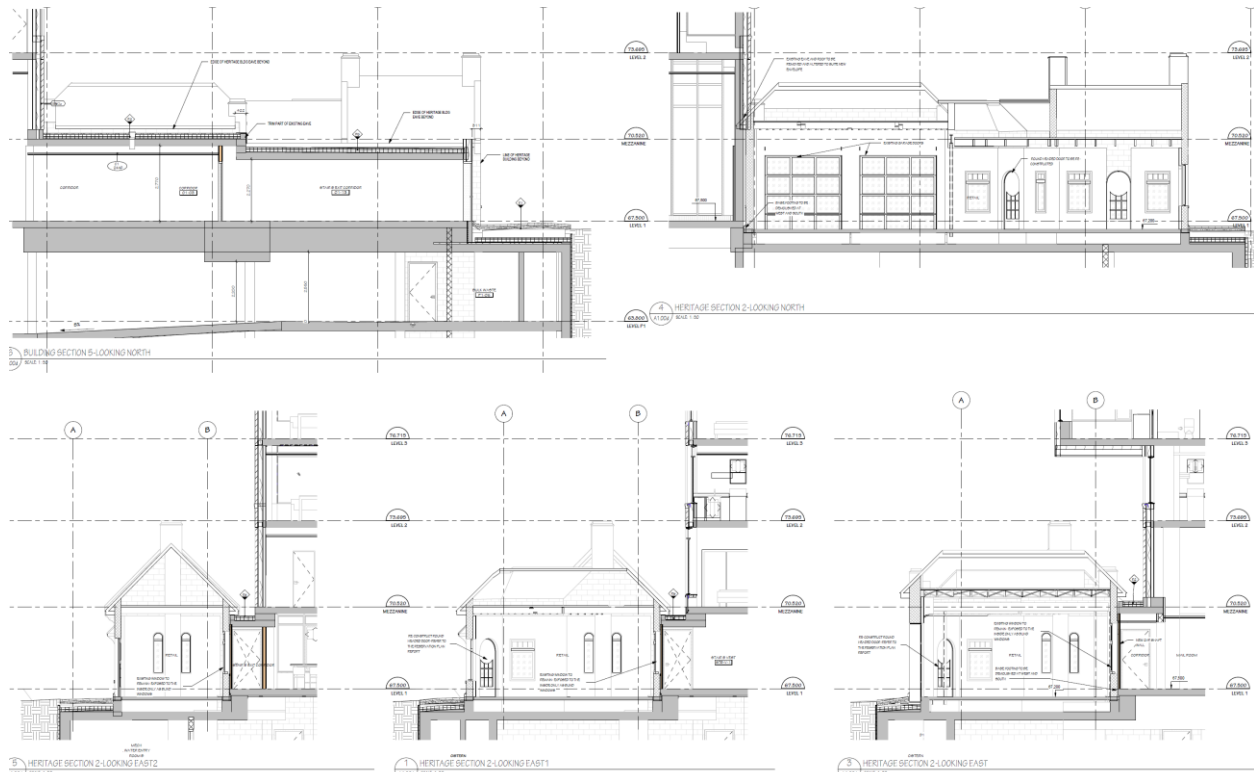
Figure 11: South Elevation: The flat roof linking the Service station to the development has been stepped to avoid damaging the stepped eaves. See yellow hi-light. Source: Hobin Architecture 2023.

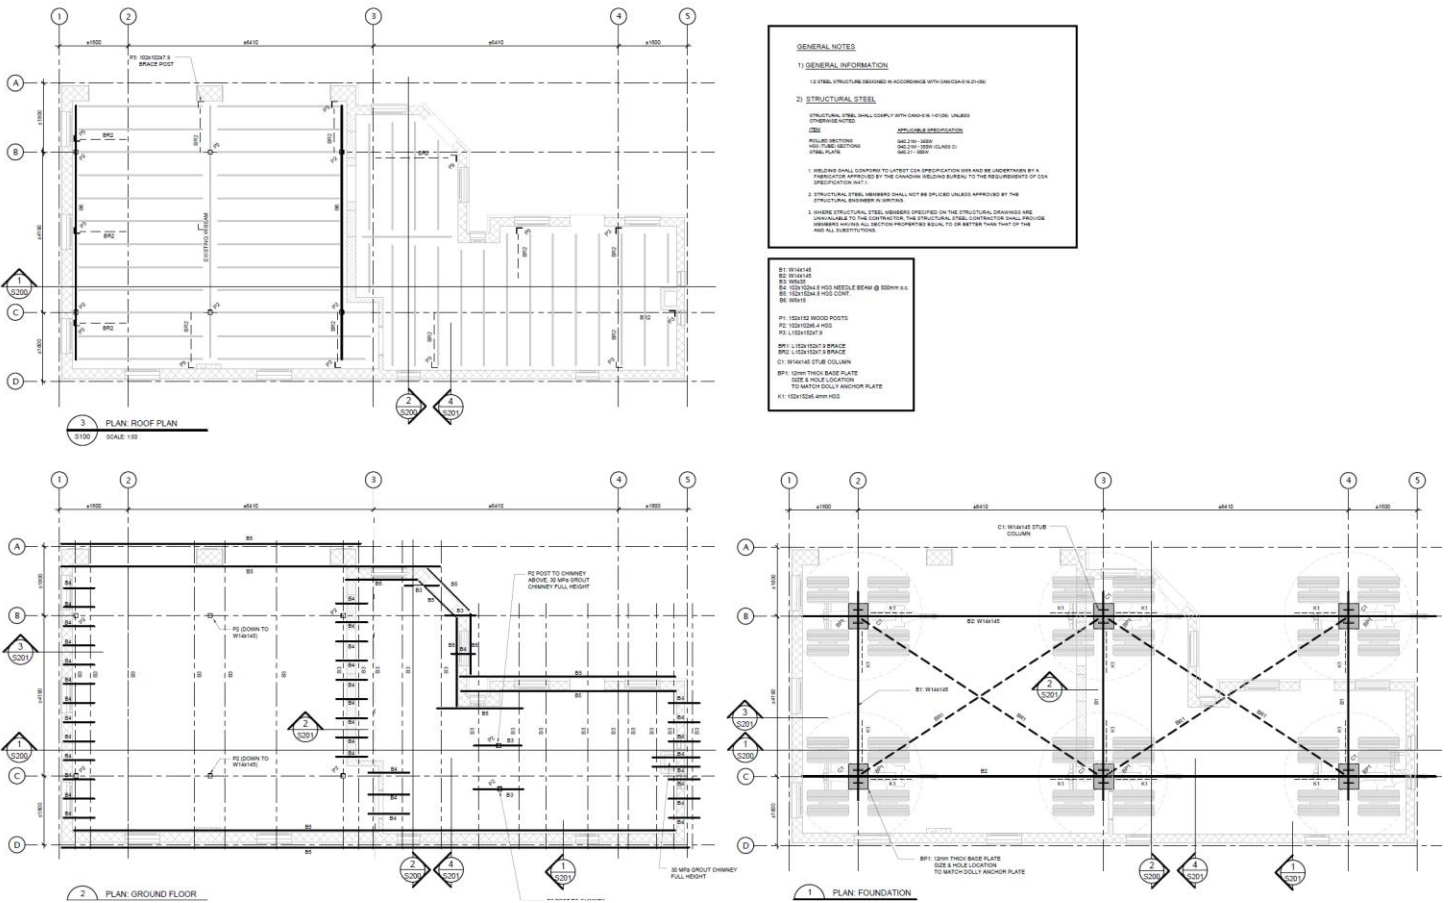
Figure 11: Positioning of structural steel and needles required to support the structure during moving. Source: Cleland Jardine Engineers. 2023.

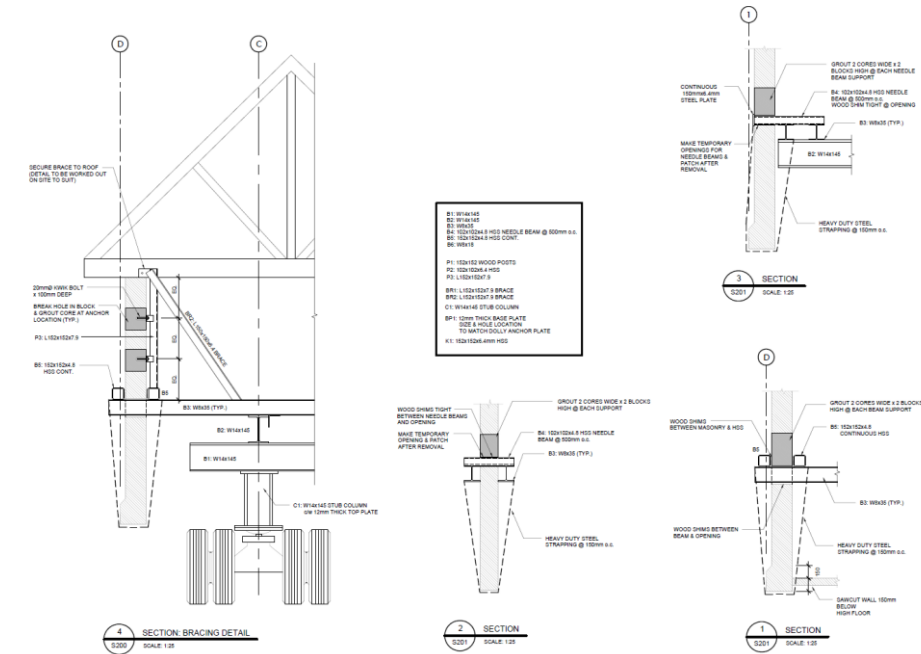
Figure 12: A series of drawings detailing the methodology for stabilizing the block walls by anchoring inserted pins in grout and introducing heavy duty steel strapping. Source: Cleland Jardine Structural Engineers 2022.

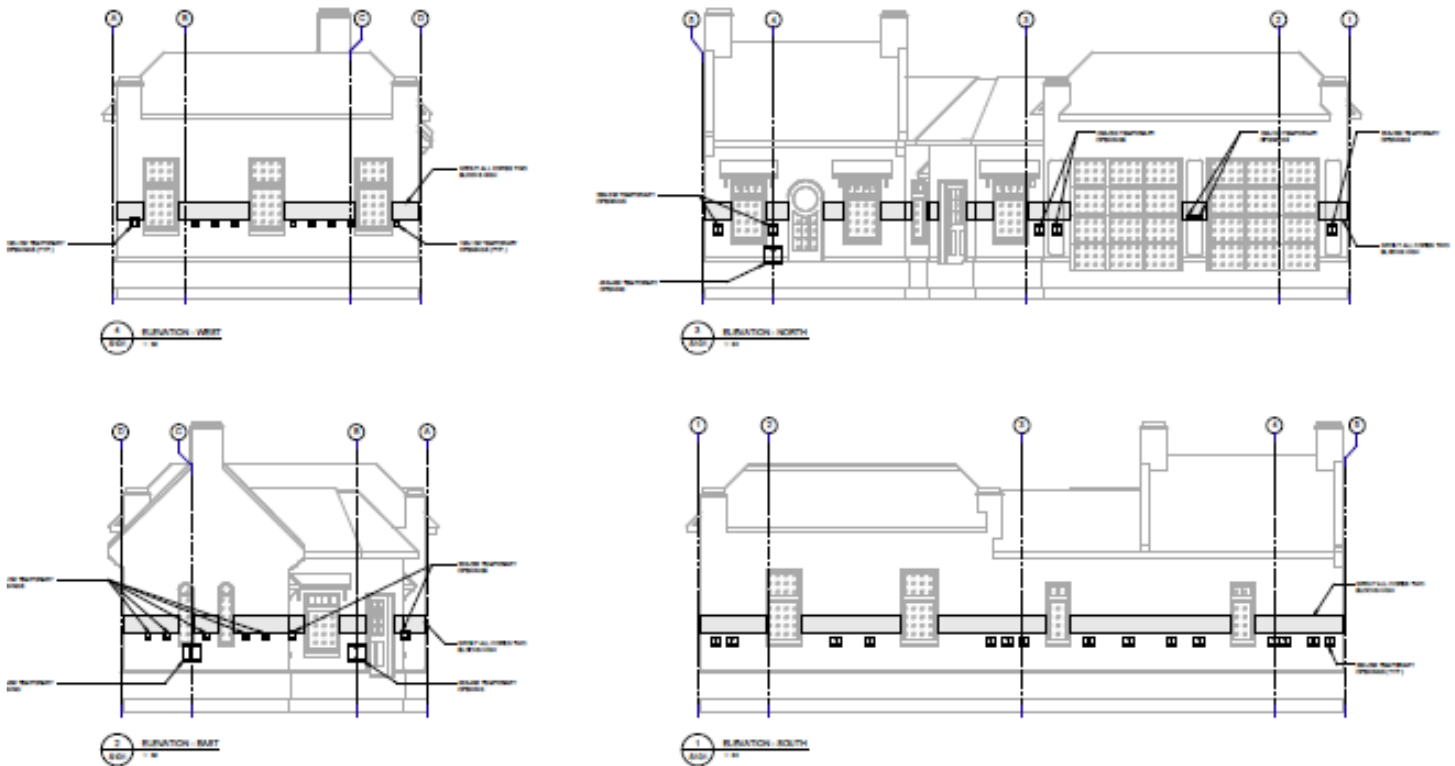
Structural Protrusions will not align with existing block coursing and removing full blocks in those areas will result in very large openings. For structural reasons, the openings should be as small as possible in order to leave as much masonry in place as possible. Since the stucco on the exterior will be patched and reparged, and the interior will be insulated and clad with drywall, openings should be cut out as required and later patch with new blocks and grout. Cleland Jardine Engineers. 2023.

Figure 13: The elevations document the openings required to stabilize the block walls. The attached drawing S101 indicates the location of masonry openings. Source: Cleland Jardine Engineers. 2023.

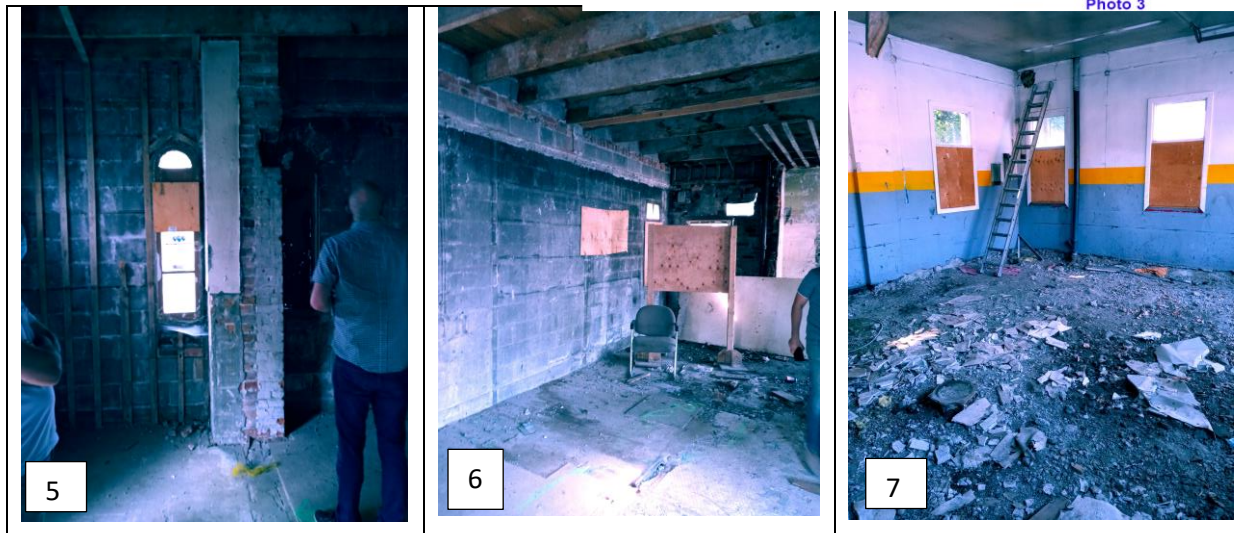
Figure 20: Interior views; 5. Looking towards the east wall with round headed windows on either side of the chimney. View 6. And 7. Interior views of transition area and the service bays. Source Commonwealth 2021

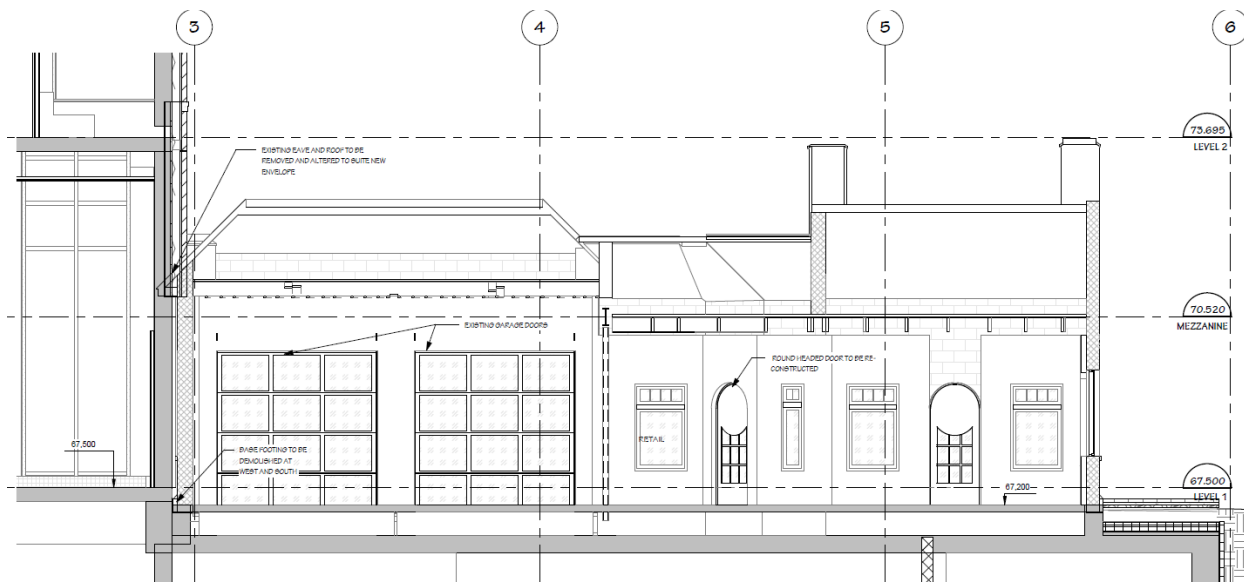
HERITAGE SECTION 2-LOOKING NORTH  
SCALE: 1/8"=1'-0"

Figure 11: Section looking north with the West wall indicating the structural shear wall will block three windows along the west elevation.

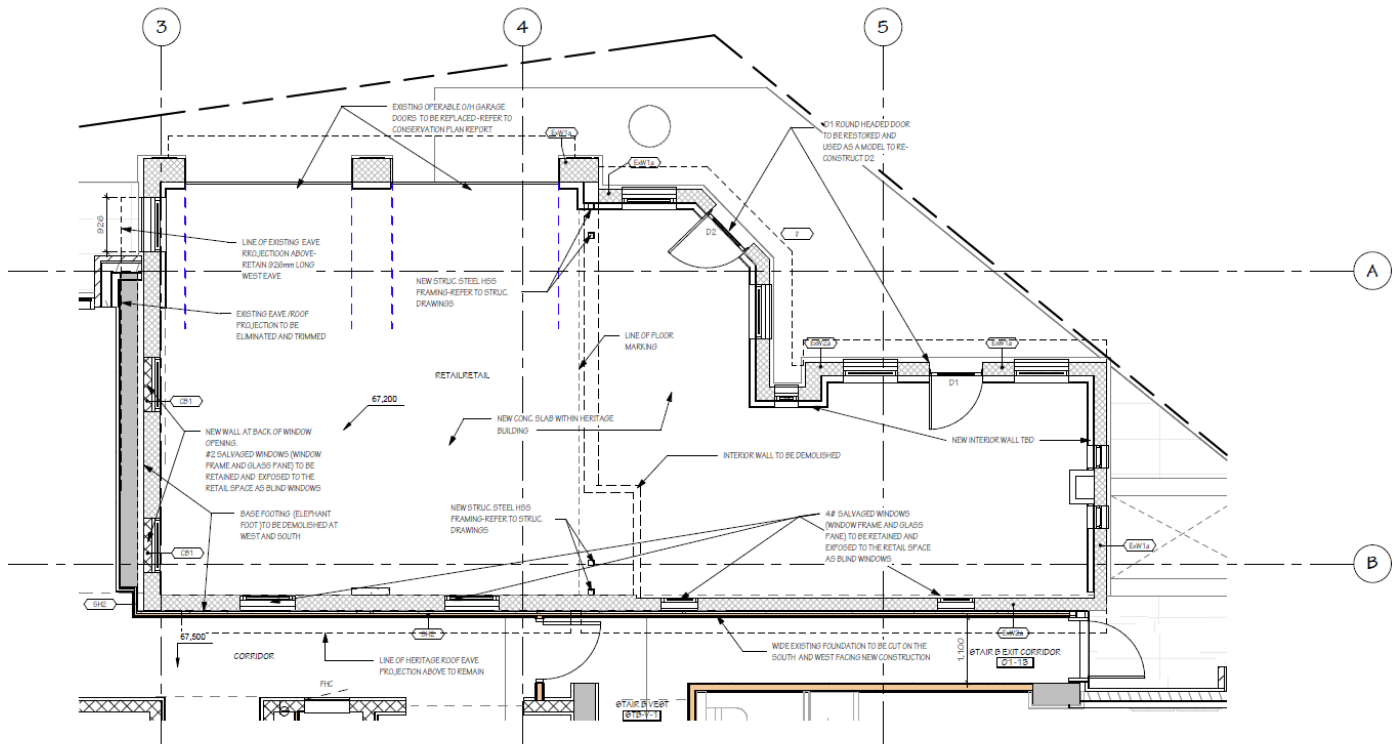
1 01-LEVEL 1-HERITAGE FLOOR PLAN  
A1.00c SCALE: 1:50

Figure 12: Retail floor plan documenting the areas of impact. Source: Hobin Architecture 2023.

- removal of the interior dividing wall,
- setting the floor level at 67.2 throughout,
- placing a shear wall adjacent to the Service Station west wall,
- Maintaining all of the windows along the west and south facades.
- Installing a 2-hour fire rated wall on the exterior south elevation.
- Insulating exterior walls and covering walls and ceiling with drywall or equivalent.

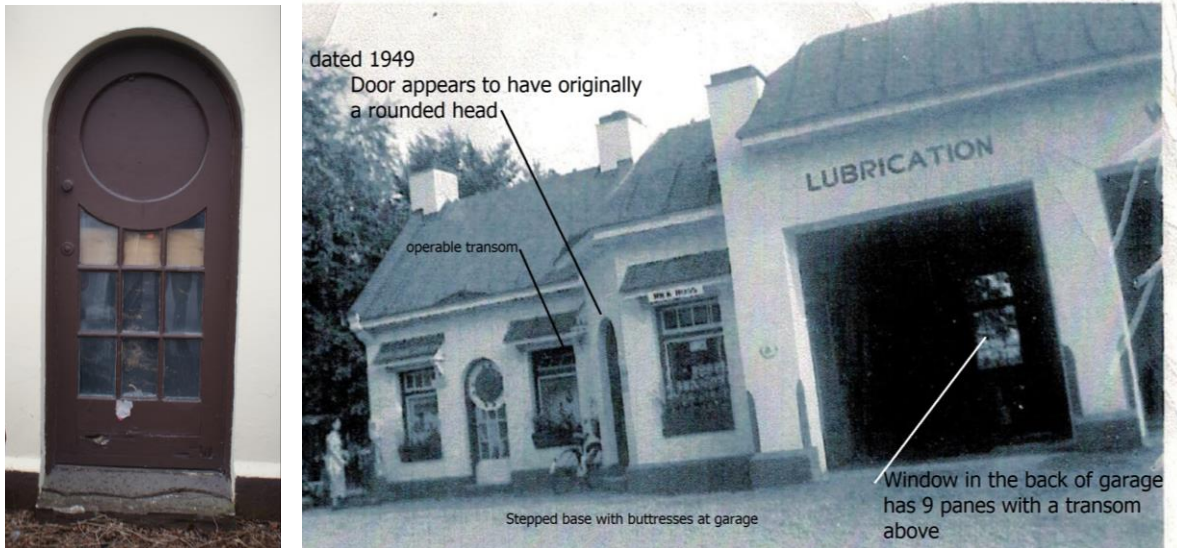
Figure 12 : Circa 1949 – 50. The historic view of the Service Station provides reference information supporting the conservation of the round headed doors at both entrances. Other features include the stepped foundation with chamfered treatment at the base of the service bay entrances. Over time, the scale of the stepped foundation has been reduced as grade was raised with the addition of asphalt. Source: Ottawa Archives, John Newcomb Collection.

The distinctive entrance door to the office will be retained and preserved, as will the awnings above the windows and doors. The round-headed door will be repaired as necessary and used as a model for the reconstruction of the second door, which had been altered at some time.
